Field Investigations of Selected Strategies To Reduce Reflective Cracking in Asphalt Concrete Overlays Constructed over Existing Jointed Concrete Pavements

ERIC D. MOODY

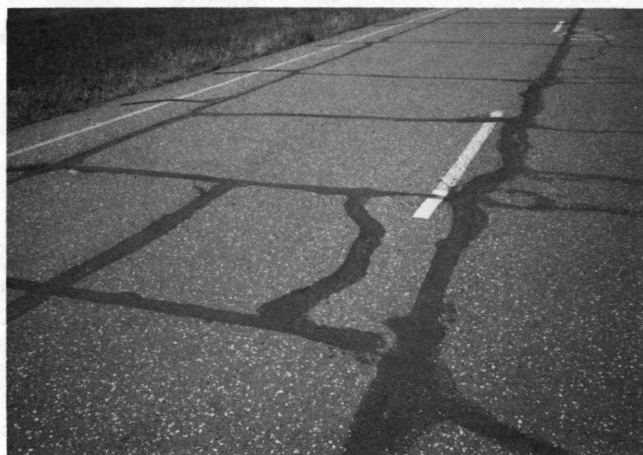
The typical distresses on the test site pavement include pumping, reflective cracking of the AC overlays, joint failures, and some shattering of the original concrete slabs. Figure 1 shows a typical section of this pavement after maintenance crews have sealed both the longitudinal and transverse reflective cracks in the AC overlay.

FIGURE 1 Reflective cracking typical of test site location.

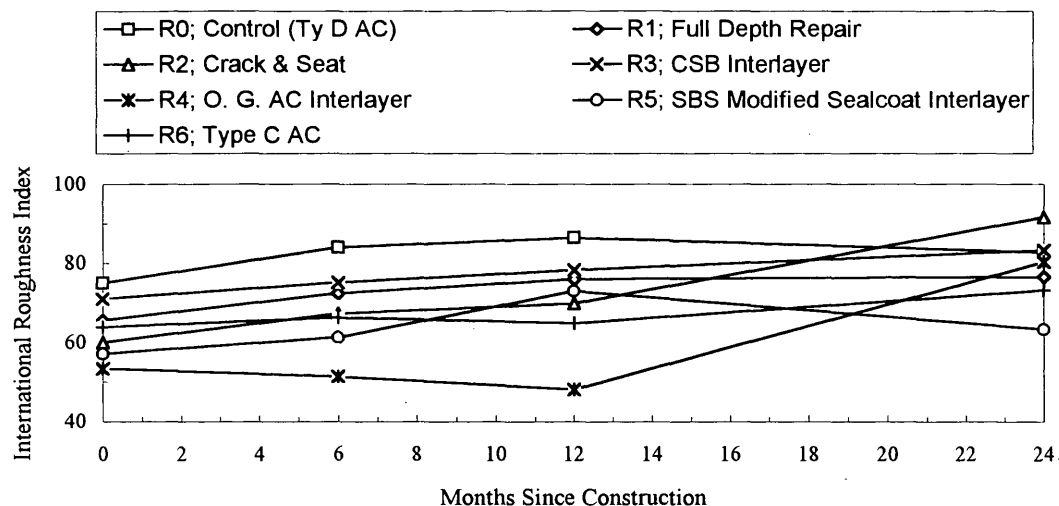
Although the results of the profile measurements of the inside lane included more variability, the IRI values are still relatively low, ranging from 50 to 90, indicating a relatively smooth pavement with high serviceability [present serviceability index (PSI) > 4.0]. The outside lane has shown a considerable increase in roughness, with IRI values increasing from a range of 60 to 75 to a range of 70 to 140. The averages for both the inside and the outside lanes are presented in Figure 6. The most substantial in-

FIGURE 4 International roughness index (inside lane).

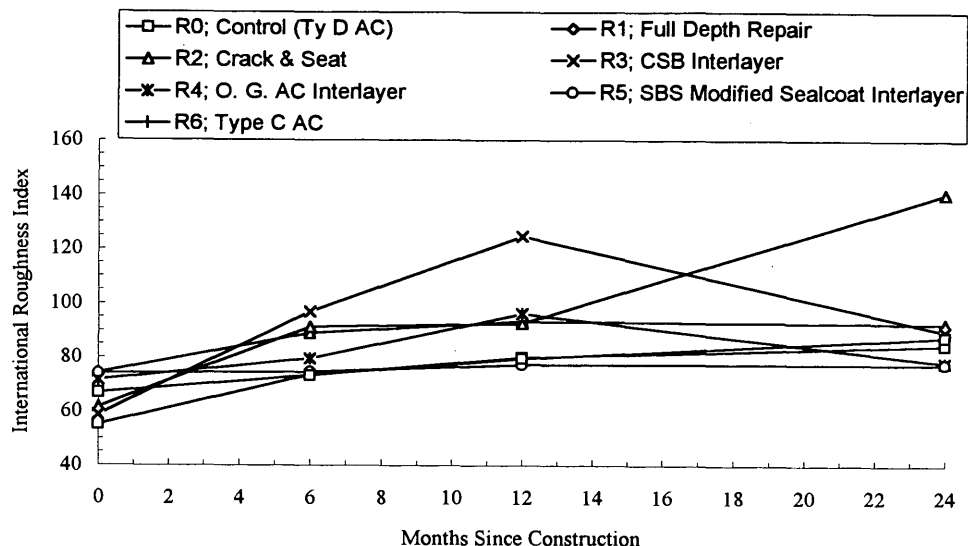
FIGURE 5 International roughness index (outside lane).

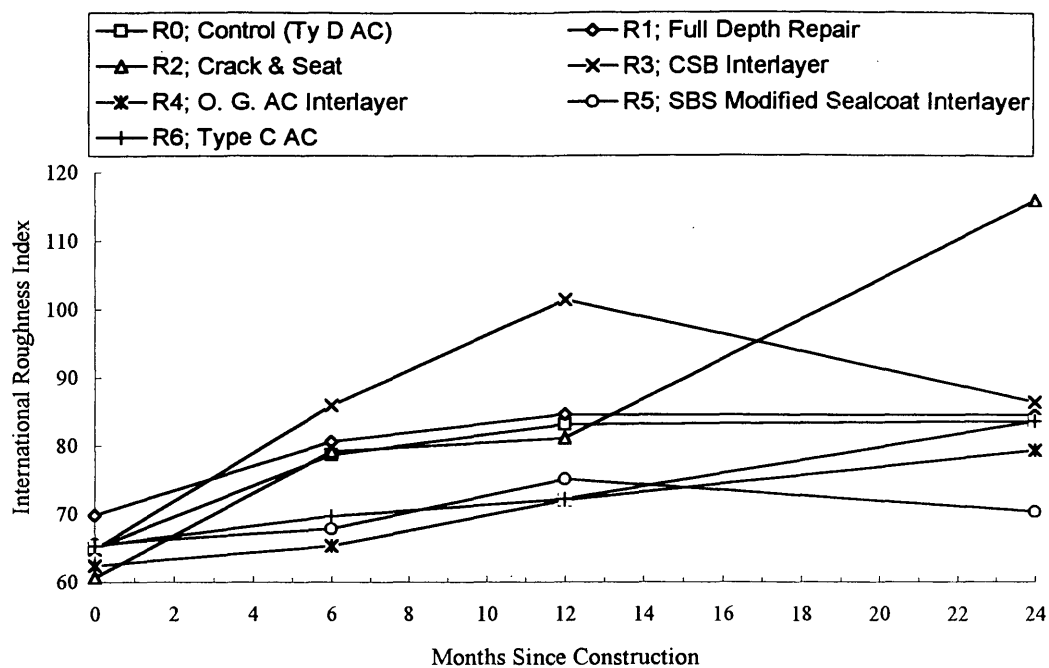
creases in roughness have occurred in Test Sections R3 and R4; however, they are still providing good serviceability ($PSI > 3.25$).

FIGURE 6 International roughness index (average of both lanes).

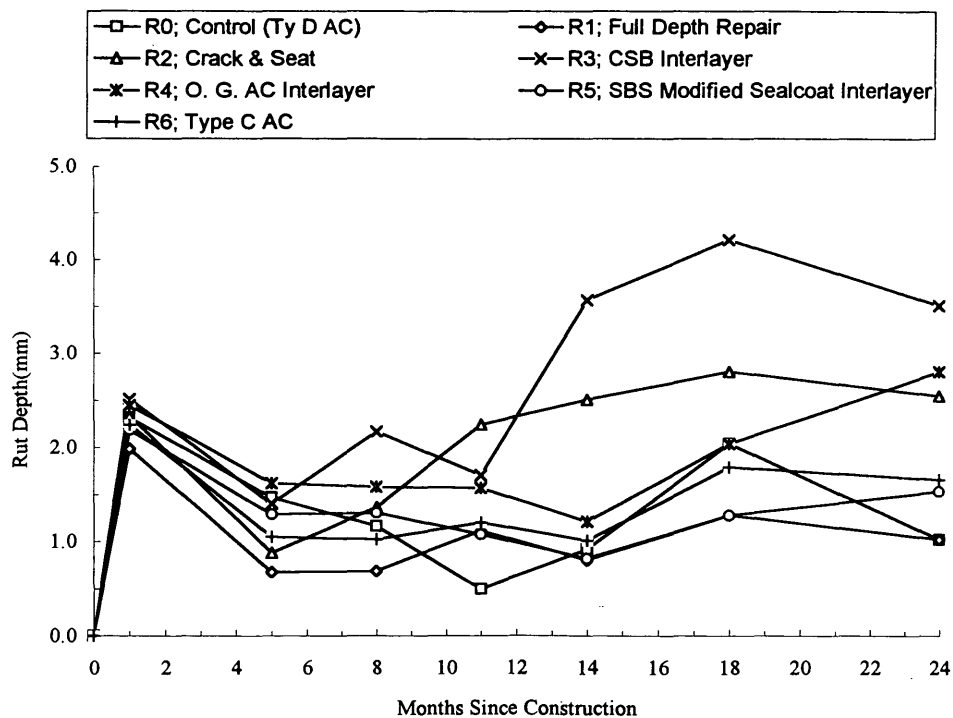
In developing the test section designs there was concern that in an attempt to eliminate reflective cracking with various stress relief layers a significant increase in the degree of rutting would result. With the exceptions of Test Section R3, the CSB interlayer, this has not proven to be the case. As shown in Figures 7 and 8 the rut depths have been minimal during the first 18 months of test section performance, ranging from 0.63 to 4.5 mm (0.025 to 0.18 in.). The CSB interlayer test section (Test Section R3) is the exception. Rut depths of 2.5 mm (0.1 in.) were measured in this test section after only 1 month of heavy traffic. These rut depths

FIGURE 7 Rut depths (inside lane).

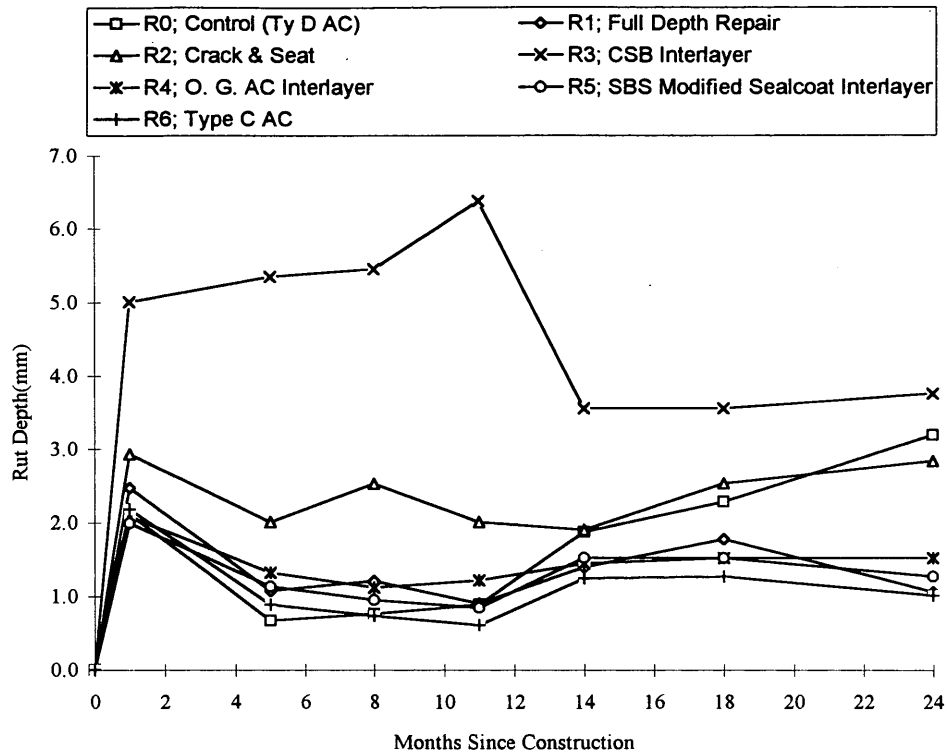
stabilized during the subsequent 17 months of performance at approximately 4.5 mm (0.17 in.).

FIGURE 8 Rut depths (outside lane).

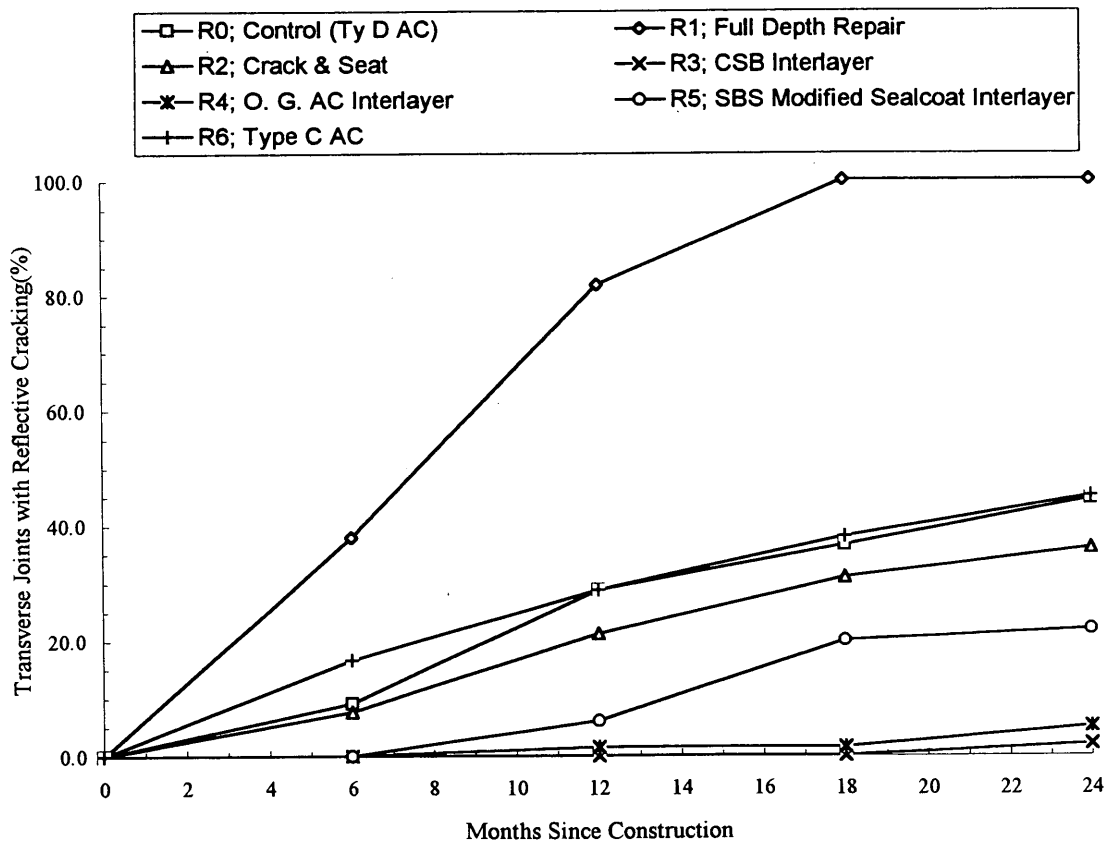
Test Section R4, the open graded AC interlayer, and Test Section R3, the CSB interlayer, have shown no reflective cracking. The control section (Test Section R0), crack and seat section (Test Section R3), and the 3-in. Type C AC section (Test Section R6)

FIGURE 9 Transverse joints showing reflective cracking (percent).

have shown moderate reflective cracking of 20 to 35 percent. The full-depth Repair section (Test Section R1) has shown the most reflective cracking, with 100 percent of the transverse joints reflecting through the Type C AC overlay after 2 years of service. All existing AC was removed on this section prior to placing the AC overlay. This essentially eliminated all stress relief between the existing JCP and the newly placed AC overlay, which has resulted in the extensive reflective cracking.

To date the reflective cracks have not been sealed with hot poured rubber. However, when these cracks are sealed the costs will be documented.
