Compacted Clay Embankment Failures

ZENON G. KYFOR AND RAYMOND L. GEMME

Embankment instability that occurred along several completed sections of a major interstate highway located in the western part of New York State is described. The affected embankments ranged in height from 4.6 m (15 ft) to 9.15 m (30 ft) and were constructed of silty clay over a silty clay foundation. Field investigations revealed that movements were taking place within the embankments and were not a result of the foundation soil. These movements were consistent with an undrained mode of failure. The embankment material was obtained from borrow excavations made outside the project limits and classified as a medium to highly plastic clay. The moisture contents of the borrow ranged from 25 to 55 percent and the plasticity index ranged from 15 to 32 percent. Drill holes progressed through the affected fills indicated that the embankment moisture contents at the time of distress exceeded the optimum moisture content (20 percent) by 5 to 10 percent based on a standard Proctor compactive effort. The undrained shear strengths at these moisture contents were not sufficient to provide for internal stability of the emb

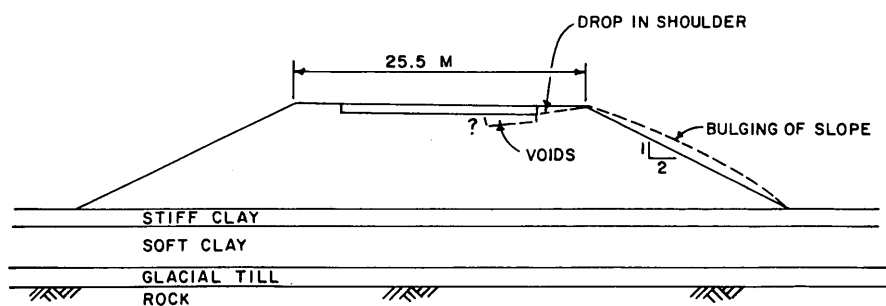
FIGURE 3 Embankment geometry showing embankment distress.

Several months after project embankments were completed and pavements were in place, three embankment areas (Figure 2) began experiencing unexplained movements (Figure 3). Eventually all embankments greater than 4.6 m (15 ft) in height would experience similar movements. The southbound (Area 1) and northbound (Area 2) lanes of the project mainline were paved with concrete, whereas the third, designated the UWLS ramp (Area 3), was paved with asphalt. The fill heights of the southbound lanes, northbound lanes, and UWLS ramp were 7.6 m (25 ft), 6.1 m (20 ft), and 9.2 m (30 ft),

The northbound lanes had experienced movements similar to those on the southbound lanes; however, they were more pronounced. The asphalt shoulder had dropped vertically 51 mm (2 in.) to 76 mm (3 in.). A separation between the shoulder and concrete pavement was measured to be 25 mm (1 in.).

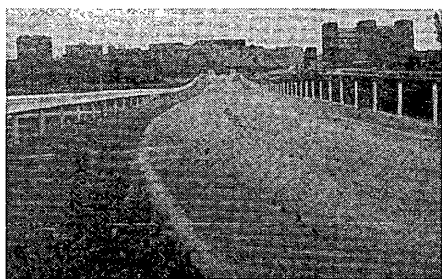
Of the three embankments, the movements that had occurred on the UWLS ramp were the most visually dramatic. In October of 1982, a crack 30.5 m (100 ft) long was noted along the centerline of the ramp (Figure 6) and a small bulge existed along the bottom portion of the embankment slope above the berm. The initial crack was approximately 25 mm (1 in.) wide and 77 mm (3 in.) deep. By February 1983, the crack was 61.0 m (200 ft) long and the asphalt pavement had dropped vertically 0.8 m (2.5 ft) (Figure 7). By this time, a large bulge was apparent in the slope.

FIGURE 6 Crack developing on UWLS ramp, October 1983.

Recommendations were made to stabilize all the project embankments that were greater than 4.6 m (15 ft) high. Stabilization consisted of flattening the embankment side slopes because material was readily available and right-of-way was not a problem. Based on an average fill height of 6.1 m (20 ft), a required F.S. of 1.25, and an undrained shear strength of 14.4 kPa (300 psf), the slopes were flattened to 1 (vertical) on 3.5 (horizontal).

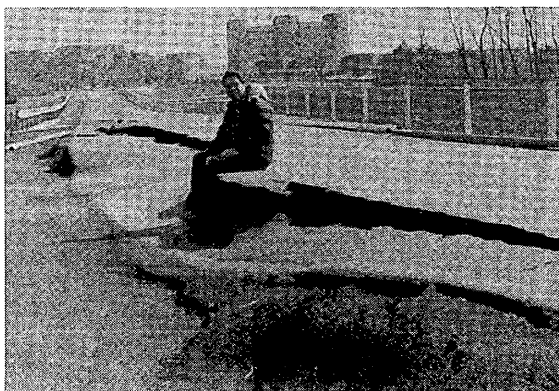
FIGURE 7 Drops of 2 to 3 ft on one side of UWLS ramp, February 1983.

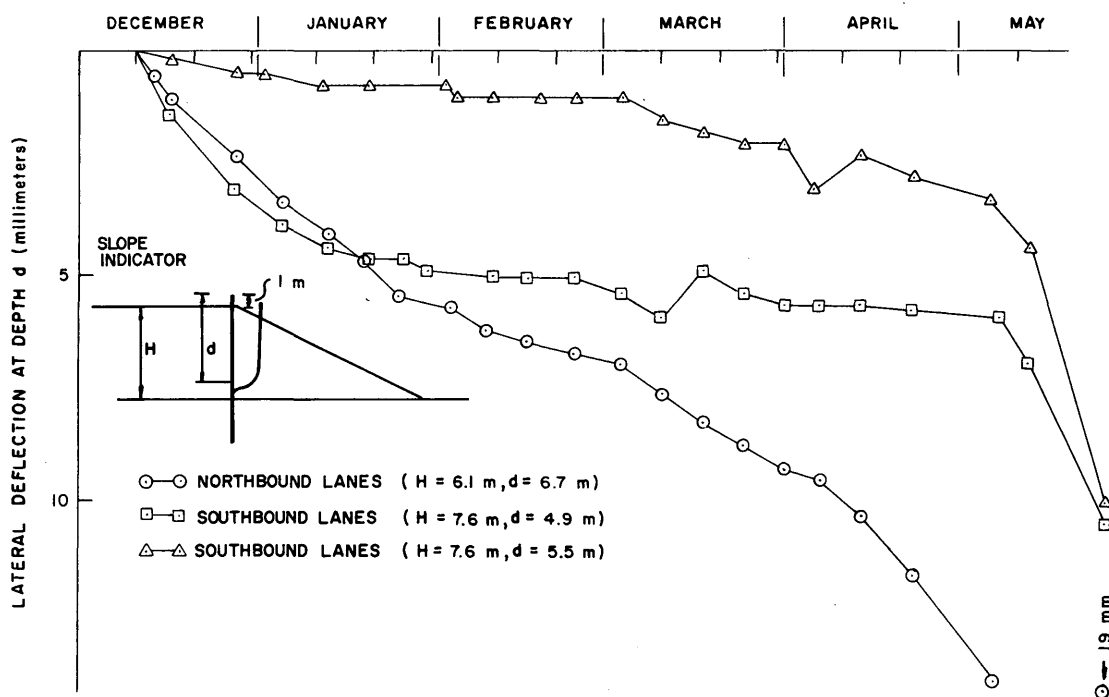
toe of the ramp slope, through the berm and into the foundation soil. Figure 8 shows the results of the inclinometer monitoring. The data indicate that the movements were all occurring within the embankments. The inclinometer progressed through the berm at the toe of the UWLS ramp slope indicated no movement.

FIGURE 8 Slope indicator monitoring results within fill.

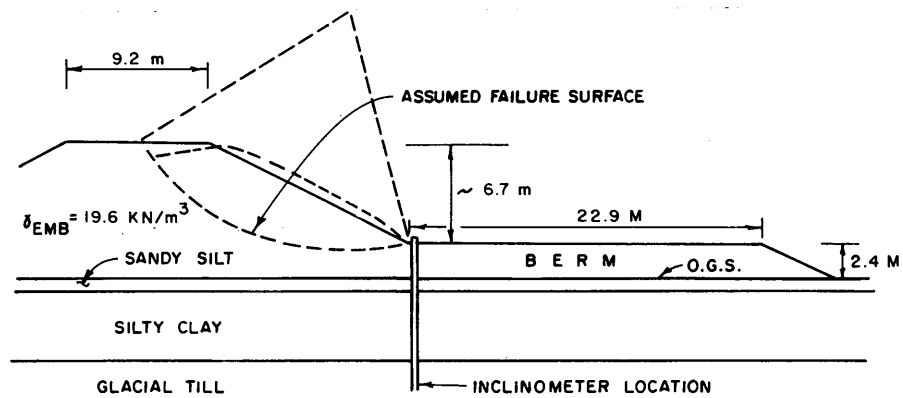
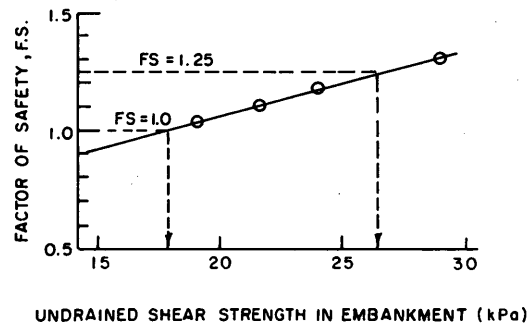
When incorporated with the results of laboratory testing, the results of these analyses show that embankments constructed of this material possessing an undrained shear strength of 14.4 kPa (300+ psf) can be built safely [factor of safety (F.S.) = 1.25] to a height of approximately 4.6 m (15 ft) and that the effective fill heights of 6.1 m (20 ft) in these areas run a high risk of failure, as actually happened. Figure 15 shows the results of a stability analysis performed on the UWLS ramp. An undrained shear strength of 26.3 kPa (550 psf) would have been required in order to ensure short-term stability of the embankment. Based on the relationship developed in Figure 9, the undrained shear strength required for stability (F.S. = 1.25) corresponds to a moisture content of 25 percent.

The moisture content found to exist in the lower portion of the fill (above the berm) approached 29 percent, corresponding to an undrained shear strength of 19.2 kPa (400+ psf).

FIGURE 15 Stability analyses for UWLS ramp.
