Minnesota Swing-Away Mailbox Support

KING K. MAK AND ROGER D. HILLE

A swing-away mailbox support was designed by the Minnesota Department of Transportation (MnDOT) for use in locales where snow and ice removal during the winter presents a problem. The Minnesota swing-away mailbox support design uses a cantilevered arm for attachment of the mailbox assembly. The cantilever arm design is intended to allow for more efficient snow plowing operation without damaging the mailbox support, which presents a maintenance problem. The design allows complete snow removal beyond the shoulder or curbline, thus reducing snow-drifting on the roadway. It is easily installed with existing highway agency equipment, can be salvaged and reinstalled, and costs considerably less than current mailbox designs approved by MnDOT. The results of four full-scale crash tests conducted on this Minnesota swing-away mailbox support and the evaluation of its impact performance are presented. The mailbox support with a single mailbox assembly was judged to have successfully met all evaluation criteria outlined in *NCHRP Report 350* and the 1985 AASHTO *Standard Specifications for Structural Supports for Highway Sig

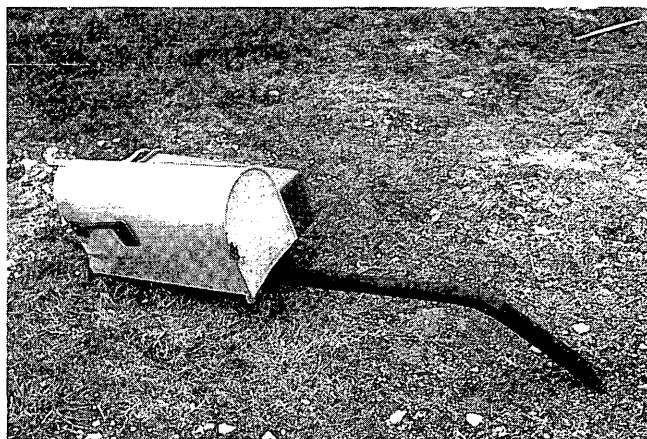
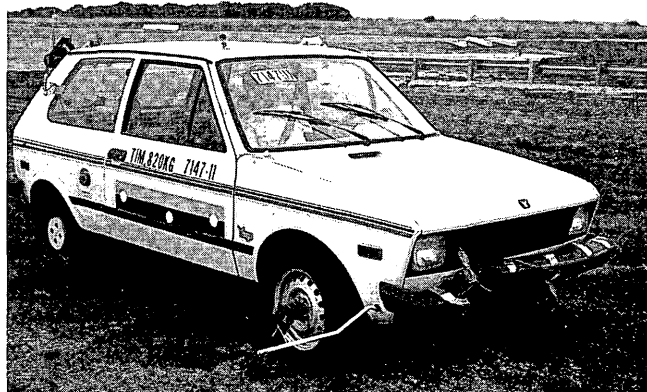
The cantilever arm and mailbox assembly came to rest approximately 17 m (55 ft) downstream and 5 m (15 ft) to the right of the impact point. The cantilever arm was only scraped, and the mailbox assembly was deformed, as shown in Figure 5. The vertical support was scraped, and the U-channel base post was bent and pushed back 180 mm (7 in.) at ground level.

The vehicle (also shown in Figure 5) sustained minimal damage. There was 80 mm (3.2 in.) of permanent deformation to the bumper where contact with the vertical support and U-channel base post occurred. There were dents in the oil pan and gas tank and scrape marks along the floor pan on the right side caused by contact with the vertical support of the mailbox test installation.

FIGURE 5 Mailbox installation (top) and vehicle (bottom) after Test 7147-11.

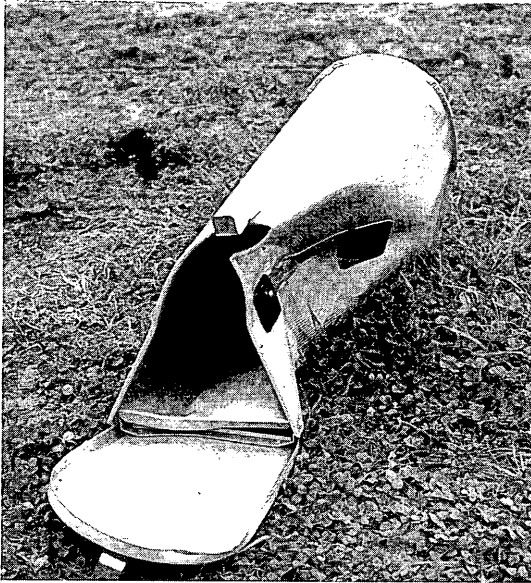
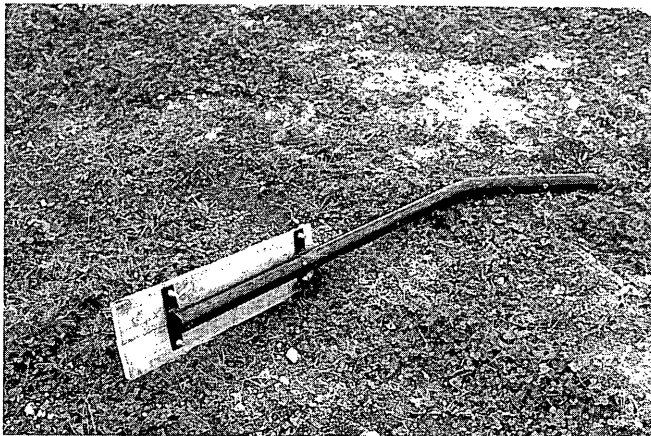
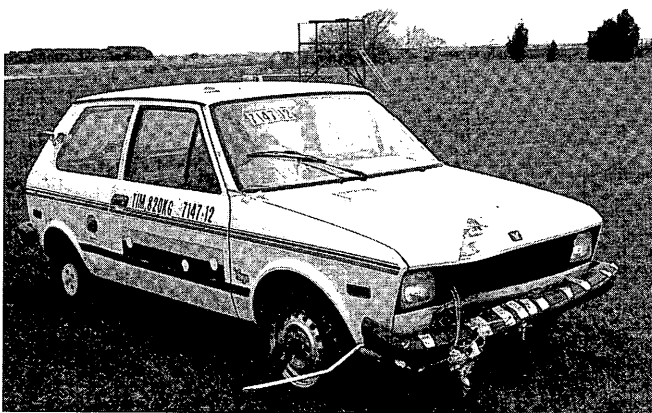
The mailbox installation separated into several pieces as shown in Figure 6. The plastic newspaper tube landed 15 m (48 ft) downstream and 8 m (25 ft) to the left of the point of impact. The deformed mailbox landed 18 m (60 ft) downstream and 5 m (18 ft) to the left of the point of impact. The cantilever arm and wood board were found 22 m (72 ft) downstream and 12 m (38 ft) to the left of the point of impact. The vertical support arm was only scraped, and the U-channel base post was bent and pushed back 150 mm (6 in.) at ground level.

The vehicle sustained minimal damage, as shown in Figure 6. There was 120 mm (4.8 in.) of permanent deformation to the bumper where contact with the vertical support and the U-channel base post occurred. The A-pillar on the driver's side was deformed from impact by the mailbox, and the windshield was cracked around the point of impact. The door post on the driver side was bent and the glass was broken out. There was also damage to the hood and grill and the right rear tire and rim. There was a dent in the gas tank, and there were scrape marks and a dent along the floor pan on the right side of the undercarriage caused by contact with the vertical support.

FIGURE 6 Mailbox installation (*top and middle*) and vehicle (*bottom*) after Test 7147-12.

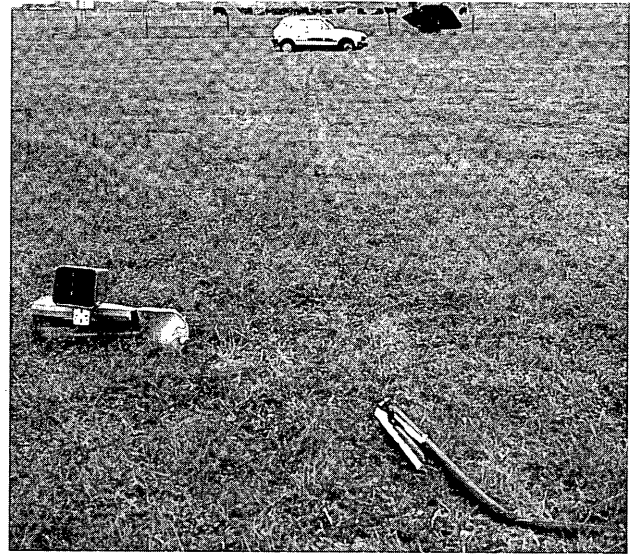
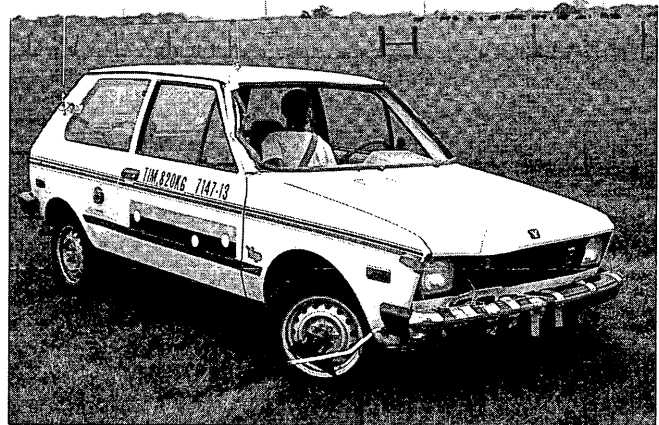
The mailbox installation separated into several pieces, as shown in Figure 7. The cantilever arm and part of the wood board landed 54 m (177 ft) downstream and 1.4 m (4.5 ft) to the right of the point of impact. The severely deformed mailbox, part of the wood board, and the plastic newspaper tube came to rest 55 m (182 ft) downstream and 0.3 m (1 ft) to the left of the point of impact. The vertical support was only scraped, and the U-channel base post was not damaged or pushed back.

The vehicle (also shown in Figure 7) sustained moderate damage. There was 30 mm (1.2 in.) of permanent deformation to the A-pillar on the passenger's side of the vehicle, and the door post on the passenger's side was deformed at the location where the cantilever arm made contact. There was also a scratch located on the left rear section of the roof from contact by the detached cantilever arm as it went over the vehicle. The windshield was broken out and was lying on the floorboard of the vehicle. However, it should be noted that the windshield actually went outward and upward after separation from the vehicle and was partially on the roof of the vehicle before falling back into the occupant compartment. The detachment of the windshield from the vehicle could be partially attributed to the poor design of the windshield, which was held in place only with a rubber grommet. Most other vehicles have a more positive

mechanism for attaching the windshield to the vehicle. In addition, previous crash tests caused damage to the A-pillar, which might have further weakened the attachment mechanism.

FIGURE 7 Mailbox installation (*top*) and vehicle (*bottom*) after Test 7147-13.

The third crash test (Test 7147-13) with the single mailbox assembly directly struck and damaged the windshield, but the windshield kept the mailbox assembly from intruding or penetrating into the occupant compartment. Damage to the windshield is normally not considered a desirable behavior since it could obstruct the driver's vision or otherwise cause the driver to lose control of the vehicle. However, given the need for a cantilever design because of the snow-plowing operation, damage to the windshield is considered an acceptable trade-off provided that there was no intrusion or penetration into the occupant compartment. It is recommended that the maximum size of mailbox used with the support be limited to size 1A or smaller.

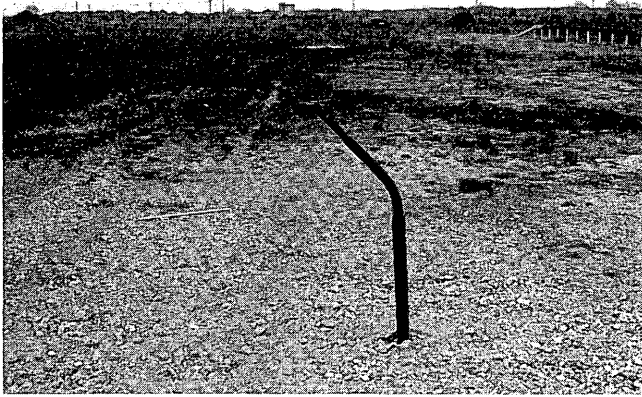
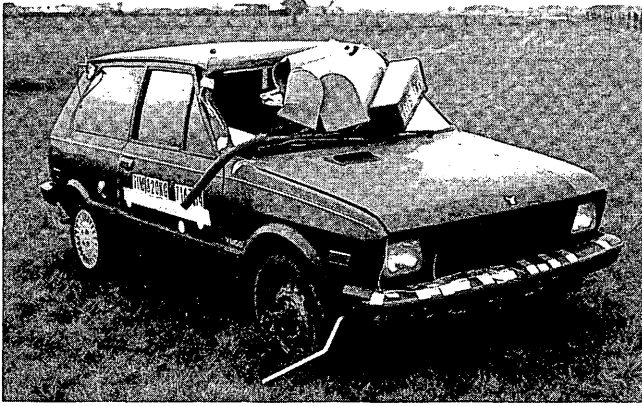
The test site and components of the mailbox test installation after the test are shown in Figure 8. The mailbox assembly was de-

FIGURE 8 Mailbox installation (top) and vehicle (bottom) after Test 7147-14.

formed, but it remained attached to the cantilever arm and remained with the vehicle through final rest. The vertical support was only scraped, and the U-channel base post was bent slightly.

The vehicle sustained moderate damage around the windshield area, as shown in Figure 8. The mailbox assembly intruded into the occupant compartment through the windshield and remained partially in the compartment throughout the test period. The roof of the vehicle was deformed upward from the inside of the vehicle approximately 50 mm (2 in.). The passenger's side door was pushed out 40 mm (1.6 in.), and the glass was shattered. The A-pillar and door post on the passenger's side was also deformed.

The fourth crash test (Test 7147-14) with triple mailbox assembly was judged to have failed to meet the evaluation criteria set forth in *NCHRP Report 350 (1)*. The mailbox assembly shattered the windshield and substantially intruded and penetrated into the occupant compartment, which was judged to be unacceptable. It appeared that two factors contributed to the unsatisfactory performance: (a) the combined weight of the triple mailbox assembly and the cantilever arm was 19 kg (42 lb), which was more than double the weight of 8.8 kg (19.5 lb) for the single mailbox assembly, and (b) the width of the triple mailbox assembly allowed the mailbox assembly to impact and penetrate the windshield before the cantilever arm struck the A-pillar of the vehicle, which would have partially counteracted against the force of the mailbox assembly into the windshield. In light of the unsatisfactory performance of the triple mailbox assembly, the use of the swing-away mailbox support design should be limited to only a single mailbox assembly. At locations where multiple mailboxes are to be installed, it is recommended that each mailbox be installed on its own support and that they be spaced at least 36 in. (0.91 m) apart to allow for unrestricted functioning of the cantilever arm.
