Impacts of 1993 Upper Mississippi River Basin Floods on Highway Systems

D. J. HAGERTY, A. C. PAROLA, AND T. E. FENSKE

An investigation of the primary and secondary highway infrastructure in the Upper Mississippi River Basin was conducted to determine the modes and mechanisms of damage caused by the 1993 flooding. Several modes of failure observed are presented. Dramatic examples of scour in sites of highway embankment breaches, scour at bridge abutments on broad floodplains, and scour in rock are presented. Flow over embankments damaged highway embankments and long reaches of highway shoulder and pavement. Slope and embankment failures were caused also by saturation of fill and slope materials and by groundwater effects. Debris transported by floodwater accumulated on secondary roadway bridges substructures, causing catastrophic collapse of structures.

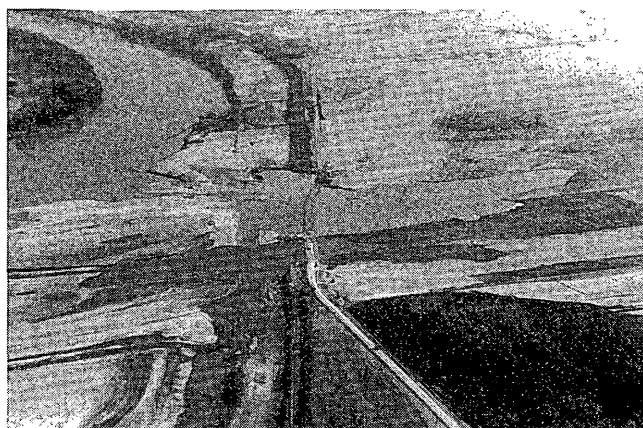
embankments are shown in Figure 1. A scour hole more than 15 m (50 ft) deep formed at the location of the breach; sediment from the scour hole was deposited downstream from the breach and on Highway 240 east of the breach.

FIGURE 1 Aerial view of embankment breach 6.5 km (4 mi) west of Glasgow, Missouri.

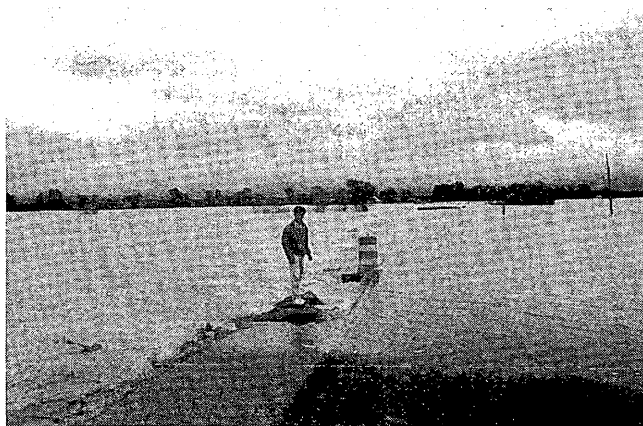
Less severe but more widespread damage was caused to highway embankments in wide, flat floodplains by overtopping flow that did not breach the embankments, as shown in Figure 2. Frequently observed damage included erosion of embankment slopes downstream from overtopped areas as well as erosion of shoulder material and asphalt pavements and undermining of concrete pavements where overtopping occurred.

FIGURE 2 Recurrence of erosion damage to section of roadway previously repaired after 1993 flooding [U.S. 65, 9.5 km (6 mi) south of Carrollton, Missouri].

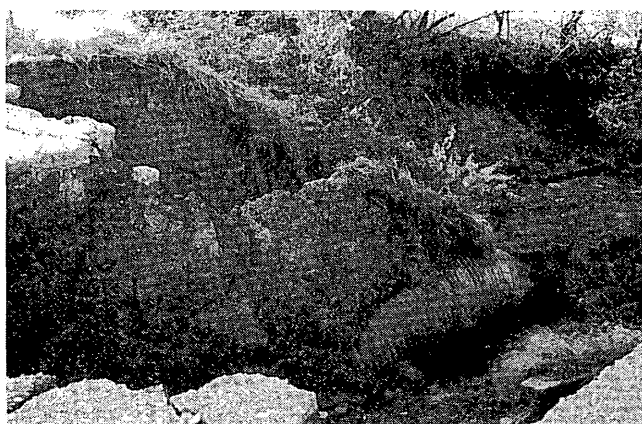
FIGURE 3 Erosion of roadway and embankment caused by overtopping flow (county road, Richardson County, Nebraska).

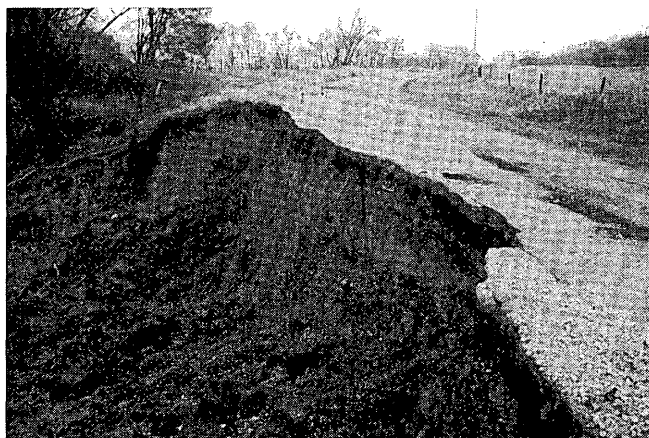
FIGURE 5 Slope Failure, roadway damage (Richardson County, Nebraska).

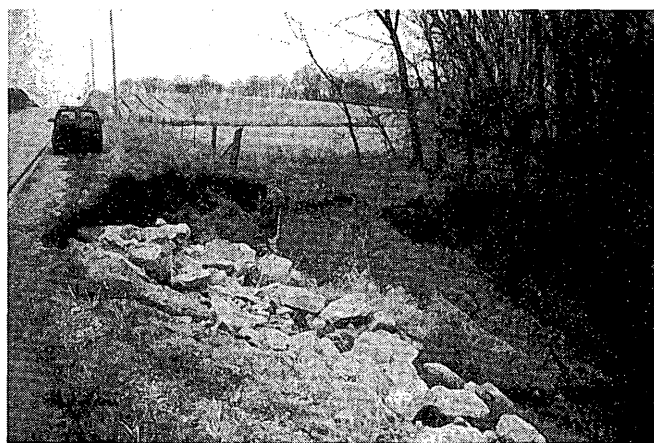
Throughout the flooded region, distress occurred in roadway shoulders, pavements subsided locally, and embankment sideslopes failed because of high groundwater levels. Water ponded in ditches and at raised culvert entrances and seeped laterally through embankments. Seeping water eroded fine-grained soil particles from within embankments and subgrades. Emergent seepage destabilized embankment slopes; localized slumps occurred in destabilized areas, and seepage outflow produced cavities in embankment and slope faces. Figure 6 shows a short stretch of Missouri Highway 59 where the embankment bulged and subsided when zones of soil flowed laterally from the west side of the embankment; the distress was aggravated by downcutting in the ditch along the toe of that embankment. In localized areas on the west slope of the embankment, concentrated outflow had produced cavities in the face of the slope. Large pieces of rock had been dumped into the slump zone in an effort to buttress the slope. The distress in this embankment was typical of the noncollapse, undramatic but widespread damage that occurred in the flooded watersheds far from large streams.

FIGURE 6 Embankment failure in Missouri 59 caused by high groundwater levels [8 km (5 mi) north of Craig, Missouri].

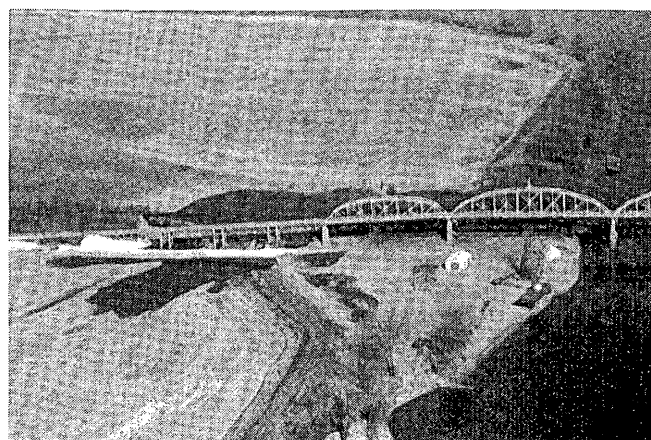
A dramatic impact of the 1993 floods was collapse of highway and railroad bridges caused by scour at piers and abutments. Typical of those failures was the collapse of a railroad span as a result of scour at the west abutment of the previously mentioned crossing over the Missouri River at Glasgow, Missouri. Five trusses, varying from 68 m (224 ft) to 105 m (344 ft) in length, carry Highway 240 between Saline and Howard counties, just downstream from the railroad bridge. Figure 7 shows an aerial view of the collapsed railroad span, the highway bridge, and the scour hole that developed at this location. Four 29.3-m long (96-ft long) approach spans carry the high-

way up to the truss structure. The scour hole was located between the second and fourth piers from the west abutment of the railroad bridge and around the second (E) and third (D) piers of the highway bridge. The approach span of the railroad bridge collapsed on July 29, 1993. All of these highway bridge main trusses are supported on foundations carried down to bedrock; all of the piers for approach spans are supported on four columns each founded on friction piles. The bedrock, at elevations between 168 m (550 ft) at the west end of the trusses and 177 m (580 ft) at the east end, is covered by only 3 to 5 m (10 to 15 ft) of soil under the channel; divers inspected the foundation under the west pier of the easternmost truss on August 19, 1993, and found no sediments over the rock but no undermining of the pier. However, severe undermining had occurred at the scour hole under the foundations of the west approach spans. The floodplain elevation under the approach spans was about 188 m (615 ft) before the flood, the bottoms of the 0.75-m thick (2.5-ft thick) pile cap footings were located at elevation 181 m (593 ft), and the timber piles had been driven 9 to 11 m (30 to 35 ft) below the bottoms of the caps. When divers inspected the foundations of piers D and E on August 12, 1993, they found the deck of the fallen railroad bridge lodged against both north legs of pier D and the northeast leg of pier

FIGURE 7 Aerial view of scour holes and bridges over Missouri River at Glasgow, Missouri.

E. All of the piles under pier D were exposed, for depths varying between 4.4 and 5.6 m (14.5 and 18.5 ft); in other words, between 11 and 12 m (35 and 40 ft) of floodplain soils had been scoured from around the foundations of pier D. Only about one-half of the pile embedment depth remained. The concrete underside of the north-west pile cap had spalled so that one pile was no longer bearing load; the underside of the northeast pile cap had spalled so badly that all but one entire pile and about 20 percent of another pile had lost contact with the pile cap. At pier E, the floodplain had been scoured down to the bottoms of the pile caps, but only slight undermining of the cap footings was noted. During the flood, pier D oscillated transversely to the bridge axis. To restore support to the friction pile foundation, sheetpiles were driven around the perimeter of the pier, and the space inside the sheetpiles was filled.

The scour hole that undermined the bridges formed 180 m (600 ft) from the right descending bank of the Missouri River. A second scour hole had formed closer to the bank of the stream; the two holes very nearly merged on the upstream side of the collapsed span. Examination of the walls of the scour holes after the floodwaters receded showed that the holes had formed in layered alluvial soils consisting primarily of sands and silts; typically, sandy silt layers 10 to 30 cm (4 to 12 in.) thick were separated by clean sand layers 2 to 5 cm (1 to 2 in.) thick. Thick recent deposits of such soils downstream of the scour hole showed that most of the scoured material was moved only a short distance before the flow velocity decreased sufficiently that the scoured material was deposited. The approach embankments for the bridges form a long barrier to flow over the floodplain to the west of the main bridge site; in contrast, the floodplain to the east of the Missouri River is relatively narrow at Glasgow. The constriction of flow by the approach embankments caused the scour that undermined the bridge piers.

The dominant mechanism of failure was scour by water bearing little load of sediment to the edge of the constriction in flow over the floodplain. The sides of the scour holes contained cavities when the holes were inspected after the floods receded; the cavities appeared to have been caused by groundwater seeping into the holes. The seeping water undoubtedly originated as temporary storage into the floodplain during inundation. The water levels in the holes were still considerably above the level of the Missouri River even in November but were well below the original floodplain elevation. Outflow seepage effects were minor compared with the

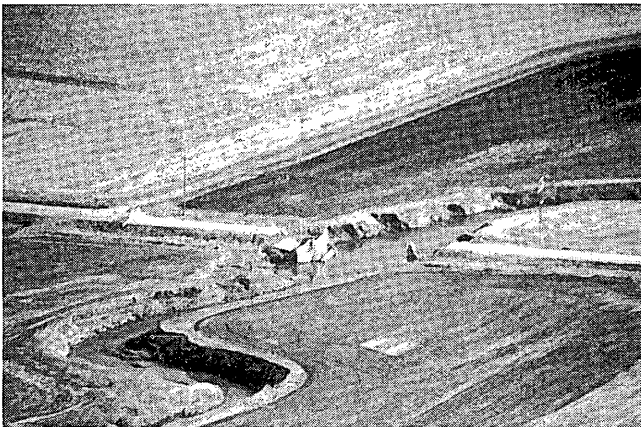
Another bridge failure occurred on Iowa Highway 71 approximately 8 mi south of Carroll, Iowa, where a three-span concrete girder bridge failed as a result of scour. Figure 8 shows the collapsed structure and the eroded embankments. Scour of the streambed beneath pier and abutment foundations, the force of floodwaters on the piers, and the weight of the bridge structure caused the pile foundation system to fail. Piles under the abutments failed in combined compression and bending. Overland flow of flood water had contributed to failures in the stream banks downstream from the bridge, and seepage out of the bank faces caused slabbing and toppling failures long after flood recession. The undermining of piers and abutment embankments by scour at this location was an important element in the failure of the bridge.

FIGURE 8 Collapse of Iowa 71 bridge 13 km (8 mi) south of Carroll, Iowa.

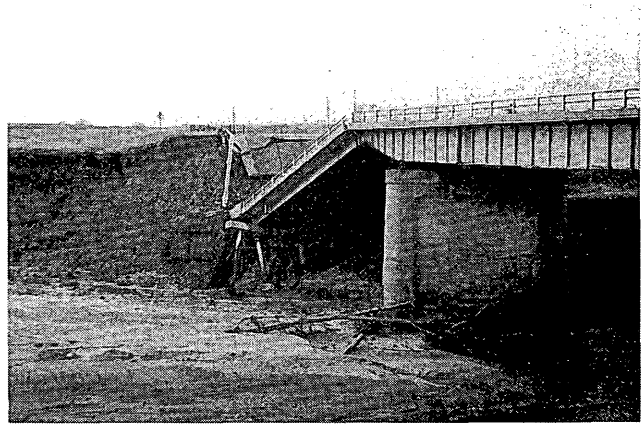
FIGURE 9 Collapse of Nebraska 8 bridge over south fork at Big Nemaha River, near Salem, Nebraska.

still very significant. Typical of the damage to bridges on small streams caused by the 1993 floods was the collapse of one span of a steel girder bridge that carried Nebraska Highway 8 over the south fork of the Big Nemaha River near Salem, Nebraska. The situation at this site was complex because downstream channel modifications have caused general degradation of the stream. The degradation has caused widening of the stream and erosion of the banks. The meandering stream was constricted at the bridge site, so constriction scour during the flood coupled with the general bank erosion to undermine the west abutment of the bridge. Figure 9 shows the affected abutment; collapse of the abutment caused the first span to shift down and to the west and to fall from the adjacent pier. At this location, bedload material as much as 23 cm (9 in.) in dimension was transported out of and along the channel and deposited on a bar just upstream from the bridge site; the bank opposite the bar was being eroded and undercut in autumn, long after flood recession.

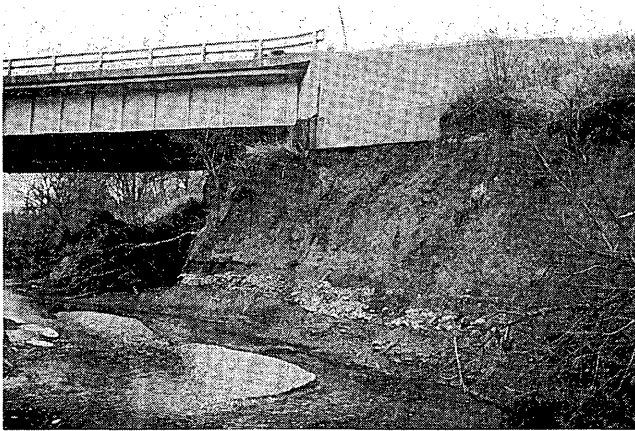
One of the more controversial topics among bridge designers is the prediction of scour depth and extent around bridge piers and abutments founded on rock. The 1993 Midwest floods provided evidence that some rock types and configurations can be eroded. Figure 10 shows the east abutment of a small bridge over Honey Creek near Pawnee City, Nebraska. The banks of the stream consist of loessial soils in the upper banks over mixed alluvial soils in the midheights of the banks, resting on a broken, discontinuous layer of limestone over green-gray fissile shale at the toe of the bank. Scour of the stream bed and the toe of the bank had undermined the bridge abutment. Examination of the bed of the stream showed that the protecting limestone had been plucked off the shale and the more

FIGURE 10 Scour effects in limestone and shale strata in bed of Honey Creek near Pawnee City, Nebraska.

vulnerable shale had been eroded as much as 1 m (several feet), as indicated by the elevation of the limestone-shale contact and the unweathered state of the shale exposed in the stream bed. At this site, the resistant limestone had not been worn away gradually; the water had plucked the limestone away in sizeable fragments. A much more dramatic instance of scour of resistant rock occurred at the Saylorville Dam north of Des Moines, Iowa. Figure 11 shows a location a short distance downstream from the crest of the dam, where flow over the emergency spillway cut down through at least 9 m (30 ft) of rock strata. At this site, a siltstone cap rock layer overlies a sequence of gray shales, thin siltstone seams, and thick, black shale layers. Scour along the emergency spillway removed a roadway downstream from the dam, moved very large slabs of siltstone down through the deep trench cut into the shales, and caused a slope failure in a loess bluff on the south side of the stream about 800 m (0.5 mi) downstream from the dam. Figure 12 shows shale boulders up to 0.6 m (2 ft) in dimension that had been moved as bed load far down the scoured trench. The exposed shale boulders had deteriorated through slaking and spalling during the 3 months between flood recession and the date when the photograph was taken.

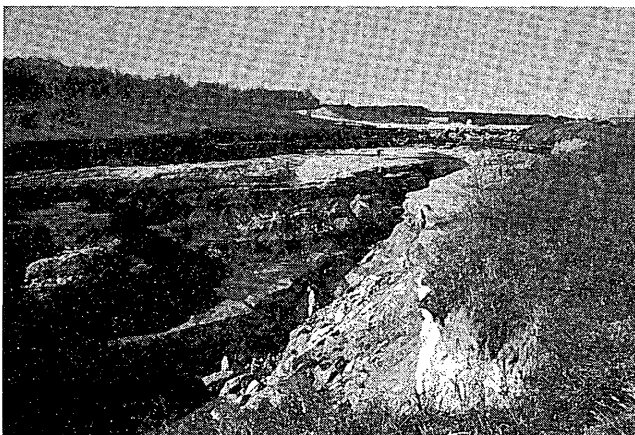
FIGURE 11 Scour Canyon in bed of emergency spillway below Saylorville Dam near Johnston, Iowa.

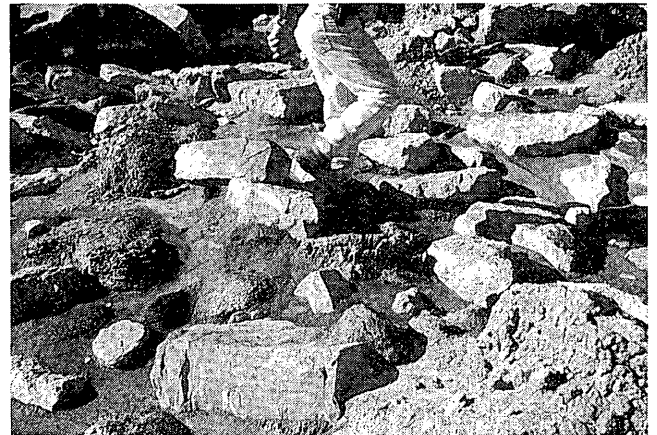
FIGURE 12 Deterioration in shale boulders in bed of emergency spillway below Saylorville Dam.

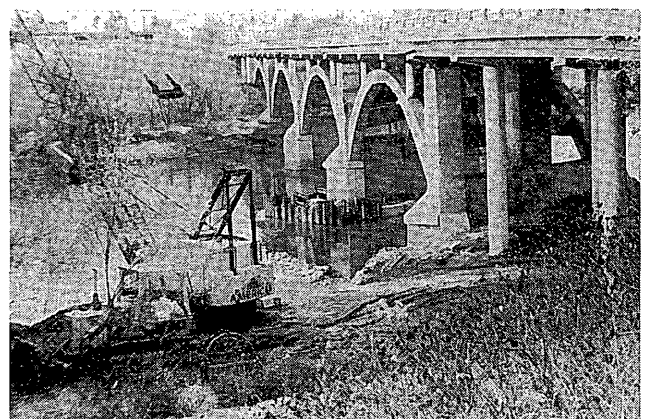
7th Street Bridge in Des Moines, Iowa. The spread footing supporting the pier located in the main channel was undermined during the flooding and required emergency repairs, as shown in Figure 13, to prevent collapse. The significance of the examples cited in the preceding paragraphs is not that shale was eroded; although some cemented shales are very hard and strong rocks, compaction shales are not cemented and are notoriously vulnerable to scour as well as to weathering. In the examples cited, the vulnerable shale layers were covered and protected to varying degrees by layers of more resistant rock. The extent of the scour in these examples indicates the serious need for additional research on how even very hard and competent rock layers can be affected by water pressures and forces.

FIGURE 13 Repair of 7th Street bridge in Des Moines, Iowa.

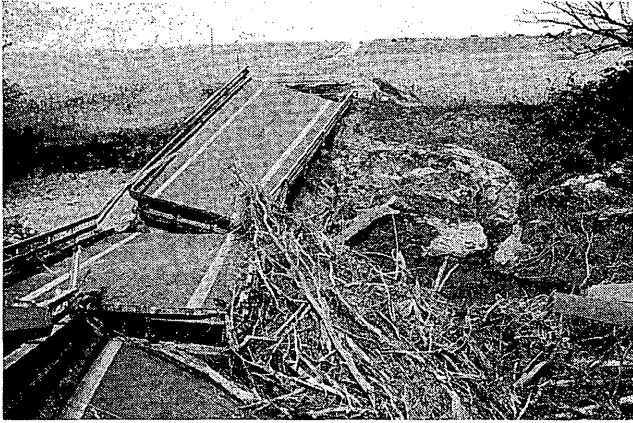
Debris transported by flood flows impacted and accumulated on piers and bridge superstructures, causing adverse effects to both bridge and stream stability. Figure 14 shows the collapsed span of Missouri Highway 113 near Skidmore, Missouri. Debris accumulated on the upstream side of the bridge and blocked flow under the bridge; resultant hydrodynamic pressure forces on the bridge were

FIGURE 14 Missouri 113 Bridge, near Skidmore, Missouri; collapse caused by debris accumulation.

sufficient to cause simultaneous rotation and translation of individual pile members about the bases of the piers at the stream bed; the pier foundation consisted of timber piles.
