Retrofit Techniques for Floating Slab Track

HOMER M. CHEN

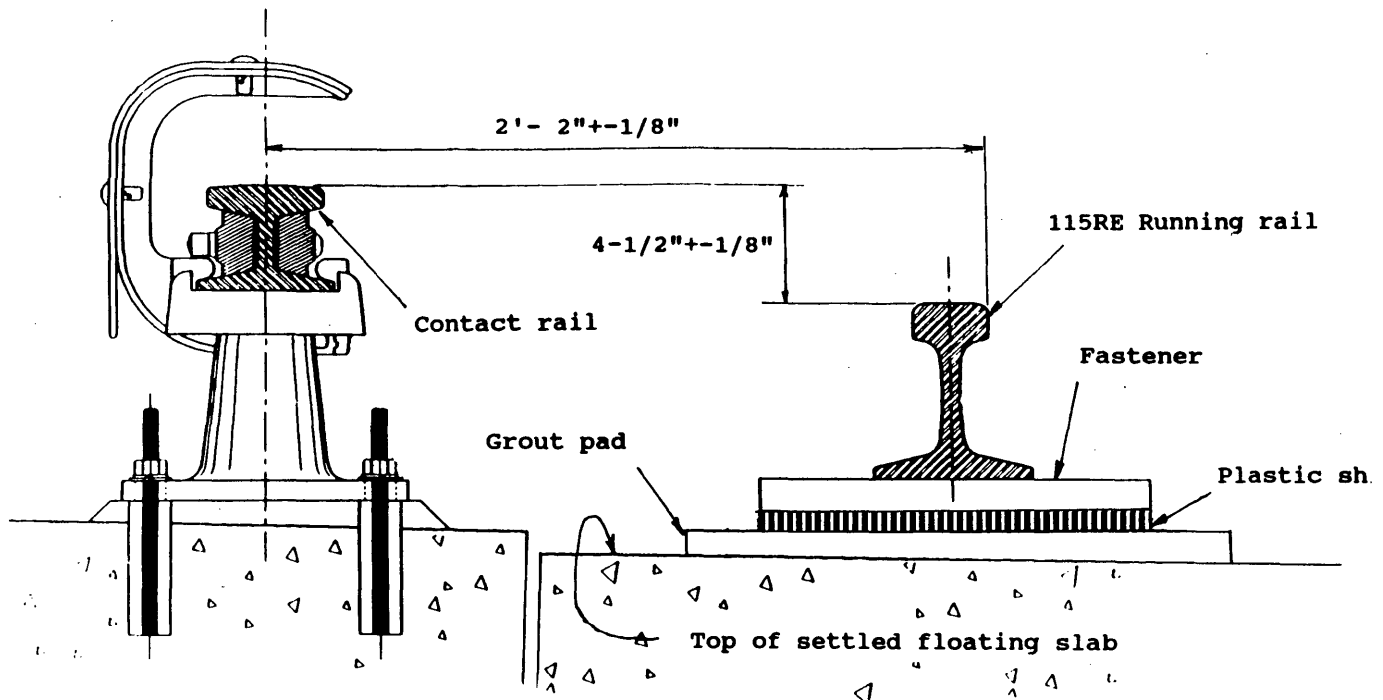
FIGURE 3 Settled floating slab with shim.

The polyurethane pads furnished by one supplier were compressed unevenly (from 3 in. thick to as thin as 1/4 in.) causing the slab to settle. The defective pads looked like squashed donuts. The worst ones disintegrated into piles of mud. Because the slab supports the track, this settling condition causes operation and maintenance

problems including differential settlement, cross-level changes, contact rail height misalignment, uneven surfacing, corrugation, rail fastener breakdown, and train speed restriction. As an emergency measure, WMATA's maintenance forces from the Office of Rail Track and Structures raised the rails to the proper elevations by inserting shims under the rail fasteners on top of floating slabs (Figure 3).

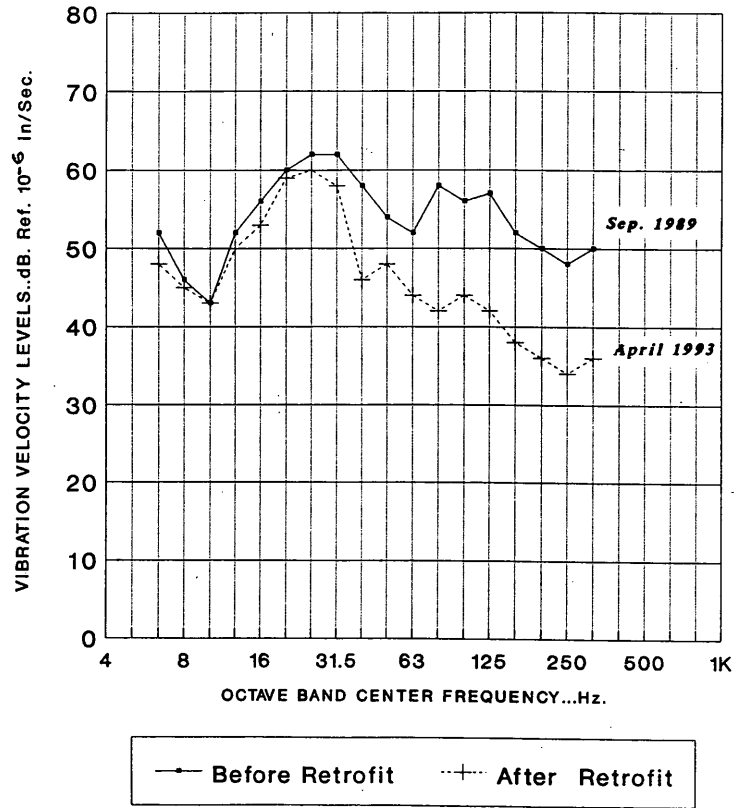
FIGURE 5 Vibration measurements before and after retrofit (at Capitol South Station on tunnel safety walk 100 ft from platform).

Noise and vibration measurements conducted by Wilson, Ihrig & Associates, Inc., Acoustical Consultant, indicated the performance of the floating slab varied from one problem area to the next. With this information, it was determined how much of the attenuation should be restored in each area (Figure 5).
