Rehabilitation of a Jointed Portland Cement Concrete Pavement on I-35 (Southbound) in Kay County, Oklahoma

JEROME F. DALEIDEN, DAVID A. OOTEN, AND MARK D. SARGENT

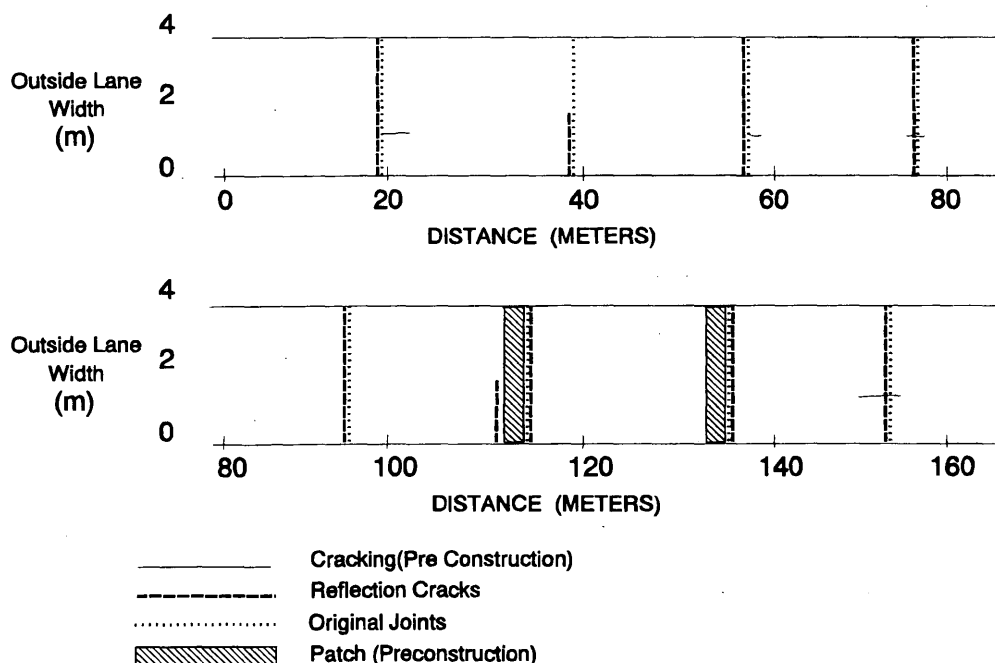
FIGURE 2 Distress summary for test section 400603 [0.1 m (4 in.) overlay].

Test Section 400603 [0.1 m (4 in.) overlay] exhibited reflective cracking at each of the underlying original joints, as well as partially along one edge of a patch. Test Section 400604 [0.1 m (4 in.) overlay, saw and seal] exhibited reflective cracking over the original joints where sawing and sealing was performed, as well as over the

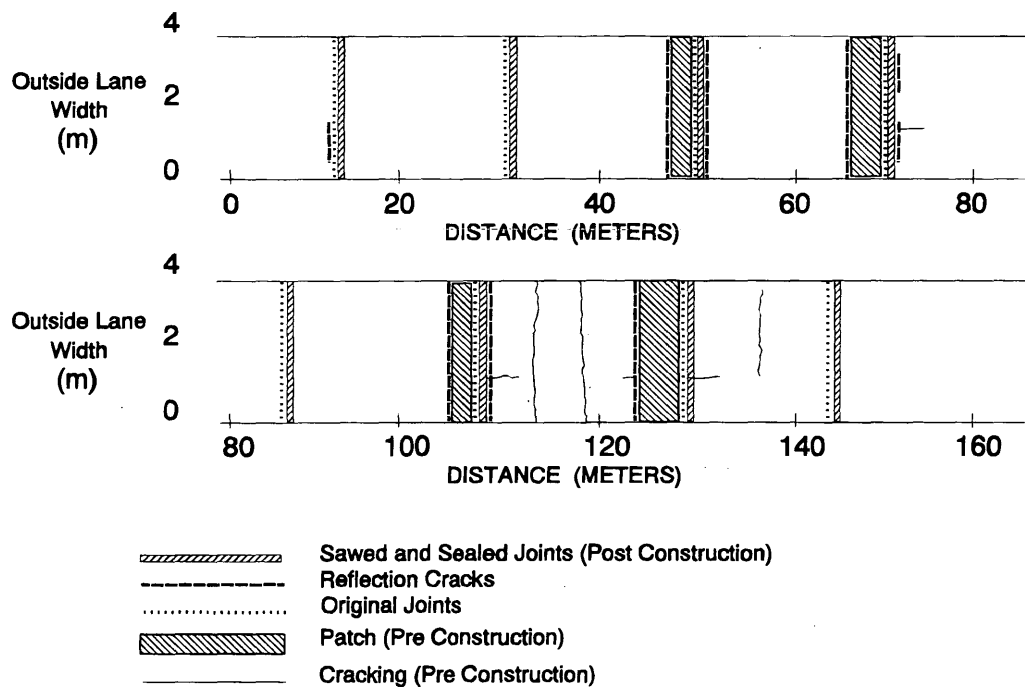
FIGURE 3 Distress summary for test section 400604 [0.1 m (4 in.) overlay, saw and seal].

leave edge of underlying patches constructed before rehabilitation. Interestingly enough, the reflective cracking took place at 50 percent (four out of eight) of the locations where sawing and sealing was conducted. Test Section 400606 [0.1-m (4-in.) overlay with drain] exhibited reflective cracking at all but one location where an original joint existed under the new overlay. A reflective crack had also developed at the location of an underlying transverse crack. Test Section 400607 [rubblized with 0.1-m (4-in.) overlay and edgedrain] exhibited a very small amount of postconstruction trans-

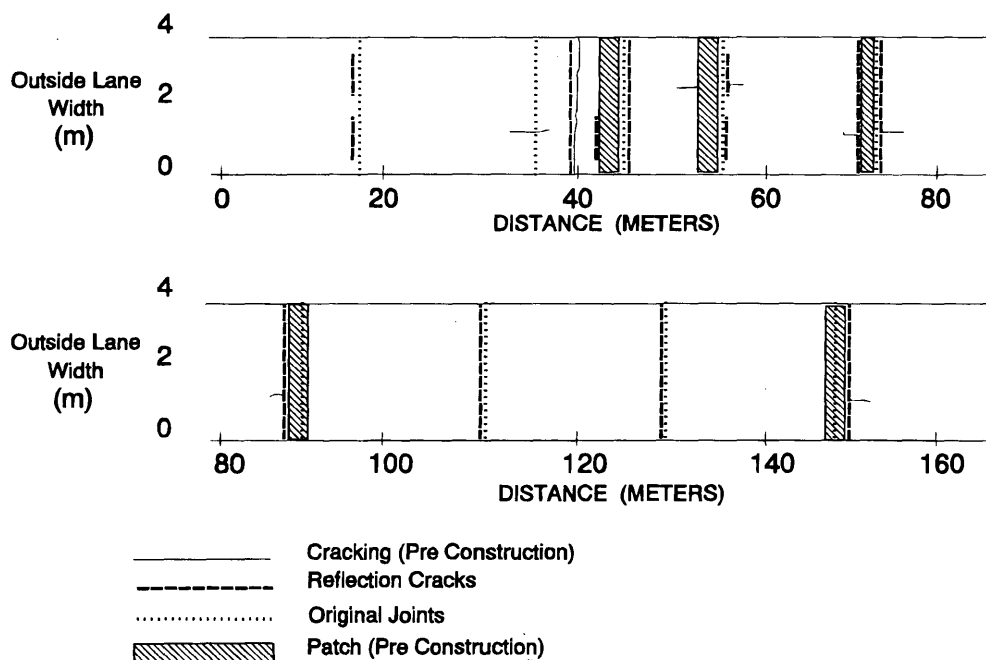
FIGURE 4 Distress summary for test section 400606 [0.1 m (4 in.) overlay with drain].

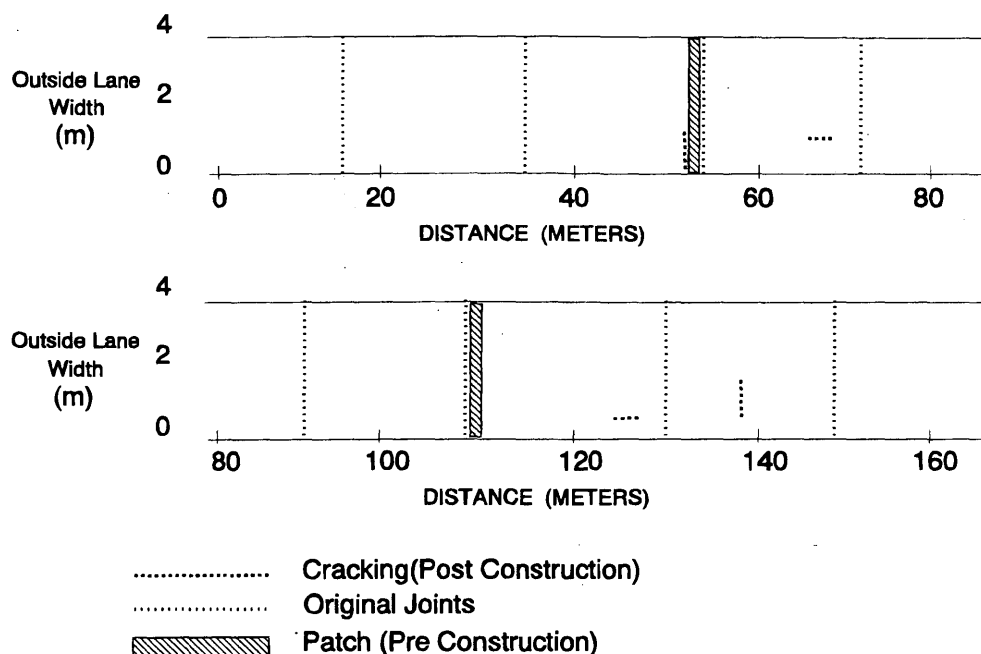
FIGURE 5 Distress summary for test section 400607 [0.1 m (4 in.) rubblized with drain].

verse and longitudinal cracking. A very short crack exists at a location where a preconstruction patch is located. Test Section 400608 [rubblized with 0.2-m (8-in.) overlay and edgedrain] exhibited no distress manifestations throughout the test section.

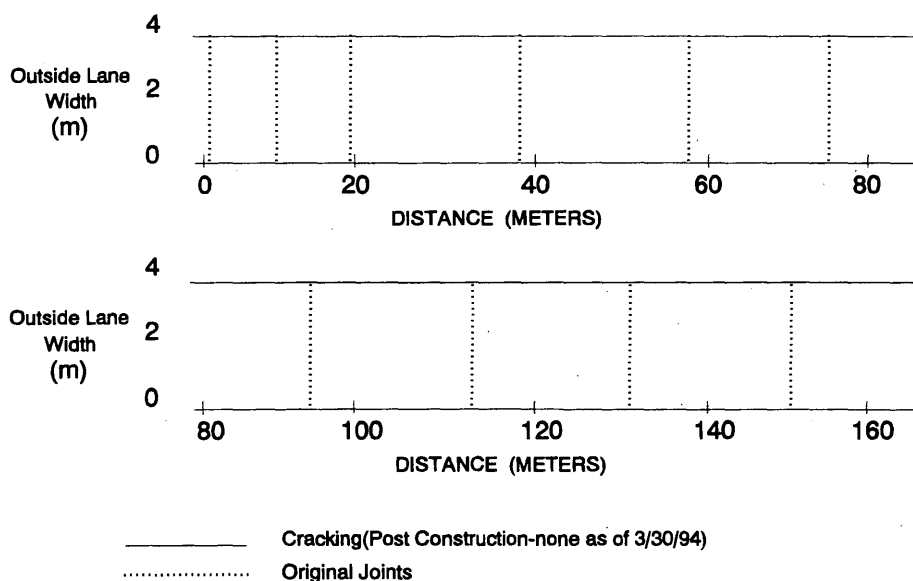
FIGURE 6 Distress summary for test section 400608 [0.2 m (8 in.) rubblized with drain].
