# **Toyota's ETCS-i System and Latch-up as a Cause of SUA**

**Presentation to the  
National Academy of Sciences Committee  
on Electronic Vehicle Controls and  
Unintended Acceleration**

**Ronald A. Belt  
24 January 2011**

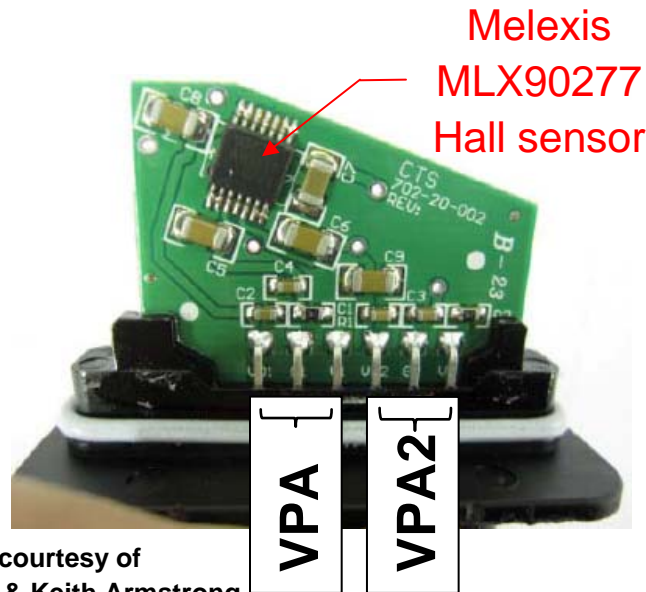
Two *identical* Hall-effect sensors in *one* package with *one common 5V supply voltage*.

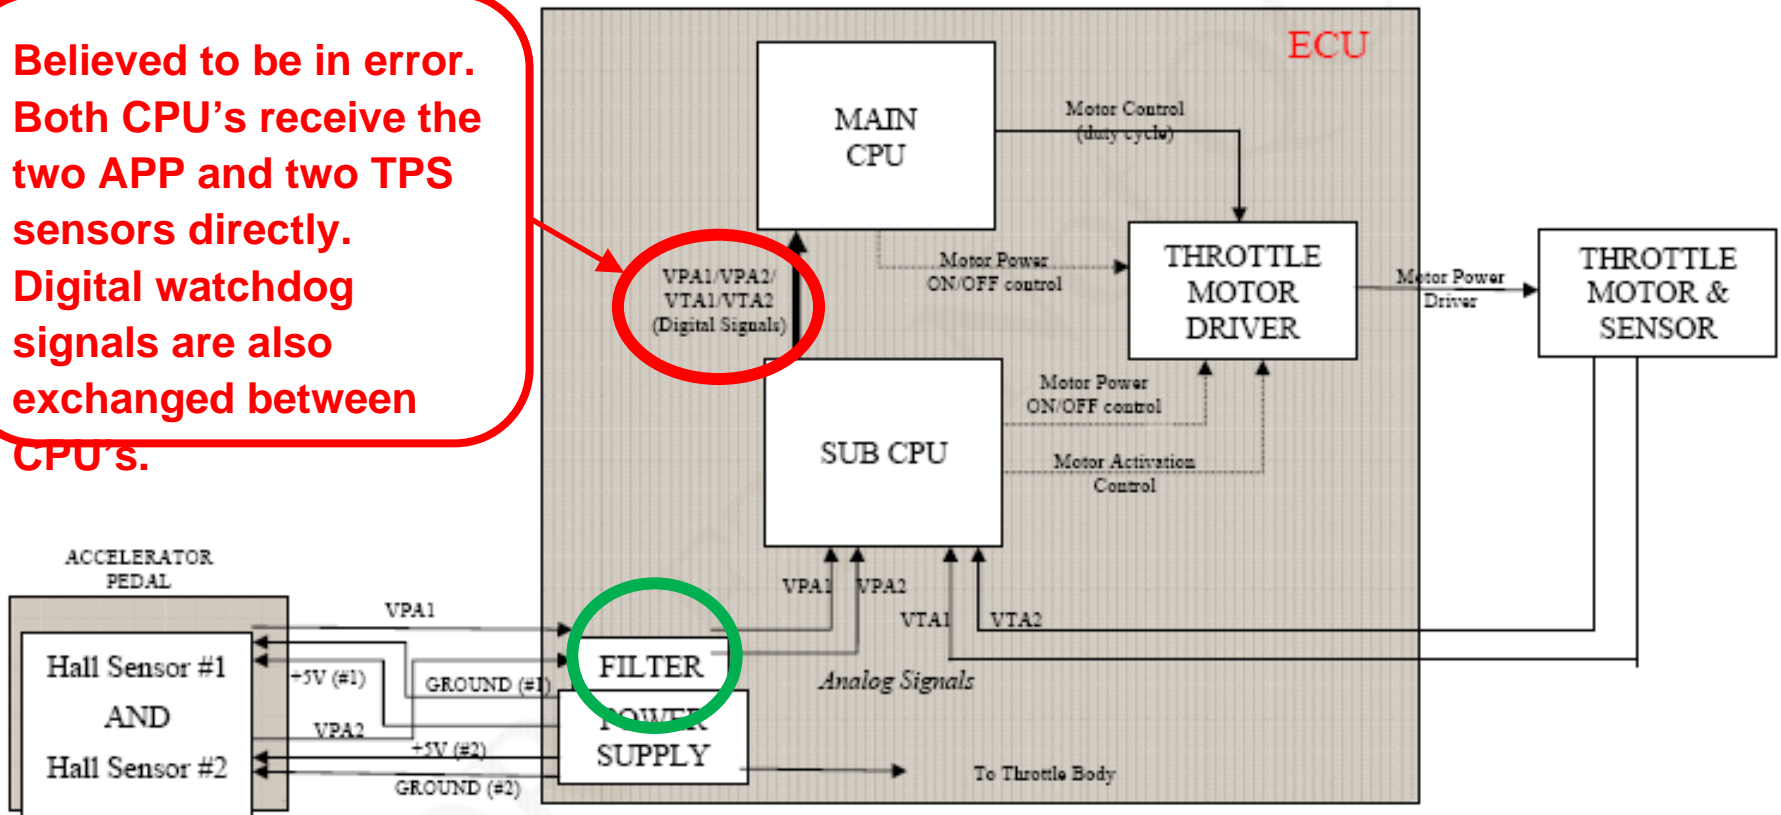
# Toyota ETCS-I System from Exponent Report

Believed to be in error. Both CPU's receive the two APP and two TPS sensors directly. Digital watchdog signals are also exchanged between CPU's.

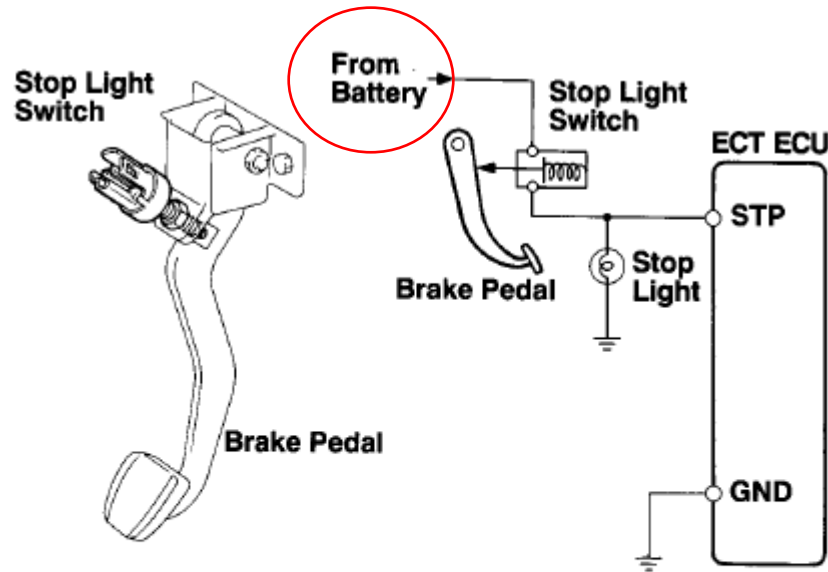
- 12V likely reduced to  $\leq 5V$  using a resistor voltage divider in ECU
- High S/N so filter not needed.

Brake Pedal	STP Terminal Voltage
Depressed	12 V
Released	0 V

If the driver depresses the brake pedal before turning on the ignition, then a voltage is instantaneously applied at an input of both microcontrollers before their 5V power supplies turn on. This can cause latch-up of the microcontroller input circuits.

Also happens with 5V supply dropout and restart.

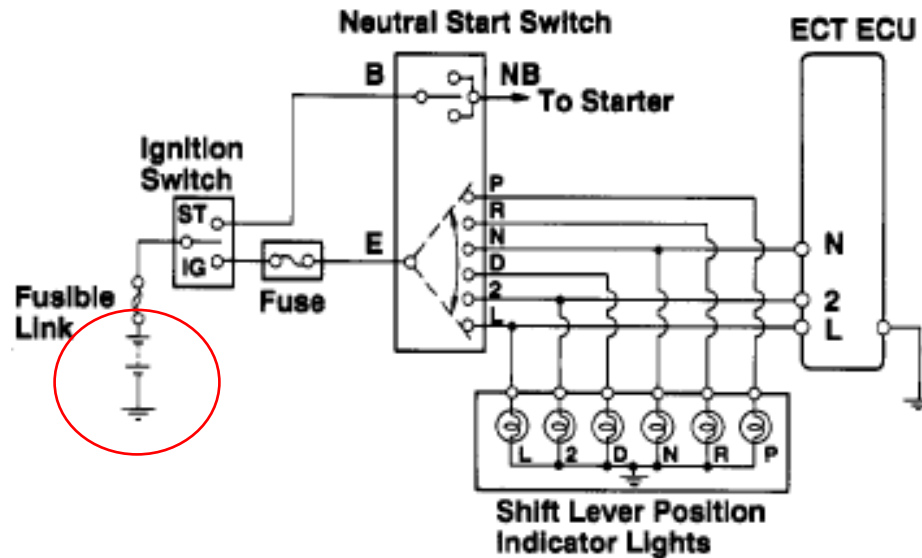
## Neutral Start Switch

If the shift selector applies a 12V battery signal to the ECU when in PARK, then when the ignition switch is turned on, there will be a race condition between the 12V battery signal arriving at the microcontroller input and the regulated 5V rail turning on the  $\mu\text{C}$ .

Also happens with 5V supply dropout and restart.

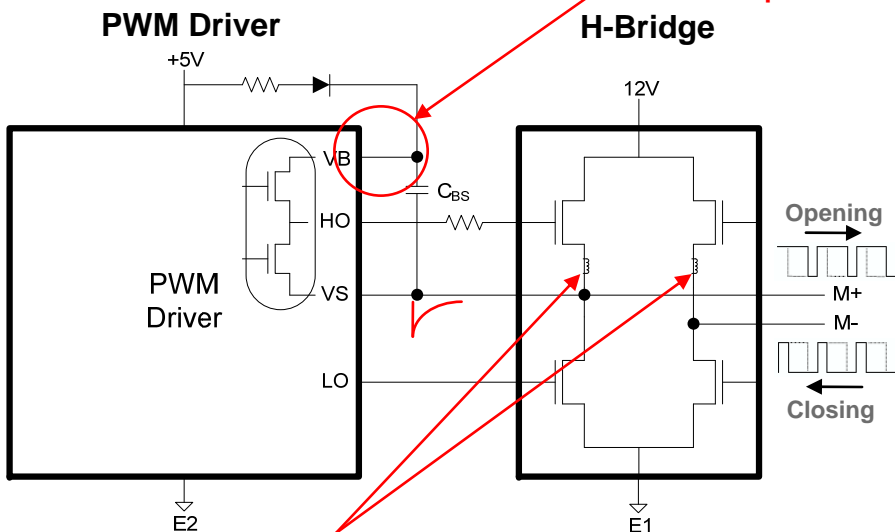
**Conventional Throttle Motor Interface Circuitry**

This node can exceed the avalanche breakdown voltage if  $C_{BS}$  is too small, causing latch-up.

Inductance  $L$  here can cause a negative  $Ldi/dt$  pulse on the  $VS$  node each time the high side transistors turn off, pulling  $VS$  below  $E1$  ground momentarily.

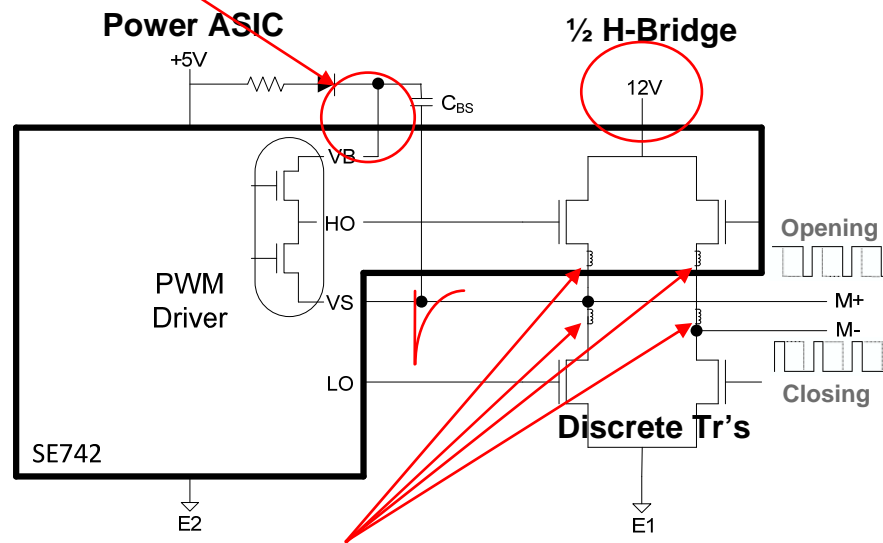
**Toyota Throttle Motor Interface Circuitry (2007 Camry)**

Partitioning the H-bridge increases the inductance  $L$ , increasing the magnitude of the negative  $Ldi/dt$  pulse on the  $VS$  node and increasing its likelihood of latch-up.

If the negative  $Ldi/dt$  pulse at  $VS$  exceeds the reverse bias on the substrate isolation junction inside the PWM driver IC, then latch-up occurs.

Acceptable operation is a delicate balance between  $-VS$  transient amplitude and PWM driver susceptibility

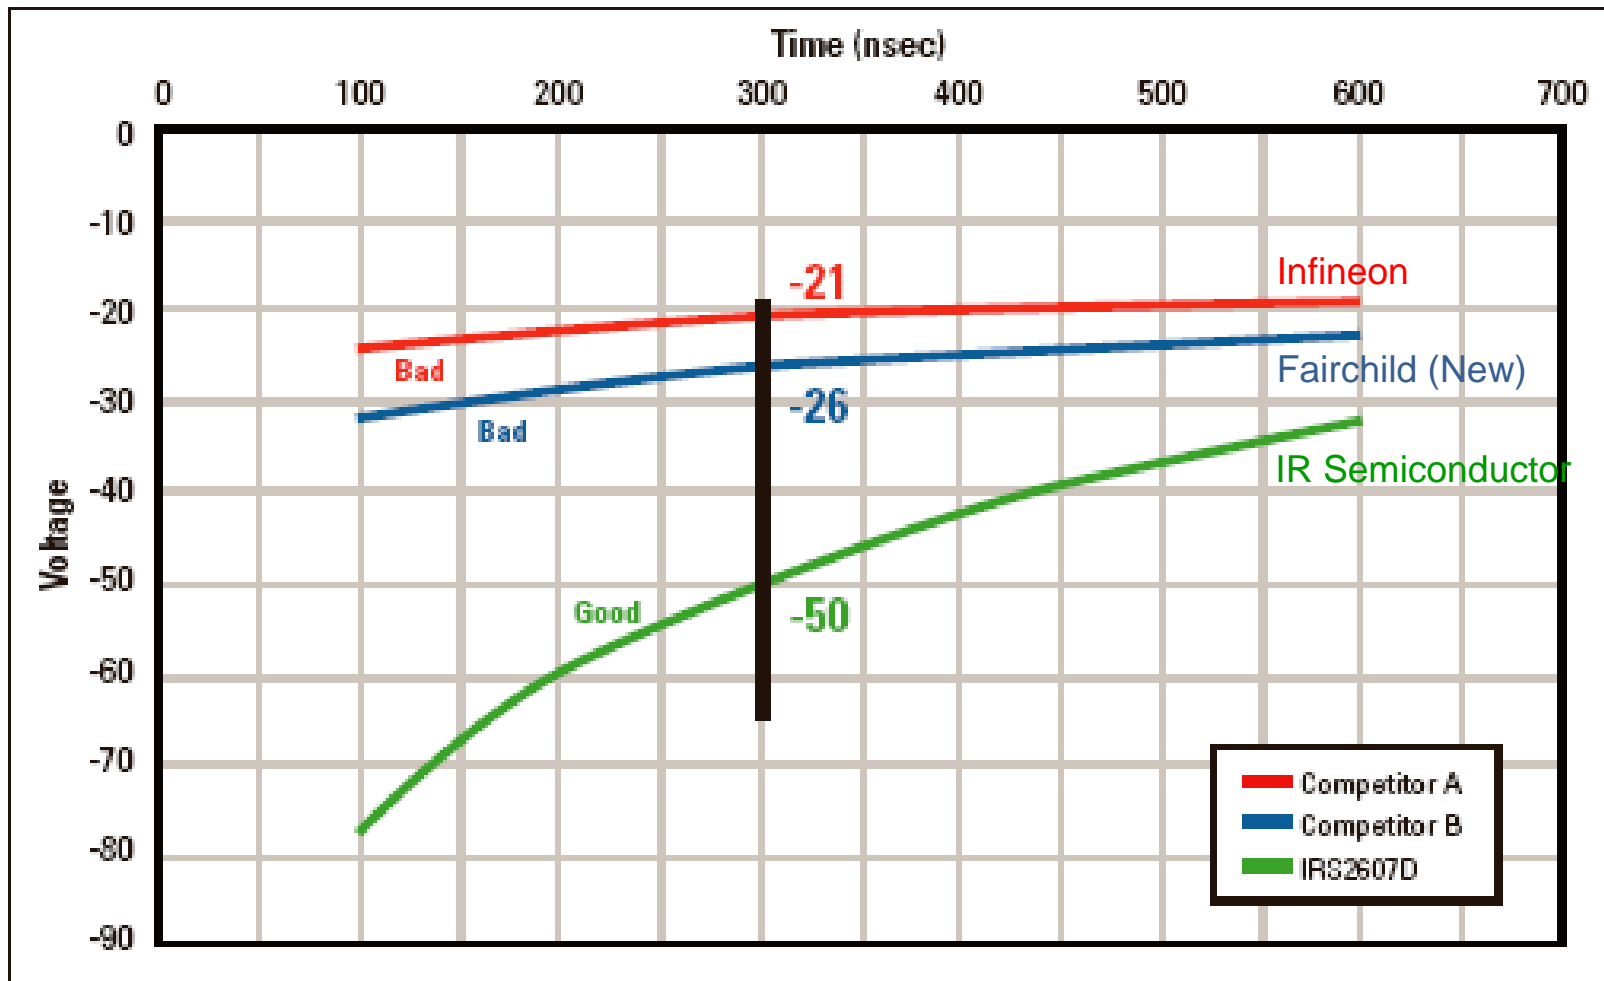
**Latch-up occurs if negative VS transient exceeds manufacturer's substrate junction reverse bias voltage (i.e., below each curve)**

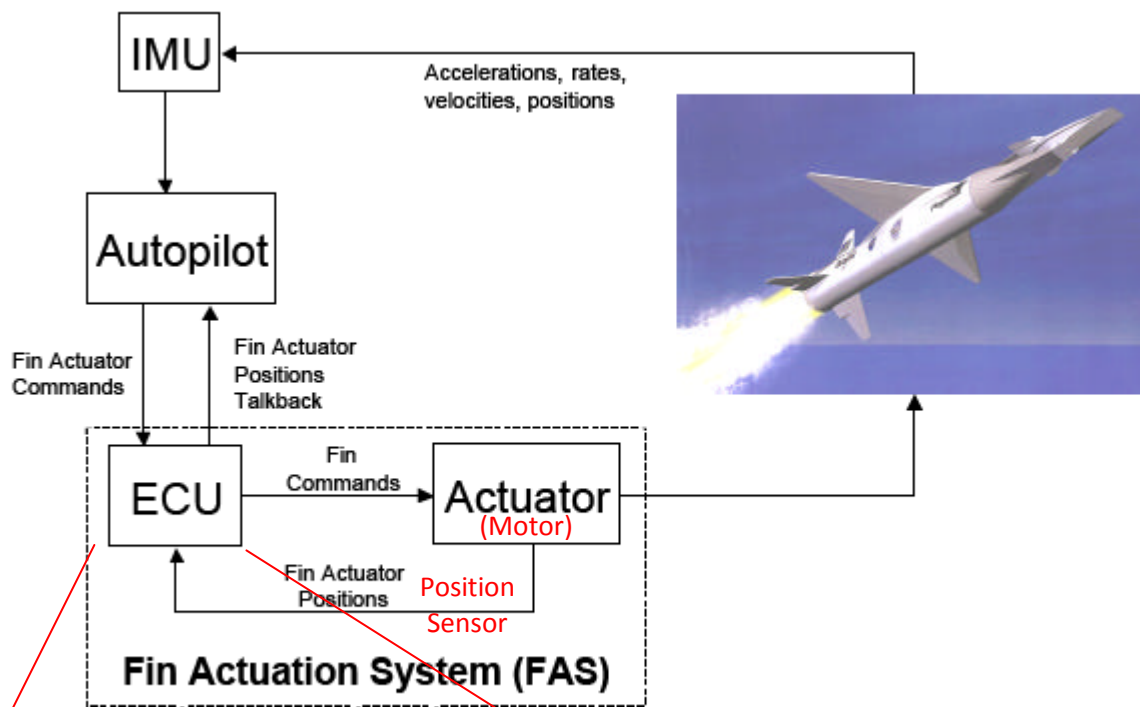
Figure 6-6. HXLV Control System Diagram

Latch-up  
Occurred  
in this IC

The first sign of a serious design problem with the FAS modifications came in early October 2003. An ECU failed during a cold-soak test simulating temperatures at high altitudes. The failures occurred when the actuators were commanded to slew at a high rate. Instead, the CPLD ceased processing, which is known as a “latch-up” condition. Should this occur in flight, the fins would stop moving, control would be lost, and the mission would fail. The unit was returned to the vendor for analysis. The contractor attempted to reproduce the failures with the ECU instrumented for diagnostic data. Although several cold-temperature cycles were made, each time the channel controlling the fin operated normally.<sup>32</sup> Griff Corpening, the Dryden chief engineer for the two X-43A Mach 7 flights, recalled that “as soon as you hooked up your diagnostic equipment, it wouldn’t [latch up] anymore. So the problem was so subtle that as soon as you interfered in any way with the circuitry, it wouldn’t [latch up].”<sup>33</sup> Not until January of 2004 was the problem resolved. The latch-up was triggered by excessive electronic noise in the ECU power boards during “current-limit states.” These occurred when the maximum electrical current value was being sent to the field effect transistors. Once the noise reached a certain level, it would cause the CPLDs to latch up.

“It was found that a combination of noise, back-feeding through the outputs of a logic device, and ground bounce were able to produce sufficient voltage below the components’ manufacturer specified limit of -0.5 volts that resulted in the FET-based device “latch-up”. The outputs then went into a tri-state condition, allowing the output voltage to gradually rise to the rail voltage. This produced a destructive condition for the H-bridge output transistors. Also, the component manufacturer determined that once the logic device was exposed to this “latch-up” condition, it became more susceptible to future latch-ups.”
