FORENSIC ANALYSIS OF ROADWAY DEPARTURE CRASHES ON LVRs

Ron W. Eck, P.E. Morgantown, WV

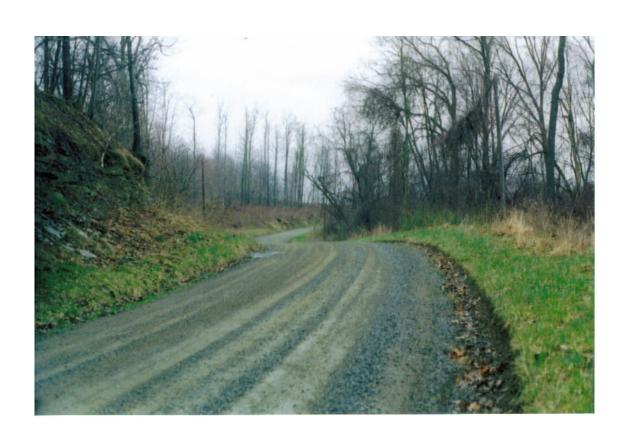
Top of Grade

Sharper horizontal curves on or near bottom of steeper downgrades

Unusually long and steep curving downgrades

- Warn drivers of extreme geometries and check the delineation
- Selective vegetation trimming to help drivers see extreme alignments
- Make sure proper procedures are followed in applying bituminous surface treatments

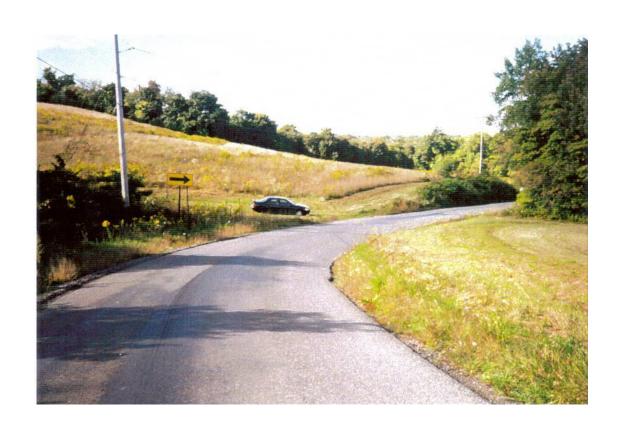
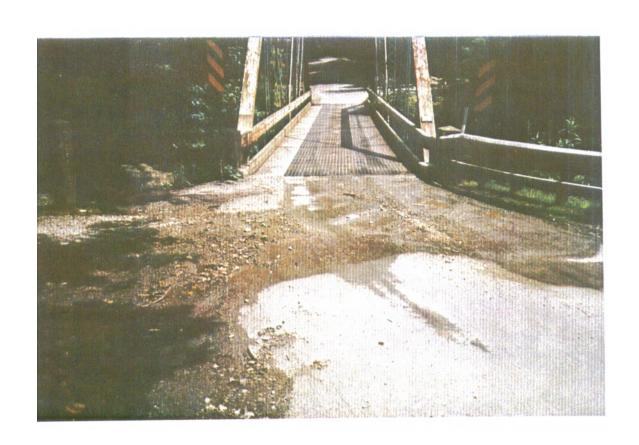
- Bit. Surface Treatments
 - -- excessive stone
 - -- bleeding
- Driveway/Side Road drainage across road

- Check driveways for compliance with design standards
 - -- water draining onto or across roadways?
 - -- mud being tracked onto roadway?
- Learn to look for expectancy violations
- Learn to "Read the Road"

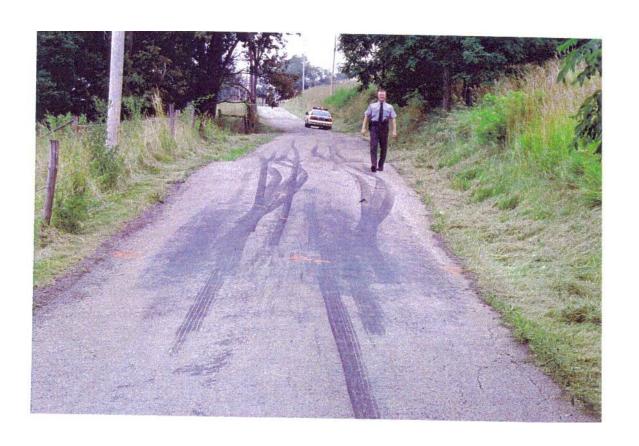
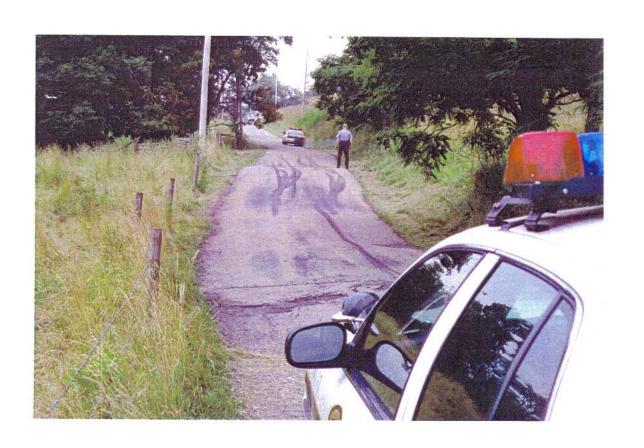
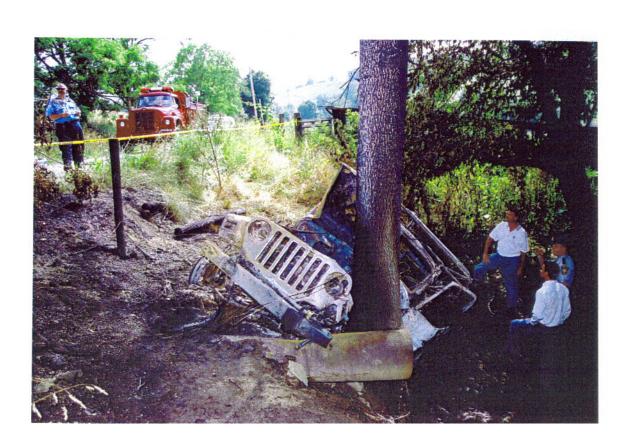
- Look for evidence that motorists are having difficulty negotiating a section of road. For example:
 - -- abundance of locked wheel tire marks
 - -- multiple gouges in pavement surface
 - -- scars on trees and roadside objects
 - -- frequent "knock-downs" of roadside objects
