The Rehabilitation of Steel Bridge Girders Using Advanced Composite Materials

Final Report for NCHRP-IDEA Project 51

Dennis R. Mertz, John W. Gillespie, Jr.,
Michael J. Chajes, and Scott A. Sabol,
University of Delaware

February 2002

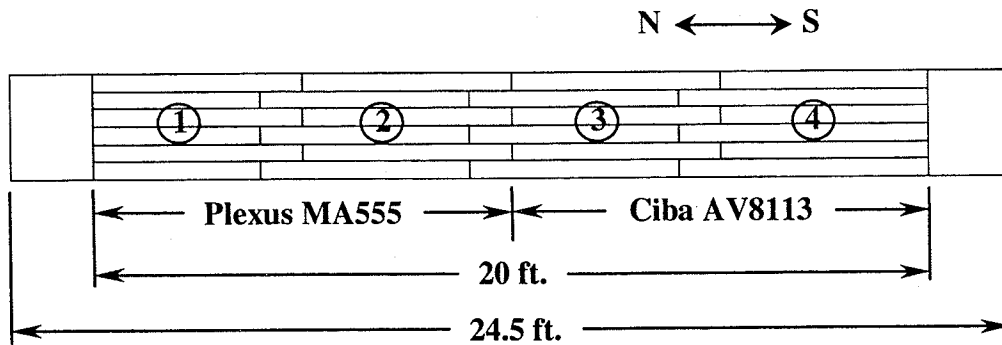
FIGURE 17 CFRP retrofit scheme.

The full-scale rehabilitation program consists of bonding CFRP plates to the underside of the tension flange of girder G5. The girder is located in the northern approach span of the I-704 bridge carrying I-95S over Christina Creek outside Newark, Delaware. The retrofit consisted of six 20-ft. CFRP plates placed side-by-side to cover the entire 9-in. wide flange. The CFRP plates are installed in four sections using three staggered joints (Figure 17). Each plate section is 5 ft. length. This allows for easier transportation, adhesive application, and installation. The use of staggered joints also provides a greater opportunity for moisture to reach the underlying bondline. Long-term observation of the joints will provide valuable insight into the effectiveness and durability of joints in this application.

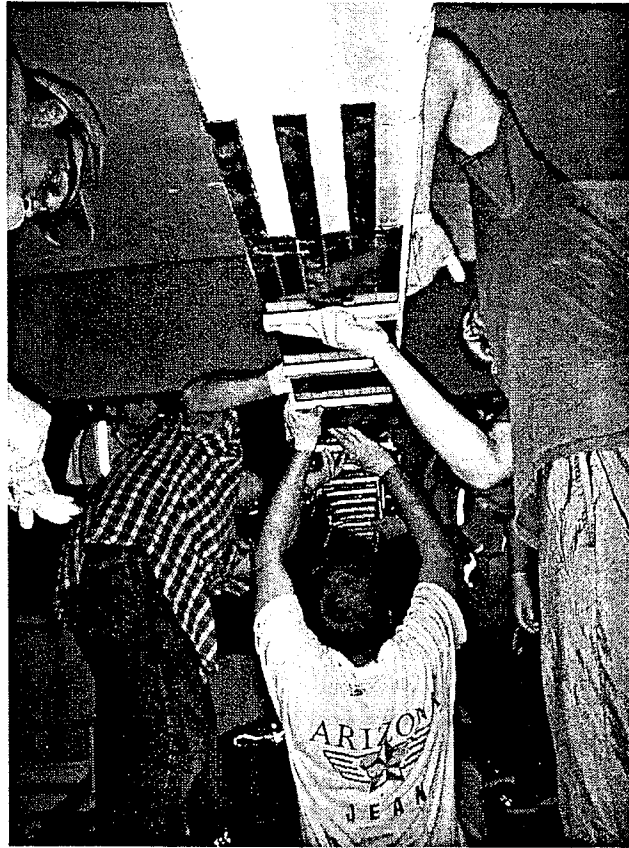
FIGURE 19 Maneuvering CFRP plates into position.

The CFRP plates were now ready to be attached. Individual plate sections were lifted into position (Figure 19), starting with section number 3. This section was placed first because of the change of adhesives at the centerline. It was important that the specific adhesion promoters applied to the steel surface interacted with the correct adhesive. While the plate sections were held in place, the clamps were attached to the girder flange and wood blocks were hot-glued to the CFRP plates. The same procedure was used for each of the other plate sections, ensuring that the joints were tight and flush before clamping. After all the plate sections were attached, the clamps were firmly tightened to achieve a thin, consistent bondline and allow the adhesives to spread and fill any dry areas (Figure 20). Adhesive squeezed out between consecutive CFRP plates in each of the section joints was noted. This indicates a bonded plate-to-plate interface and load path directly across the joint. Further, adhesive squeezed out along the ends of the retrofit indicates the plates are sufficiently bonded at these locations and prevents penetration of moisture to the bondline, which may initiate plate debonding.

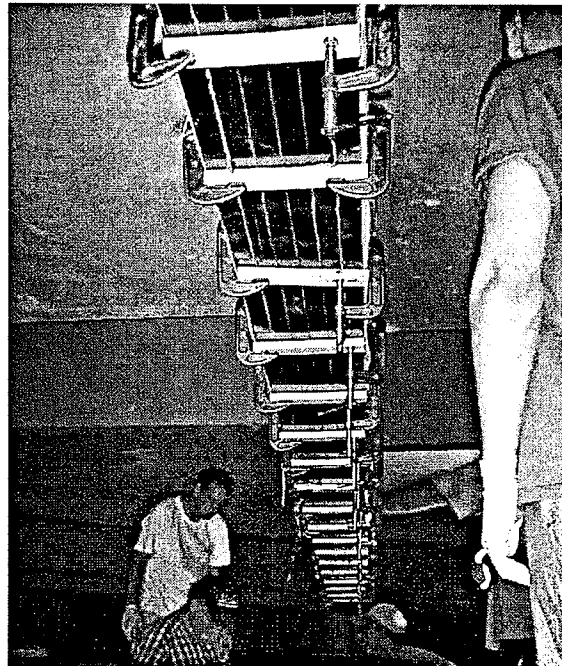
FIGURE 20 CFRP plates fully clamped to girder.

The excess adhesive was cleaned from the CFRP plates after clamping. The clamps were left in place for approximately 8 hours while the adhesives cured. The Plexus adhesive reaches 75% of its full strength in 2 hours at room temperature. The Ciba adhesive reaches handling strength in 4 hours at room temperature. Considering that the temperature during the rehabilitation procedure was approximately 70°F, eight hours of curing time provided enough time for both adhesives to reach sufficient strength for the clamps to be removed and traffic allowed back over the rehabilitated girder. A longer period of time might have been better but due to traffic coordination issues was not possible.

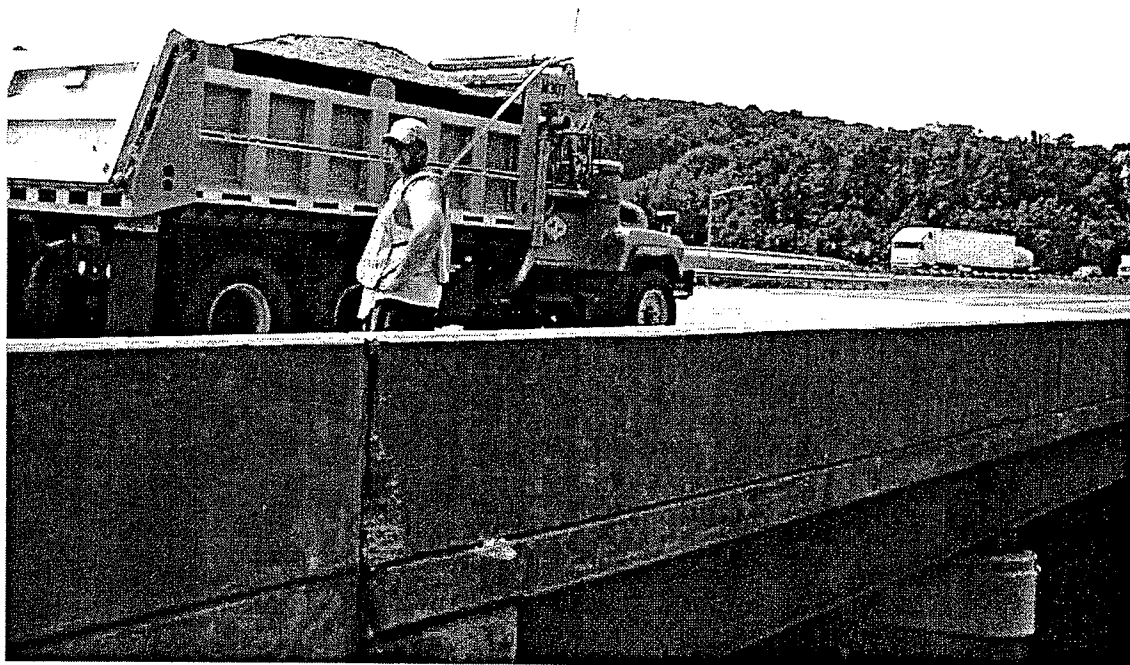
Figure 21 Diagnostic load test of Bridge 1-704.

A comparison of the load test data indicates that the CFRP plates reduce tension flange strains by 11%. Using the method of transformed section, a strain decrease of 10% was calculated (10% difference). It can be seen that the relatively simple analysis method was able to sufficiently predict the decrease in strain provided by the CFRP retrofit. More complex methods of analysis, including laminate theory or finite element models, may be used but are not needed.
