Research on Bolt Failures in Wolf Creek Structural Plate Pipe

JOHN N. MACADAM, Research Engineer, Research Center, Armco Steel Corporation, Middletown, Ohio

An investigation of high strength bolts in $\frac{3}{8}$ -in. thick structural plate was undertaken following discovery of an 18 $\frac{1}{2}$ -ft diameter pipe failure at Wolf Creek, Montana, in July 1964. Fractured A 490 bolts were found to meet ASTM hardness and chemistry requirements. Static load seam strength tests on $\frac{3}{4}$ -in. diameter A 325 and A 490 bolts in $\frac{3}{8}$ -in. corrugated structural plate were made to determine effects of initial bolt torque, reduced temperatures, freezing water, and prying action from plate bending. No evidence of bolt or joint weakness was observed.

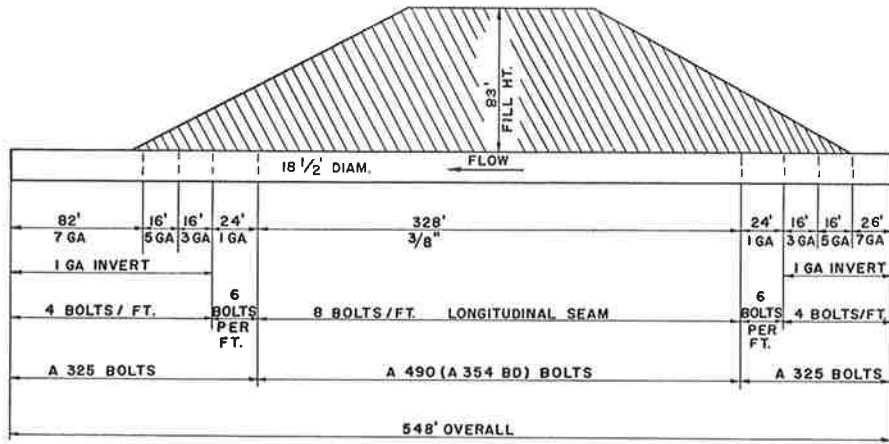
This culvert structure is 548 ft long under a maximum rock fill height of 83 ft. In the center portion, where fill loads are greatest, $\frac{3}{8}$ -in. thick plates are used with $\frac{3}{4}$ -in. ASTM A 490¹ high strength bolts. Near the ends lighter gage plates are used with ASTM A 325 bolts (Fig. 1).

Figure 1. Wolf Creek structural plate pipe.

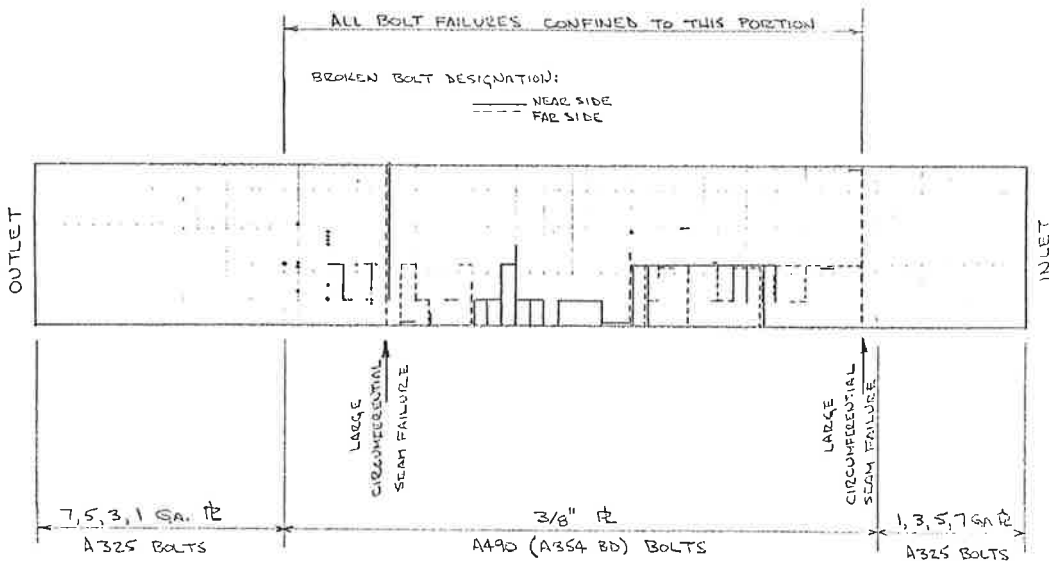
Figure 2. Diagram of failure.

All failed bolts were A 490 in $\frac{3}{8}$ -in. plate. No failures occurred among the A 325 bolts used in the lighter gage plates. Beginning at the first ring of $\frac{3}{8}$ -in. plate from the outlet end of the pipe, a few bolts were broken in the seams in the lower half of the pipe. No movement of the plates had occurred up to 194 ft from the outlet end, at which point there was a large circumferential seam failure. Another large circumferential seam separation occurred 90 ft from the inlet end of the pipe, which was one ring removed from the juncture of $\frac{3}{8}$ -in. and 1-gage rings. Between these 2 circumferential failures, the plates in the lower half of the pipe had telescoped to within 1 to 2 ft of each other at longitudinal seams, reducing the pipe diameter to approximately 16 to 17 ft. These seams were boltless with the nut or head of bolt missing. Several other longitudinal and circumferential seams had failed bolts in this portion of the structure.

Figure 2 is a diagram of the failure showing the location of broken bolts and the pattern of failure.

Because the failures (Fig. 2) were near or below the water level, it appeared that an environmental effect such as corrosion might be the primary cause of failure.

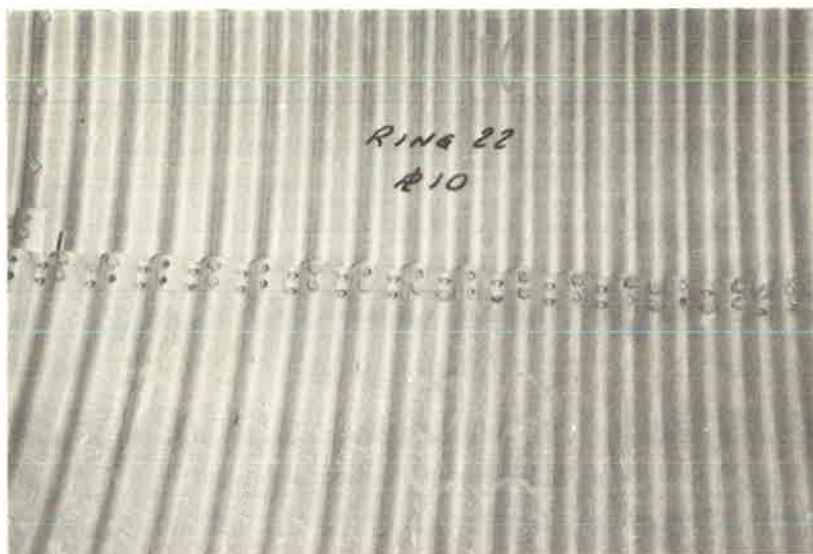
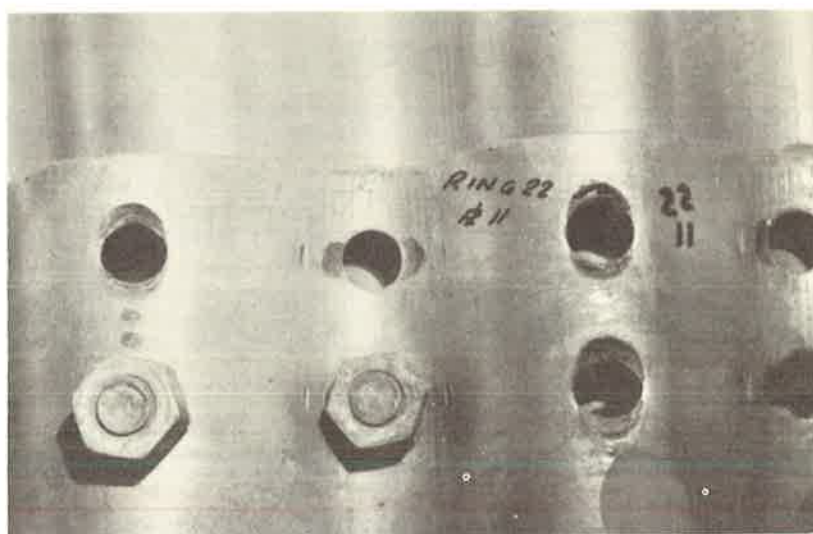
Figure 3. Longitudinal seam—no deformation of plate material at bolt holes.

Engineers inspecting the failure reported that in most instances (except where circumferential seam bolts had obviously sheared to accommodate the change in shape of the failed structure) there was no evidence of any distortion of the plate at the bolt holes (Fig. 3).

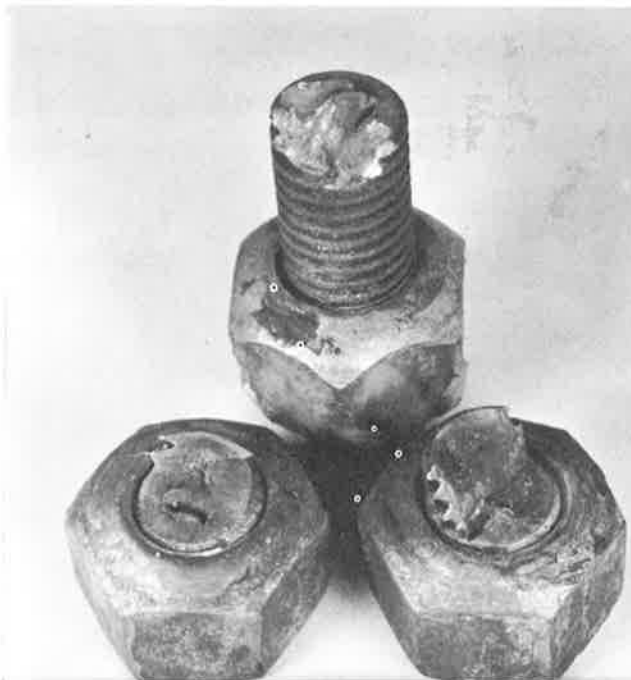
Figure 4. Broken bolts obtained from Wolf Creek.

Approximately 40 broken bolts were obtained from Wolf Creek following discovery of the failure. Hardnesses determined on 6 Wolf Creek bolts are given in Table 1. Check analysis chemistry is also given. Hardness and chemistry meet ASTM requirements indicating that failure was not due to defective bolt material.

Generally, the fracture surface of the bolts was of a brittle nature. The fractures occurred in the threads at various distances from the nut. If bolt shear had been the mode of failure, the fracture surface would be along the shear plane, which is one plate thickness from the nut for lapped joints. Several of the fracture surfaces were rather flat and perpendicular to the axis of the bolt. This type of fracture could possibly be identified with torsion-tensile failure (Fig. 4).

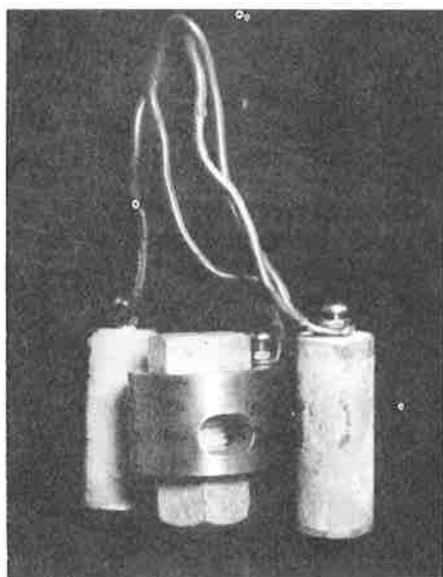
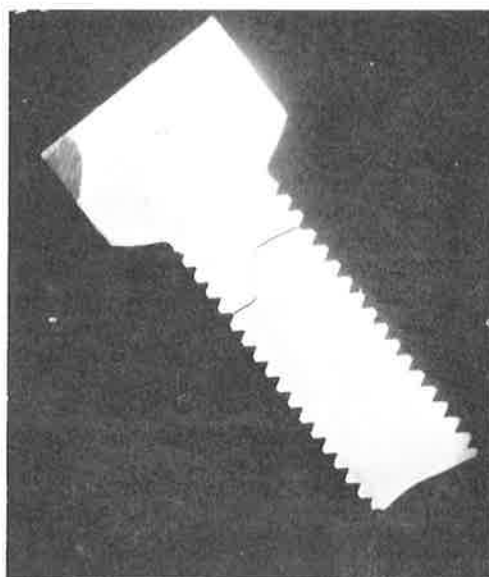
ultimate torque cracked after 4 days (Fig. 15). A softer bolt (R_C 30) tested in the same manner had not cracked after 70 days. Numerous other tests on the low and high hardness bolts were made with attempts to vary the magnitude of stress, the electrolyte, and the method of charging. The same trend of results was obtained; i. e., the high hardness A 490 bolts (approximately R_C 38) showed much greater susceptibility to hydrogen-stress cracking than the softer A 325 bolts (approximately R_C 30).

Figure 15. Bolt stressed by tightening in "solid" block: at right, cracks in R_C 38 (A 490) bolt after 4 days in tap water.
