# NCHRP Report 417

## Highway Infrastructure Damage Caused by the 1993 Upper Mississippi River Basin Flooding

6. AUTHOR(S): A.C. Parola et al.		PB99-124240	
7. PERFORMING ORGANIZATION NAME(S) AND ADDRESS(ES) The University of Louisville Research Foundation Louisville, Kentucky		8. PERFORMING ORGANIZATION REPORT NUMBER HR 12-39

The University of Louisville Research Foundation  
Louisville, Kentucky

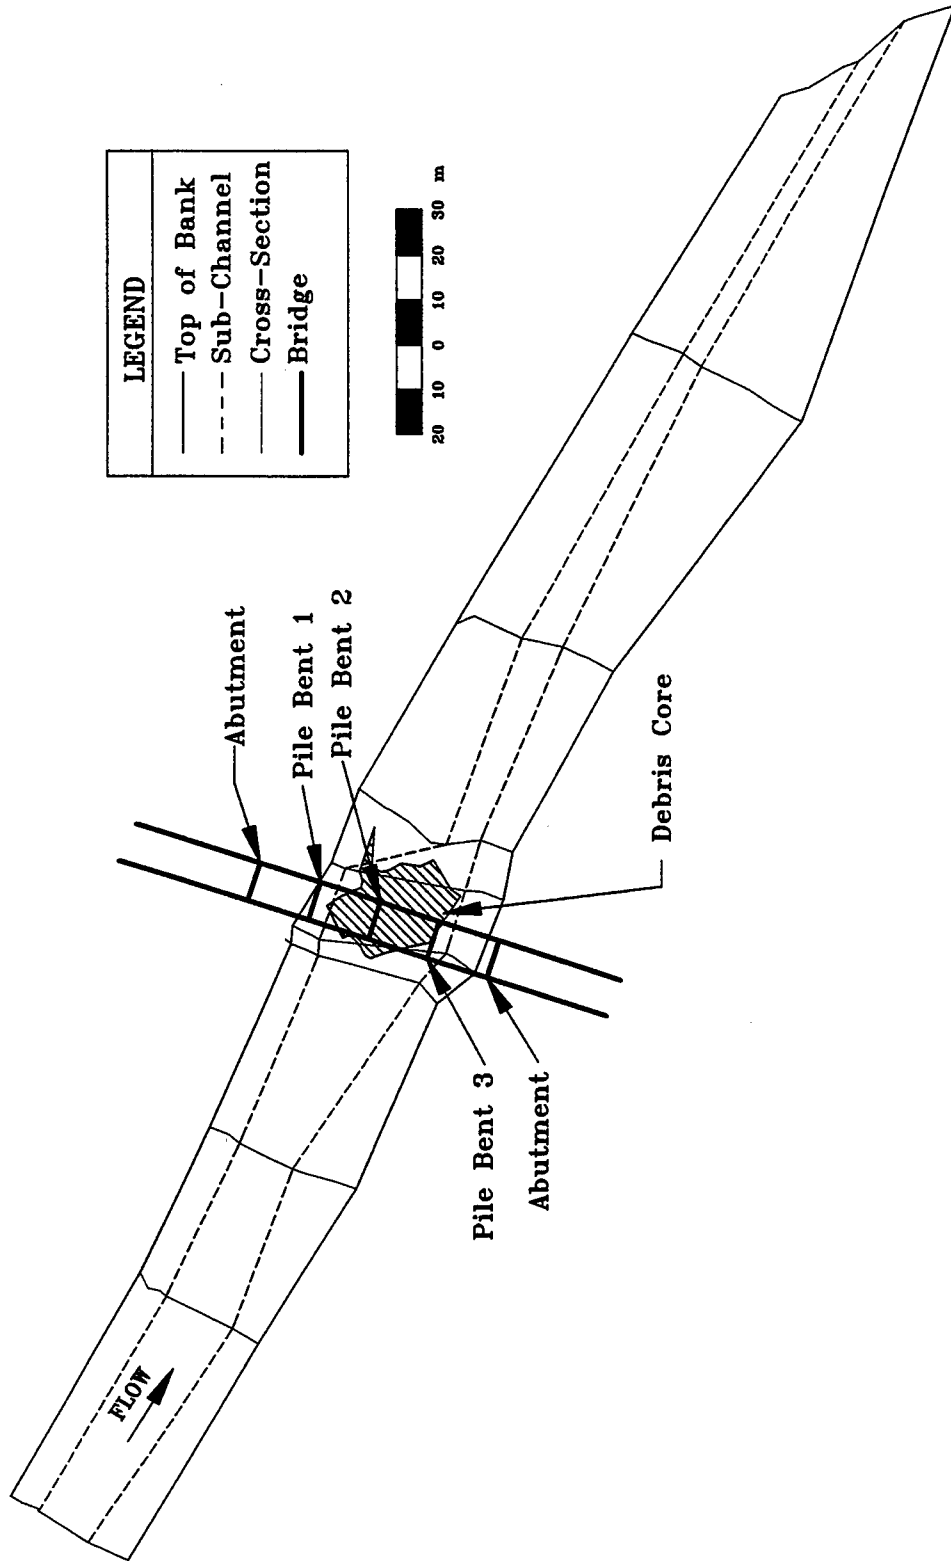
Figure 3.4. Stream flow direction and debris accumulation at Missouri Highway 113 bridge over Florida Creek, near Skidmore, Missouri.

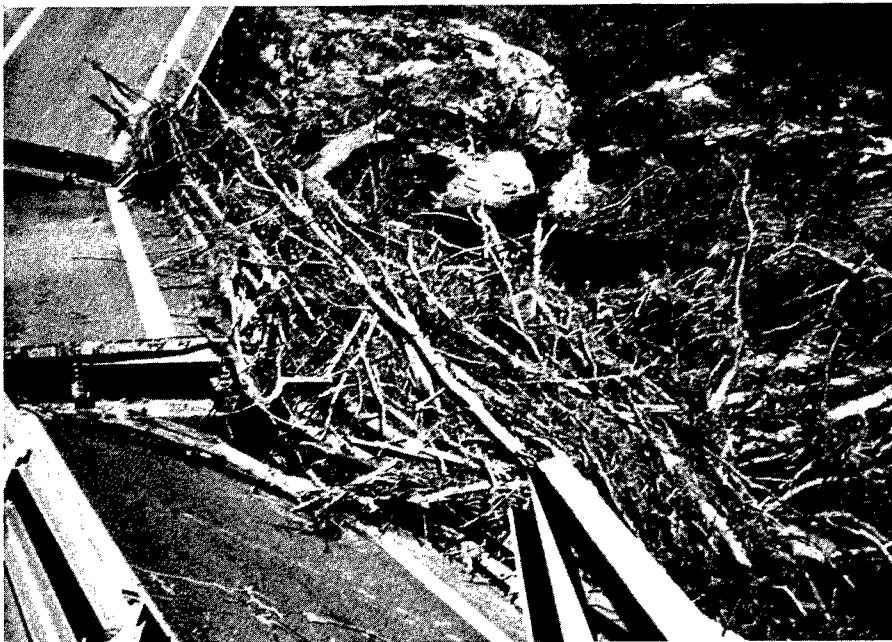
Figure 3.6. View, looking north, of Missouri Highway 113 bridge over Florida Creek, near Skidmore, Missouri, after flood recession.

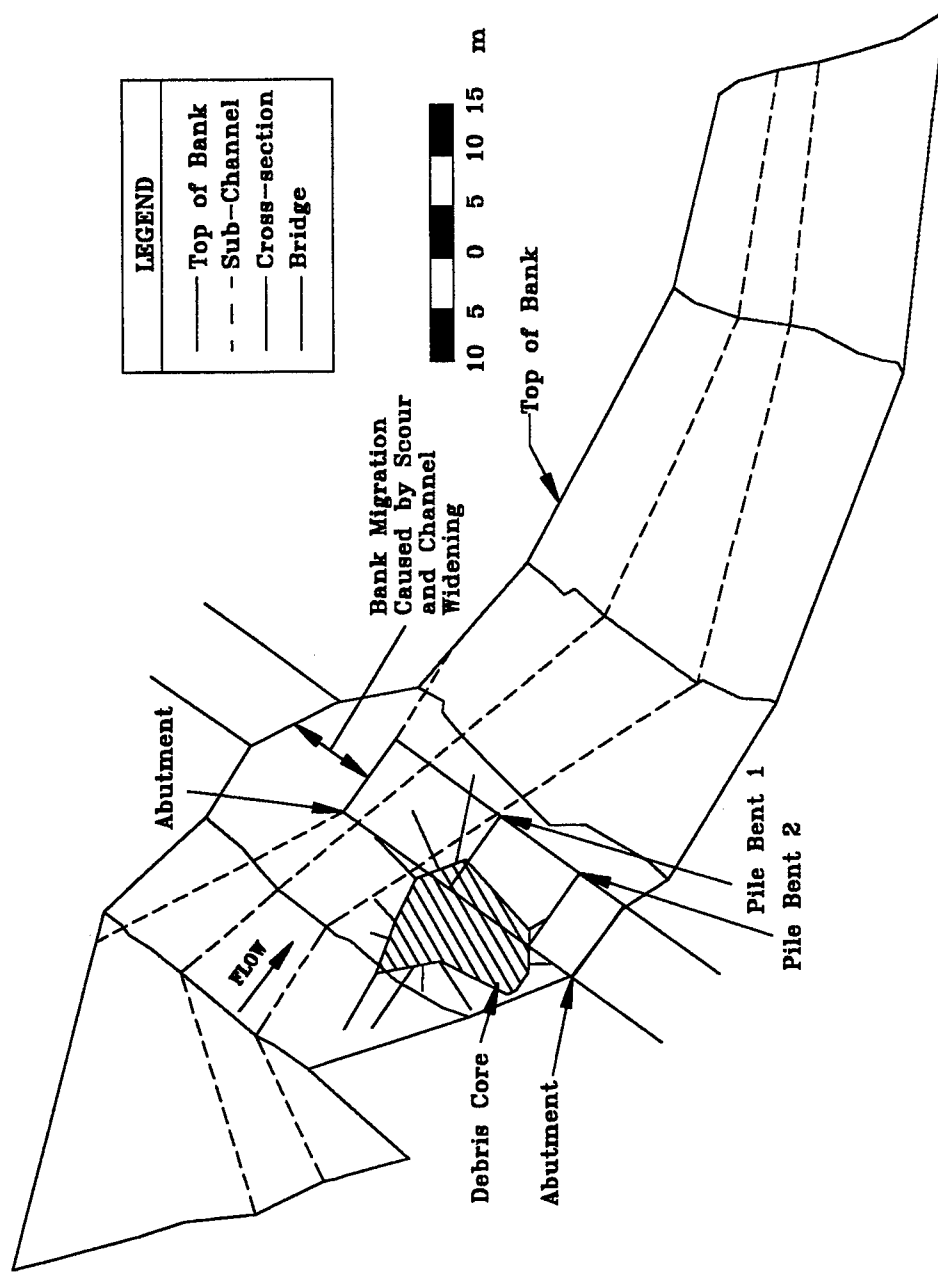
Figure 3.10. Stream flow direction and debris accumulation at county bridge over Halfbreed Creek, near Falls City, Nebraska.

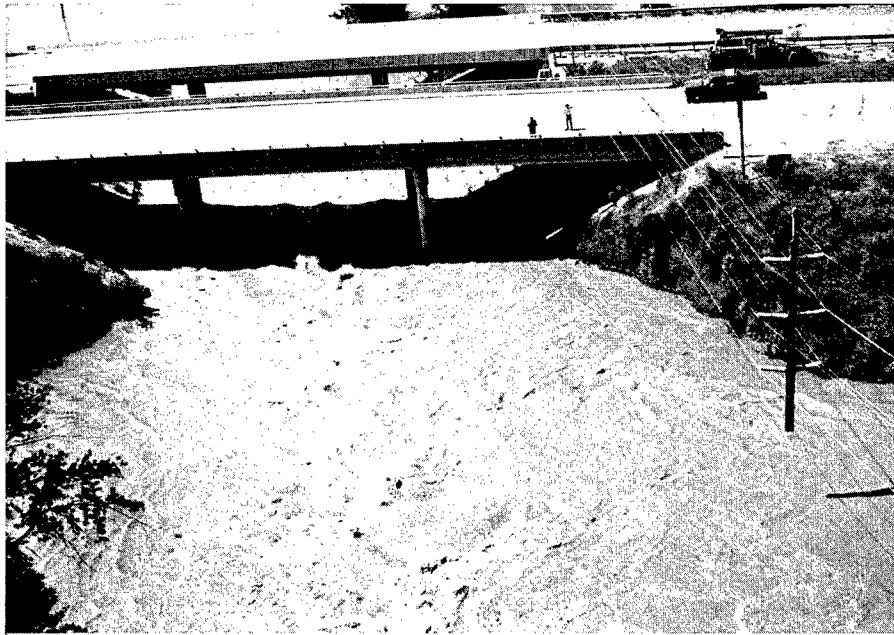
Figure 3.14a. Aerial view, looking northwest, of high-velocity flow at U.S. Highway 54 and KD Trail before southwest embankment erosion, at Jefferson City, Missouri (courtesy of Missouri Highway and Transportation Department).

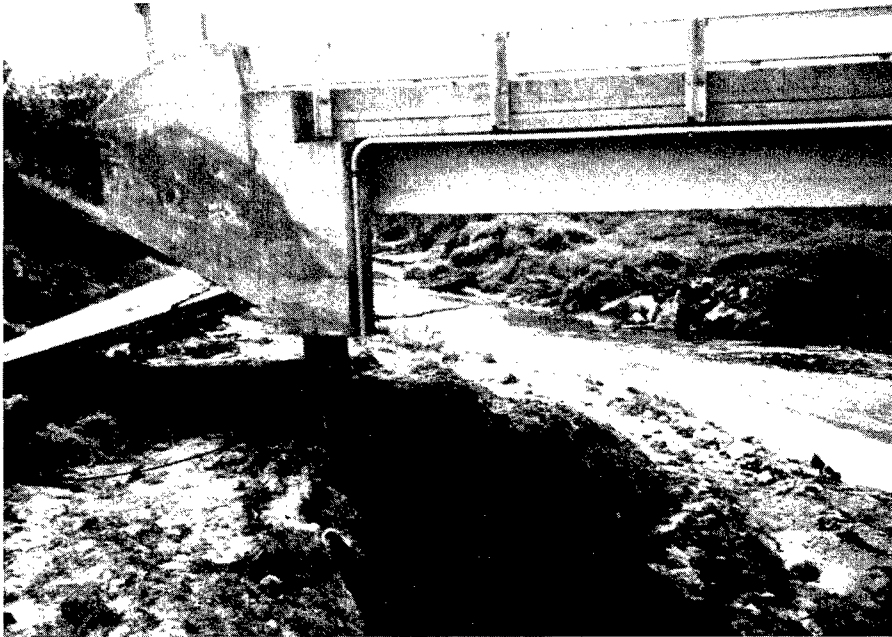
Figure 3.15. Erosion of bridge approach embankment, frequently called "washout"; Crawford County Road M14, Iowa (courtesy of Iowa Department of Transportation).

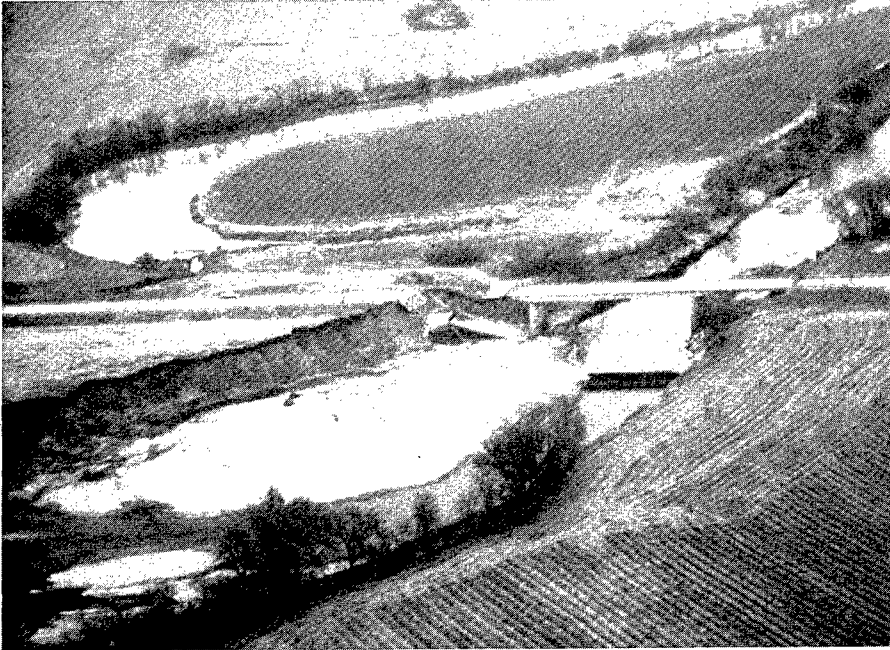
Figure 3.18. Downstream view of Nebraska Highway 8 bridge failure caused by lateral bank migration of left bank. Sediment deposition after the collapse has covered portions of the collapsed structure and the thalweg has shifted to the opposite bank.

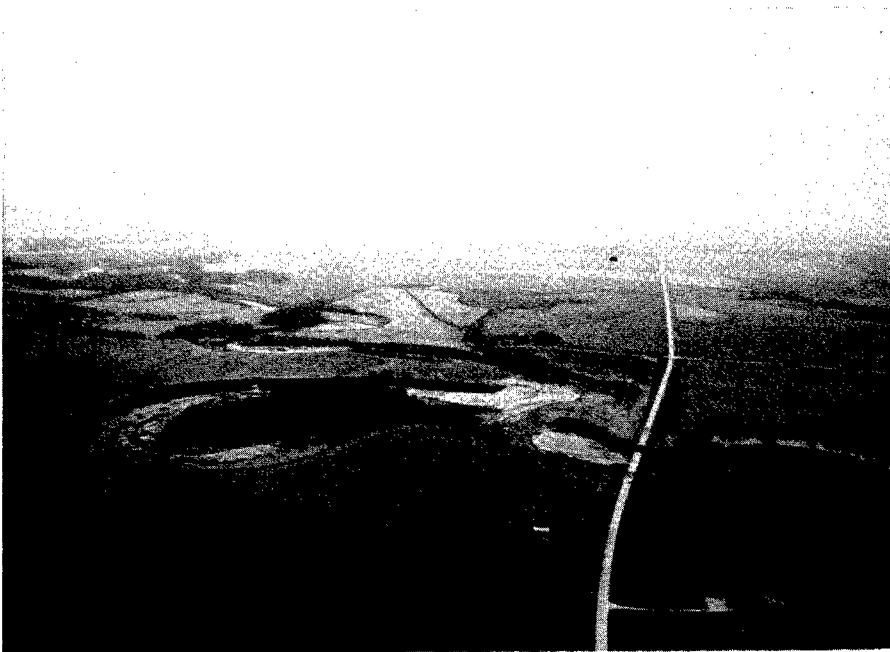
Figure 3.19. Meander loop cutoff that occurred subsequent to collapse of Nebraska Highway 8 bridge (flow through bridge is from left to right in figure).

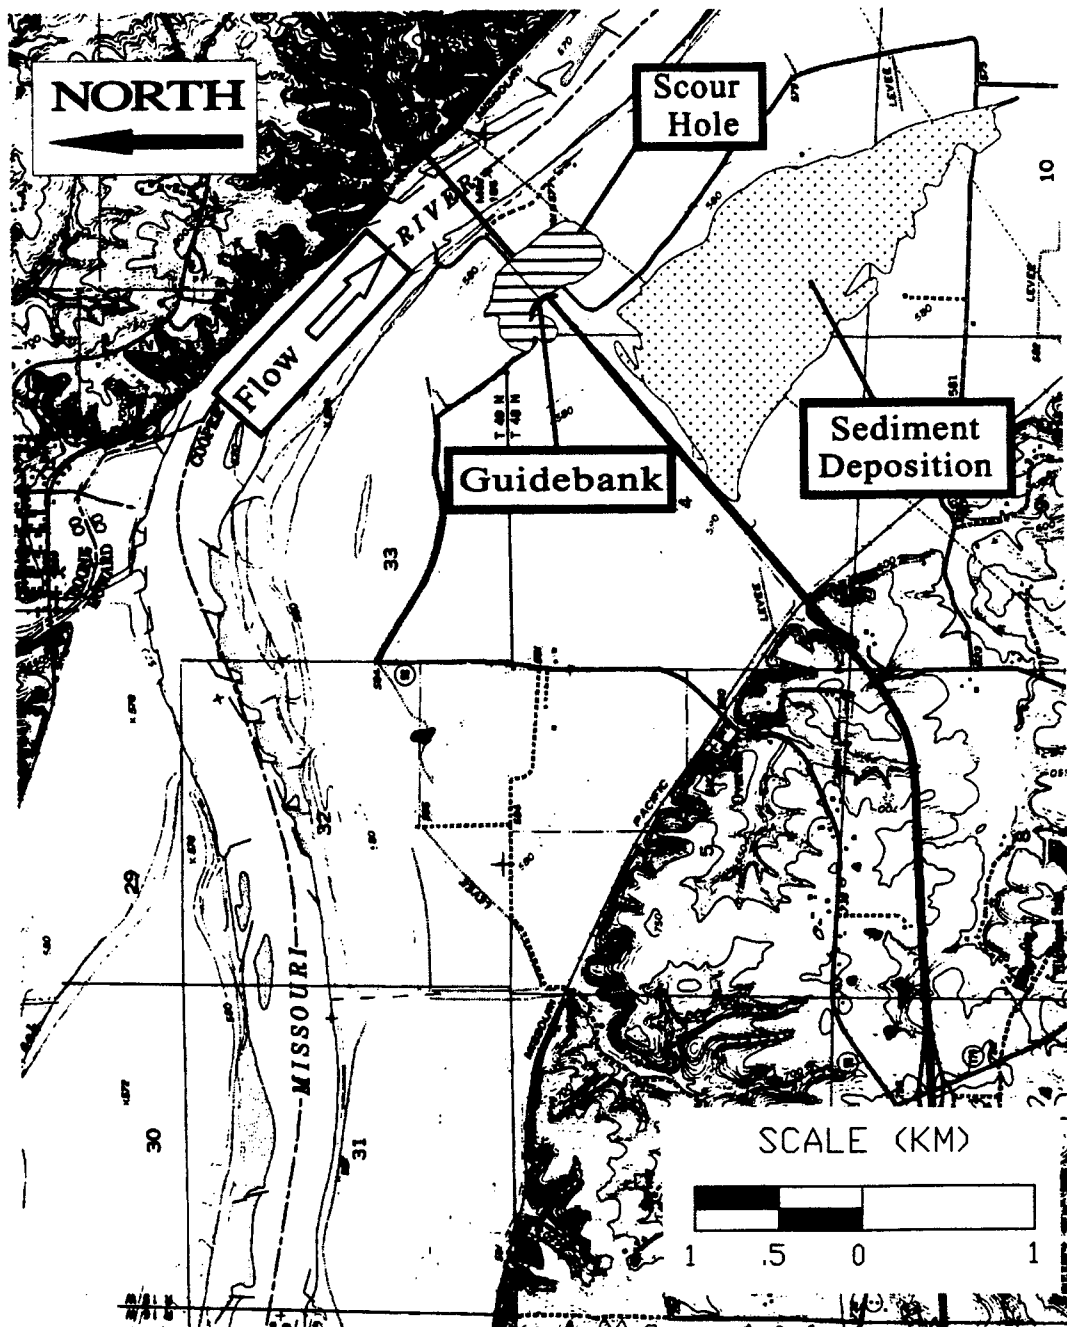
Figure 3.20. Scour and sediment deposition downstream of Interstate 70, near Rocheport, Missouri.

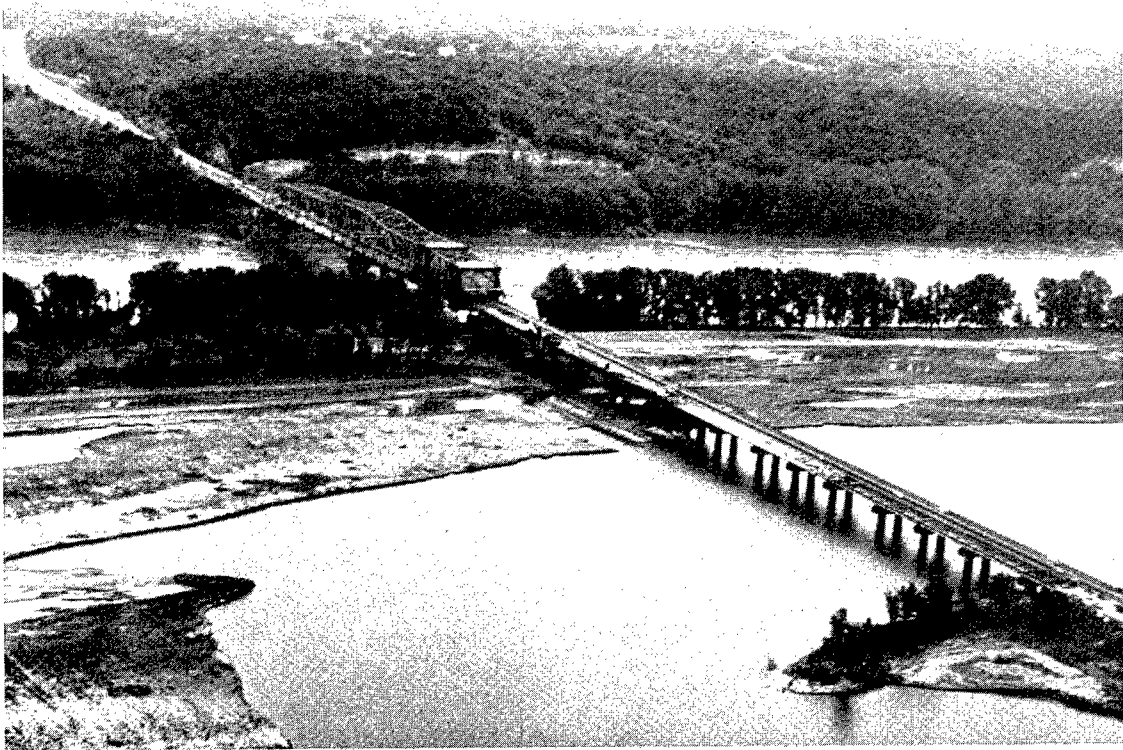
Figure 3.21. Downstream view, looking southeast, of the Missouri River floodplain scour hole at Interstate 70 crossing, near Rocheport, Missouri.

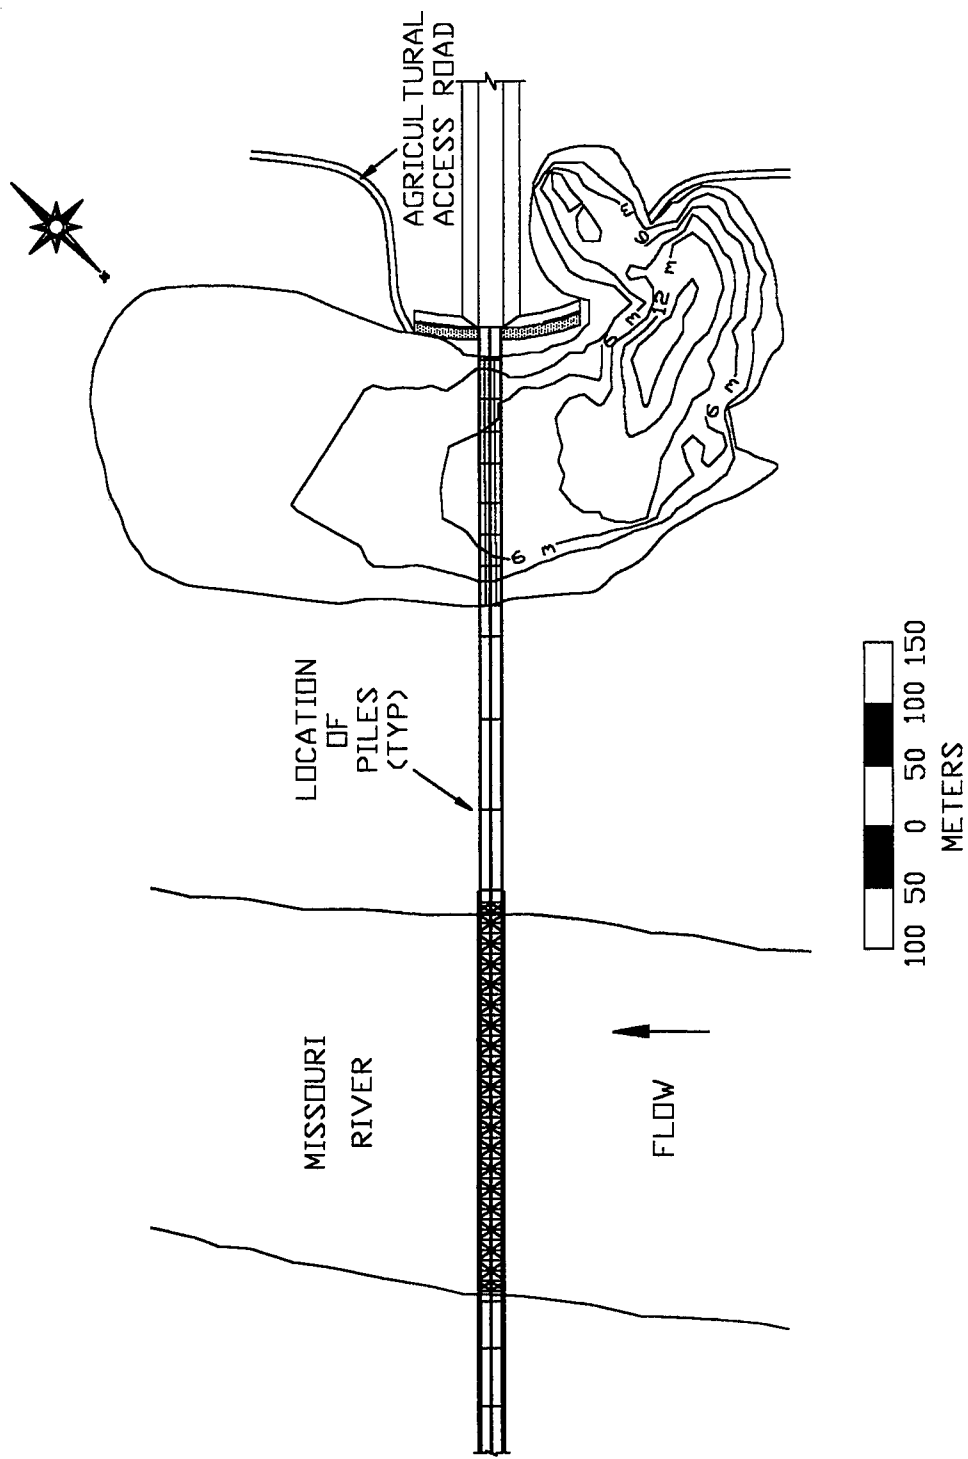
Figure 3.22. Scour hole contours at west abutment of Interstate 70 bridge, near Rocheport, Missouri.

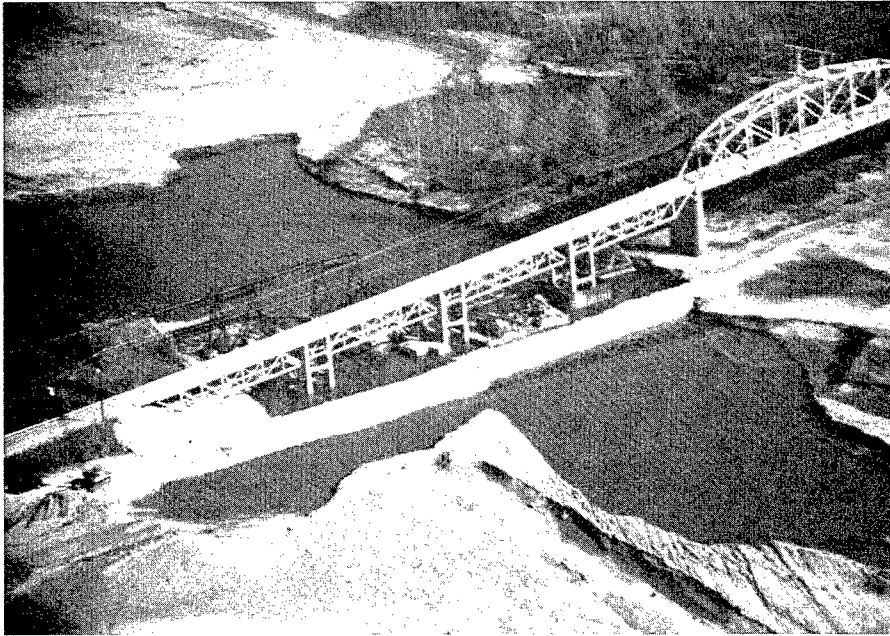
The scour pattern caused by the complex flow over the levees and around the railroad embankment can be inferred from Figures 3.27 and Figure 3.28. The maximum depth of the scour hole from the ambient floodplain level (186 m) was approximately 9 m. The location of the maximum scour depth coincided with the third pier from the west abutment of the railroad bridge. The third pier collapsed and caused with two spans of the railroad bridge. A large truss section was transported downstream until it lodged against the highway bridge piers. The combination of local

Figure 3.27. View, looking north, of scour holes and levee breach at west embankment abutment of railroad bridge and Missouri Highway 240 bridge, near Glasgow, Missouri. (Note: fill for repair work in place along downstream side of embankment).

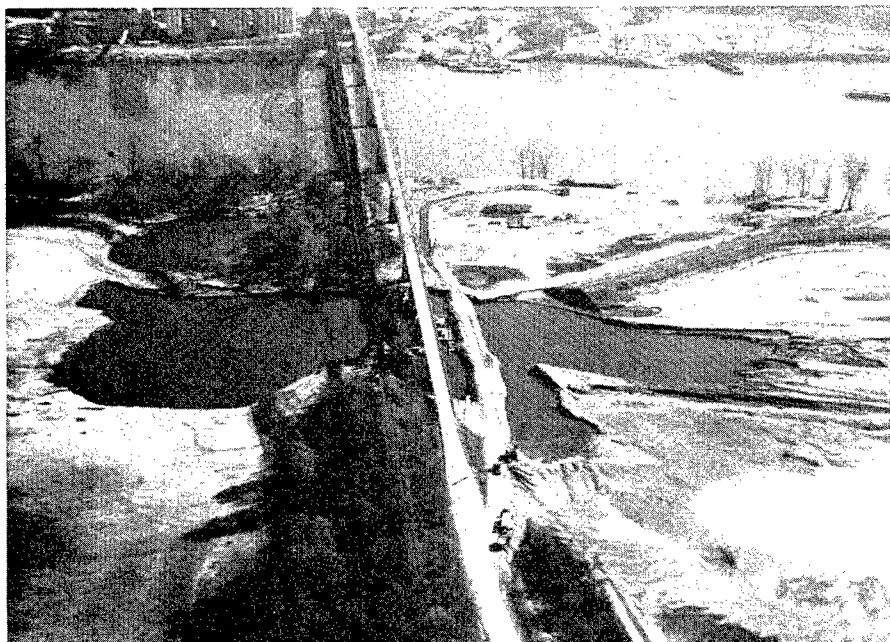
Figure 3.28. View, looking east, of scour hole and levee breach at Missouri Highway 240 bridge, near Glasgow, Missouri.

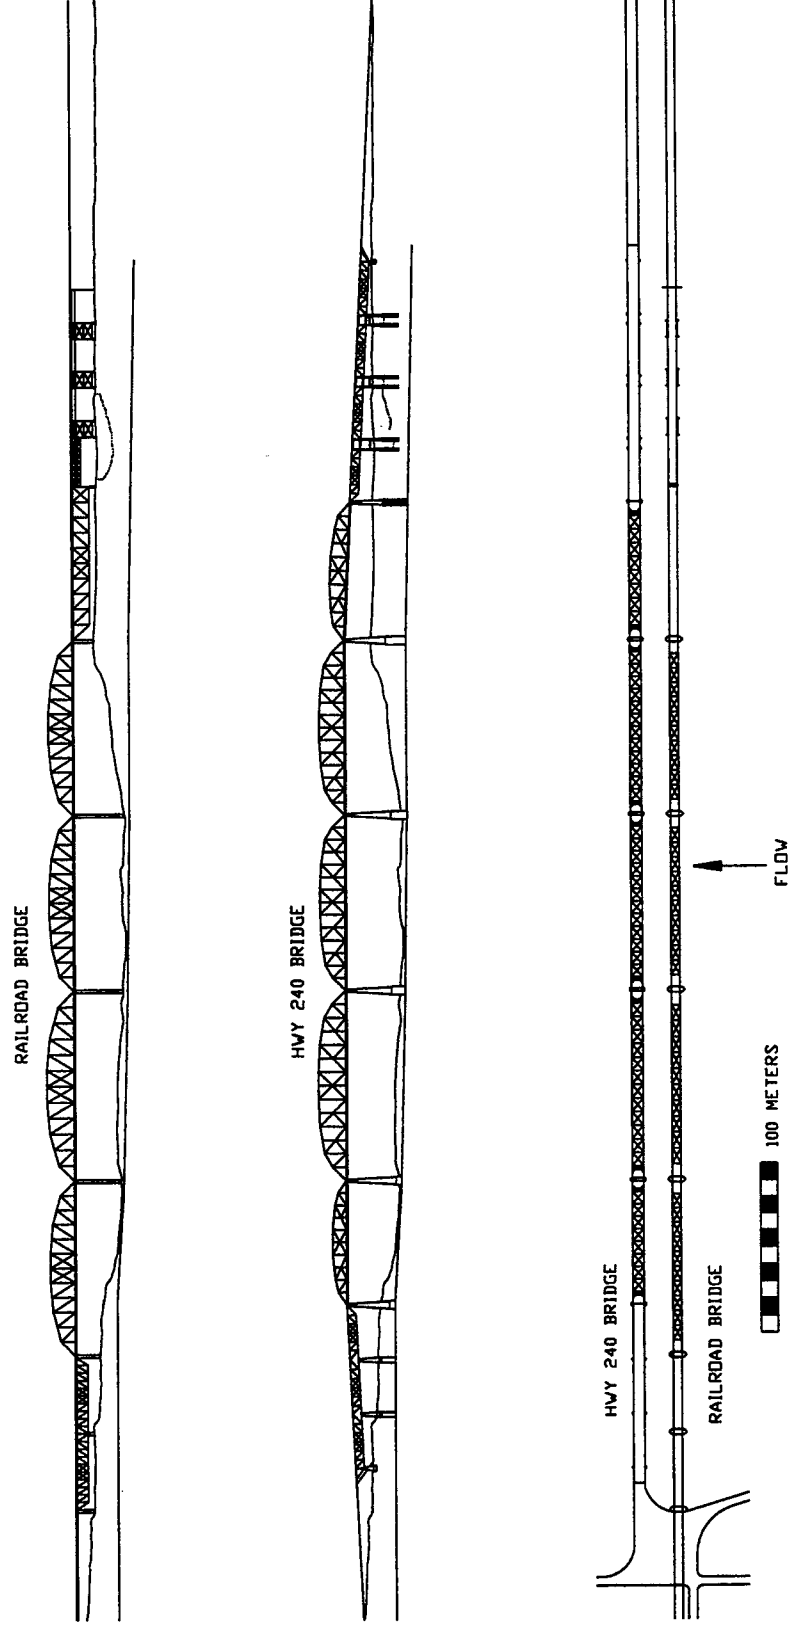
The scour hole that undermined the bridges formed 180 m from the right descending bank of the Missouri River. A second scour hole had formed closer to the bank of the stream; the two holes very nearly merged on the upstream side of the collapsed span. Examination of the walls of the scour holes, after the floodwater receded, showed that the holes had formed in layered alluvial soils consisting primarily of sands and silts; typically, sandy silt layers 100 to 300 mm thick were separated by clean sand layers 20 to 50 mm thick. Thick recent deposits of such soils downstream of the scour hole showed that most of the scoured material was moved only a short distance before the flow velocity decreased sufficiently that the scoured material was deposited. The approach embankments for the bridges form a long barrier to flow over the floodplain to the west of the main bridge site; in contrast, the floodplain to the east of the Missouri River is relatively narrow at Glasgow. The constriction of flow by the approach embankments caused the scour that undermined the bridge piers.

Figure 3.29. Downstream view of Missouri Highway 240 highway bridge and railroad bridge, near Glasgow, Missouri (bridge design courtesy of Missouri Highway and Transportation Department).

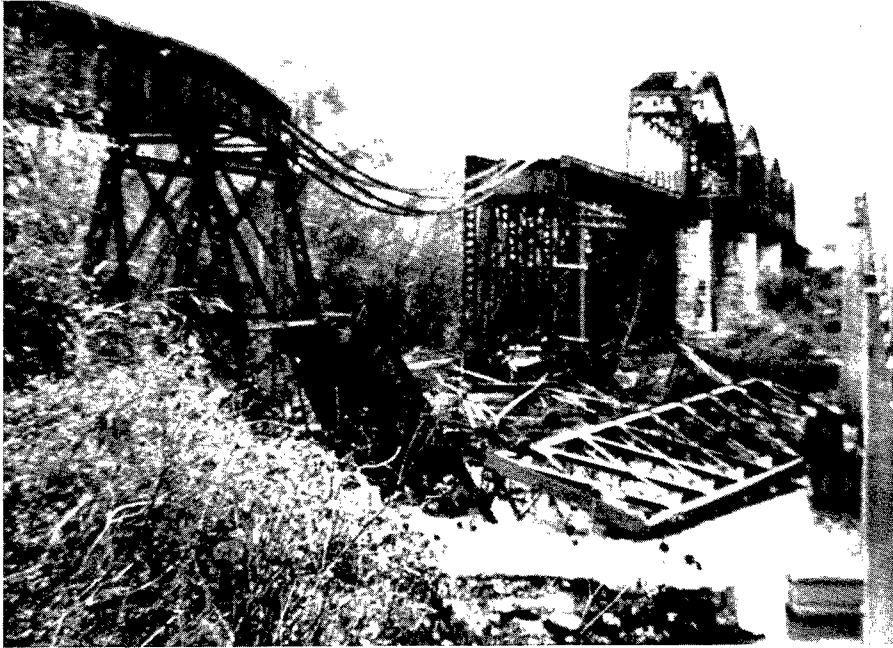
Figure 3.31. View, looking east, of collapsed railroad bridge span upstream of Missouri Highway 240 bridge, near Glasgow, Missouri.

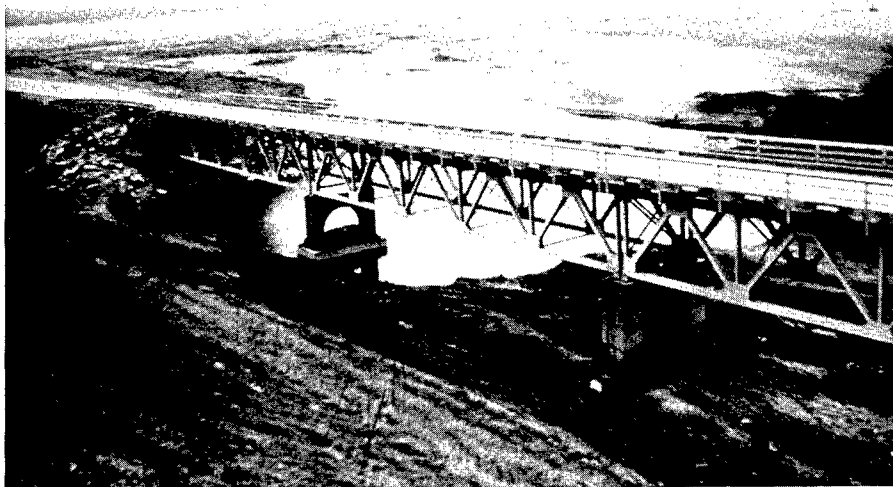
Figure 3.32. Scour hole formed at breached terminus of levee and U.S. Highway 159 bridge embankment, causing failure of approach embankment. View from top of railroad embankment, near Rulo, Nebraska.

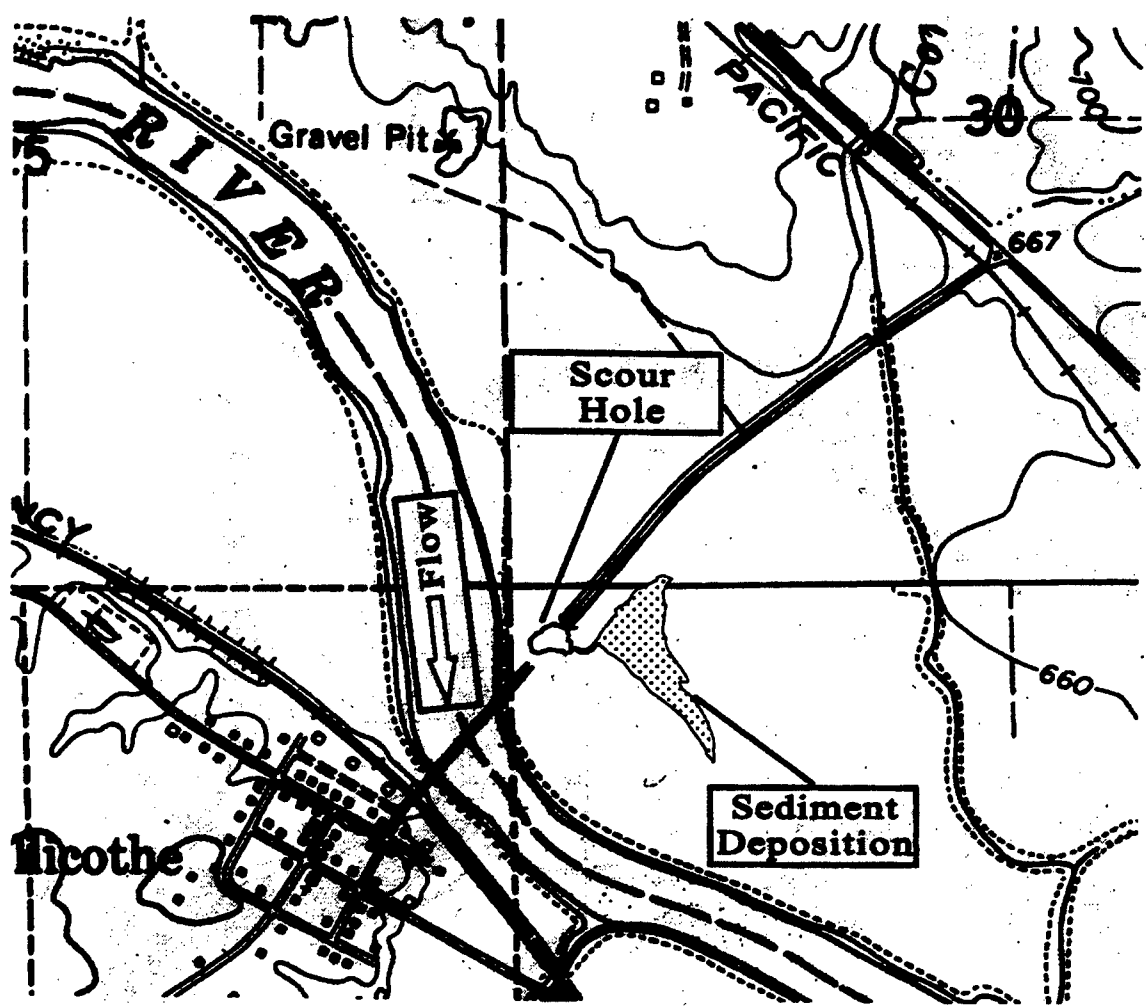
Figure 3.35. Scour hole and sediment deposition on the Des Moines River floodplain, near Chillicothe, Iowa.

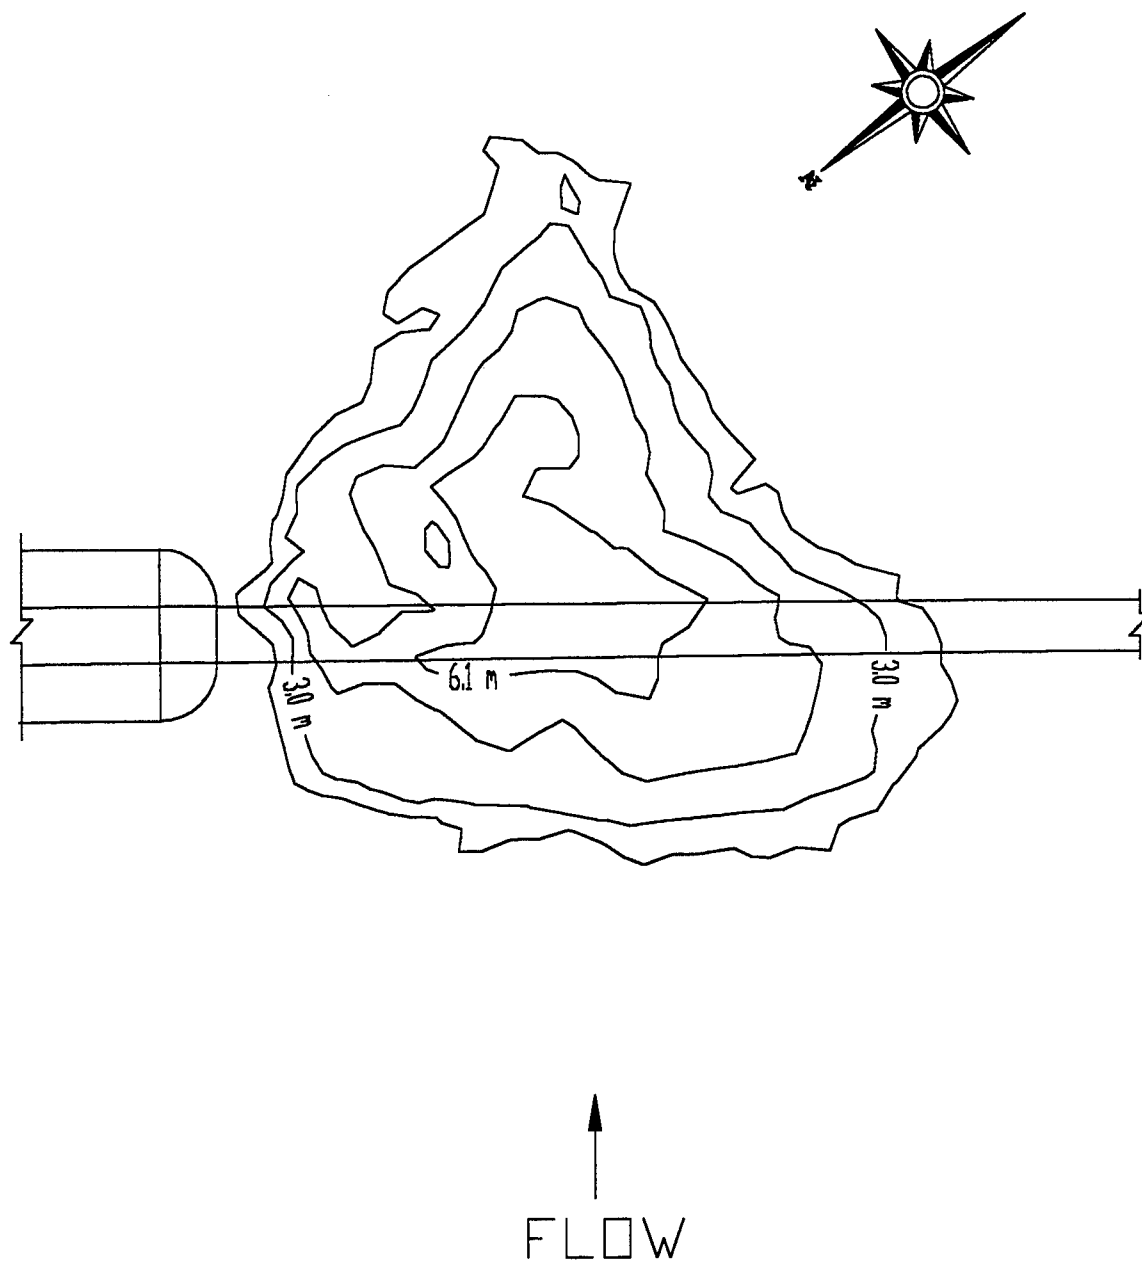
Figure 3.36. Scour hole contours at east abutment of county road bridge crossing the Des Moines River at Chillicothe, Iowa.

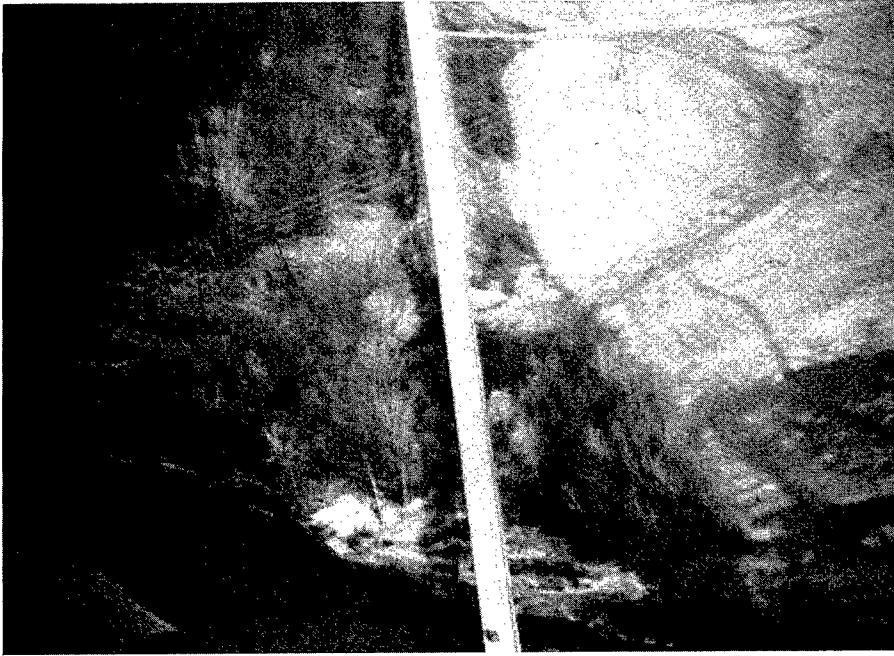
Figure 3.39. Aerial view, looking northeast, of county road and bridge over the Des Moines River, near Chillicothe, Iowa. Developed scour hole (center in figure) and transported sediment (located to the right).

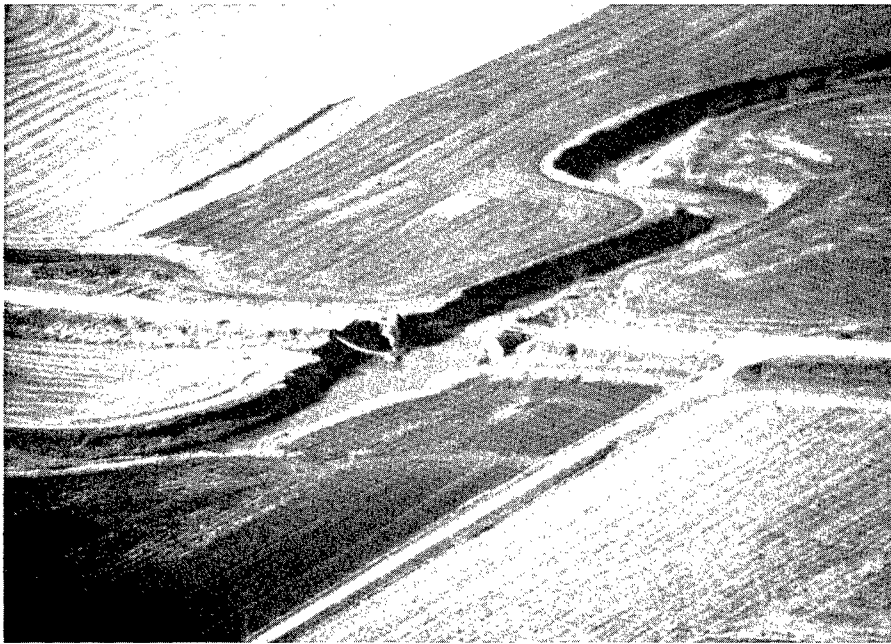
Figure 3.41. Aerial view, looking west (upstream), of Iowa Highway 71 bridge failure at Brushy Creek, approximately 13 km south of Carroll, Iowa.

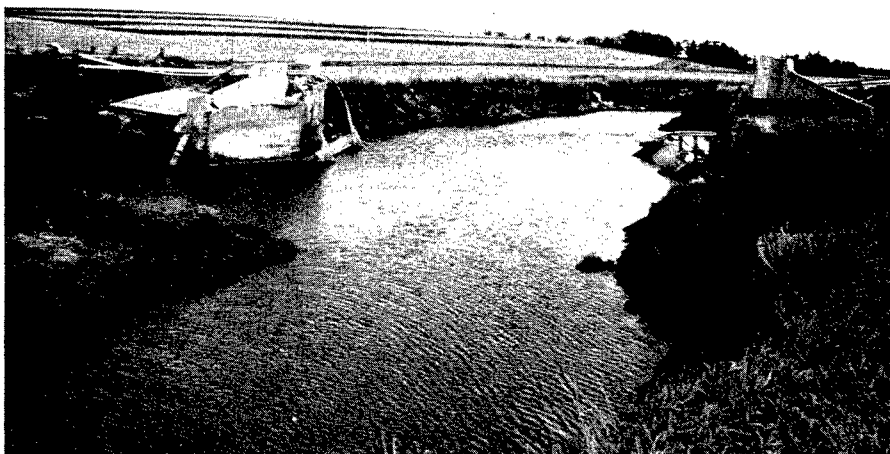
Figure 3.42. View, looking southeast (downstream), of Iowa Highway 71 bridge failure at Brushy Creek, approximately 13 km south of Carroll, Iowa.

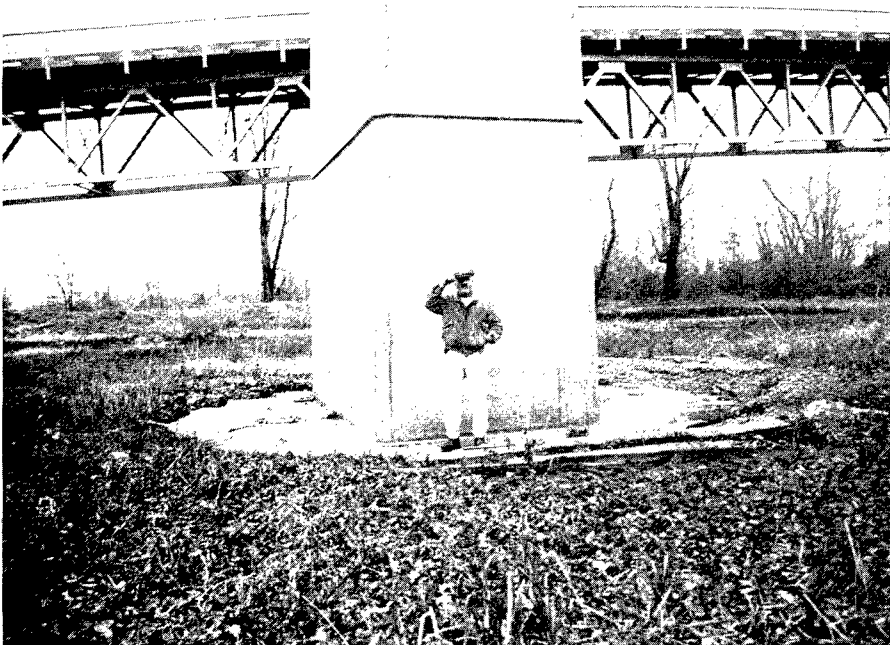
Figure 3.45. Railroad bridge pier (upstream from U.S. Highway 159 bridge) protected from Missouri River floodplain flow by wide foundation, near Rulo, Nebraska.

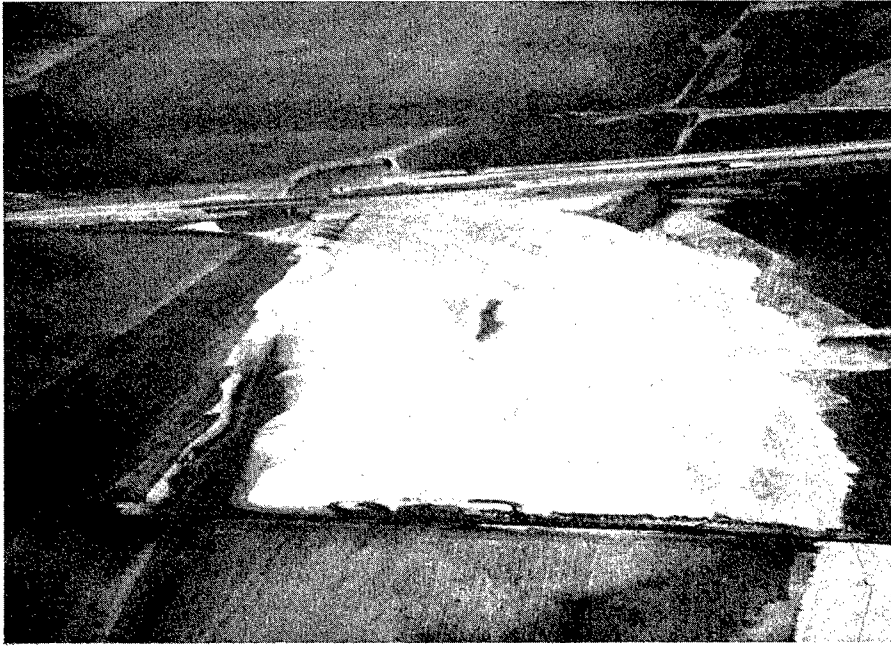
Figure 3.46. Highway embankment scour and downstream sediment deposition on the Missouri River floodplain, near Jefferson City, Missouri.

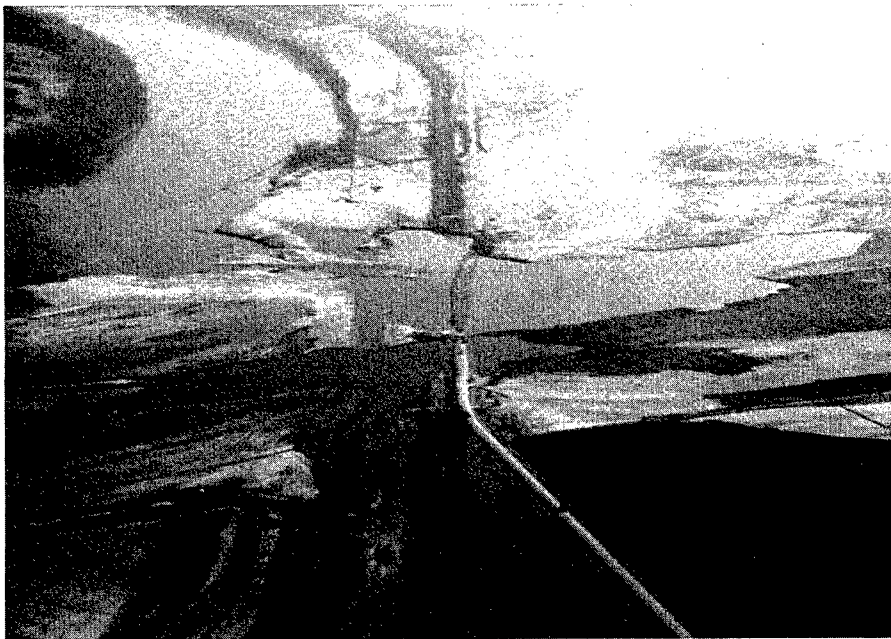
Figure 3.47. Aerial view, looking east, of breach in railroad and Missouri Highway 240 embankments, near Glasgow, Missouri. Scour hole on the Missouri River floodplain (flow from left to right).

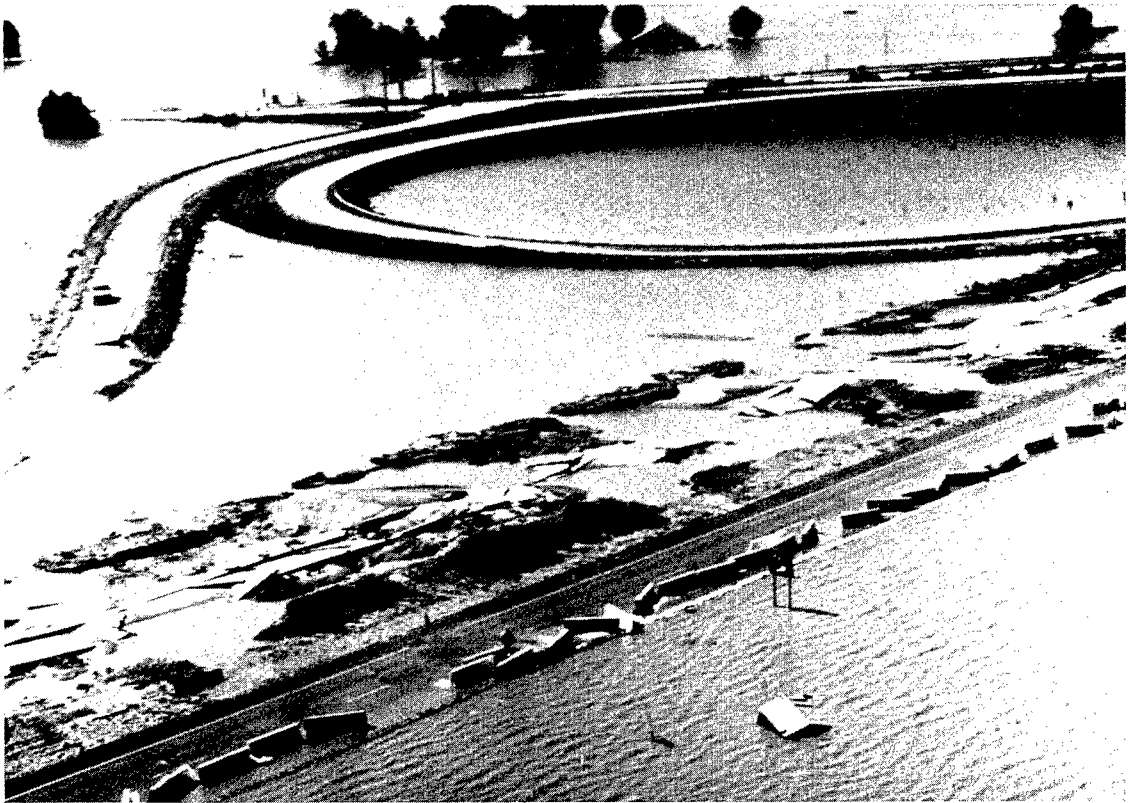
Figure 3.48. Erosion of highway embankments, shoulders, and undermining of pavement on the Missouri River floodplain (courtesy of Missouri Highway and Transportation Department).

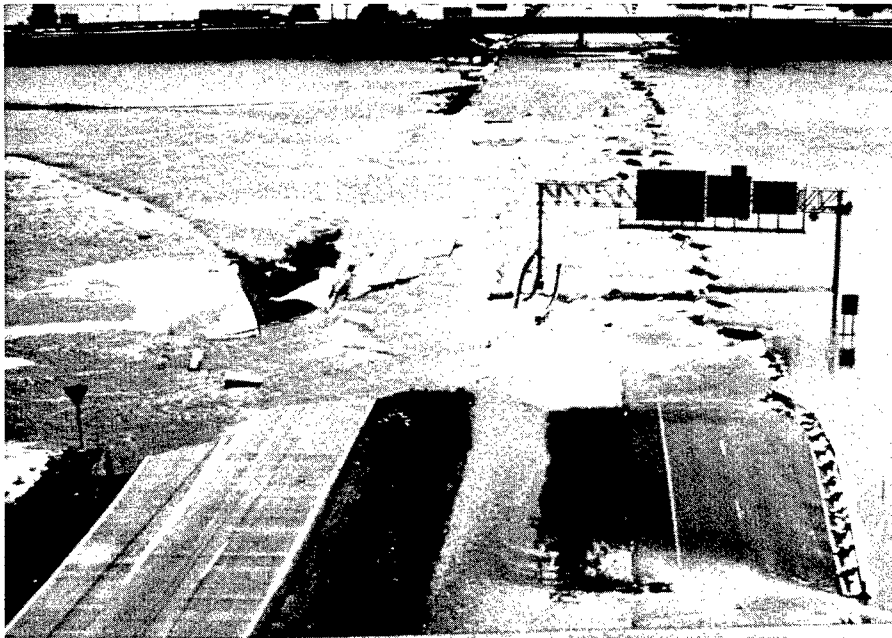
Figure 3.50. Complex flow over a wide floodplain embankment, Missouri River floodplain. Large water surface elevation difference between the upstream and downstream sides of embankment (courtesy of Missouri Highway and Transportation Department).

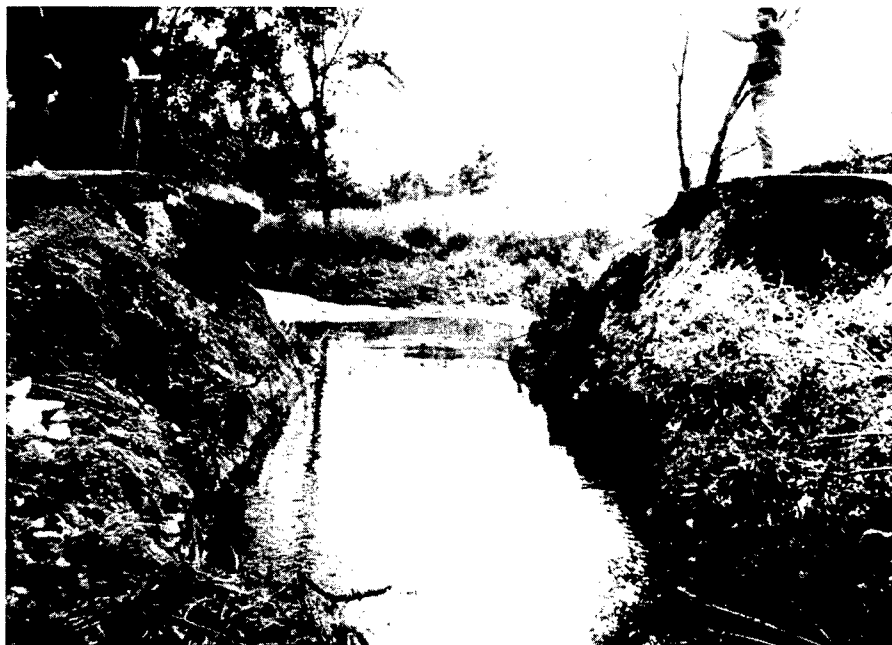
Figure 3.51. Culvert "washout" located on County Highway BB in Adair County, west of Kirksville, Missouri (courtesy of Missouri Highway and Transportation Department).

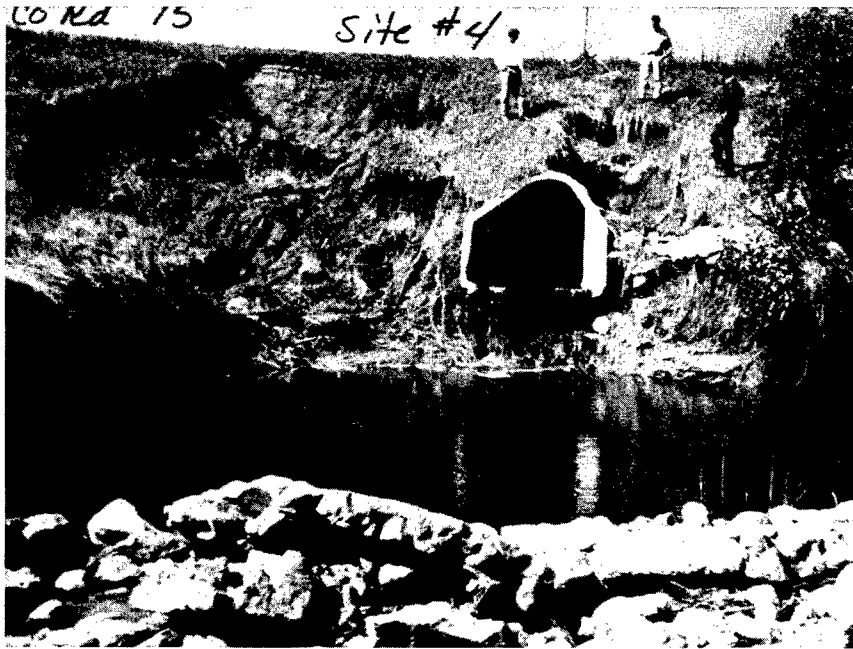
Figure 3.52. View of roadway embankment erosion and scour at culvert outlet, Williams County Road 15, near Williston, North Dakota (courtesy of North Dakota Department of Transportation).
