# NCHRP Report 417

## Highway Infrastructure Damage Caused by the 1993 Upper Mississippi River Basin Flooding

6. AUTHOR(S): A.C. Parola et al.		PB99-124240	
7. PERFORMING ORGANIZATION NAME(S) AND ADDRESS(ES) The University of Louisville Research Foundation Louisville, Kentucky		8. PERFORMING ORGANIZATION REPORT NUMBER HR 12-39

The University of Louisville Research Foundation  
Louisville, Kentucky

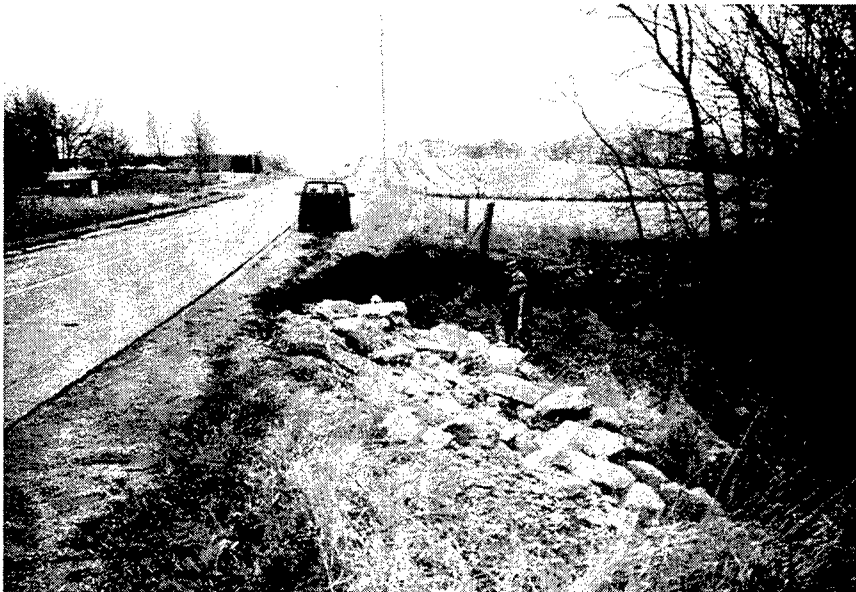
Figure 3.53. Embankment failure on Missouri Highway 59, caused by high groundwater levels (8 km north of Craig, Missouri).

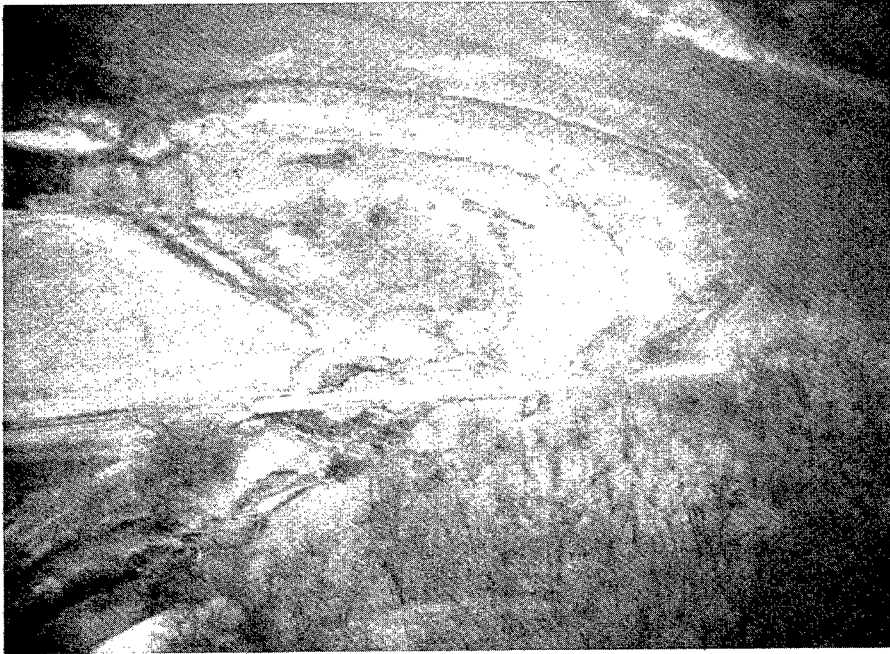
Figure 3.54. Debris accumulation on a pier of a county bridge tributary stream in the Big Nemaha River system, Nebraska.

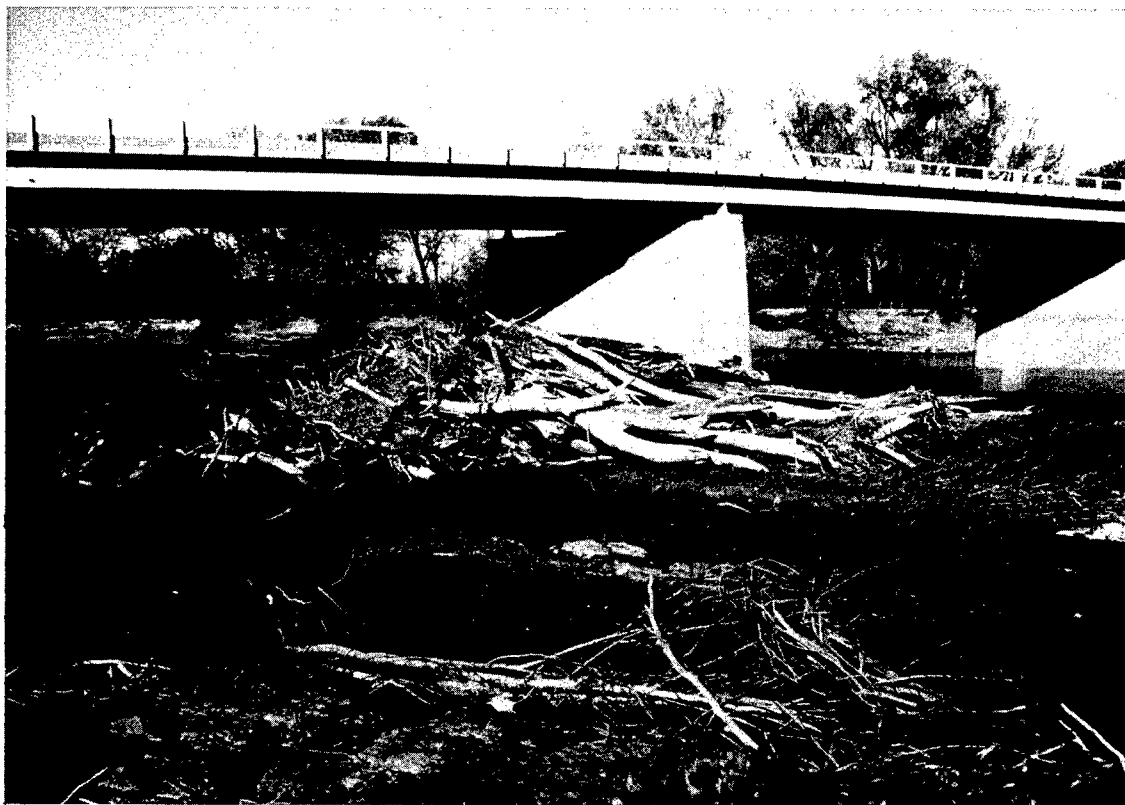
Figure 3.56. Des Moines River debris accumulation and downstream sediment deposit (view looking upstream).

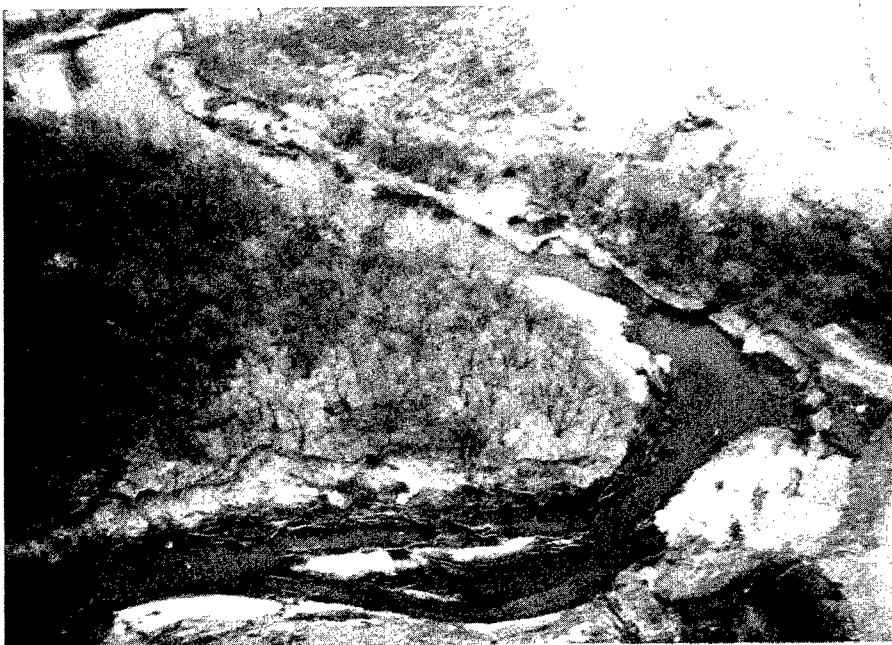
Figure 3.58. Bank failure and sources of debris, Big Nemaha River, near Falls City, Nebraska.
