SHRP-C-620

**Evaluation of NORCURE Process  
for Electrochemical Chloride Removal  
from Steel-Reinforced Concrete Bridge Components**

ELTECH Research Corporation  
Fairport Harbor, Ohio

**Strategic Highway Research Program  
National Research Council  
Washington, DC 1993**

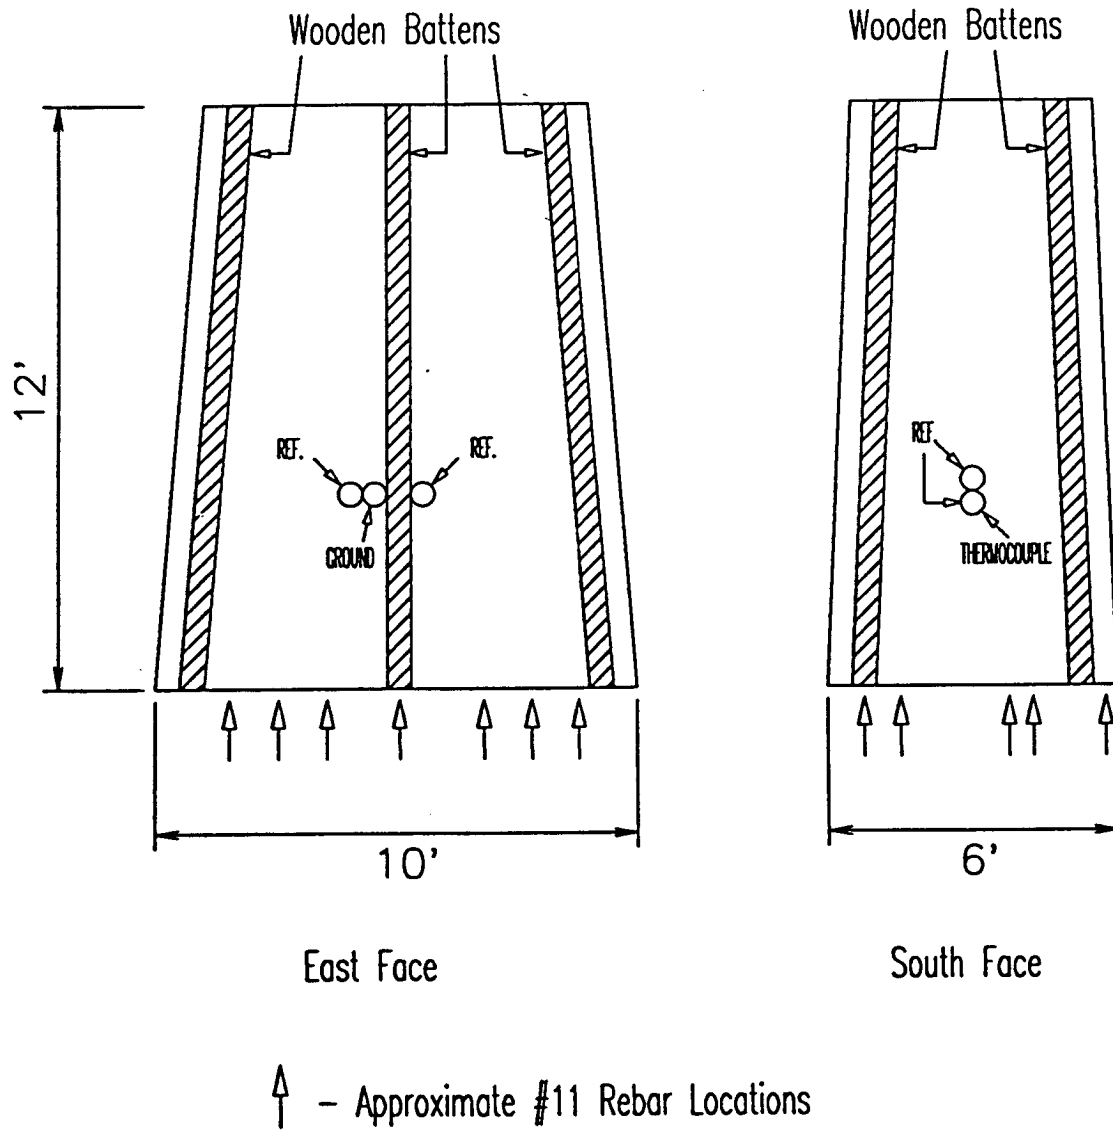
**Figure 4. Layout of Burlington Skyway Bent S-19**

Roadway drainage, which contained deicing salt in the winter months, flowed through an open deck joint above the Pier causing corrosion of the reinforcement, in spite of the high concrete cover. The chloride analysis of cores taken from each face is detailed in Table 4.

Chloride ion concentration at the level of the reinforcement averaged 4.09 lb/yd<sup>3</sup> (0.106 percent by weight of concrete); well above the threshold for corrosion. In spite of this, however, the pier was in relatively good condition. The concrete was uncracked with no delaminations, and reinforcement continuity was good.

Installation of the NORCURE™ chloride removal system was conducted on July 4-5, 1989. Reference electrodes were installed in each face, and thermocouples were installed in the north and south faces at the depth of the reinforcement. Wooden battens, approximately 1.5 in. wide by 0.75 in. thick (40-mm x 20-mm), were fastened vertically to the concrete using insulated anchor screws. A schematic of the installation as applied to the east and south faces is shown by Figure 4.

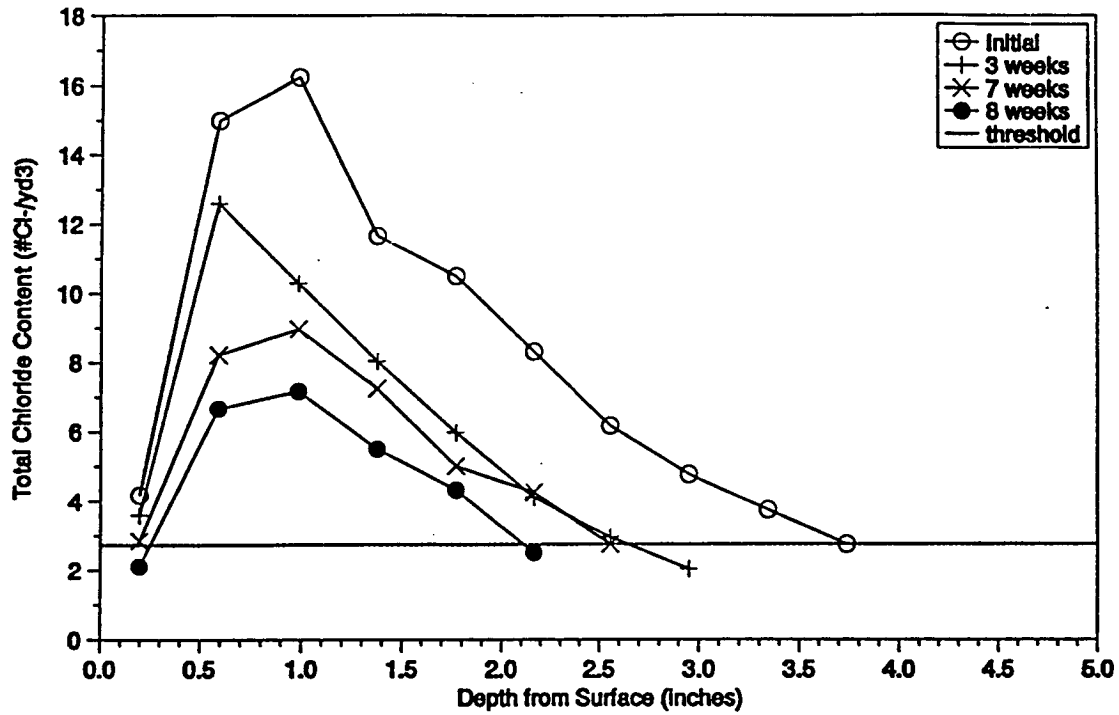
Figure 11. Burlington Chloride Profile: South Face, Between Bars

Chloride ion contents as a function of depth are shown for each treated face in Figures 11, 12, 13 and 14. These profiles were established by taking 4-in. (100 mm) diameter cores, cutting cores into 0.4-in. (10 mm) thick slices, and measuring the acid-soluble chloride ion content. Since the flow of drainage water over the column was uneven, chloride ion content can be expected to vary considerably over each face. In an effort to minimize these variations, cores taken at various stages of treatment were taken vertically below each other on the face.

Chloride ion removal was relatively rapid during the first three weeks of operation, but the rate of removal decreased with time. All faces showed very little difference in analyses between seven and eight weeks of operation. These are illustrated by the data shown on Figures 11, 12, 13 and 14. Performance is also summarized by Table 7, which shows the total grams of chloride removed (from concrete analysis), percentage of chloride removed, and current efficiency for the process. Current efficiency is here defined as the amount of chloride removed relative to the theoretical amount which could have been removed if 100 percent of the current was carried by the movement of chloride ions.

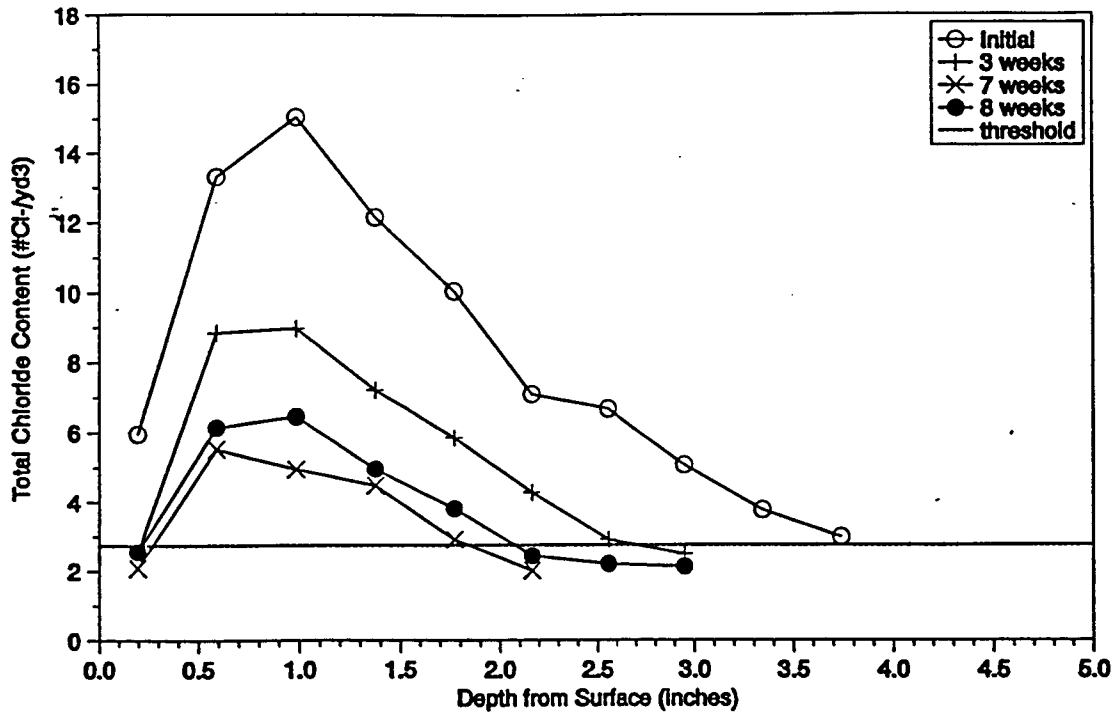
Figure 13. Burlington Chloride Profile: West Face, Over Bars

Another difficulty is the identical current efficiencies reported over rebar and between rebar on the west face. From other work done under SHRP contract C-102A, one would expect to see a significantly higher efficiency over the rebar. This is especially true of Pier S-19 since the steel is widely spaced. Again, there seems to be no convenient explanation for this result. Perhaps the inhomogeneous nature of the chloride ion within the pier is again responsible for this discrepancy.

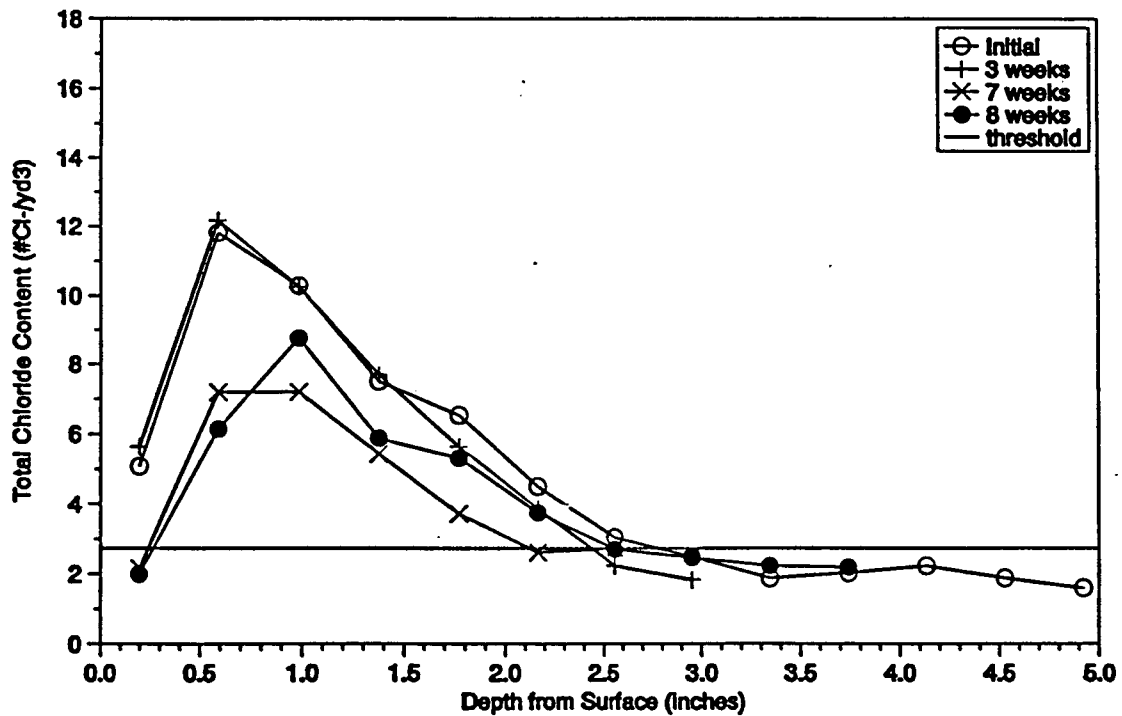
Figure 14. Burlington Chloride Profile: East Face, Over Bars

One obvious discrepancy presented by Table 7 is the difference in current efficiency and chloride ion removed between the east face, and the west and south faces. Current efficiency was calculated at 11 percent for the east face, and about 30 percent and 32 percent for the south and west faces, respectively. There is no obvious explanation for this large discrepancy. Poor distribution of current could account for this difference, but current distribution was measured during the process and was reported to be good to all faces. As judged by other work done under contract C-102A, one could expect a current efficiency, for this amount of chloride ion concentration and total charge passed, to be about 20 percent. It therefore appears that the efficiency calculated for the east face is too low, while the efficiencies reported for the south and west faces are too high. It may be that this is simply a consequence of the inhomogeneous nature of the chloride ion concentration within the column, and that a more accurate calculation is not possible without taking a much larger number of samples.
