SHRP-H-354

Innovative Materials Development and Testing

Volume 3: Treatment of Cracks in Asphalt Concrete-Surfaced Pavements

October 1993

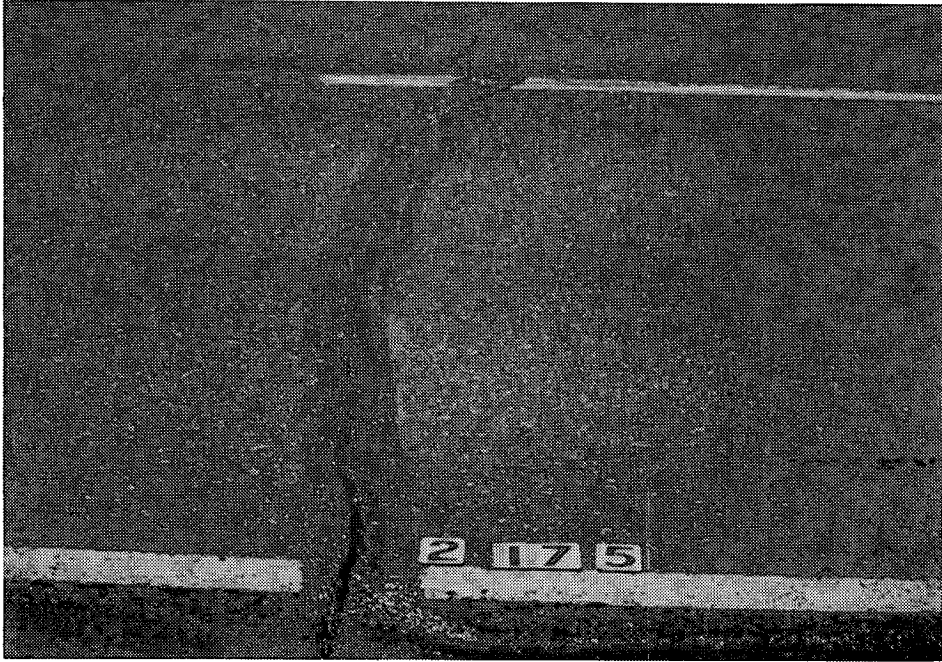
Several Hi-Spec treatments at Wichita and Elma were subject to considerable amounts of bubbling. This bubbling occurred in both airblasted and hot-airblasted test sections and was believed to have been the result of capillary moisture emanating from saturated base layers. It was observed more in the uncut crack sections where the cleaning/drying operation was less effective because of the small crack channels. In order to minimize the bubbling, airblasting operators were instructed to be more meticulous in drying the cracks. Roughly 15 to 20 minutes of curing time typically was needed for the Hi-Spec.

Figure 10. Hi-Spec reservoir-and-flush configuration

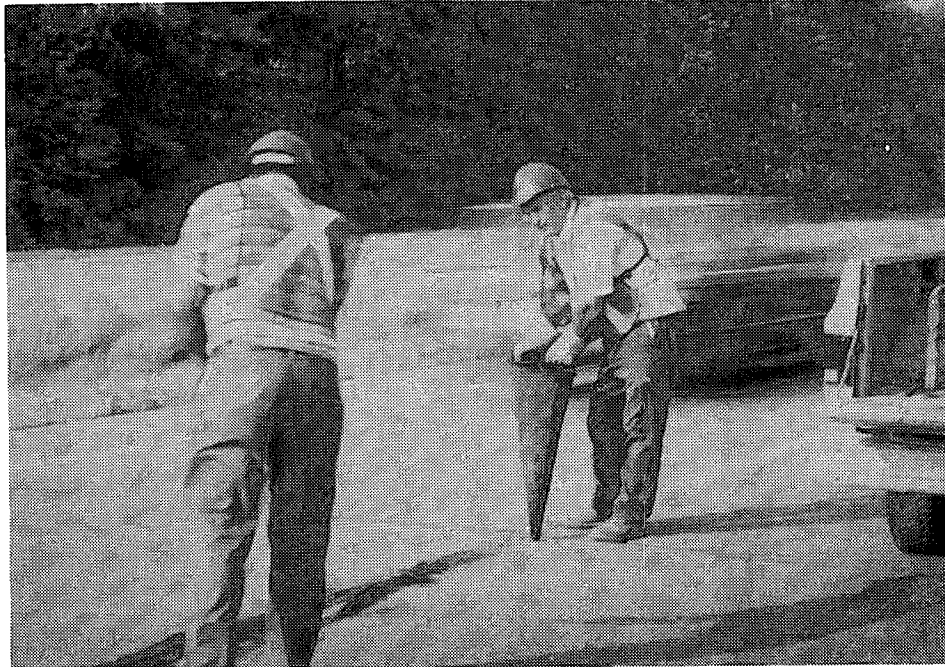
Two basic problems were experienced with the installation of CRF. First, throughout the test sections a few short segments of deep, wide cracks permitted the highly liquid emulsion to run down into the pavement base, necessitating repeated applications to successfully fill the segments. Although the manufacturers recommendations suggested the placement of sand at the bottom of deep, wide cracks to serve as a barrier, such action was not taken in this case because of the small number of sizable cracks.

Figure 15. Witco CRF flush-fill configuration

Second, although lane closures were maintained for a few hours after placement, CRF tracked heavily when exposed to traffic. The emulsion typically "broke" within 30 minutes after application, and had formed a skin prior to the lane opening. Obviously, however, traffic was able to dislodge a good portion of the material from the crack. In this case, sand should have been used as a blotter to prevent tracking.

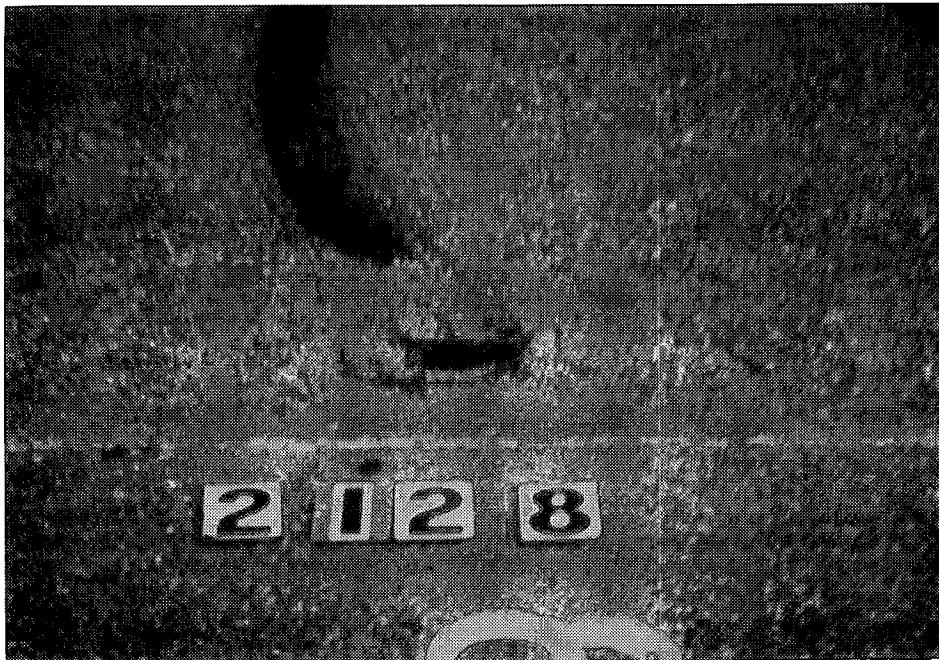
Figure 29. High-severity pull-out of Koch 9030 band-aid seal at Abilene

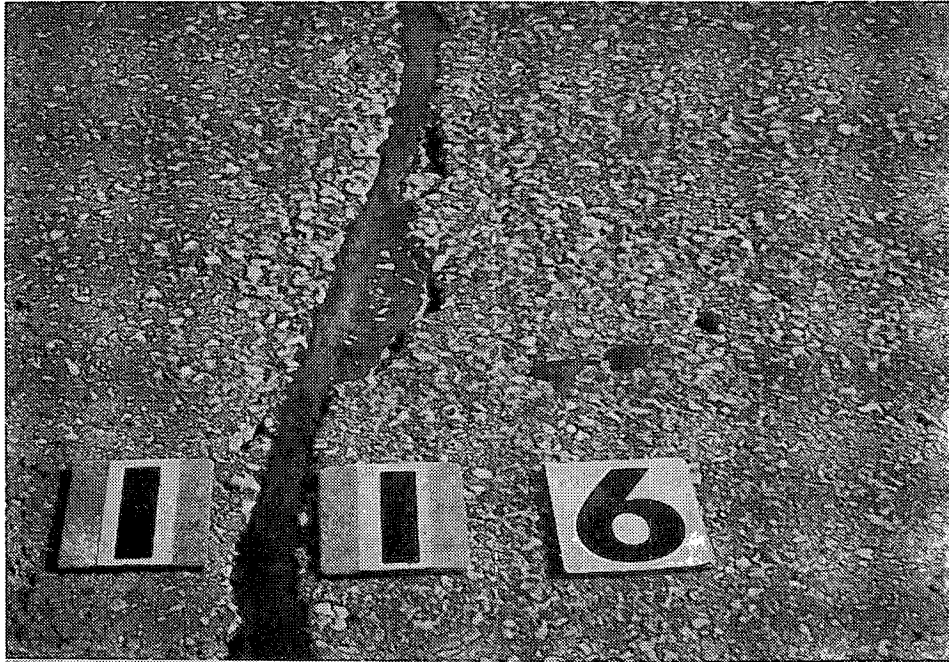
Nationally, the E-5 silicone treatment averaged 6 percent high-severity edge deterioration. The majority of these failures were attributed directly or indirectly to missed crack or secondary crack segments that were not sealed during installation. Most of the deteriorated edge segments observed are believed to be outgrowths of these unsealed auxiliary crack segments, propagating from the combined forces of climate and traffic. Figure 32 illustrates a typical spall and secondary crack associated with an 890-SL silicone seal at Abilene.

Figure 32. Typical spall and secondary crack adjacent to 890-SL seal
