SHRP-H-355

# **Innovative Materials Development and Testing**

## **Volume 4: Joint Seal Repair**

Lynn D. Evans  
A. Russell Romine  
ERES Consultants, Inc.  
Savoy, Illinois

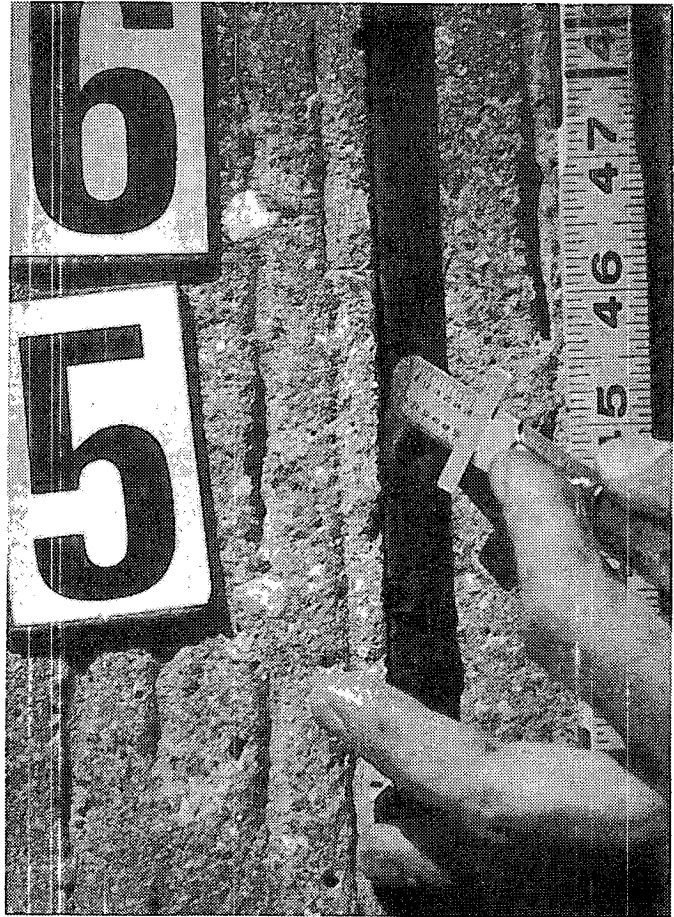
For all five evaluations the table shows values for left, right, and percent. The left and right values correspond with the inches of spalling or adhesion loss on the approach side and leave side of the joint. The percent value is the average percent of joint length that contains partial-depth spalling on either side of the joint.

**Figure 23. Partial-depth adhesion loss**

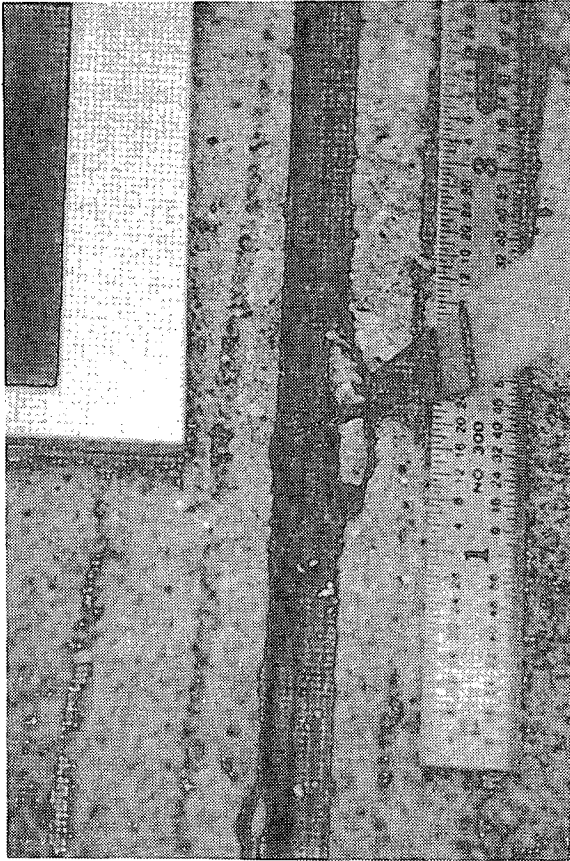
**Figure 24. Full-depth spall failure**

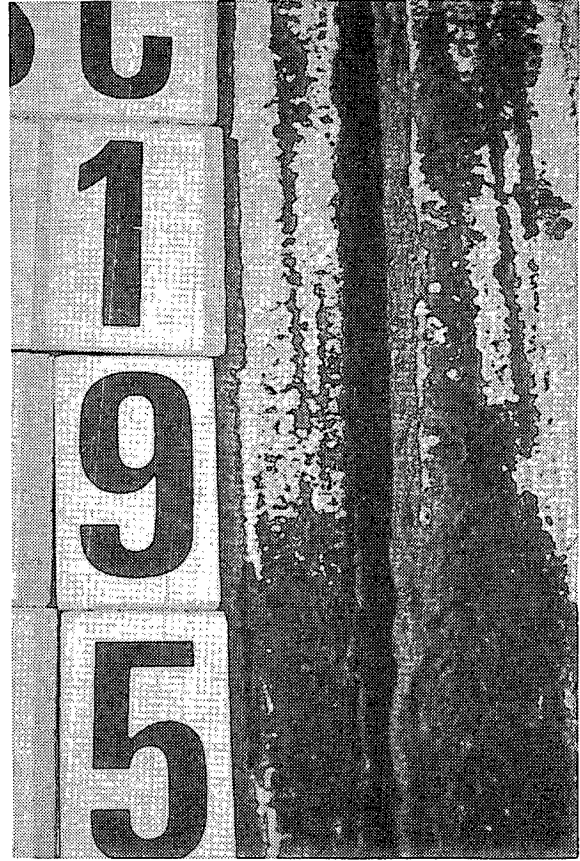
**Figure 25. Overband wear**

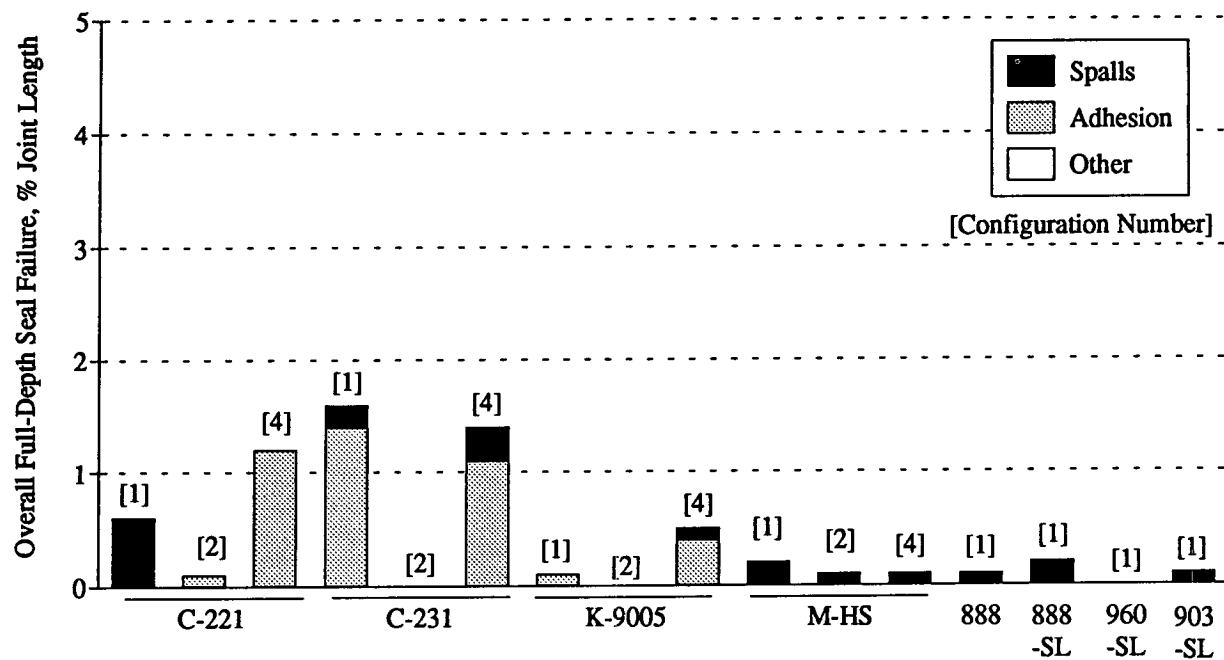
Figure 26. Overall failure at Arizona I-17 site after 18 months

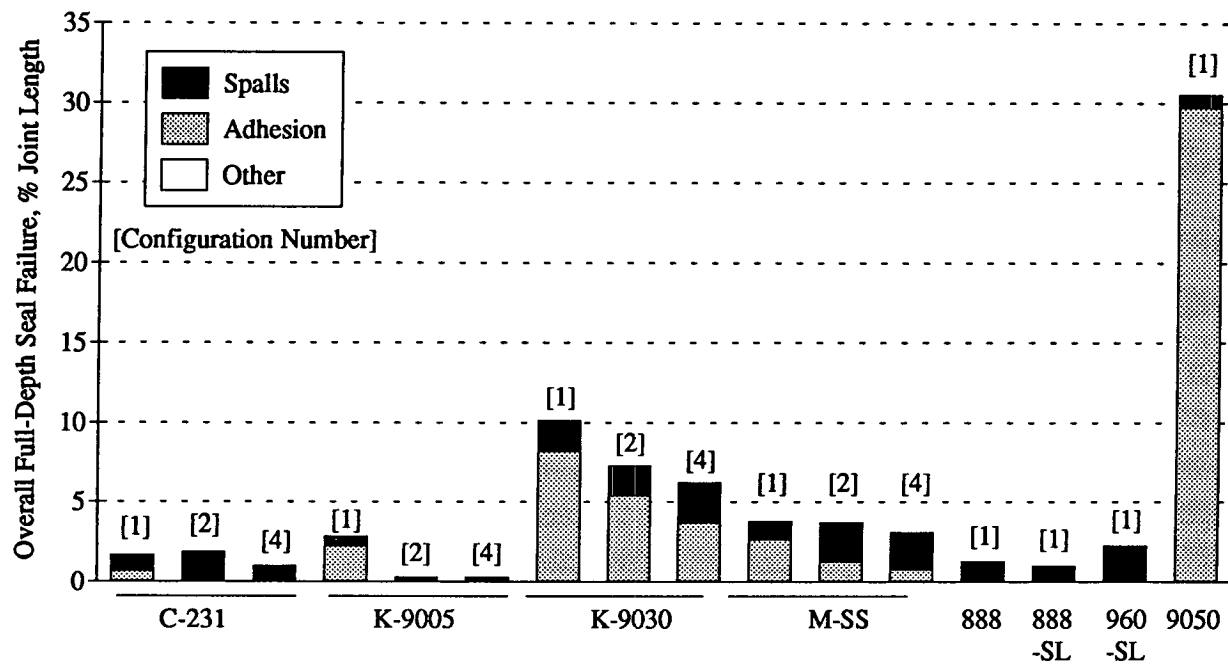
Figure 27. Overall failure at Colorado I-25 site after 18 months

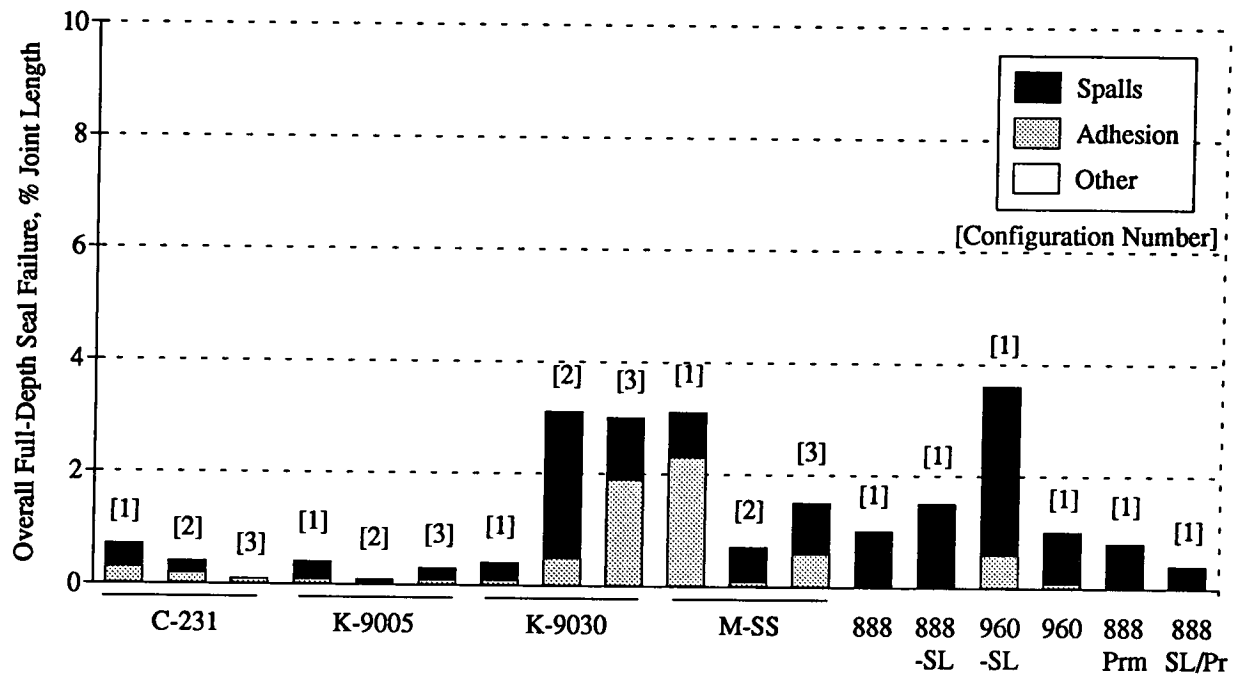
Figure 28. Overall failure at Iowa I-80 site after 18 months

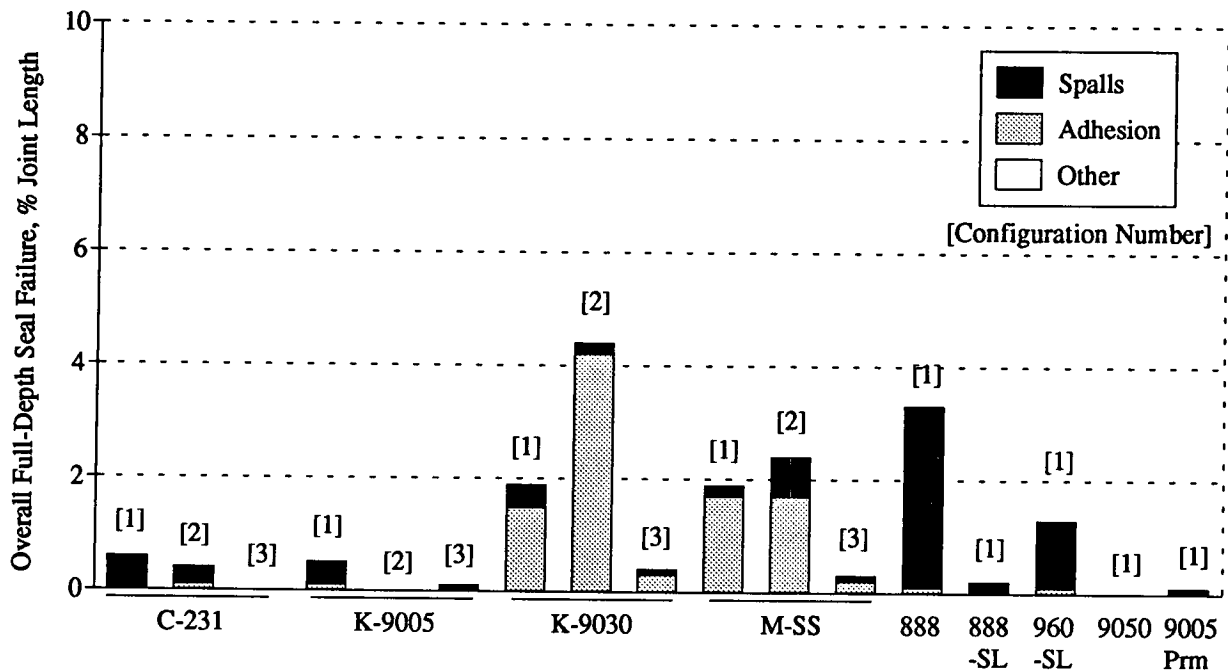
Figure 29. Overall failure at Kentucky US 127 site after 18 months

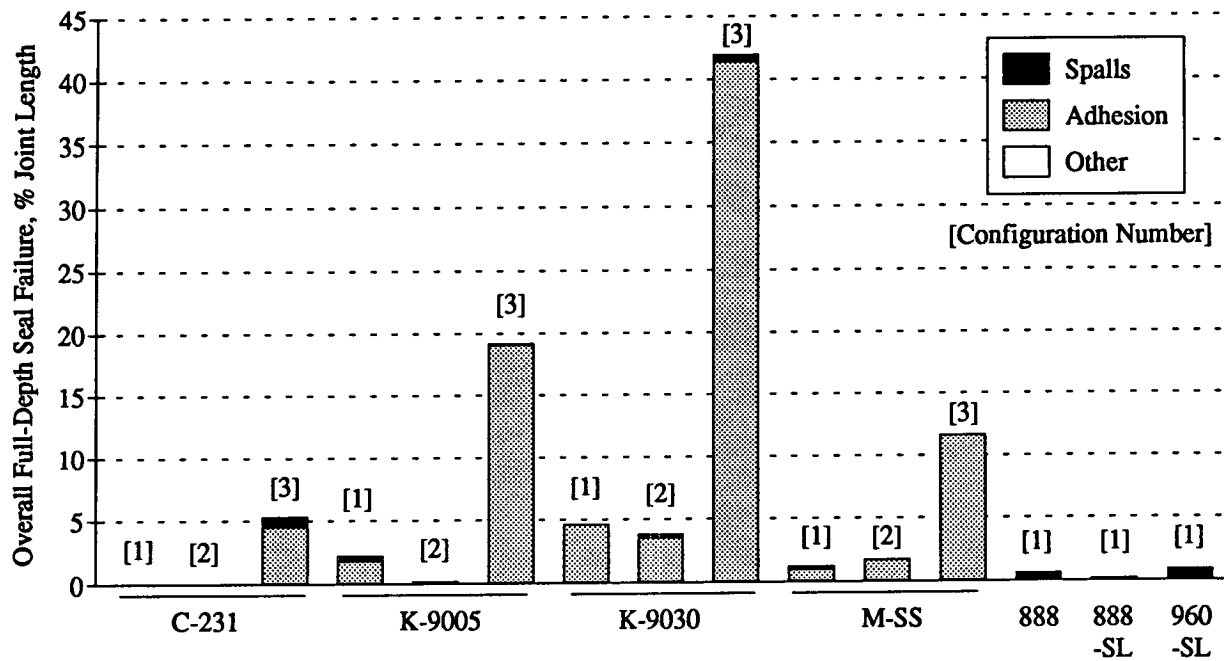
**Figure 30. Overall failure at South Carolina I-77 site after 18 months**

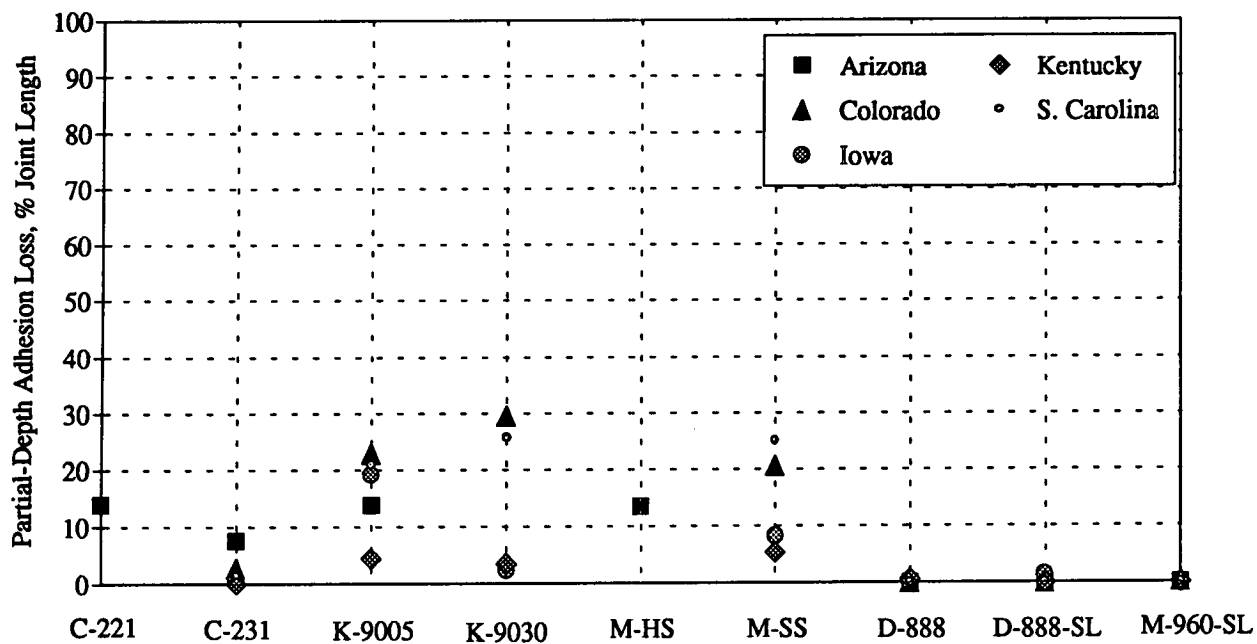
The partial- and full-depth adhesion loss for recessed-joint sealants is compared between states in figures 54 and 55. One thing that stands out is the excellent adhesion performance of the silicone sealants in every state. Only slight adhesion loss in silicone sealants has been noted in any state, with the majority of that distress related to partial-depth spalling. Small amounts of full-depth adhesion failure have been observed in hot-applied seals, with most sealants exhibiting less than 0.5 percent of the joint length failed.

**Figure 54. Partial-depth adhesion loss for recessed joint seals (18 months)**

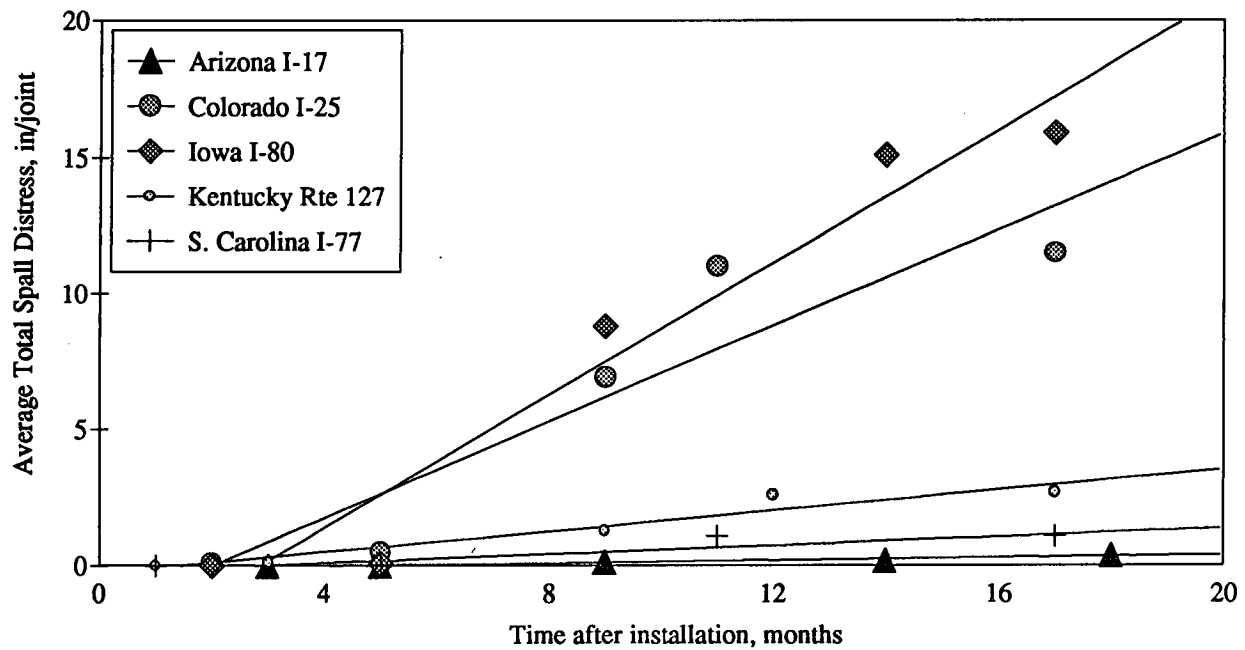
The relationship between time and spall failure at the test sites is shown for silicone sealants in figure 59 and for hot-applied sealants in figure 60. Both these figures indicate a large increase in spalling in the fall and early winter period between the 5th and 9th months at the dry-freeze site in Colorado and the wet-freeze site in Iowa. The Kentucky site also exhibited a slight increase in spalling through the early winter period. Spalling in the 1st year after resealing joints in the two cold-region states was significantly increased through the early winter months.

**Figure 59. Relation of time to spall failure for silicone seals (18 months)**

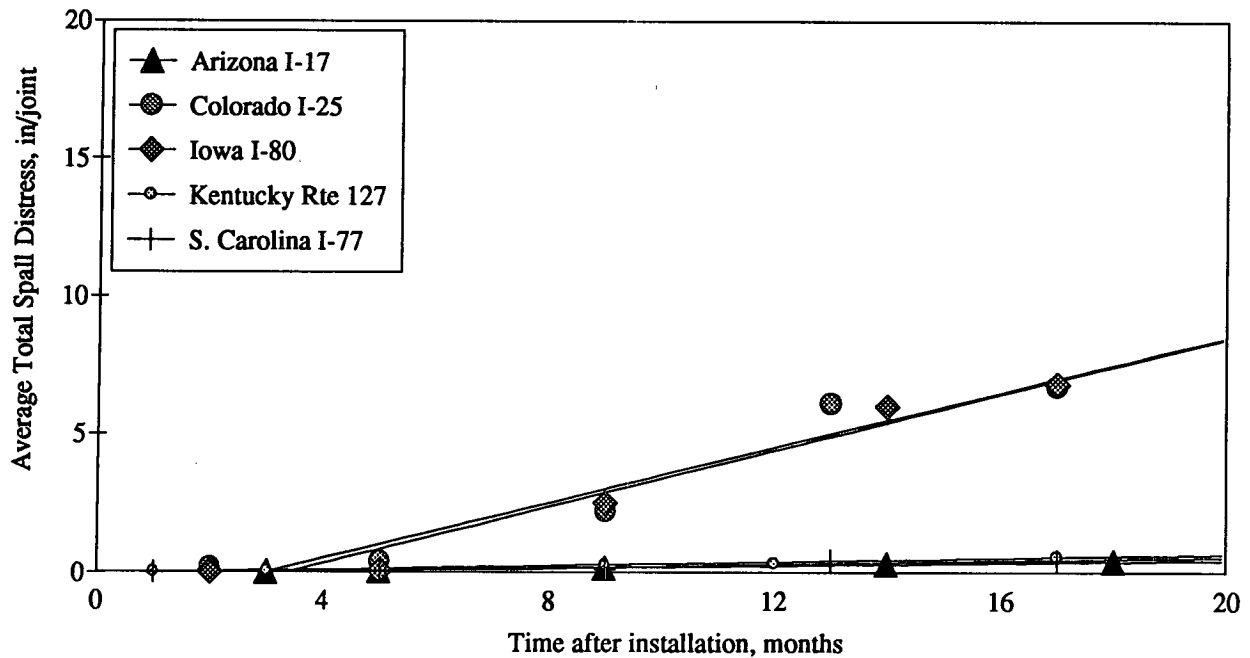
**Figure 60. Relation of time to spall failure for rubberized asphalt seals**

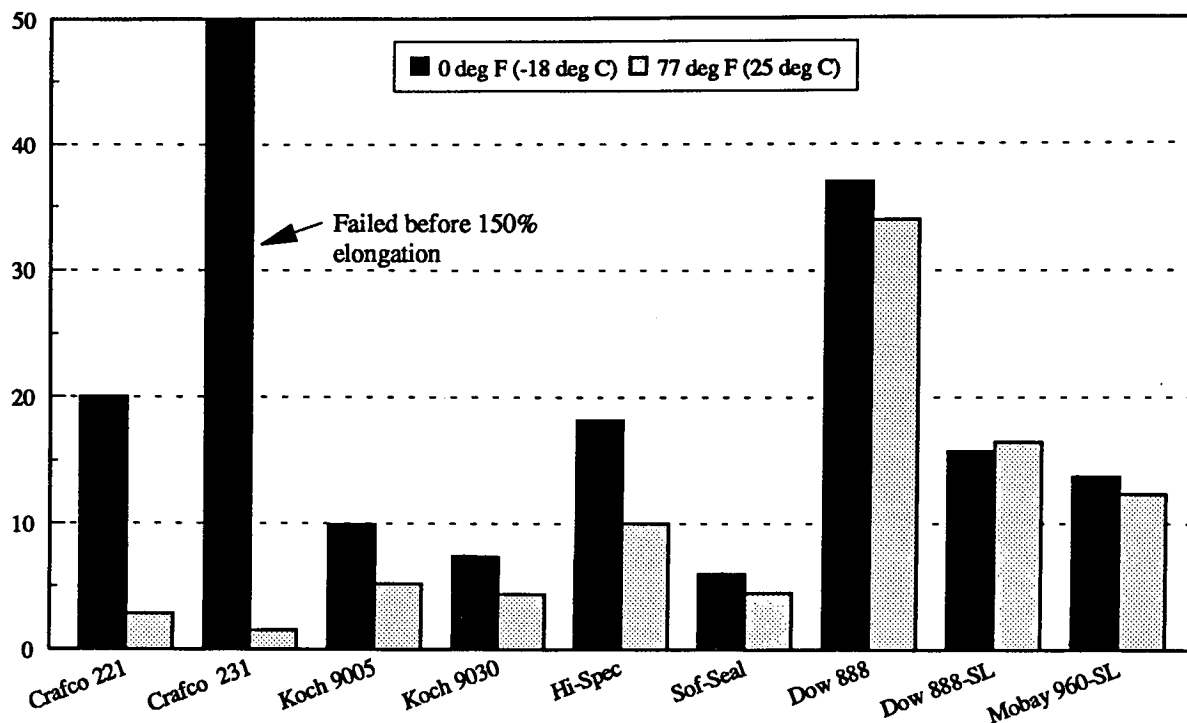
An across-temperature tensile test comparison of the hot-applied sealants indicates some unique differences in materials, as shown in figure 61. Between the temperatures of 77°F (25°C) and 0°F (-18°C), the stress in ASTM D-412 samples elongated to 150 percent of their original length increased between 1.3 and 1.9 times for the Koch and W. R. Meadows sealants. However, the stress in both of the Crafcro sealants increased significantly, with the RoadSaver 221 increasing 7.1 times and the RoadSaver 231 failing in cohesion before reaching 150 percent elongation at 0°F (-18°C). These differences have not yet translated into differences in adhesion performance at the test sites. In fact, the RoadSaver 231 is not

Figure 61. ASTM D-412 stress at 150 percent elongation
