SHRP-H-356

Innovative Materials Development and Testing

Volume 5: Partial Depth Spall Repair in Jointed Concrete Pavements

Cynthia A. Good Mojab
Arti J. Patel
A. Russell Romine
ERES Consultants, Inc.
Savoy, Illinois

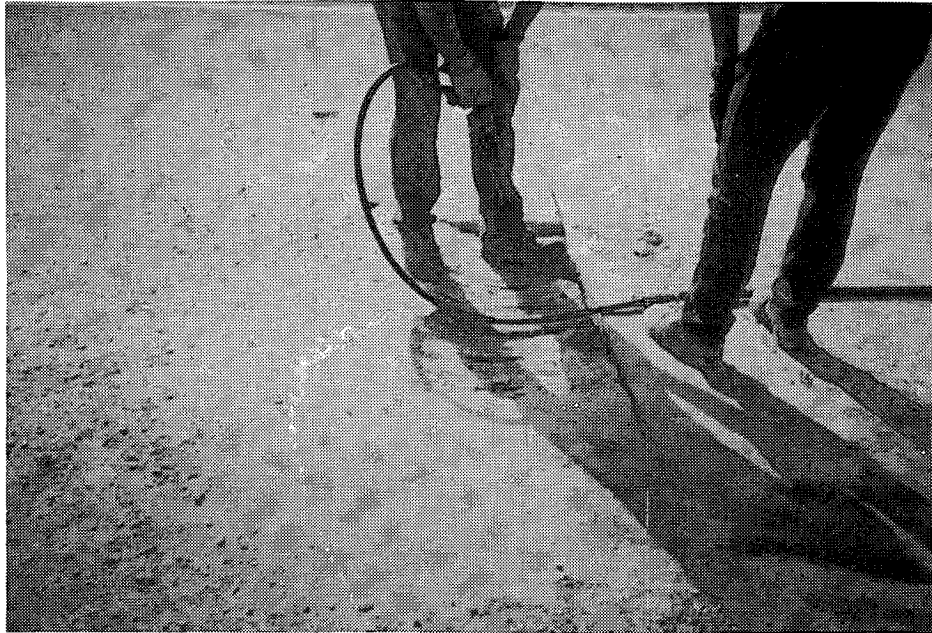
Figure 8. Corners of patch being removed after milling

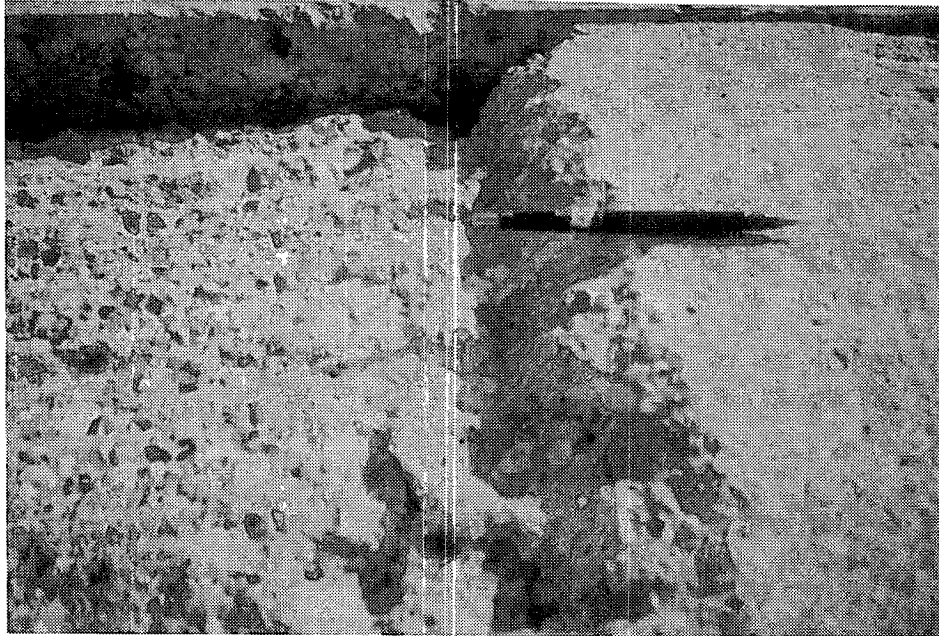
Figure 13. Patch bottom after milling

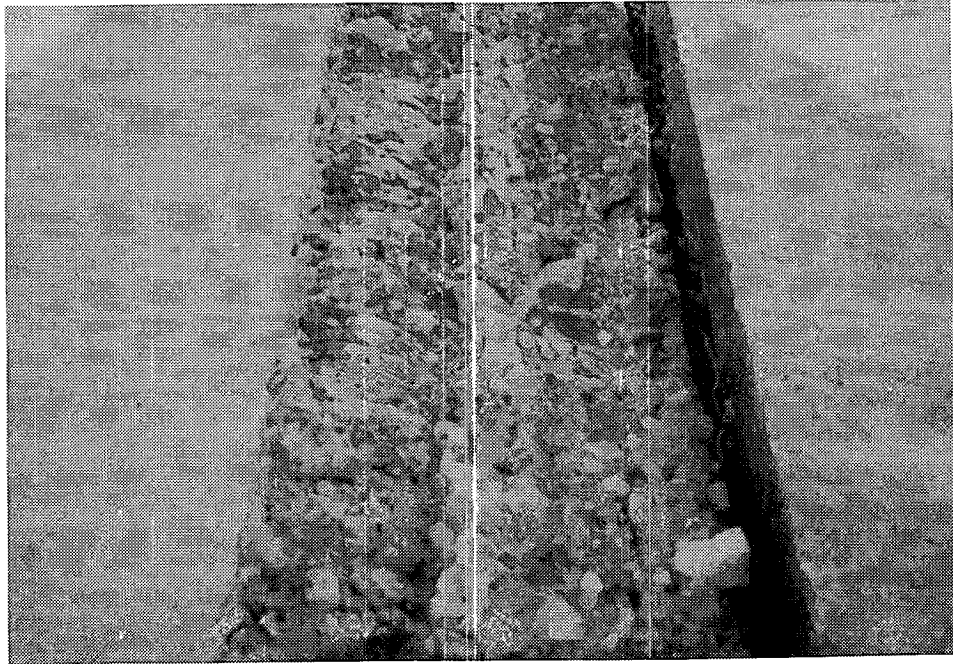
Figure 14. Patch bottom after waterblasting

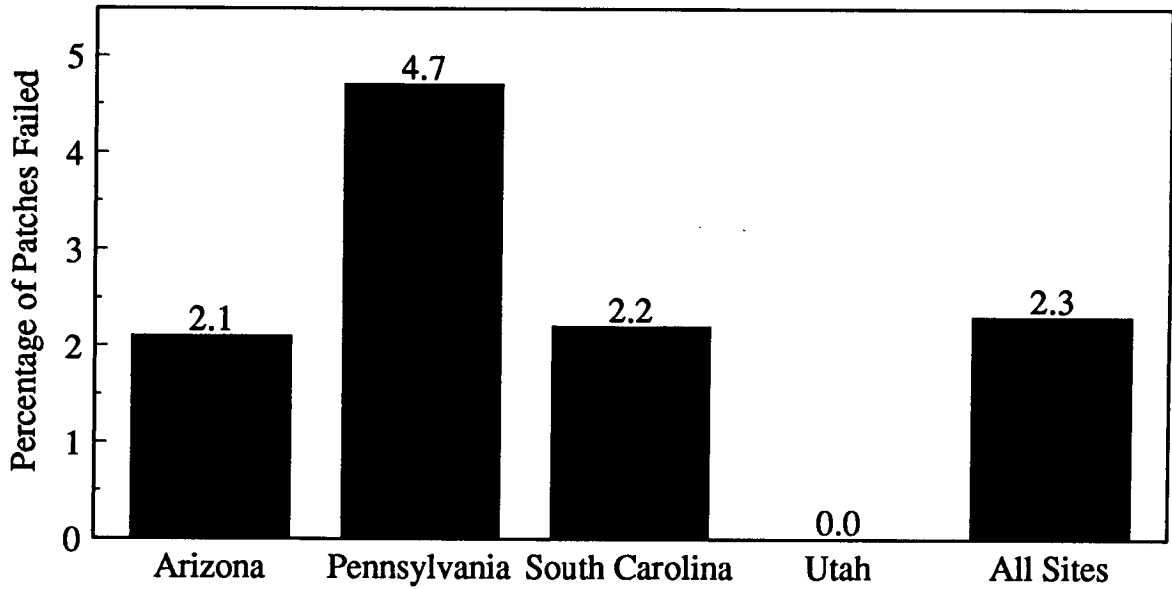
Figure 18. Percentage of patches failed by site

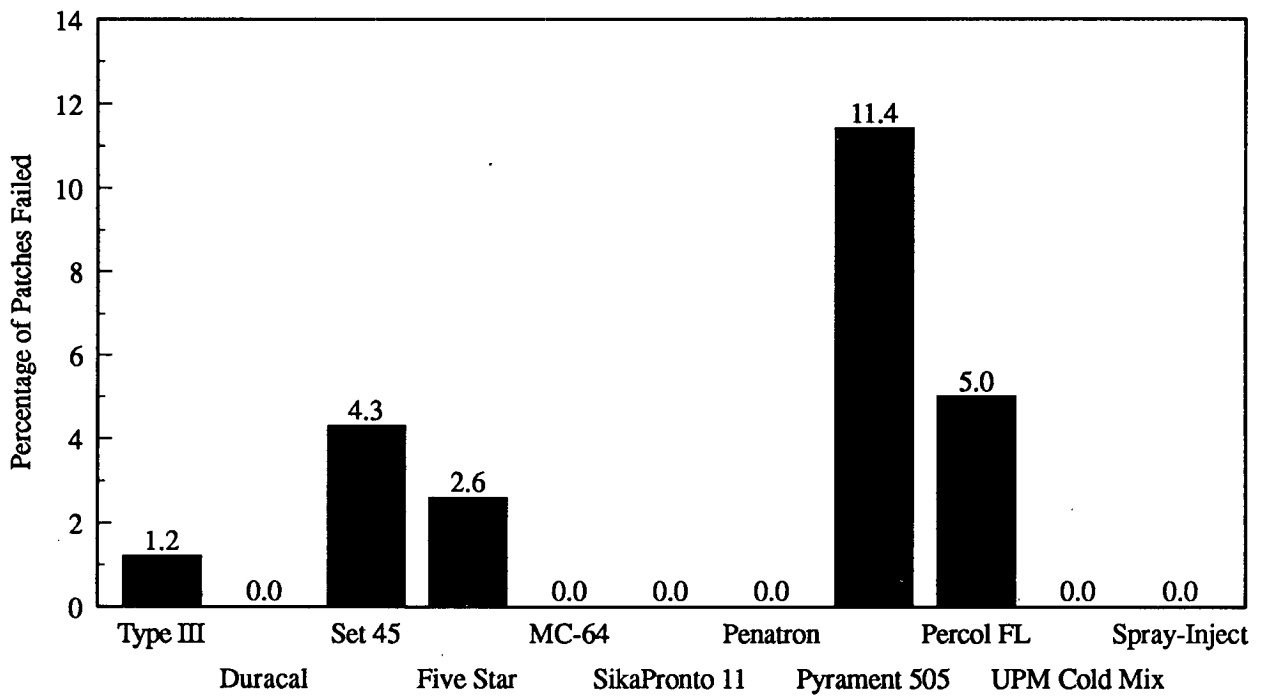
Figure 19. Percentage of patches failed by material

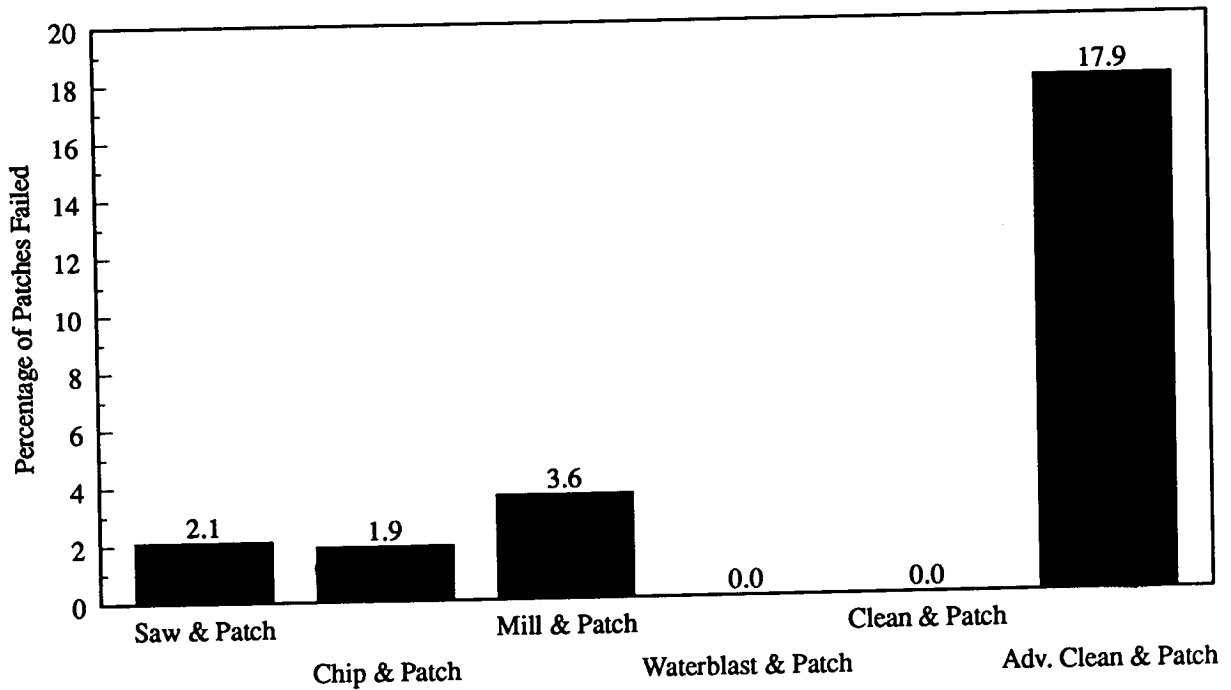
Figure 20. Percentage of patches failed by concrete-removal procedure
