SHRP-S-669

# **Electrochemical Chloride Removal and Protection of Concrete Bridge Components: Field Trials**

ELTECH Research Corporation  
Fairport Harbor, Ohio

**Strategic Highway Research Program**  
National Research Council  
Washington, DC 1993

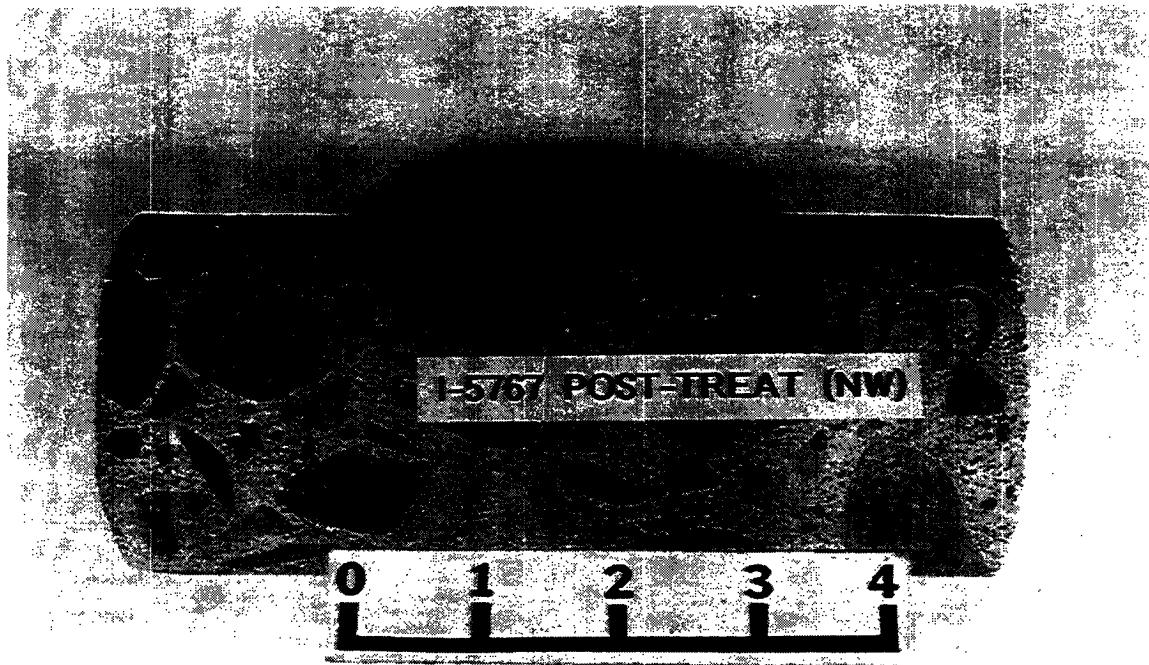
**Figure 5-23. Core 1B for Post-Treatment Petrographic Analysis**

The core had a full-width fracture parallel to the surface at a depth of 1-1/2 to 2-1/4 in. (4 to 6 cm) below the surface. There are heavy deposits of corrosion product along the fracture plane.

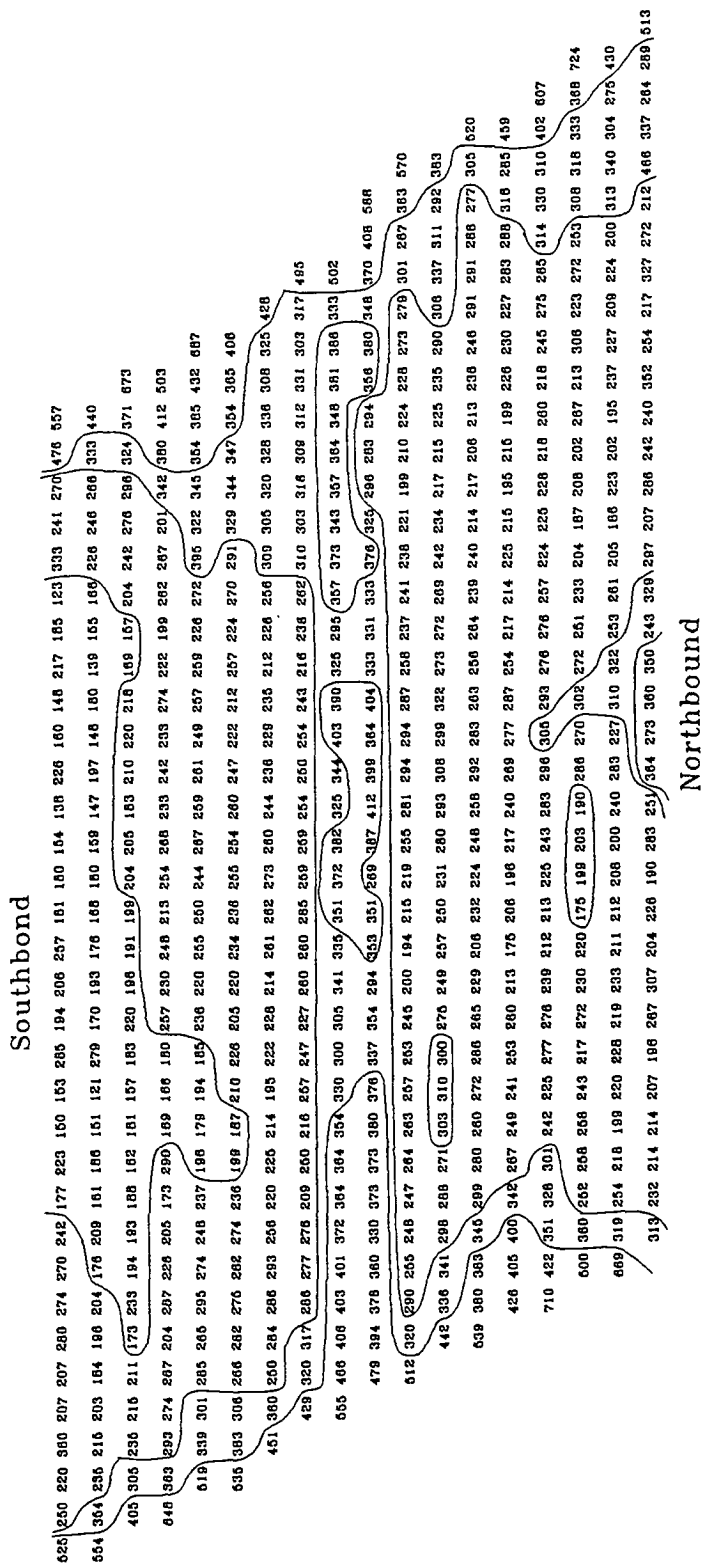
Figure A-1. Static Potential Contour Map

A static potential survey was done that included 590 readings. A contour map of these static potential readings is shown in Figure A-1 in Appendix A, and the readings summarized in Table 2-4. The northbound and southbound lanes of the deck were similar, but the northbound lane was slightly more corrosive.

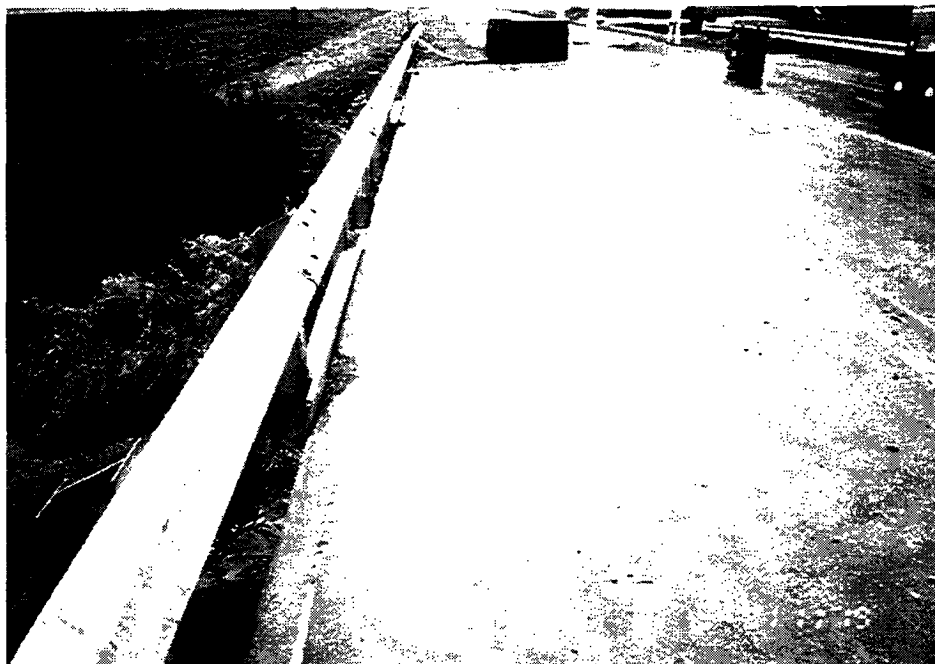
**Figure A-8. Damage to the Bridge after Removing the Latex Concrete Barrier**

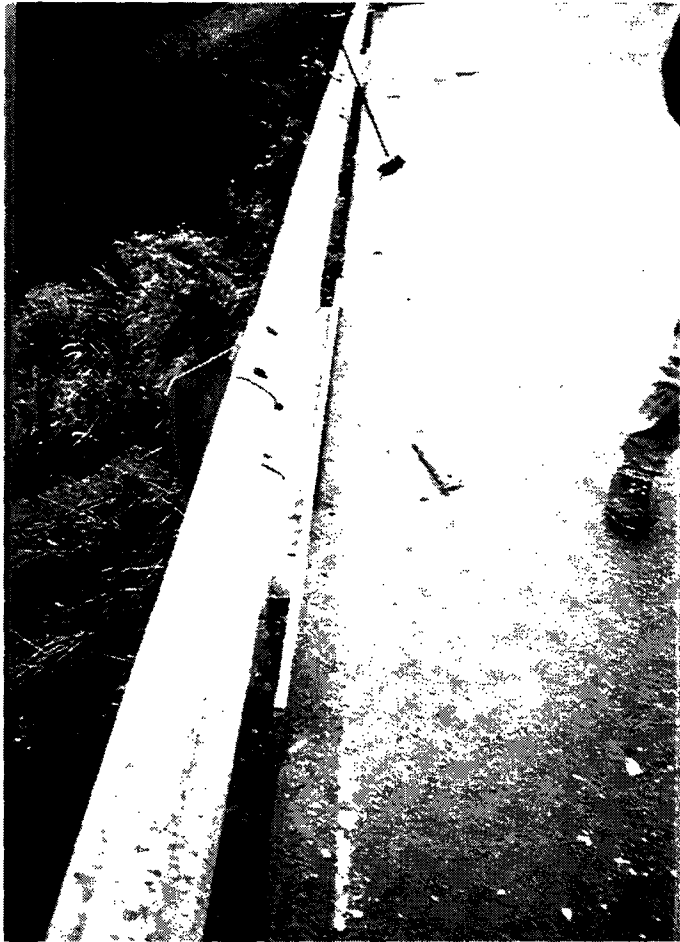
**Figure A-9. Bridge Edge Repairs**
