# Appraisal of Guardrail Installations by Car Impact and Laboratory Tests

WILLIAM G. CICHOWSKI, PAUL C. SKEELS, AND WILLIAM R. HAWKINS, *Respectively, Project Engineer and Head, Experimental Engineering Dept.; and Road Design Engineers, Plant Engineering Dept., General Motors Proving Ground, Milford, Mich.*

This paper describes the guardrail tests conducted at the General Motors Proving Ground since the previous paper, "Full-Scale Appraisals of Guardrail Installations by Car Impact Tests," was presented in January 1959 (HRB Proc., 38:353). Approximately 105 tests have been conducted since that time, including tests of improved end sections, chain link fence and cable type barriers, rail mounting and spacing from post, post strength, beam strength, special posts and mounting on superelevated curves.

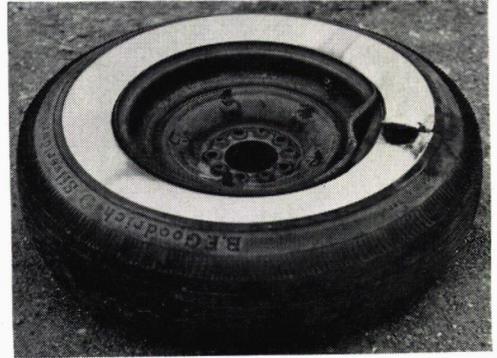
Figure 5. Tire and wheel damage from post contact.

wheel that has snagged a post. This vehicle was traveling at 35 mph contacting the guardrail at a 20-deg included angle.

California has tested guardrail with 8-in. blocking out of the ribbon and a 6-in. channel rub rail to aid in the prevention of post-vehicle snagging. (2) This method is not necessary for the specialized proving ground roads with low volume traffic and small angles of departures.

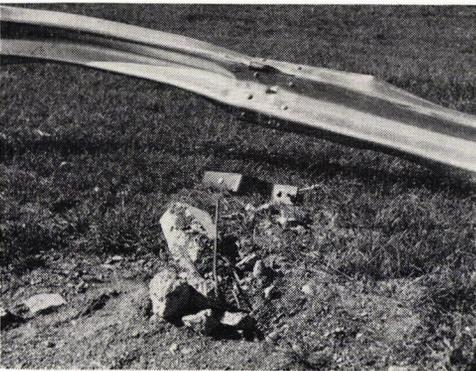
Figure 7. Post failure.

The junction of the spring bracket with the post was the only area in which difficulty has been encountered. If the ribbon does not have sufficient

longitudinal tension integrity, the brackets (acting as torque arms) burst the post at its lower mounting holes (Fig. 7). This has been improved by using wider spacing of

the bolt holes in the bracket and providing end anchors for the ribbon.

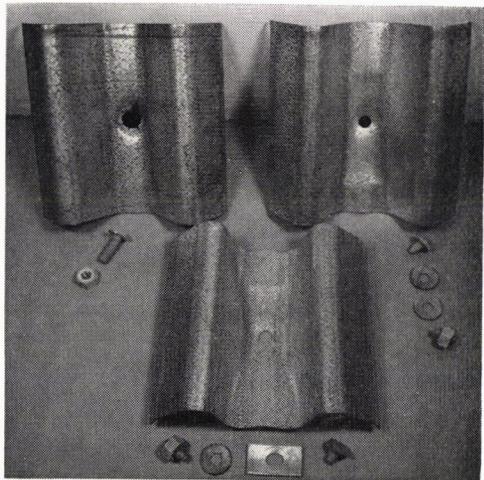
Figure 8. Bolt pull through test

The single  $\frac{5}{8}$ -in. diameter bolt connecting the guardrail ribbon to the post or bracket was found to be inadequate. The  $1\frac{1}{4}$ -in. diameter head on these bolts was often pulled through the ribbon without breaking the bolt. Laboratory tests indicated that a straight pull of 5,550 lb on the bolt would duplicate this failure. If a drilled hole was used instead of a slotted hole, the bolt would pull through at 13,250 lb load (Fig. 8). A plain steel washer was added as a reinforcement, and the bolt broke at 15,750 lb. Because the plain washer did not have an elongated hole to accommodate the bolt head

properly, some  $1\frac{3}{4} \times 3 \times \frac{1}{8}$ -in. steel plates were made. This type of washer distributed the load more uniformly to the bolt, and a value of 16,275 lb was reached before bolt failure. Ribbon-to-mounting failure has not been experienced since these reinforcing plates have been added to the guardrail installations.

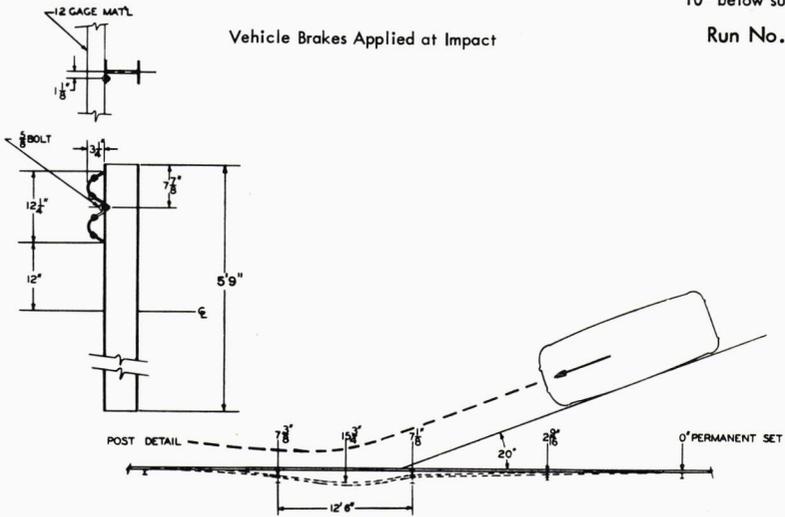
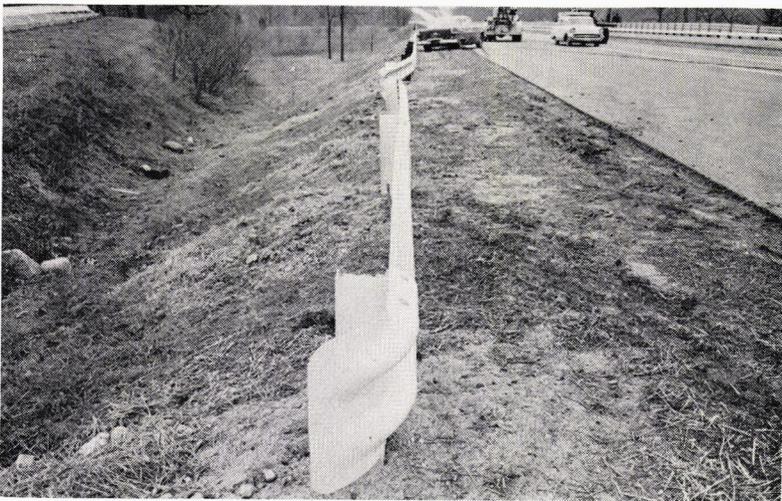
Figure 26.

Guardrail Damage - one section of ribbon

Vehicle - 1956 Pontiac 4 Dr. - Wt. 4163 lbs.  
 Estimate of Damage: \$100.00

Ground Condition - Glacial Till; 6" frozen layer  
 10" below surface

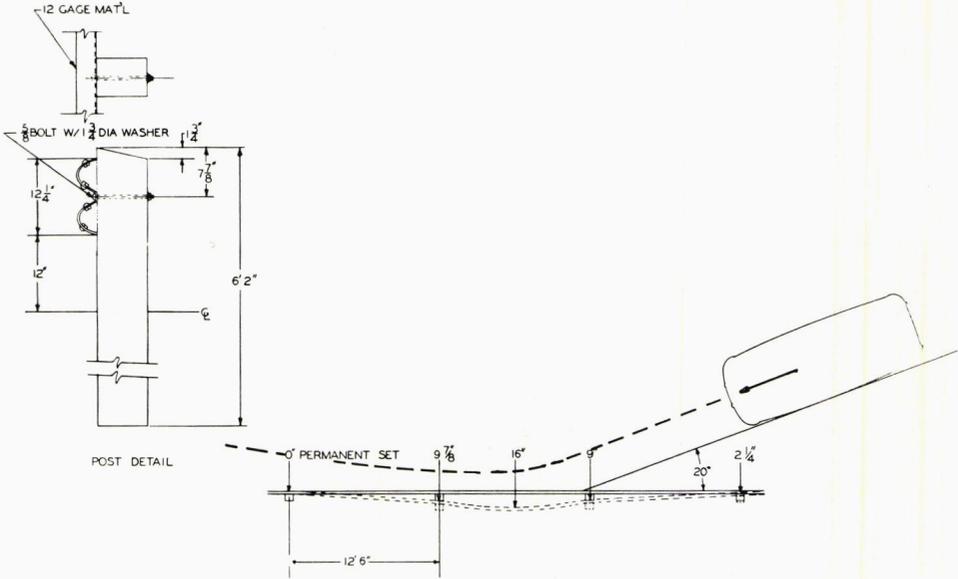
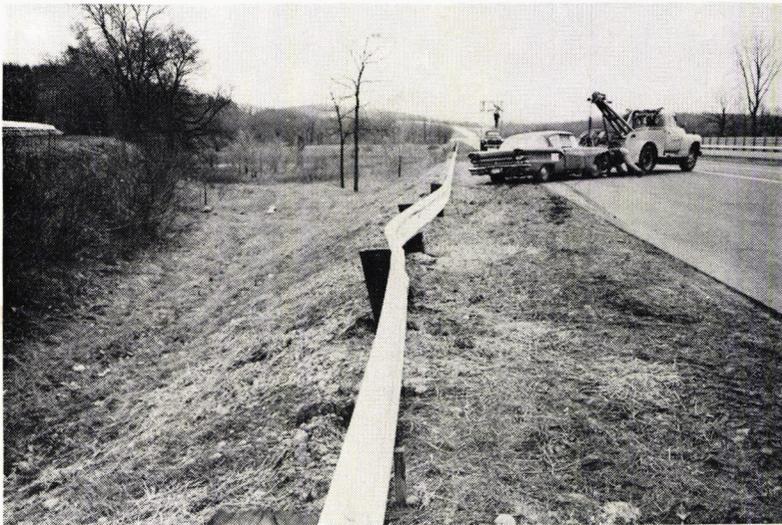
Figure 27.

Guardrail Damage - one section of ribbon

Vehicle - 1958 Pontiac 2 Dr. Ht. - Wt. 4029 lbs.  
 Estimate of Damage: \$100.00

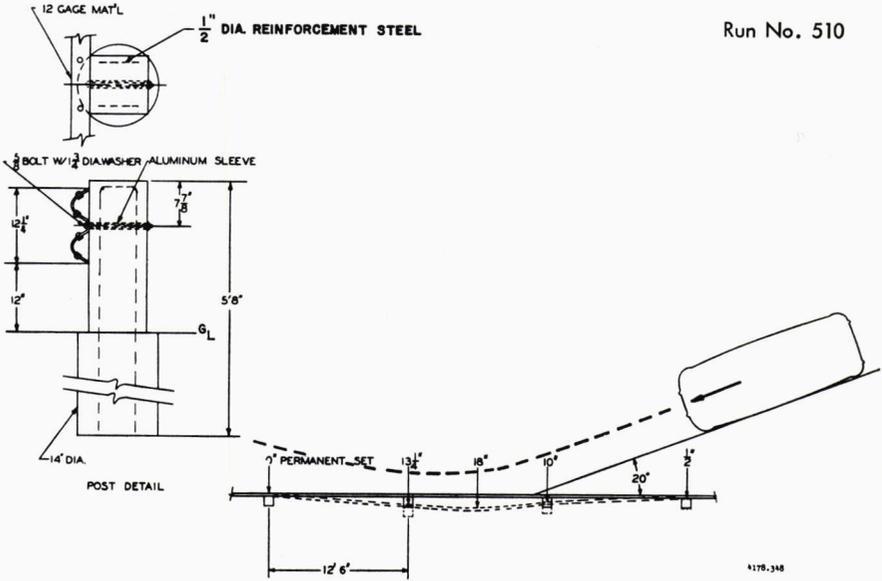
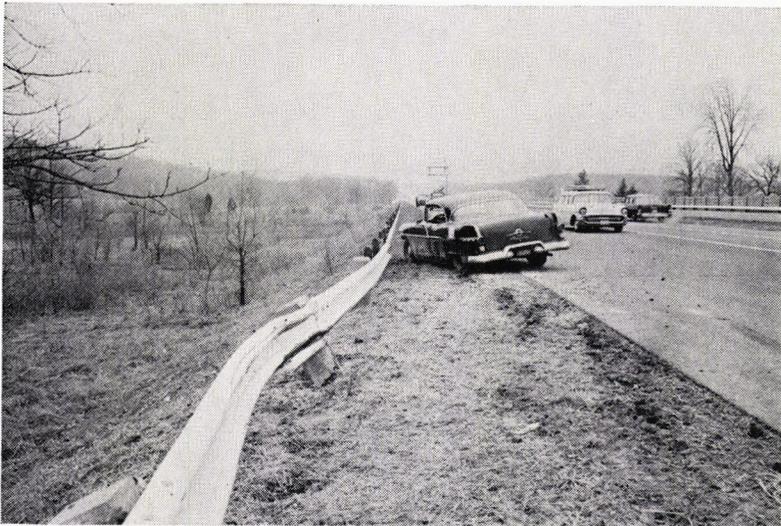
Figure 28.

Guardrail Damage - three posts  
two sections of ribbon

Vehicle - 1956 Pontiac 4 Dr. Ht. - Wt. 4033 lbs.  
Estimate of Damage: \$250.00

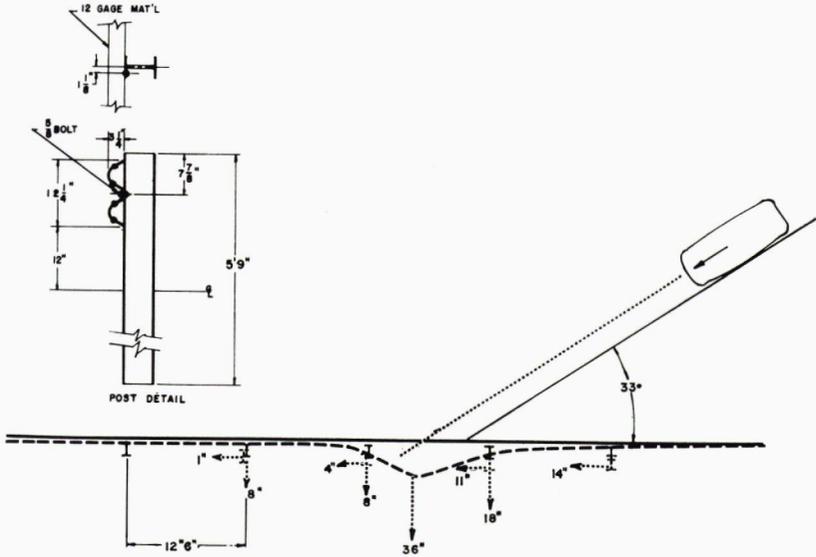
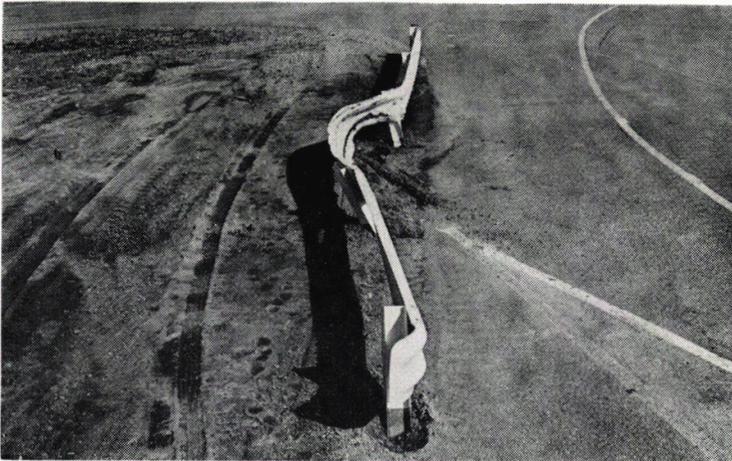
Figure 30.

Vehicle - 1956 Pontiac 4 Dr. Ht. - Wt. 4163 lbs.  
Estimate of Damage: \$150.00

Dummy Injury - left rear possibly fatal  
right rear broken wrist

Guardrail Damage - 3 posts  
3 sections of rail

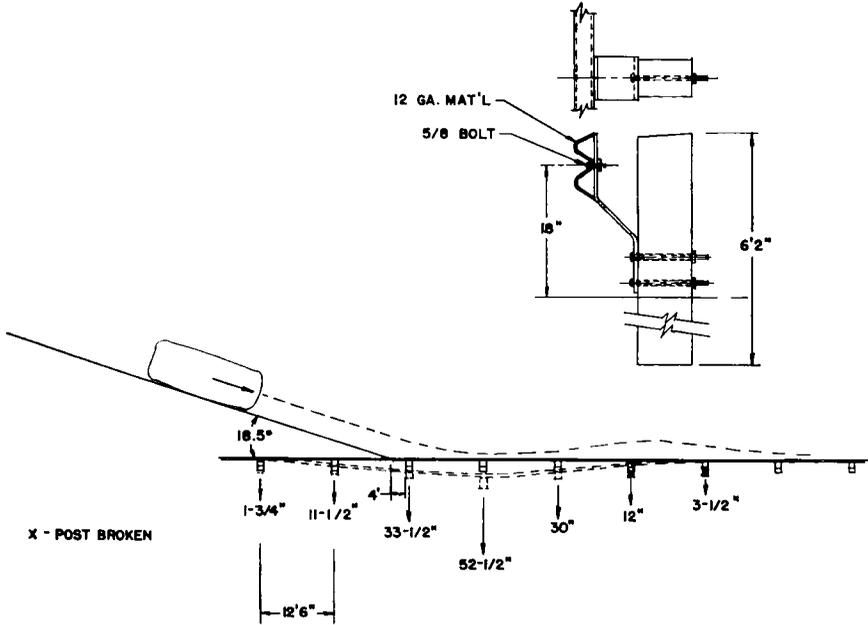
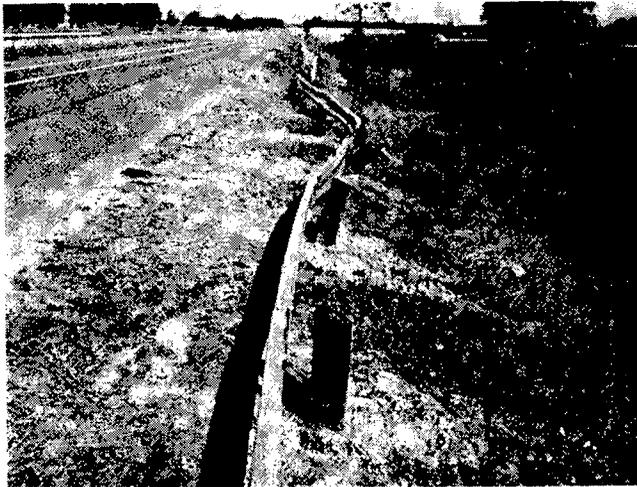
Figure 40.

Beam Type Guard Rail - mounted on spring brackets	Dummy Injury - none used
Posts - 6" x 8" wood posts 6' 2" long	Guardrail Damage - two posts three sections of rail
Speed - 68.4 mph, Impact Angle 18.5°	Vehicle Deceleration - Longitudinal: 16.4 G's Transverse: 13.1 G's
Vehicle - 1958 Pontiac 4 Dr. Hr. - Wt. 4150 lbs. Estimate of Damage: \$300.00	Ground Condition - Glacial Till: Dry

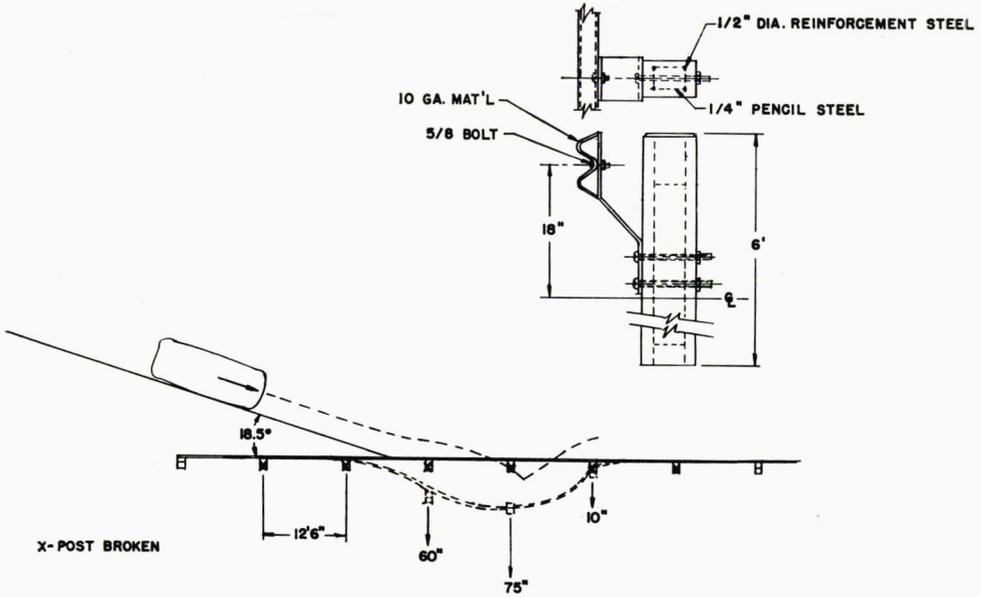
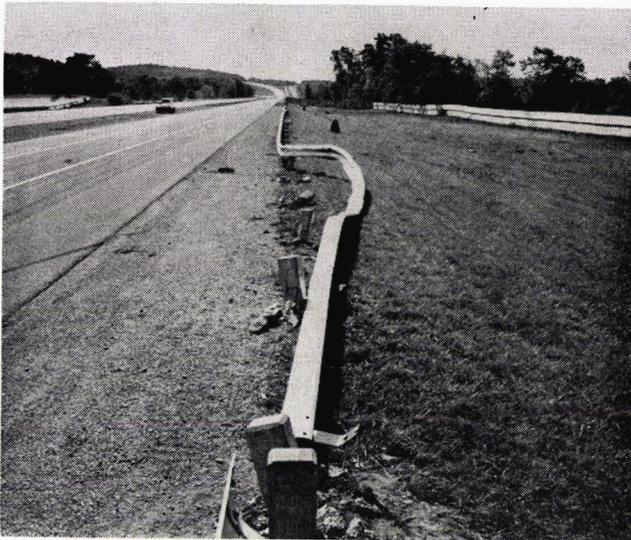
Figure 41.

Beam Type Guardrail (10 gauge) - mounted on spring brackets	Dummy Injury - none used
Posts - 6" x 8" Pre Cast Concrete 6' 0" long	Guardrail Damage - six posts four sections of rail
Speed - 64.8 mph, Impact Angle 20.5°	Vehicle Deceleration - Longitudinal: 9.3 G's Transverse: 6.4 G's
Vehicle - 1958 Pontiac 4 Dr. Ht. - Wt. 4085 lbs. Estimate of Damage: \$450.00	Ground Condition - Glacial Till: Dry

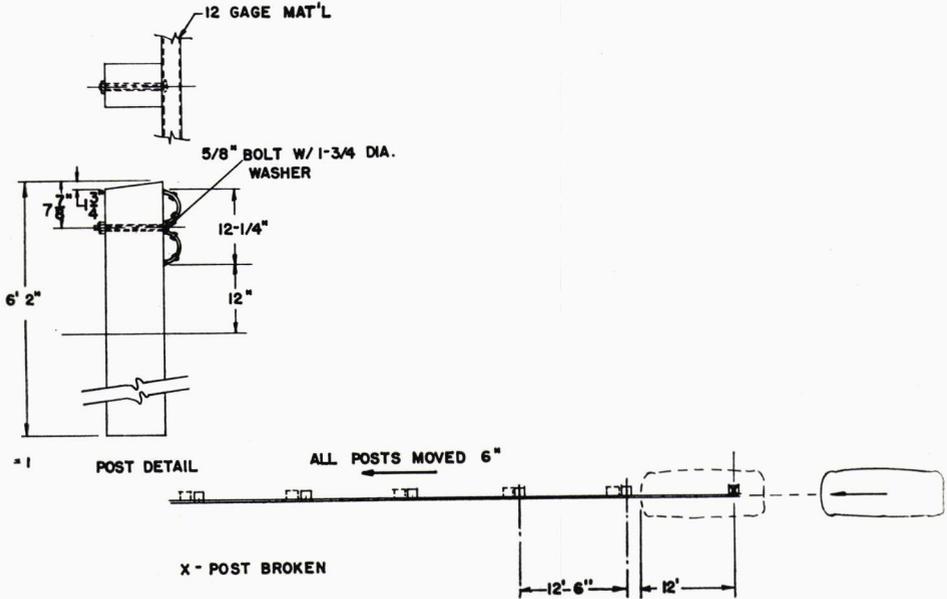
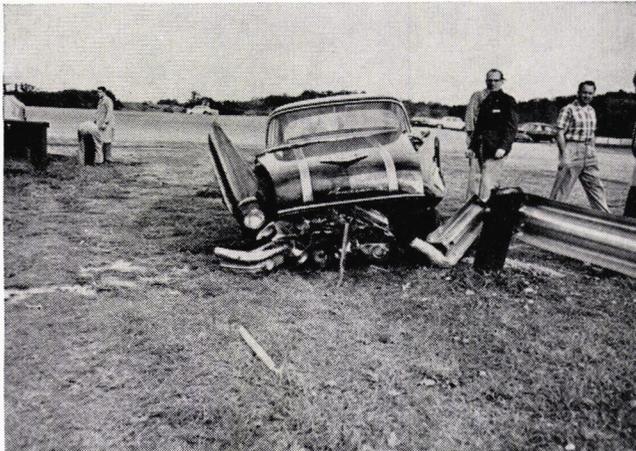
Figure 44.

Guardrail Damage - one post  
one section of rail

Vehicle - 1956 Pontiac 4 Dr. Ht. - Wt. 4033 lbs.  
Estimate of Damage: Total Loss

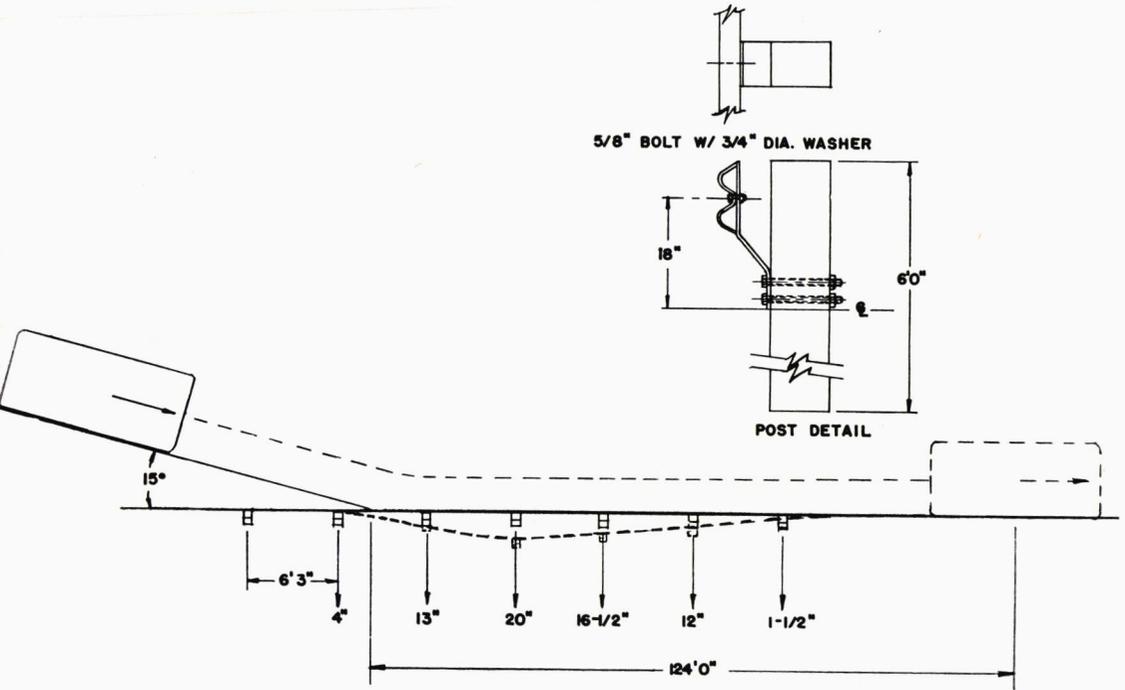
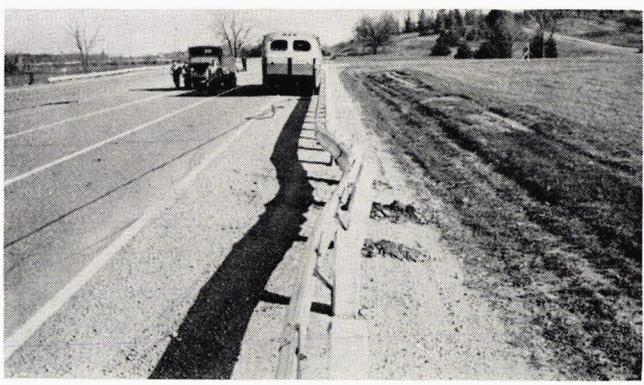
Figure 47.

Beam Type Guardrail	Dummy Injury - none used
Posts - 6" x 8" Pre Cast Concrete 6' 0" long	Guardrail Damage - three sections of rail
Speed - 27 mph, Impact Angle 15°	Vehicle Deceleration - instrumentation failure
Vehicle - 51 Passenger Bus - Wt. 23,590 lbs.	Ground Condition - Glacial Till; Dry
Vehicle Brakes Not Applied	Run No. 539

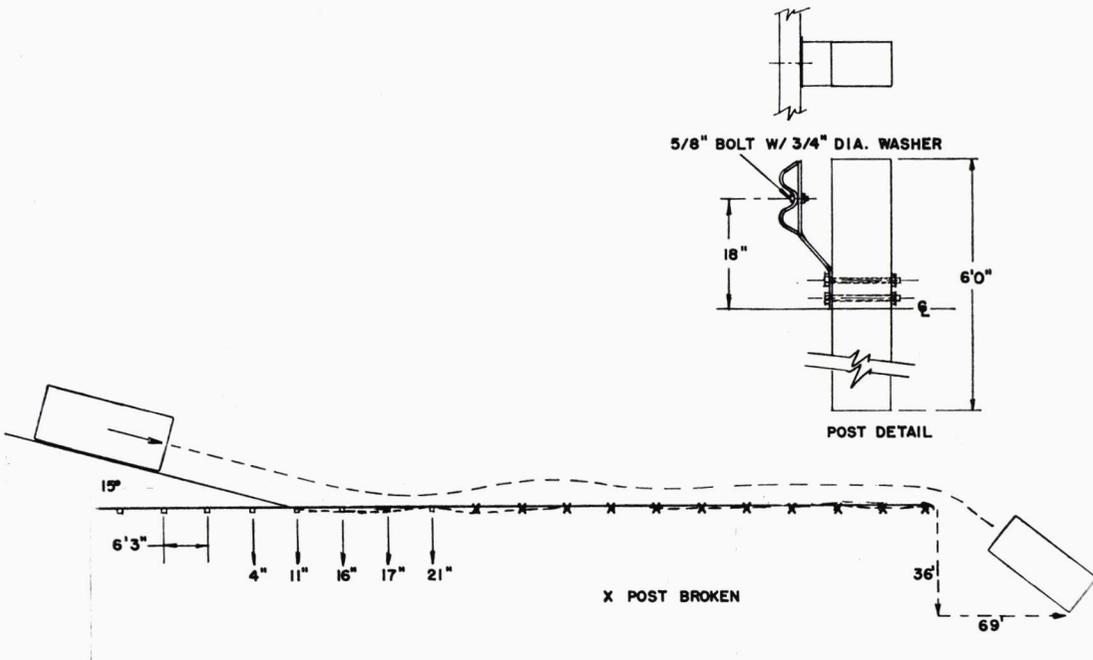
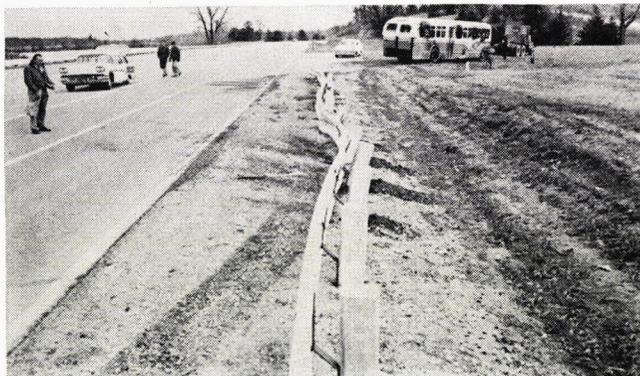
Figure 48.

Guardrail Damage - eleven posts  
six section of rail

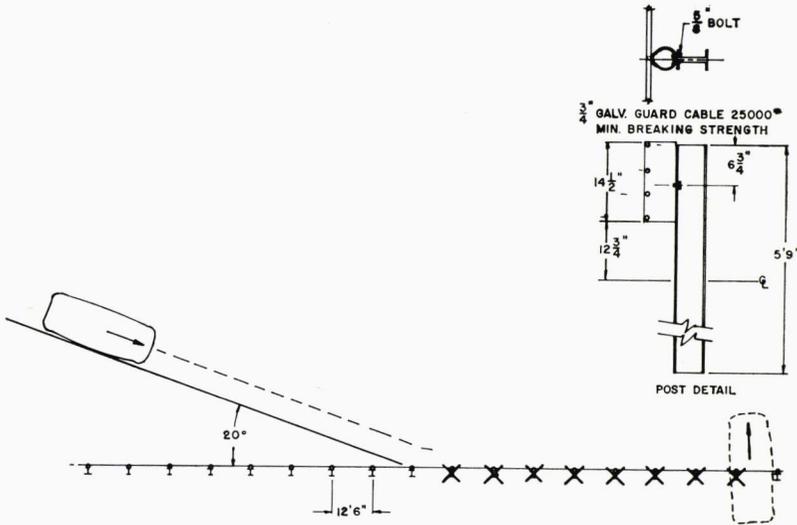
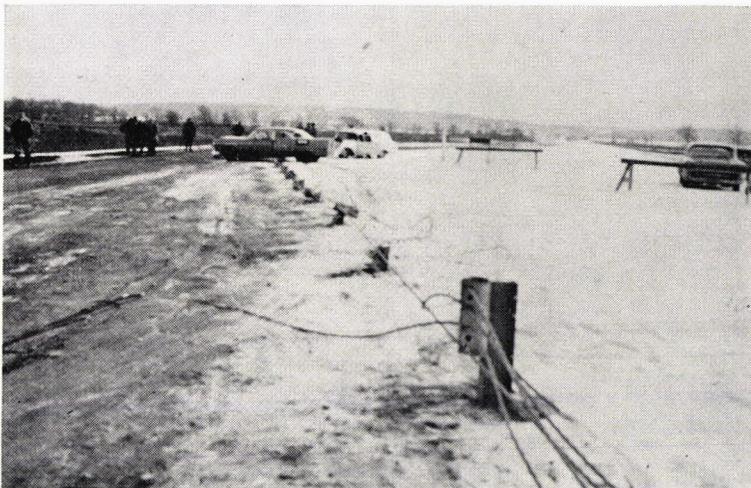
Figure 49.

Guardrail Damage - 3 cables broken  
4 posts

Vehicle - 1958 4 Dr. Oldsmobile - Wt.  
Estimate of Damage: \$700.00

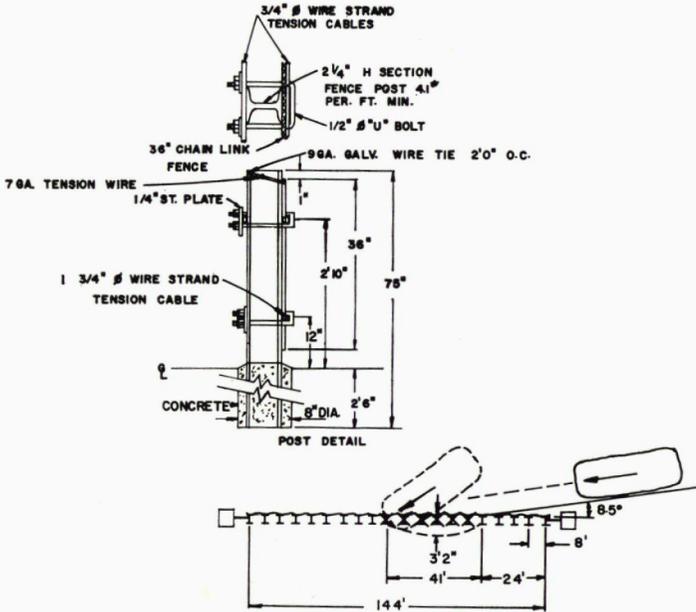
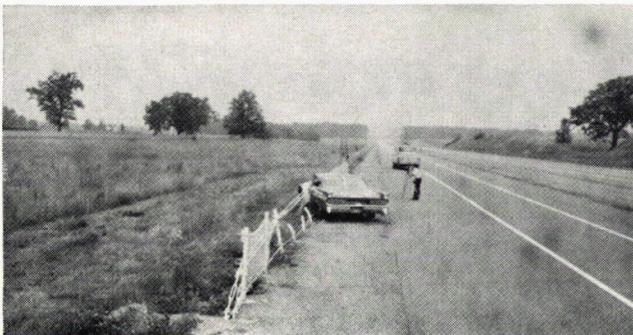
Figure 53.

Guardrail Damage - 6 Posts  
41 ft. Fence

X - POST BROKEN

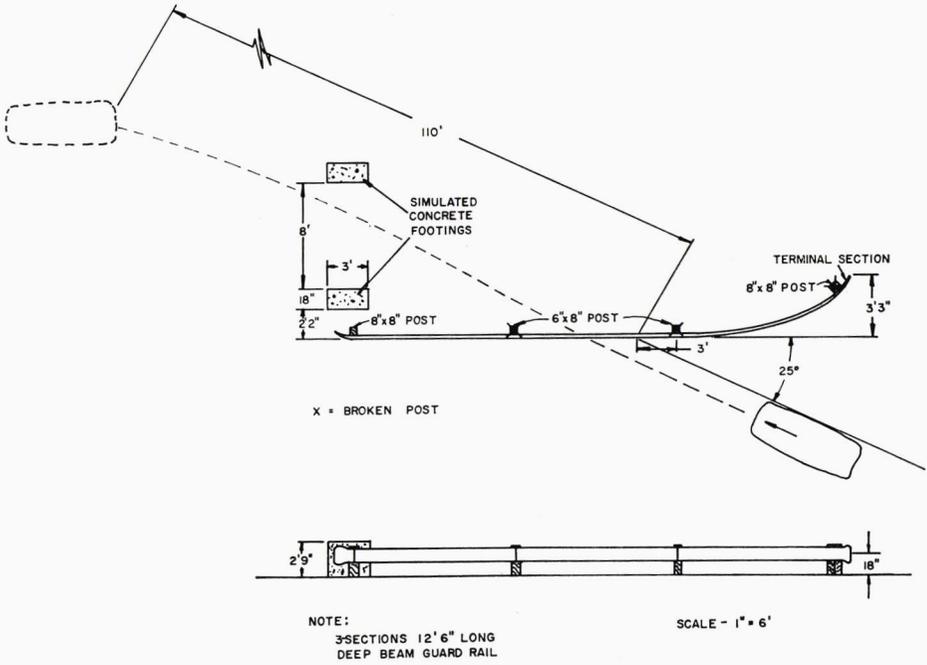
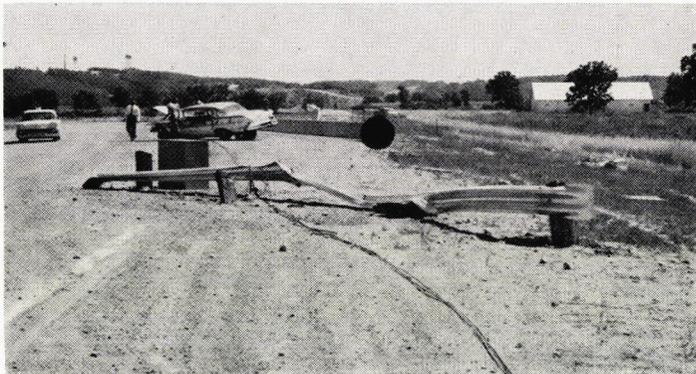
Figure 54.

Guardrail Damage - 2 posts  
3 sections of rail

Vehicle - 1958 Chevrolet 4Dr. - Wt. 3963 lbs  
Estimate of Damage: Total Loss
