Corrective Measures Employing Epoxy Resins on Concrete Bridge Decks

HAROLD W. GOLDBERGER, *Engineer of Maintenance,*
Garden State Parkway, New Jersey Highway Authority, Red Bank, N. J.

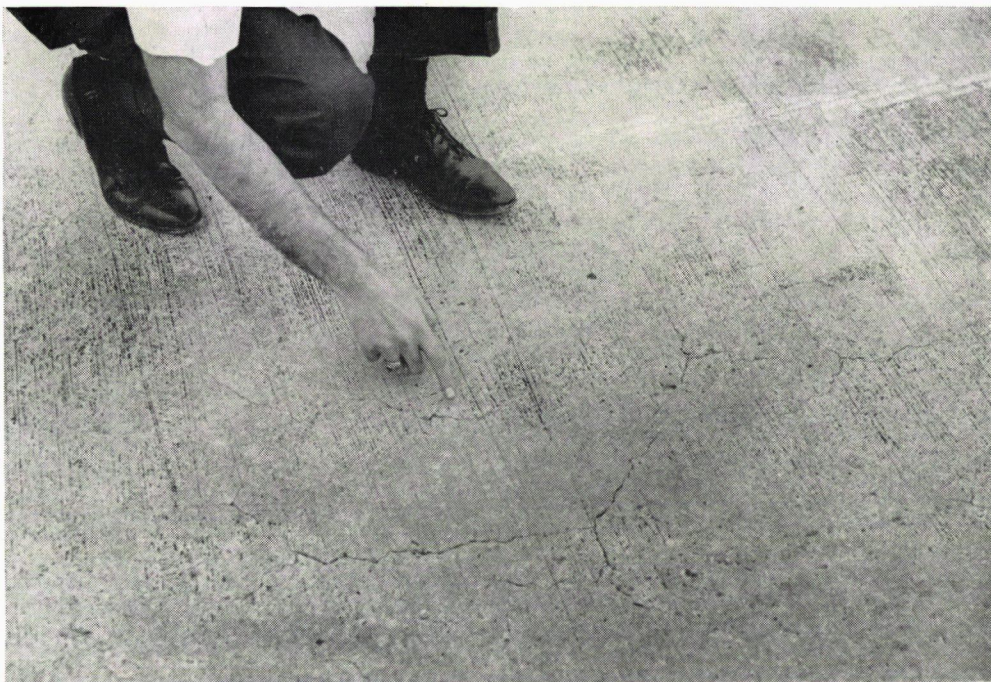
Figure 2. Typical pattern of surface cracks on roadway.

In addition to the spalled areas, numerous hairline cracks were found in most Parkway bridge decks. A careful inspection of the underside of the bridge decks revealed that the crack patterns on the top of the decks were extended completely through the concrete to the underside of the concrete slab. Although these cracks may not seem to be dangerous, they are potential forerunners of spalled or scaled areas. A crack between the curb and the bridge deck permitted the deicing salts to flow down onto the structural steel, causing extensive corrosion damage. In addition, spalled areas appeared along the joint. The repair of each type of damage not only is expensive, but it also inconveniences the traveling public, especially those who pay a toll for the privilege of making a trip on

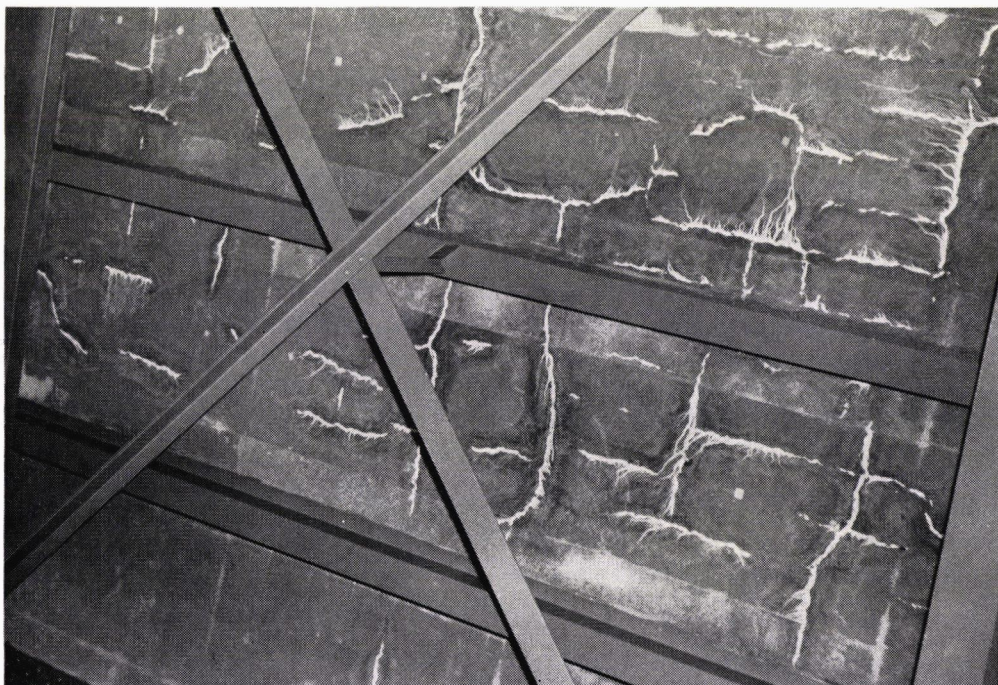
Figure 3. Penetrating cracks as seen from beneath bridge. Patterns follow positions of reinforcing rods.

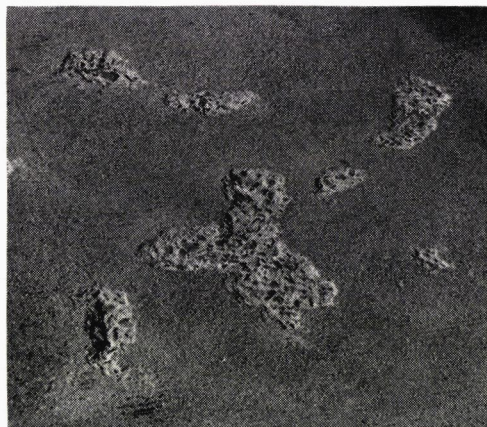
The main problem on the bridges, as was the case on the New Jersey Turnpike, is a deterioration of the concrete decks and curbs from the action of deicing salt penetrating cracks that form directly over reinforcing steel, causing scaled and spalled areas to develop. The following is quoted from the 39th Annual Meeting paper: "Investigation of deck failures revealed that reinforcing steel was too close to the surface of the concrete. In some cases the steel was within $\frac{1}{2}$ in. of the surface. Where that condition existed, hairline cracks appeared in the concrete deck surface. In time, these cracks became wider due to the use of rock salt or calcium chloride for snow and ice control. Brine formed by melting snow and the rock salt found its way into the cracks and onto the reinforcing steel. The steel rusted under these conditions, expanded, weakened the

concrete, and finally a spalled area was formed."

Figure 4. Spalled area resulting from untreated hairline cracks.

spalled areas did not fail under traffic, but the areas around the patches did fail. The conclusion reached from this behavior is that after a deck is patched, the entire area must be sealed to prevent pavement deterioration.

Several spalled areas and cracks more than $\frac{1}{8}$ -in. wide in the decks were patched and sealed with epoxy troweling compound mixes. Cracks smaller than this were taken care of in the over-all sealing operation. However, before this patching could be accomplished it was necessary to remove all deteriorated concrete so

that a firm bond between concrete and epoxy could be made. Previous work with epoxies indicated that this was a necessary and important step. Failure to get a good bond would result in the patch lifting at the first freeze. An air compressor and a small chipping hammer easily cleaned out loose material, and all holes and cracks were blown clean with compressed air. The holes were primed with an unfilled epoxy mix and then patched with a sand-filled compound using the epoxy troweling compound mixer, which meters and mixes the epoxy components and sand in a continuous operation. This mixer enables one man to do the work of the three required in earlier patching operations.
