Median Barriers: One Year's Experience and Further Controlled Full-Scale Tests

J. L. BEATON, R. N. FIELD, AND K. MOSKOWITZ,
Respectively, Supervising Highway Engineer, Materials and Research Department; Materials and Research Engineering Associate, Materials and Research Department; and Assistant Traffic Engineer, Traffic Department, California Division of Highways

Development of two types of barriers for use in the medians of California freeways was reported at the 39th Annual Meeting. As outlined in that report, it was planned to continue studying these two barriers under actual operating conditions.

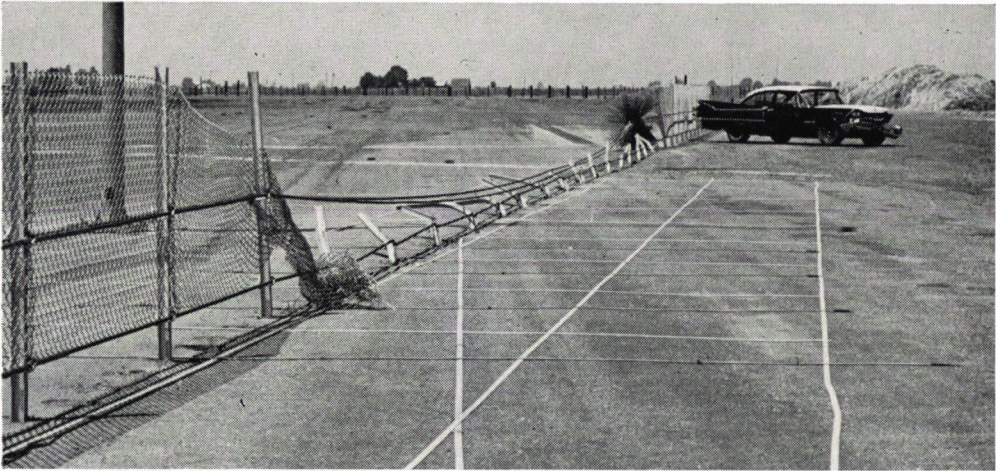
TEST NO. 1

Fabric: Chain link on impact side of barrier. Fabric under top cable but not contained under bottom cable.

Opposing side 5 foot or more encroachment for 3/10 seconds.

Barrier Damage: Approximately 130 feet of mesh gathered up between top cables at point of spin-out. No cable fitting damage or failures. Damage was typical of that recorded during 1959 test series. Slight cracking of post footings was result of "green" concrete. No posts pulled out of footings. There was no appreciable movement of the post footings.

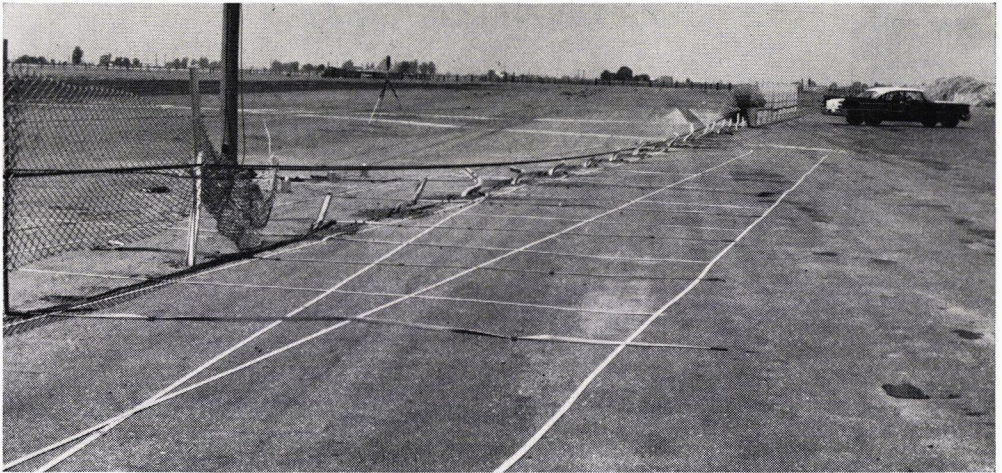
TEST NO. 2

Fabric: Chain link on impact side of barrier. "U" of cable clamp on impact side. Fabric contained under cable.

Opposing side 5 foot or more encroachment for 5/10 seconds.

Barrier Damage: Approximately 130 feet of mesh gathered up between cables at point of "spin out". Fabric and post damage was very similar to that of Test No. 1. Slight cracking of post footings was result of "green" concrete. No posts pulled out of footings. There was no appreciable movement of the post footings.

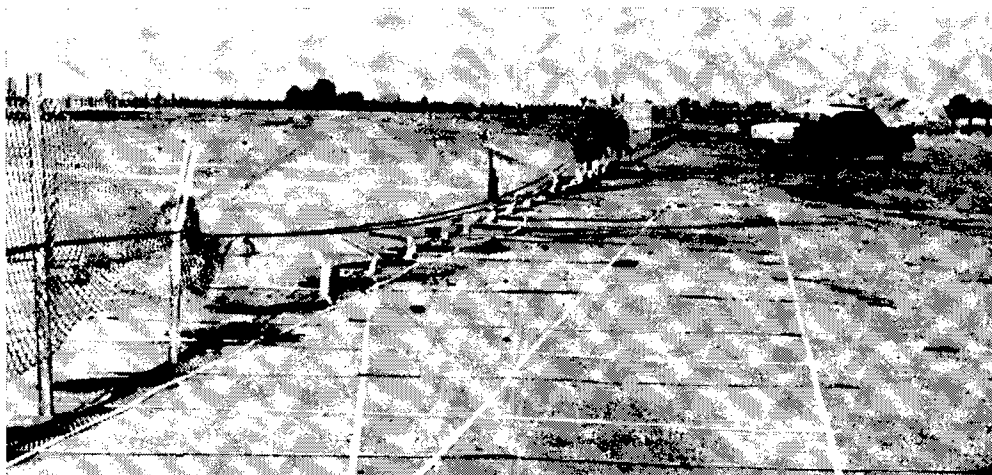
TEST NO. 3

Fabric: Chain link on impact side of barrier. "U" of cable clamp on impact side. Fabric contained under cable.

Opposing side 5 foot encroachment for 6/10 seconds.

Barrier Damage: Approximately 125 feet of mesh gathered up between cables at point of spin-out. Fabric and post damage was very similar to that of Tests No. 1 and 2. One post pulled out of socket footing. Twenty posts pulled between 1/2 inch and 2 inches out of sockets. Slight cracking of footings was not severe enough to prevent re-use on Test No. 5.

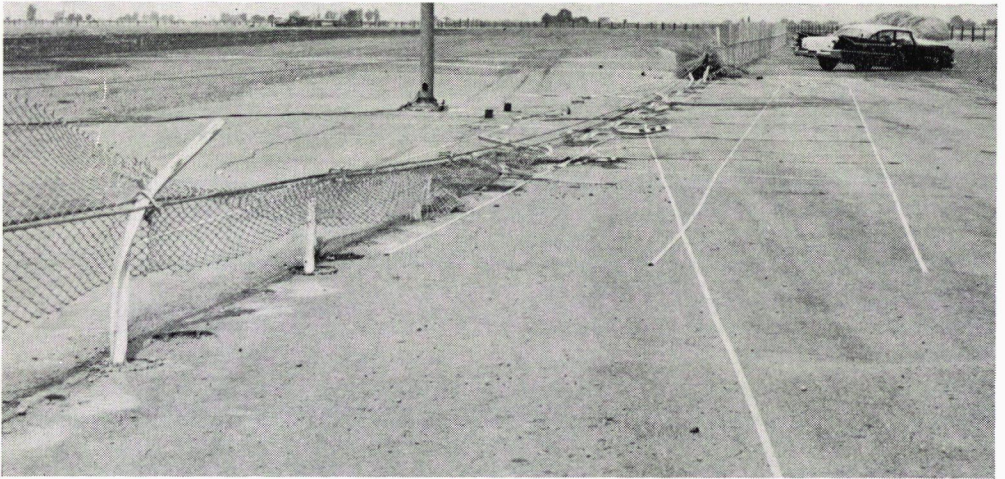
TEST NO. 4

Fabric: Chain link and "U" of cable clamps on opposite side from impact. Fabric contained under cable.

Opposing side 6 foot or more encroachment for 1/10 seconds.

Barrier Damage: Approximately 90 feet of fabric gathered up between cables at point of "spin out". There was no failure of the turnbuckles; however, the cable was badly kinked adjacent to the cable pull on the front turnbuckle (impact side) and also 10 feet ahead of point of spin-out where post had pulled out of footing. Footing failure and cracked footings were result of "green" concrete.

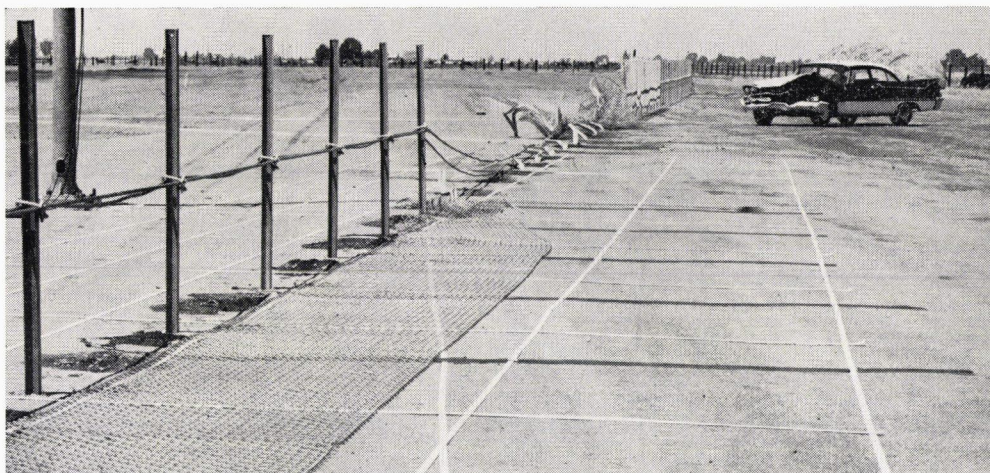
TEST NO. 5

Fabric: Chain link on impact side of barrier. "U" of cable clamps on opposite side. Fabric not contained by cable.

Performance: See Exhibit 8. Car started "spin-out" approximately 70 feet from point of impact due to posts #2 and #3 pulling out of sockets and jamming at the second turnbuckle located 58 feet ahead of impact. Posts, clamps and fabric passed over first turnbuckle located 50 feet ahead of impact and jammed on second turnbuckle. The vehicle carried entire bundle 10 feet further as dead-end located 100 feet behind point of impact failed. Fabric fastened with 12 gage steel tie wires was torn from posts for 70 feet behind point of impact and fell to pavement.

Opposing side 6 foot or more encroachment for 2/10 seconds.

Barrier Damage: Preformed dead-end failed under extreme loading caused by posts and clamps jamming on turnbuckle. The dead-end had been removed from a cable used on a previous installation. During removal, a critical amount of aluminum oxide coating was stripped from the inside of the weave resulting in insufficient friction for the assembly to retain the cable under normal collision loads. Socket type post footings from Test No. 3 were re-used for this test. No additional cracking was noted.

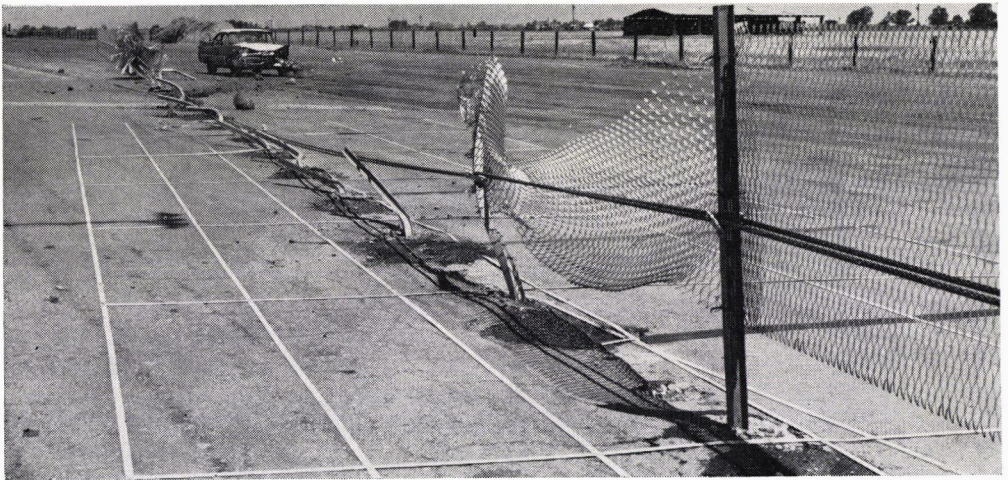
TEST NO. 6

Fabric: Expanded steel mesh on impact side of barrier. "U" of cable clamp on impact side. Fabric not contained by cables. Fabric 18 gage galvanized steel, 1.33 inch x 3 inch diamond, 8 foot 4 inch x 42 inch panels.

Performance: See Exhibit 9. All wheels remained on pavement throughout run with a very slight yawing of vehicle. Post No. 11 pulled out of footing; however, there was no measurable change in vehicle reaction when compared to Test No. 2 on 8 inch x 30 inch PCC footings. The expanded metal fabric reacted very similarly to chain link fabric under identical collision conditions. Very smooth deceleration to 160° spin-out at approximately 80 feet from impact.

Opposing side 5 foot encroachment for 3/10 seconds.

Barrier Damage: Fourteen panels (112 feet) of expanded metal gathered up at point of spin out. The severe cracking of all post footings in the collision zone and complete failure of one was due to "green" concrete.

Test 6 used expanded steel mesh instead of chain-link fabric. No difference in barrier action was noted. However, first cost and maintenance costs of the expanded fabric will be markedly higher than for the chain link-fabric. This is due primarily to the higher first cost of the expanded metal, but it will also be affected by the fact that this material is furnished at present only in short panels.

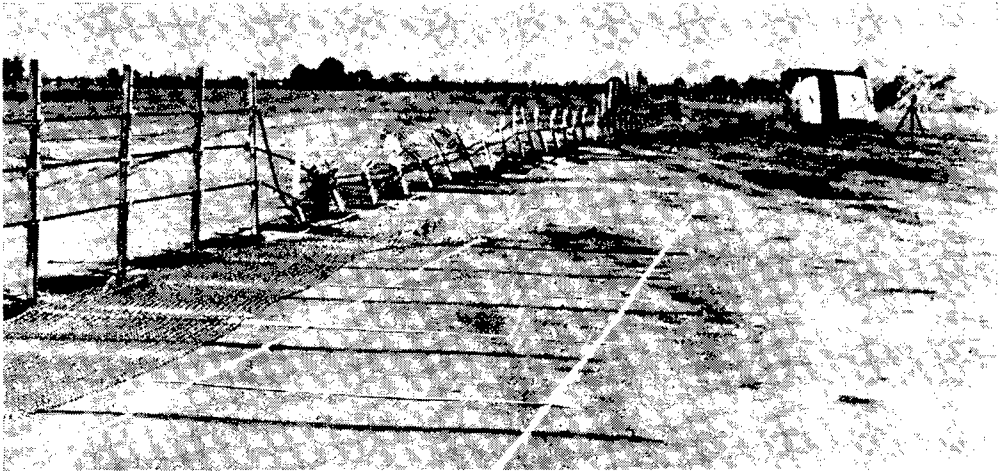
TEST NO. 7

Fabric: Chain link on impact side of barrier. Fabric not contained by cable. "U" of clamp on impact side.

Opposing side 5 foot encroachment for 1/10 seconds.

Barrier Damage: The preformed cable splice located 125 feet ahead of impact failed as the windshield post sliding along the cable passed the frayed ends of the splice. At this location, the failure had no appreciable effect on the vehicle reaction; however, had the splice been installed 20 feet closer to the point of impact, the vehicle would have rolled over the barrier as the splice released.

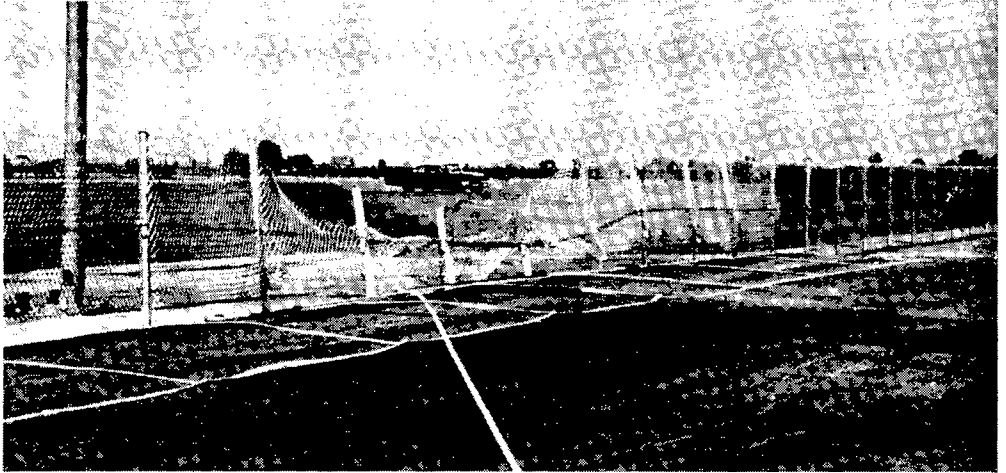
TEST NO. 8

Fabric: Chain link on impact side of barrier. "U" of cable clamps on impact side. Fabric not contained by cables.

Performance: See Exhibit 11. The vehicle left the crown of the ramp and traveled airborne 17 feet to point of impact. Data films show that the vehicle had dropped only 2 inches along the trajectory from the crown of the ramp to the barrier. At the point of impact, the cables were below the center of the bumper at an effective height of 20 inches. The bumper contacted the post forcing it back and down and the cable was carried down with the post. The left front tire contacted the barrier at an intersection of post and cable further forcing the cable down and rolling over with no tendency to snag. As the vehicle progressed across the barrier each wheel was successively forced into its wheel well. There was no tendency for any part of the vehicle to snag on the cables. The 7 gage tension wire cracked the top of the windshield before failing at the 3/8 inch turnbuckle located 150 feet behind the point of impact.

Barrier Damage: Post collision height of cables at point of impact was approximately 8 inches above the crown elevation of the simulated super. No post footings were cracked.

6 ft away from the edge of the shoulder at the bottom of the simulated ditch, the car traveling at a 20-deg angle of collision would pass on over the barrier. After a study of the car's trajectory this was remedied in Test 9 by duplicating the previous test conditions but moving the barrier up the slope of the ditch to within 1 ft of the edge of the simulated shoulder, thus giving the car an opportunity to penetrate the barrier and become engaged under the cable.

Analysis of the trajectory of the car in the pictures of Test 8 indicates that a barrier to be effective should be placed no lower than 27 in. above a horizontal projection from the top edge of an approaching 8 percent grade. This is about the maximum superelevation that will be encountered in roads that justify the use of median barriers. The best solution for this condition is to place the barrier at the top or before the top of the superelevation. If it is necessary to place the barrier on the ditch side of the cross-slope, then the barrier cable should be no lower than 27 in. above the crown nor higher than 33 in. above the ground surface.

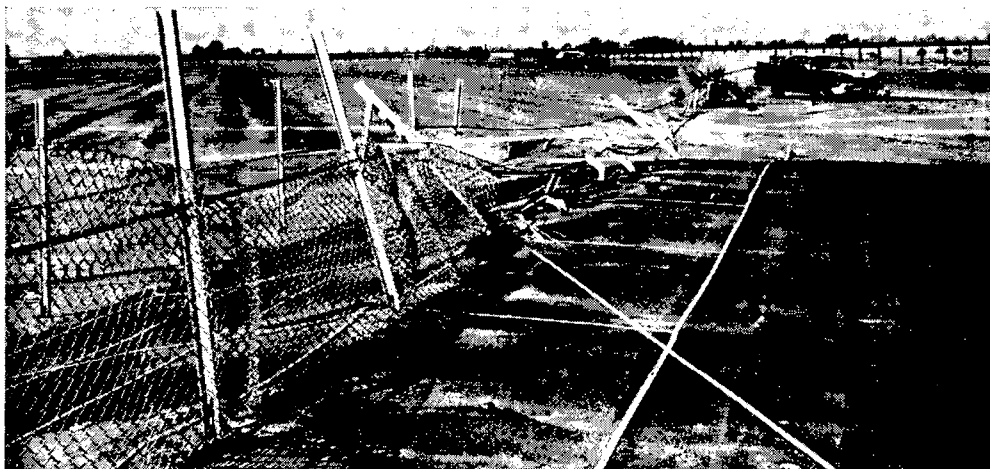
TEST NO. 9

Fabric: Chain link on impact side of barrier. "U" of cable clamps facing impact. Fabric not contained by cable.

Barrier Damage: 125 feet of fabric was gathered up at point of spin out. Seven post footings were cracked due to "green" PCC. None of the posts were moved from the asphalt filled sockets.

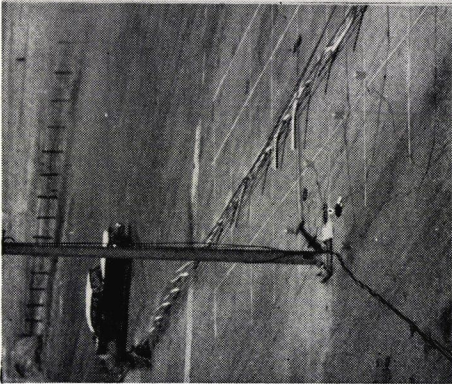
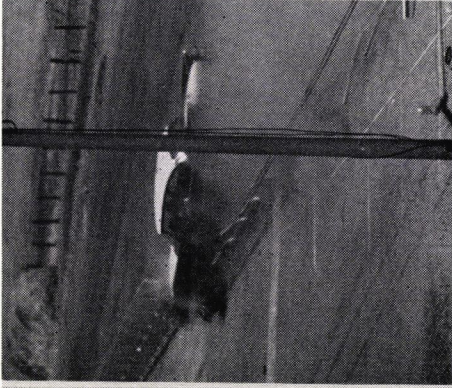
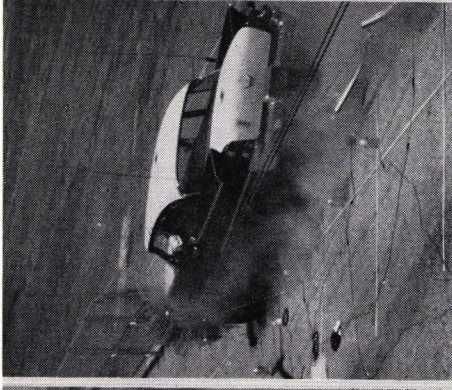
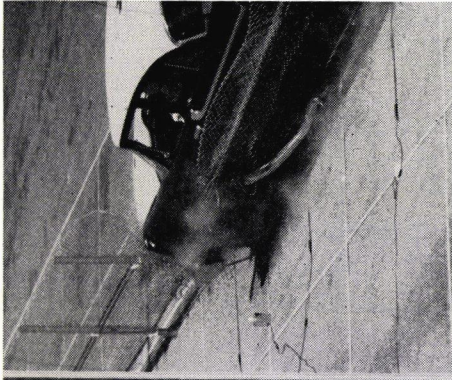
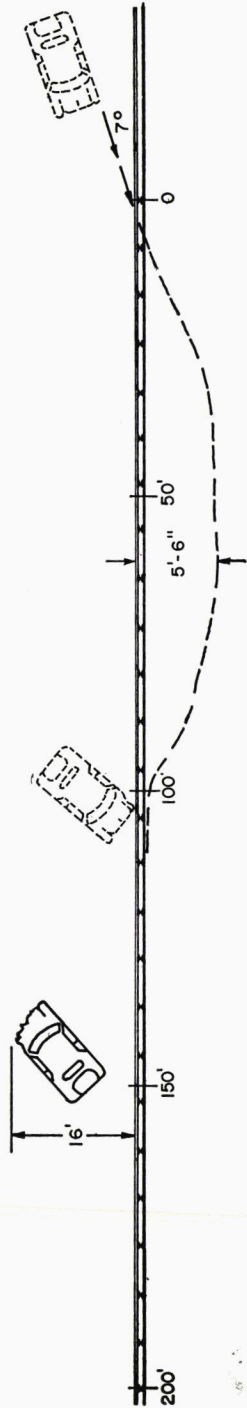
TEST NO. 1
 DATE 6-8-61
 VEHICLE Dodge 59 Sedan
 SPEED 78 MPH
 IMPACT ANGLE 7°
 VEHICLE WEIGHT . . . 4300 lbs.
 (W/DUMMY & INSTRUMENTATION)

FENCE DAMAGE 152' damaged
 CABLE FITTING DAMAGE none
 CABLE DAMAGE none
 POST DAMAGE 19 damaged
 POST FOOTING DAMAGE 7 cracked
 MAX DYNAMIC DEFLECTION OF CABLES . 5 1/2'
 VEHICLE DECELERATION (PEAK LONG) . 6.5g's
 VEHICLE DAMAGE \$ 350

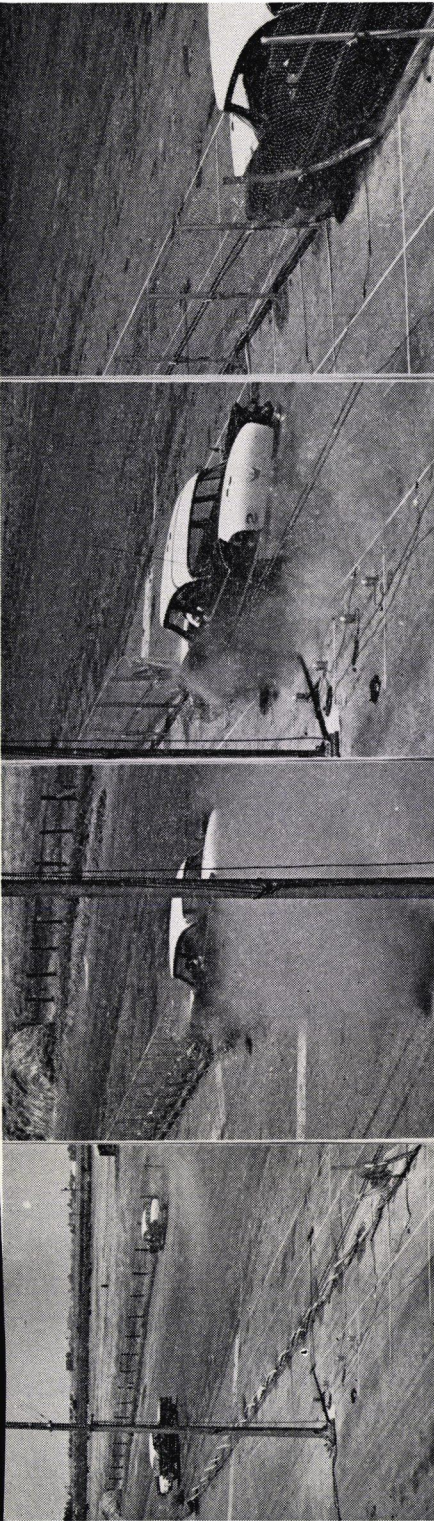
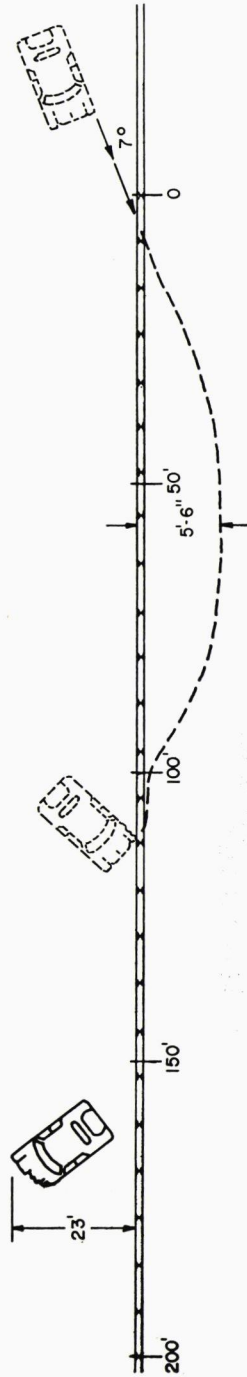
TEST NO. 2
 DATE 6-13-61
 VEHICLE Dodge 59 Sedan
 SPEED 84 MPH
 IMPACT ANGLE ... 7°
 VEHICLE WEIGHT ... 4300 lbs.
 (W/DUMMY & INSTRUMENTATION)

FENCE DAMAGE140' damaged
 CABLE FITTING DAMAGE none
 CABLE DAMAGE slight fraying
 POST DAMAGE19 damaged
 POST FOOTING DAMAGE12 cracked
 MAX. DYNAMIC DEFLECTION OF CABLES .. 6'
 VEHICLE DECELERATION (PEAK LONG.) .. 2.4 g's
 VEHICLE DAMAGE # 350

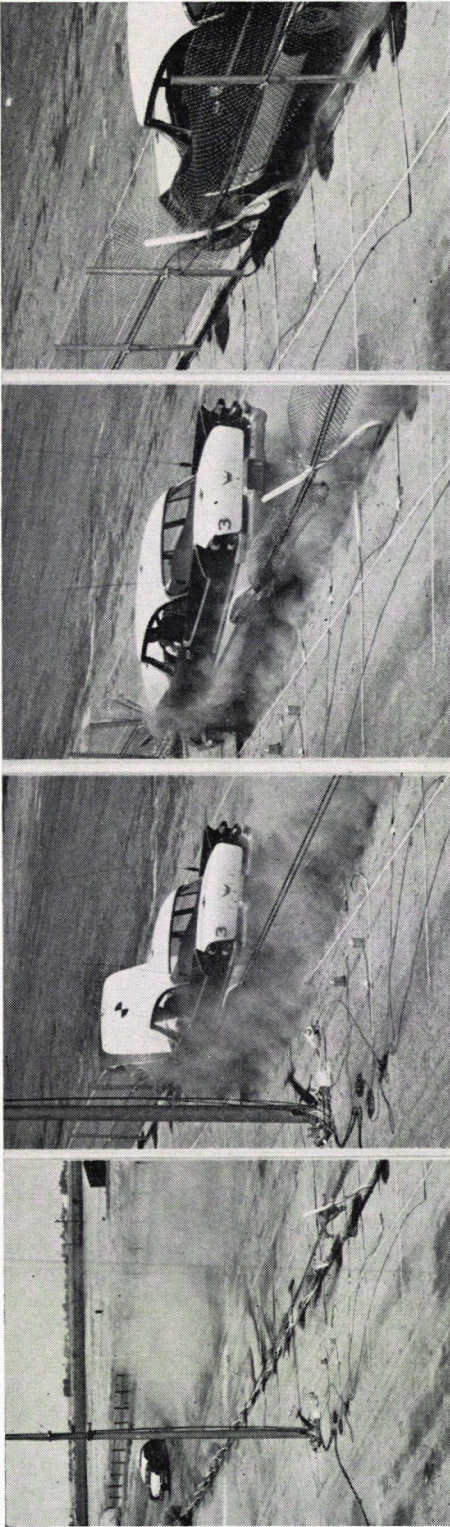
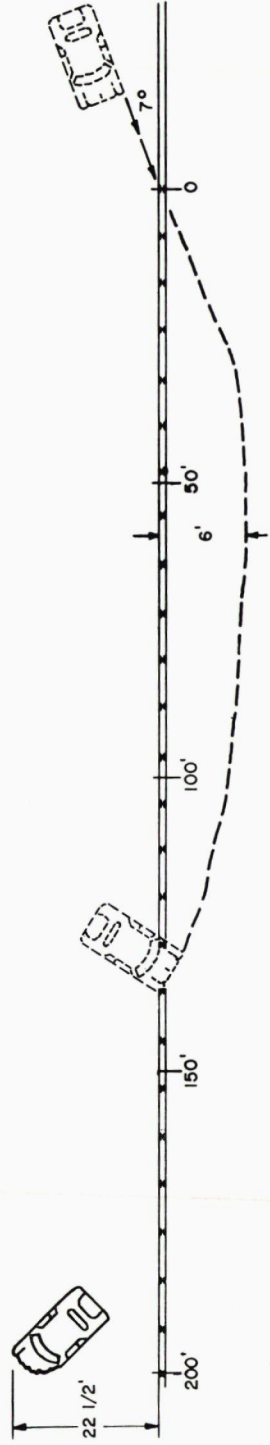
TEST NO.....	3
DATE	6-19-61
VEHICLE	Dodge 59 Sedan
SPEED	86 M.P.H.
IMPACT ANGLE	7°
VEHICLE WEIGHT ..	4300 lbs.
(W/DUMMY & INSTRUMENTATION)

FENCE.....	48" Chain link	FENCE DAMAGE	152' Damaged
	at 9" above pvmt.	CABLE FITTING DAMAGE	None
CABLE	3/4" 6 x 19	CABLE DAMAGE	None
	IWRC 2 at 30" above pavement.	POST DAMAGE	20 Damaged - 1 Pulled Out
POST FOOTING	Design D	POST FOOTING DAMAGE	5 Cracked
POST SPACING	8' O.C.	MAX. DYNAMIC DEFLECTION OF CABLES ..	6'
LENGTH OF INSTALLATION ..	600'	VEHICLE DECELERATION (PEAK LONG) ..	4 G's
GROUND CONDITION	Dry	VEHICLE DAMAGE	350

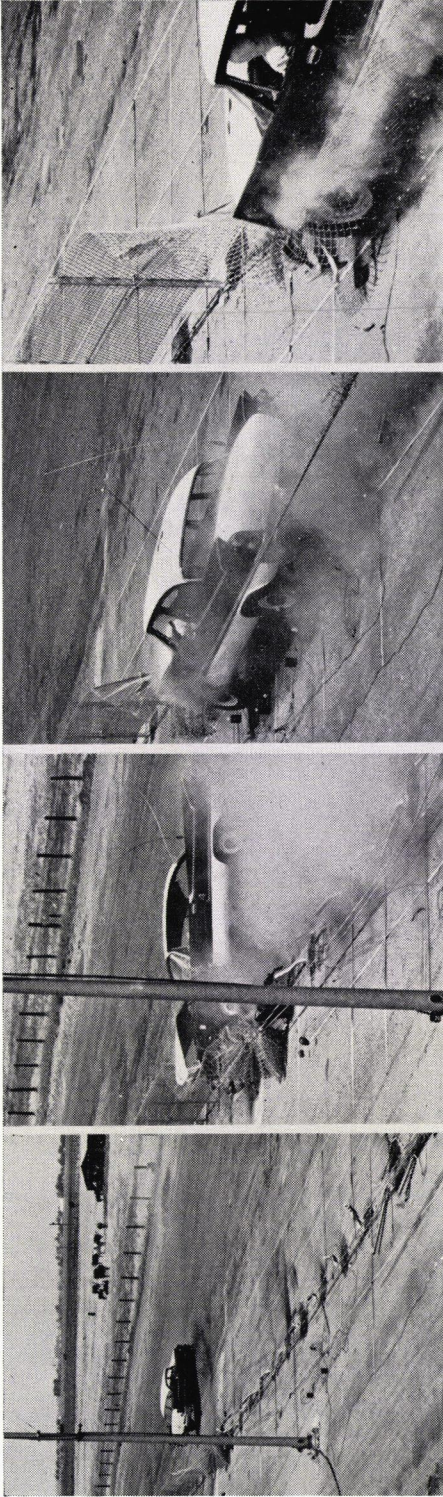
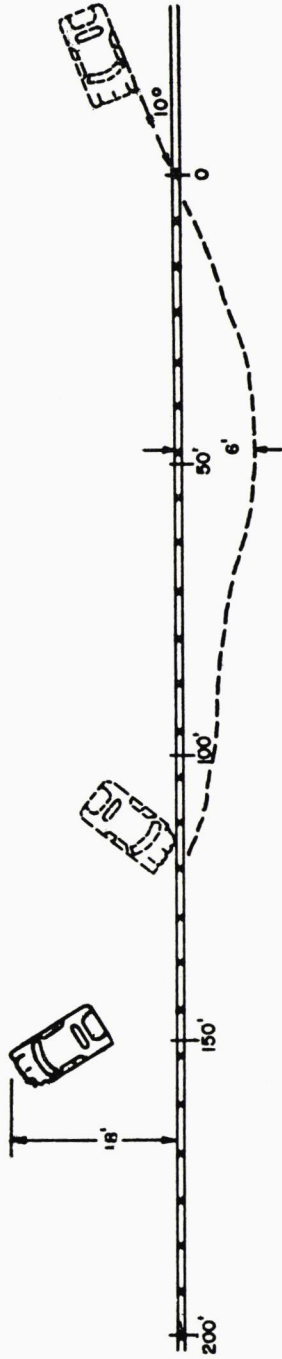
TEST NO.....4
DATE.....6-26-61
VEHICLE.....Dodge 59 Sedan
SPEED.....76 MPH
IMPACT ANGLE.....10°
VEHICLE WEIGHT...4300 lbs.
(W/DUMMY & INSTRUMENTATION)

FENCE DAMAGE.....136' damaged
CABLE FITTING DAMAGE.....1 turnbuckle slightly bent
CABLE DAMAGE.....none
POST DAMAGE......17 damaged - 1 pulled out
POST FOOTING DAMAGE......16 cracked - 1 failed
MAX DYNAMIC DEFLECTION OF CABLES...6'
VEHICLE DECELERATION (PEAK LONG)...3.6 g's
VEHICLE DAMAGE.....\$700

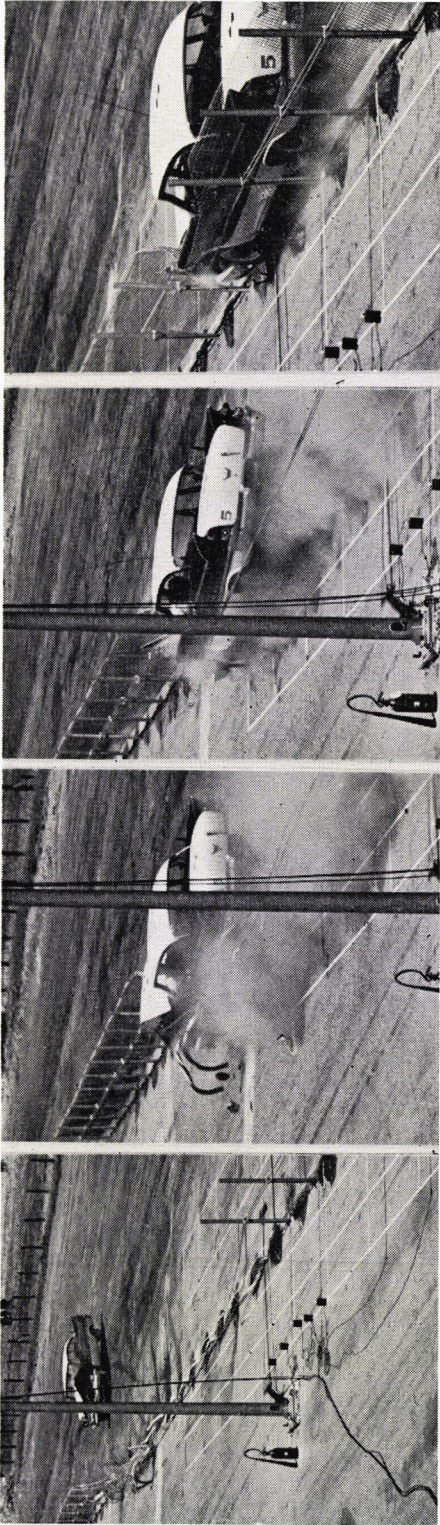
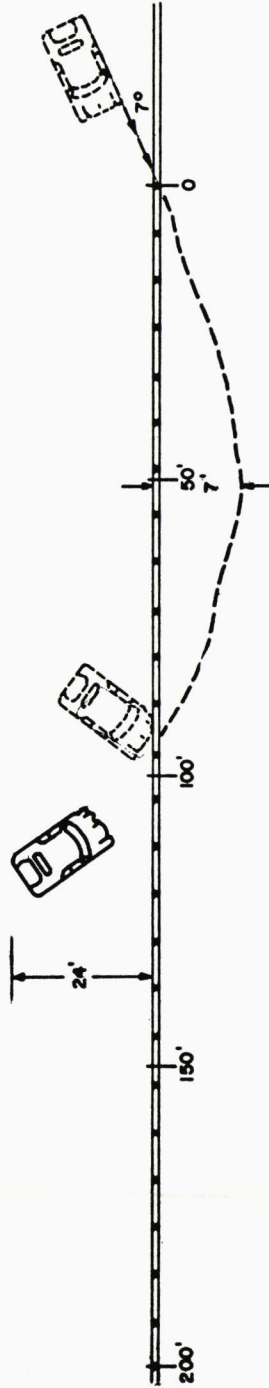
TEST NO.....5
 DATE.....6-30-61
 VEHICLE.....Dodge 59 Sedan
 SPEED.....84 MPH
 IMPACT ANGLE.....7°
 VEHICLE WEIGHT...4300 lbs.
 (W/DUMMY & INSTRUMENTATION)

FENCE DAMAGE.....112' damaged
 CABLE FITTING DAMAGE.....1 deadend failed
 CABLE DAMAGE.....none
 POST DAMAGE.....15 damaged-2 pulled out
 POST FOOTING DAMAGE 10 cracked
 MAX. DYNAMIC DEFLECTION OF CABLES..7'
 VEHICLE DECELERATION (PEAK LONG)..4.8 g's
 VEHICLE DAMAGE.....# 350

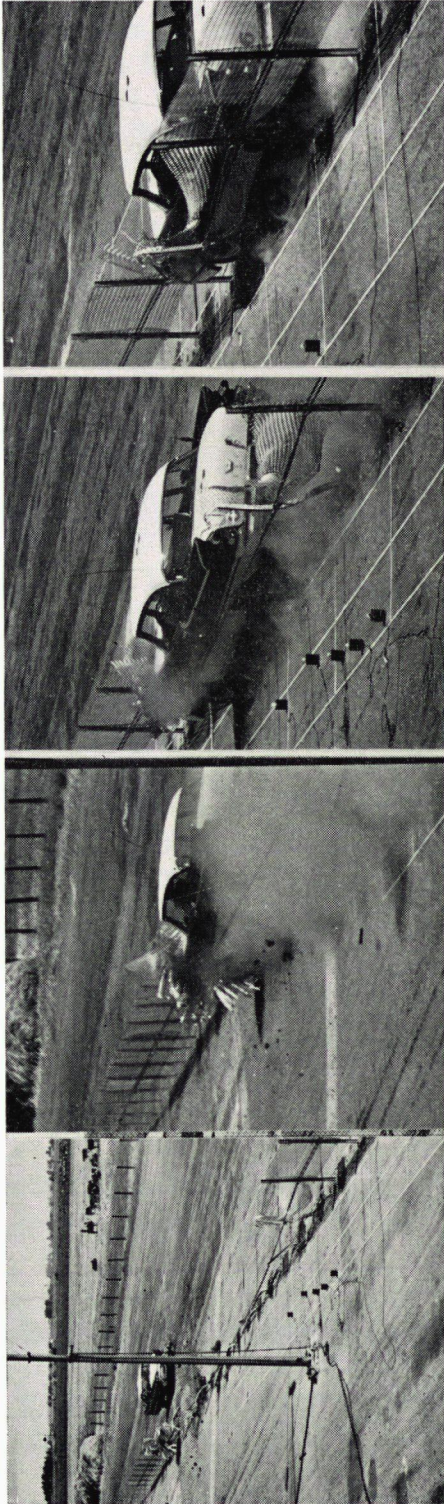
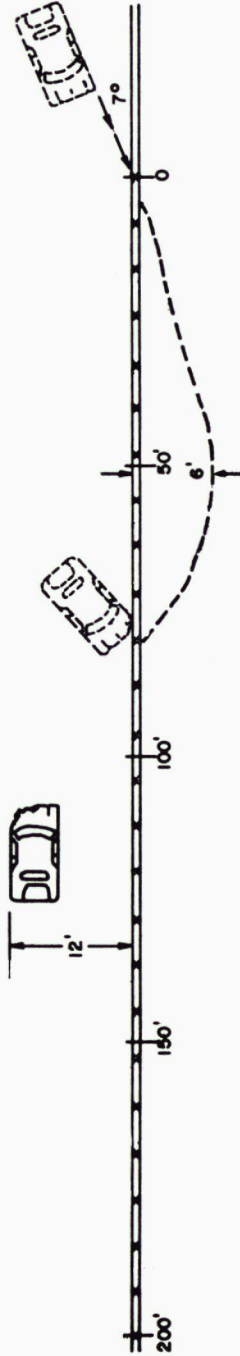
FENCE 42" 18 ga. steel expanded metal 1.35" x 3" diameter at 5" above post.	FENCE DAMAGE 136' expanded metal damaged	TEST NO. 6
CABLE 3/4" 6 F19 WRC 2 at 30" above pavement.	CABLE FITTING DAMAGE none	DATE 7-10-61
POST FOOTING Design C	CABLE DAMAGE none	VEHICLE Dodge 59 Sedan
POST SPACING 8' O.C.	POST DAMAGE 16 damaged, 1 pulled out	SPEED 75 MPH
LENGTH OF INSTALLATION 600'	MAX. DYNAMIC DEFLECTION OF CABLES 6'	IMPACT ANGLE 7°
GROUND CONDITION Dry	VEHICLE DECELERATION (PEAK LONG) 3 g's	VEHICLE WEIGHT 4300 lbs. (W/DUMMY & INSTRUMENTATION)
	VEHICLE DAMAGE \$ 350

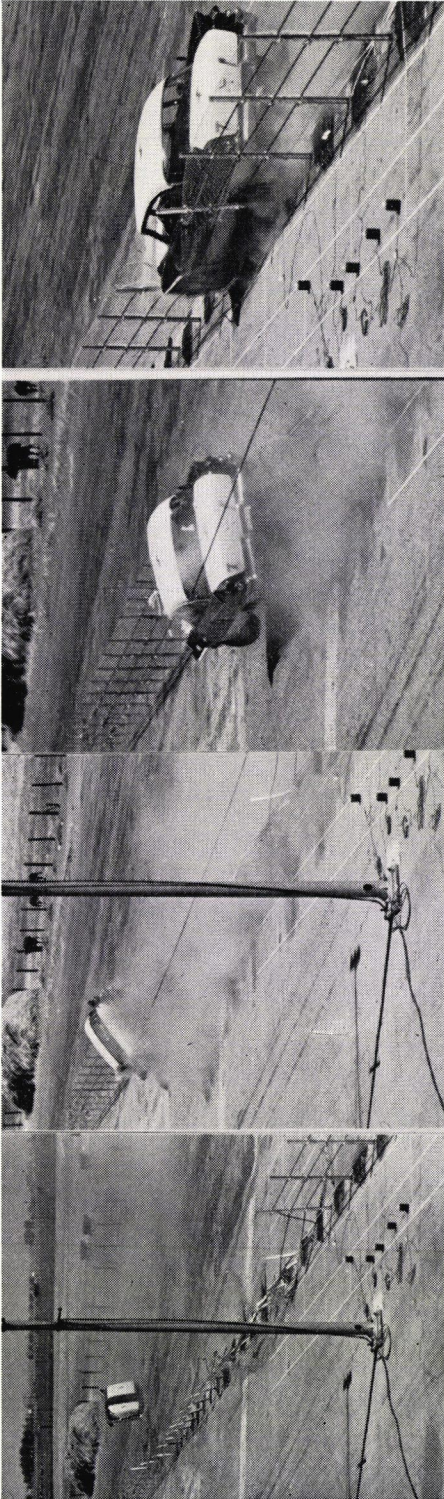
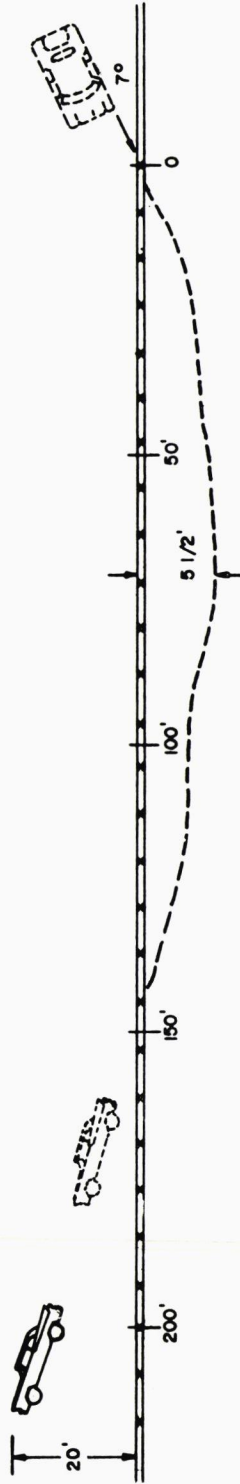
FENCE 48" chain link at 9" above pavement.	FENCE DAMAGE 184' damaged	TEST NO. 7
CABLE 3/4" 6 x 19 IWRC 3 et 20" 32" and 44" above pavement	CABLE FITTING DAMAGE preformed splice failed	DATE 7-14-61
POST FOOTING Design D	CABLE DAMAGE none	VEHICLE Dodge 59 Sedan
POST SPACING 8' O.C.	POST DAMAGE19 damaged	SPEED 77 MPH
LENGTH OF INSTALLATION 600'	POST FOOTING DAMAGE12 cracked	IMPACT ANGLE 7°
GROUND CONDITION Dry	MAX. DYNAMIC DEFLECTION OF CABLES 5 1/2'	VEHICLE WEIGHT 4300 lbs.
		VEHICLE DECELERATION (PEAK LONG) 6.8 g's	(W/DUMMY & INSTRUMENTATION)	
		VEHICLE DAMAGE Total loss

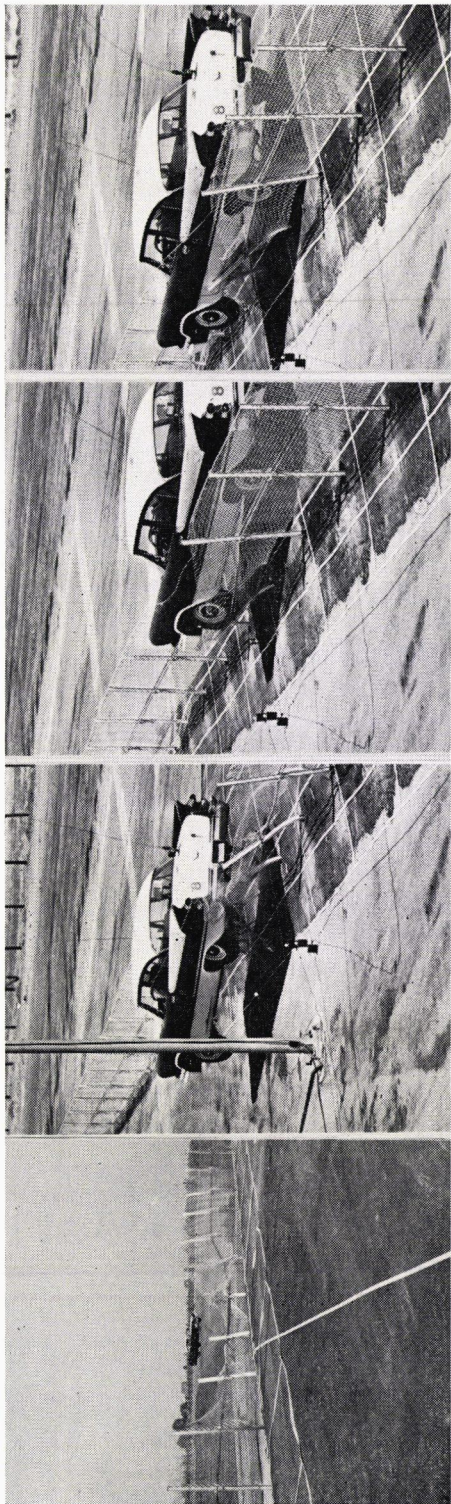
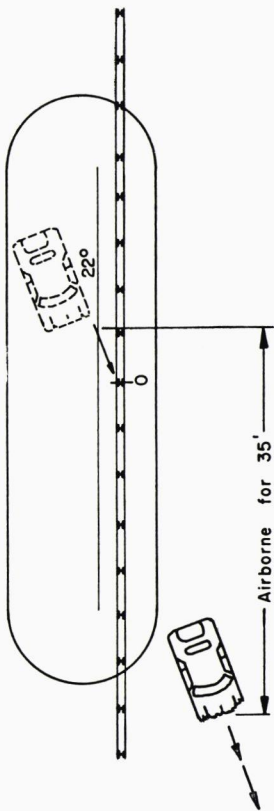
FENCE	48" Chain link at 9" above pavement.	FENCE DAMAGE	35' damaged	TEST NO.	8
CABLE	3/4" 6 x 19 WRC 2 at 30" above pavement.	CABLE FITTING DAMAGE	none	DATE	8-18-61
POST FOOTING	Design B	CABLE DAMAGE	none	VEHICLE	Dodge 59 Sedan
POST SPACING	8' O.C.	POST DAMAGE	7 damaged	SPEED	74 MPH
LENGTH OF INSTALLATION	400'	MAX. DYNAMIC DEFLECTION OF CABLES	Vehicle jumped barrier	IMPACT ANGLE	22°
GROUND CONDITION	Dry	VEHICLE DECELERATION (PEAK LONG.)	1.7 G's (at end of jump)	VEHICLE WEIGHT	4300 lbs.
		VEHICLE DAMAGE	150	(W/DUMMY & INSTRUMENTATION)

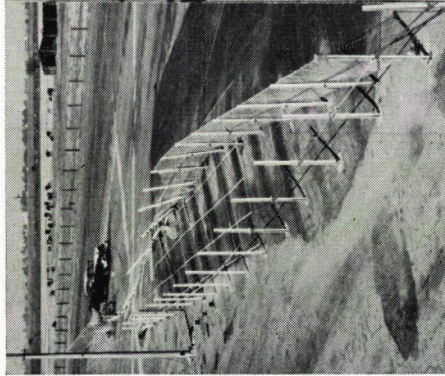
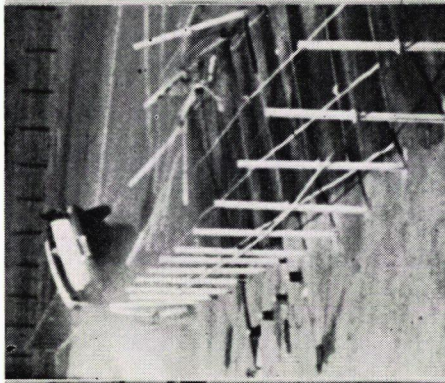
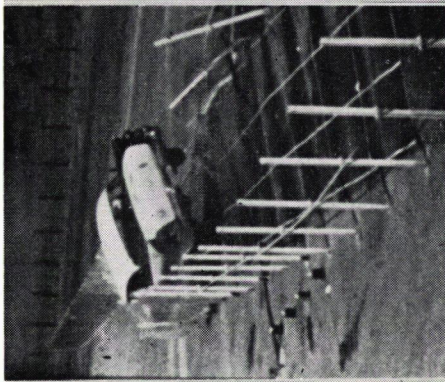
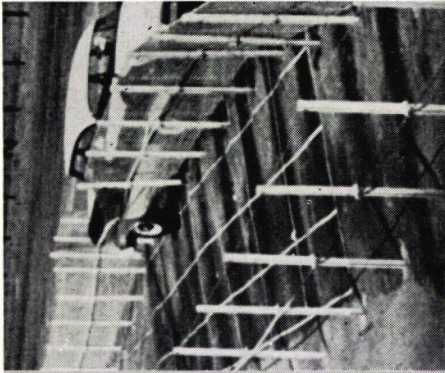
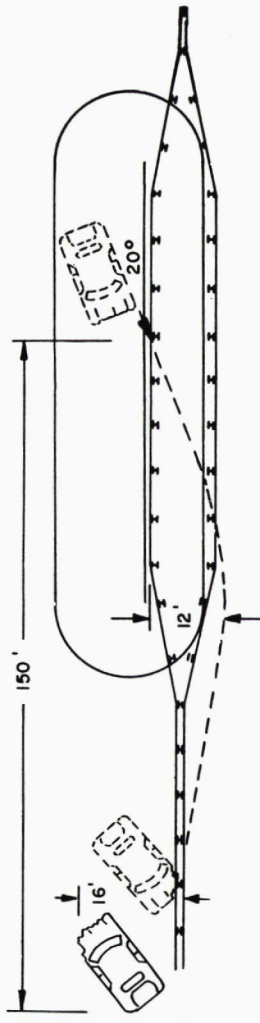
FENCE DAMAGE 136' damaged
 CABLE FITTING DAMAGE..... none
 CABLE DAMAGE..... none
 POST DAMAGE..... 22 damaged - 11 slightly bent
 POST FOOTING DAMAGE..... 7 anchors cracked
 MAX. DYNAMIC DEFLECTION OF CABLES.. 12"
 VEHICLE DAMAGE..... \$ 750
