Cleaning and Resealing of Concrete Pavement Joints by Contract

FRED E. STERNBERG, Senior Highway Engineer, and
WARREN M. CREAMER, Chief Engineer
Connecticut State Highway Department

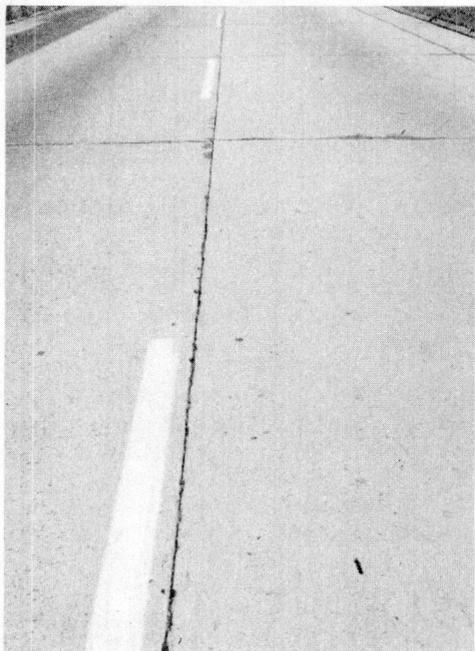
Due to the lateness of the season the contractor was not permitted to start work until April 1, 1955. The appearance of the joint seal on US 5 and 15 prior to and after resealing is shown in Figures 1 through 3. Figure 2 indicates very well the typical condition of too many of our transverse joints. The age of this seal is not definitely known but is probably not less than two years. In all cases where tie bars were used at the longitudinal joints the old joint seal in the longitudinal joint appeared to be in comparatively good condition. In our early concrete pavements where tie bars were not used the

Figure 1. Joints on US 5 and 15 prior to cleaning.

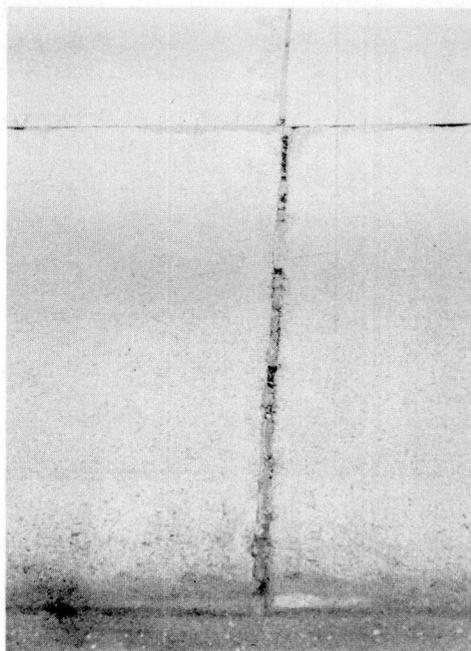
Figure 2. Typical condition of seal in transverse joint prior to cleaning and re-sealing.

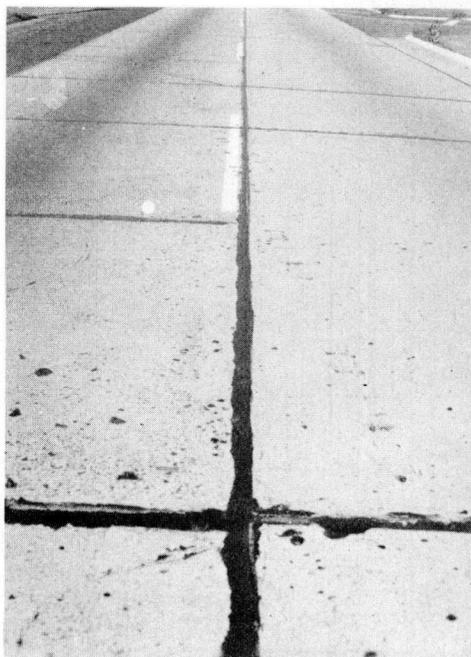
Figure 3. Joints after cleaning and re-sealing.

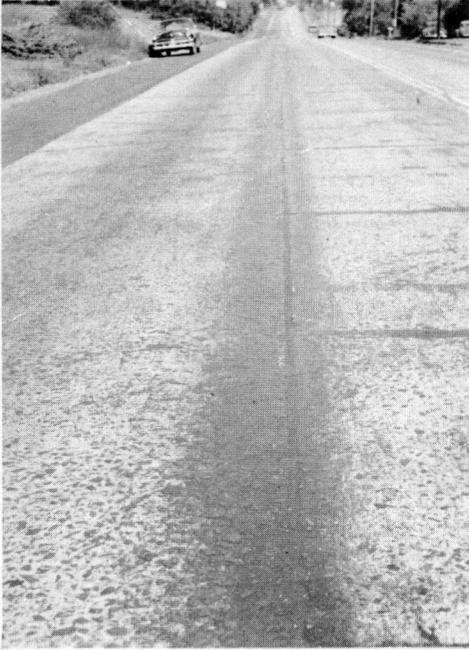
The condition of the cold-poured seal on US 1 several weeks after the joints were resealed is shown in Figure 4. The use of

Figure 4. Appearance of joints two weeks after resealing with cold-poured type seal.

the cold-poured type seal was called for to determine if this material could be successfully used. In the past our experience in sealing the joints of newly constructed pavement with the cold-poured type has not been successful except where it was used in sawed joints. The air temperature at the time of resealing the joints on US 1 was between 85 F and 90 F. A paper tape was placed over the fresh seal and on the same day upon the completion of the resealing in this area the road was opened to traffic. Shortly after traffic began to travel over this area the paper tape began to pull away from the joint with some of the seal adhering to it. Once the tape was removed the fresh seal was tracked over the pavement resulting in a rather messy condition.

fully used in the sawed joints during warm weather its use in the wider transverse joints has not proved satisfactory. In any case, further use of the cold-poured type seal was discontinued on this project for the time being.

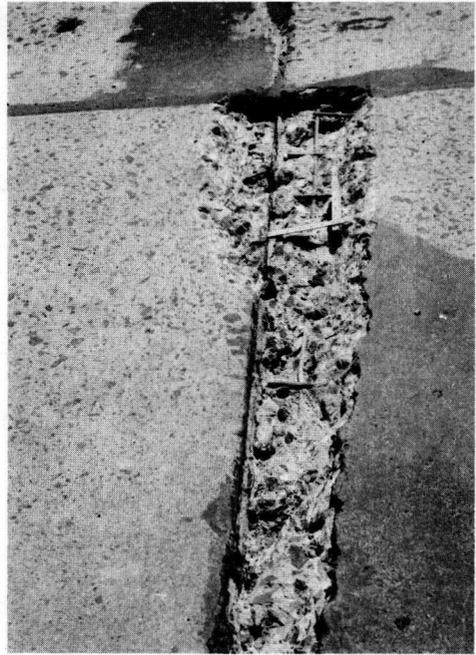
The extent to which joint deterioration has progressed in much of our older concrete pavement is indicated in Figure 5. This concrete is 30 years old and outside of the evident distress at the joints the surface is in good condition. The expansion joint spacing is 60 ft with bar mat reinforcement as visible in Figure 5. Load transfers were not installed in any of our concrete pavements at that time. The original joint filler which was of the pre-moulded bituminous type $\frac{1}{2}$ -in. thick, has become so impregnated with silt or sand as to make recognition very uncertain. Transverse joints in this condition are going to be more susceptible to localized pressures due to the infiltration of varying amounts of silt or sand since there is no compressible gasket left which might absorb such pressures created by the restrained expansion of the pavement. Examination of the joint seal during the summer in a pavement only $3\frac{1}{2}$ years old indicated considerable fine silt was accumulating in some of the joints between the contact areas of the joint and the seal although at the time the external appearance of the seal gave no indication of the possibility of such a condition. However, the following winter at temperatures of 10 F to 14 F this same seal was badly cracked and in places pulled away from the joint face thus providing a ready opening for the entrance of foreign material. The following summer, traffic appeared to knead the cracks together and blacken the surface of the seal so that a casual observation would seem to indicate satisfactory condition of the seal. Observations made of the joint seal on a pavement $7\frac{1}{2}$ years old indicated the seal was completely removed in a few joints with partial removal in numerous joints. Upon the removal of seal from what appeared to be a well sealed joint, considerable foreign material was uncovered between the seal and the concrete varying from fine silt up to $\frac{3}{8}$ inch stone. Nine samples of joint seal were removed from the joints of a concrete pavement $3\frac{1}{2}$ years old and taken to the laboratory where 10 percent to 83 percent insoluble material was found in the seal. In all cases, the observed joint seal has been a rubber asphalt compound of the hot-poured type.

Figure 5. Spalled joint with wire fabric showing.

On the basis of the severe joint spalling and the observations of the condition of the asphalt rubber compound in use, our joint sealing program is being revised. Those pavements which are 3 to 5 years old will be resealed first followed by those which are over 5 years old and up to 10 years of age and progressing to the older pavements last. The idea is to prevent our newer pavements from approaching the condition of distress now prevalent in our older pavements.

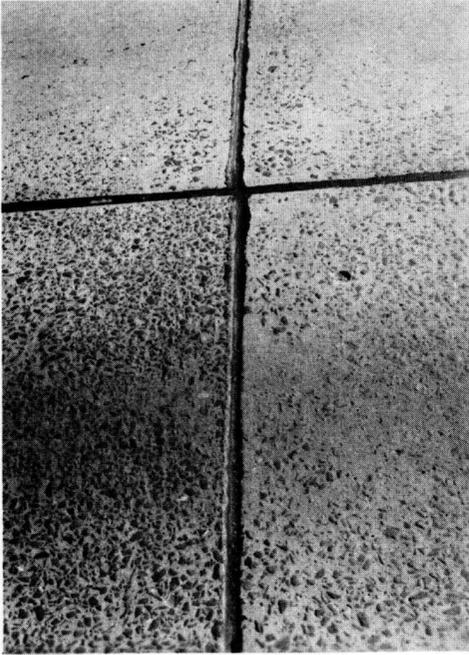
In November, four months after the transverse joints and cracks were resealed on US 1, an examination was made of the seal condition. Figure 11 is a typical resealed joint on US 1. Although the seal was poured flush with the pavement with two applications there is now a very noticeable slump in the seal at the transverse expansion joints. The air temperature at the time this inspection was made was between 50 F and 60 F. On the basis of the difficulty encountered in sawing this pavement the highly probable tempera-

Figure 11. Typical resealed transverse expansion joint on US 1.

ture at which restrained expansion begins is somewhere between 65 F and 75 F. If it is assumed that the concrete, on the day inspection was made, had contracted through a temperature of 25 F the expected opening might be 0.09 in. which in this width of joint seal would not cause the amount of necking down now visible. In several cases where the sawed concrete in the relief joints was removed by hand, evidence of where the joint seal had run down into the joint was found in air pockets in the concrete near the subgrade. It is quite possible that despite the fact that the joints were tightly closed at the time the seal was poured, some of this seal did flow down through the joint. The condition of the joint seal in some of the resealed joints on US 1 is shown in Figures 12, 13, and 14. In Figure 12 considerable coarse material is becoming embedded in the seal. The extraneous material appears to be one of the causes why each summer the joint seal at numerous joints continues to spread over the pavement under the action of traffic without any apparent loss of material in the joint. The brass plate in the lower left hand corner indicates the date on which this pavement was poured (April 30, 1928). Figure 13 is a typical condition of the joint

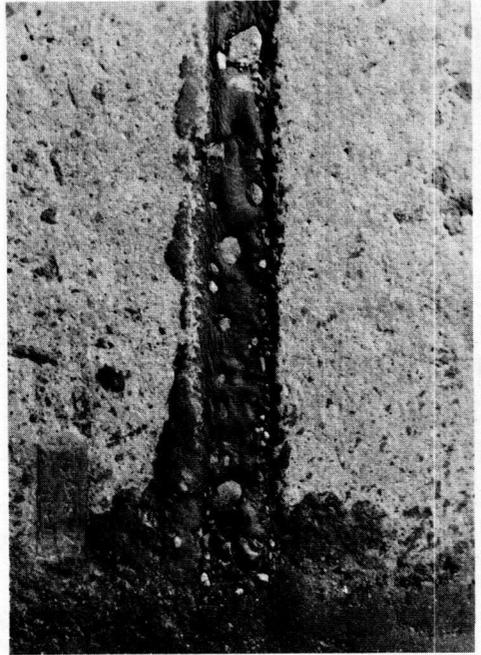
Figure 12. The embedded stone in the joint seal will cause some displacement of asphalt in the summer.

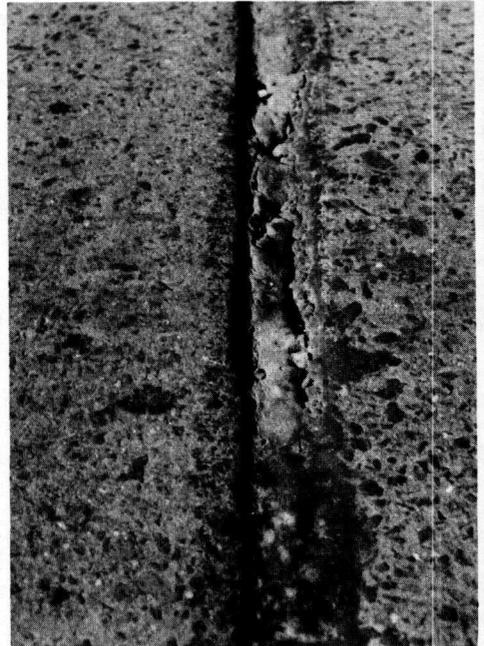
Figure 13. Partial cracking of joint seal four months after resealing.

seal observed in three transverse joints and Figure 14 shows condition of joint seal at a transverse crack. Determination of the specific gravity of the joint seal at these cracks indicates an increase in weight of 5.6 percent to 54 percent. In removing the seal samples, considerable silt and fine sand was encountered under the seal and in the joint. Figure 15 shows considerable subsurface water coming out of the resealed longitudinal joint on US 5 and 15 the day after a rain. The water is visible on the pavement for three to five days after a heavy rainfall. There are no visible cracks in the longitudinal seal in this area.

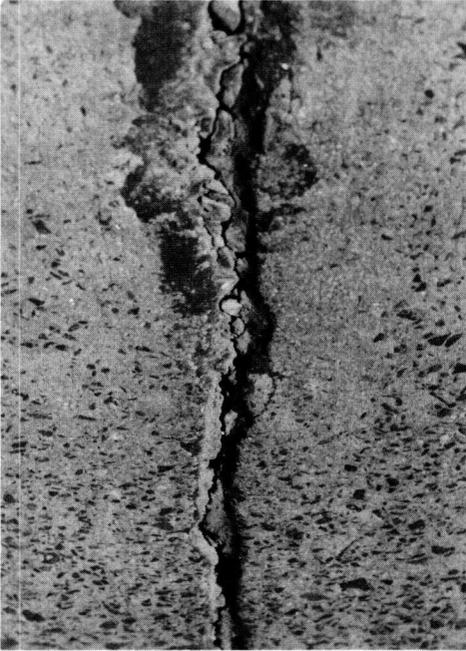
Figure 14. Seal failure four months after crack was resealed.

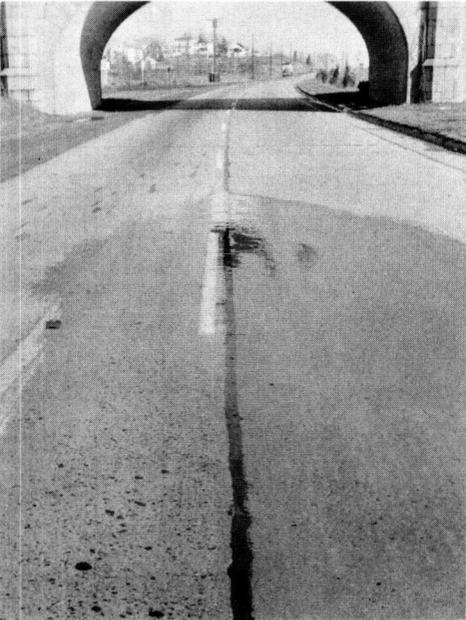
Figure 15. Subsurface water coming through the resealed longitudinal joint on US 5.

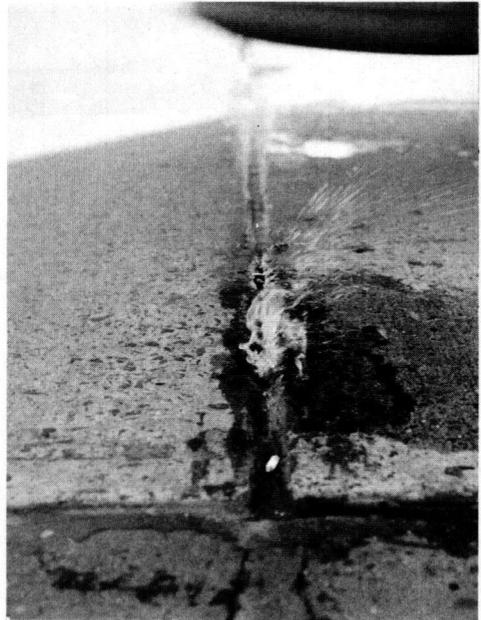
Figure 16 is a resealed transverse joint in the same areas as the longitudinal joint in Figure 15. Water could be observed through the two openings in the joint seal standing within 1 in. of the top of pavement and the pumping action caused by heavy trucks passing over the joint forced considerable water out of the joint.

Figure 16. Pumping at resealed transverse joint.
