Continuously-Reinforced Concrete Pavement in California After Eight Years Service

BAILEY TREMPER, Supervising Materials and Research Engineer,
California Division of Highways

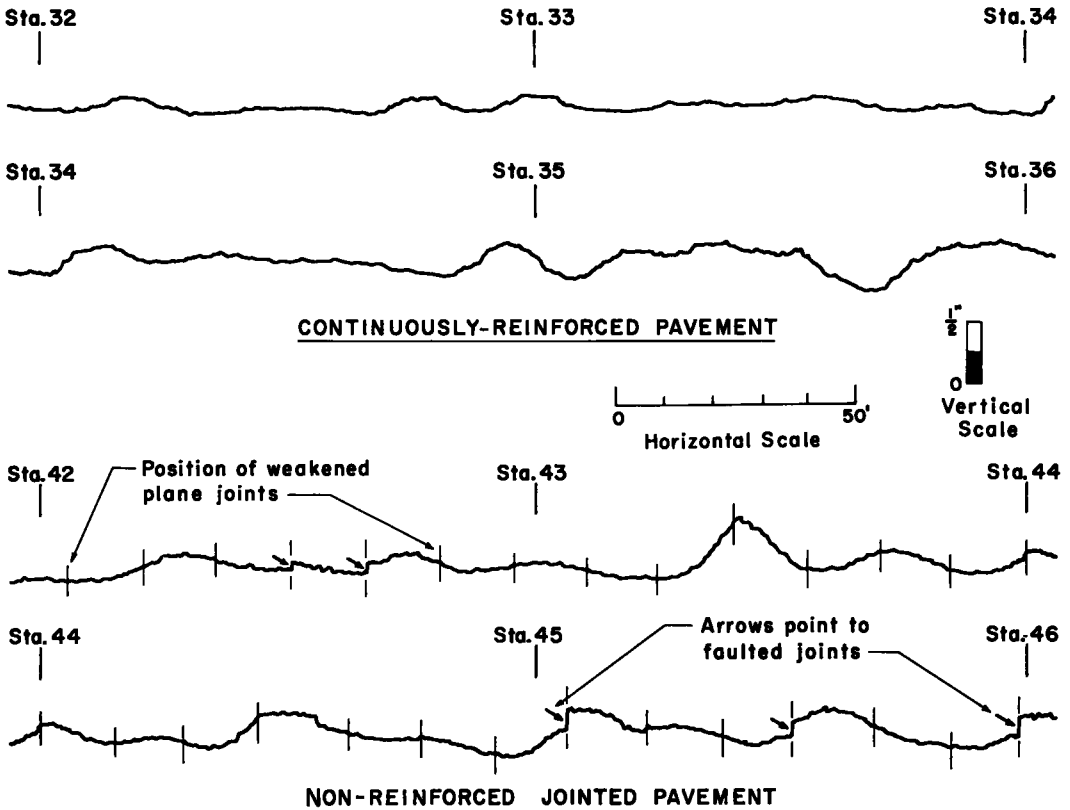
Short sections of profilograms obtained during the afternoon of June 25, 1957, are shown in Figure 4. These sections include those shown in Stanton's Figure 20. They are fairly representative of the entire reinforced and non-reinforced sections other than those affected by settlement at cross culverts. It will be noted that a moderate amount of faulting is indicated at a few of the joints in the non-reinforced section.

measured accurately from profilograms and only those of greater magnitude are considered in the following discussion. Such faulting has developed only in the non-reinforced section lying east of the reinforced section. In this portion, faulting of 0.10 in. or more has developed in the outer (driving) lane at 17 percent of the joints. The average faulting at these joints is 0.14 in. This faulting and random cracks in 6 percent of the slabs are the only evidence of distress in the non-reinforced pavement.

Figure 4. Profilograms of outer (driving) lane taken afternoon of June 25, 1957, temperature 103 F; Fairfield test section.

index of 10 in. or less is typical of well-finished new pavements or of older pavements that have remained exceptionally smooth. If the profile index is greater than 40, the pavement is rated as unquestionably rough and uncomfortable to passengers in automobiles. Present profile indices for the pavements in question, after eliminating irregularities due to local settlements, are 12.6 for both the reinforced and non-reinforced sections. The index does not take account of the moderate faults that have developed in portions of the non-reinforced pavement, some of which may be noticed by more sensitive passengers.
