Welded Wire Fabric Reinforcement for Asphaltic Concrete

L. L. SMITH and W. GARTNER, Jr., Respectively, Assistant Research Engineer, and Assistant Engineer of Research and In-Service Training, State Road Department of Florida

I. Welded Wire Fabric Reinforcement to Alleviate Rutting and/or Shoving of Pavements at Intersections

II. Reflection Cracking in Asphaltic Concrete Overlays Placed on Old Portland Cement Concrete Pavements

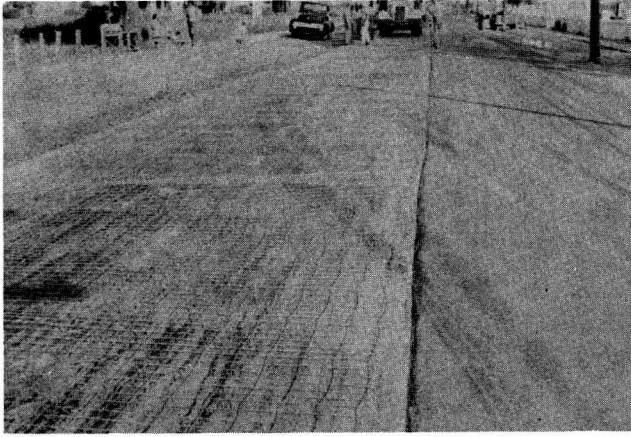
When the wire was properly positioned it was noted that the edge of fabric closest to the centerline was longer than the outside edge of fabric. This caused a series of humps or waves to develop in this longer edge. This wave action in the fabric is shown in Figure 5.

It was not possible to apply sufficient tension to make the fabric lay flat because the applied tension caused the unrolled fabric to curve due to the longer inside edge. The tension was released and paving began. While paving over the fabric, bulges that developed in front of the finisher were partially eliminated by the use of a crimping tool, as shown in Figure 6. When the wave action of the inside edge became excessive, the fabric was cut from the inside edge towards the outside edge and was cut only enough to permit it to lay flat by lapping the fabric at the cut.

Figure 5. Fabric reinforcement in approach lane before placement of surface course. Note bulging along edge of fabric nearest centerline of pavement.

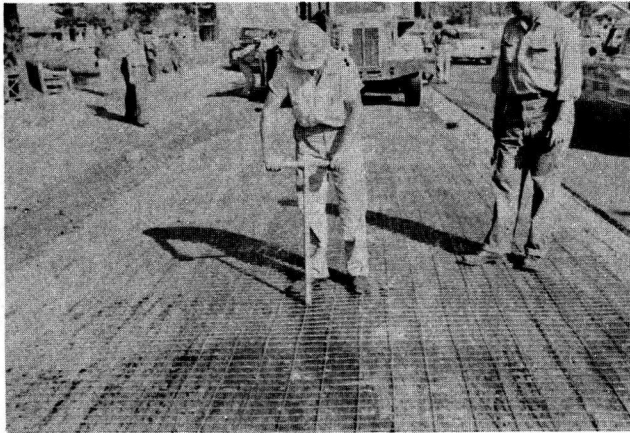
Figure 6. Using crimping tool to eliminate bulges in wire fabric.

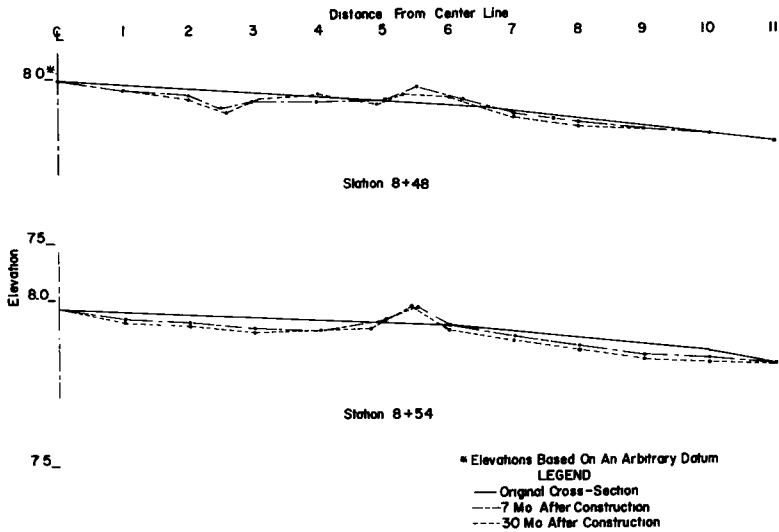
Figure 8. Distortion of Pearce Street section without reinforcement.

Cross-sections were made again after 30 months of service. These cross-sections also indicated that no significant changes could be found in the reinforced section, but that the sections without the fabric continued to distort. Figures 8 and 9 show typical areas where excessive pavement distortion had occurred in the sections without the fabric.

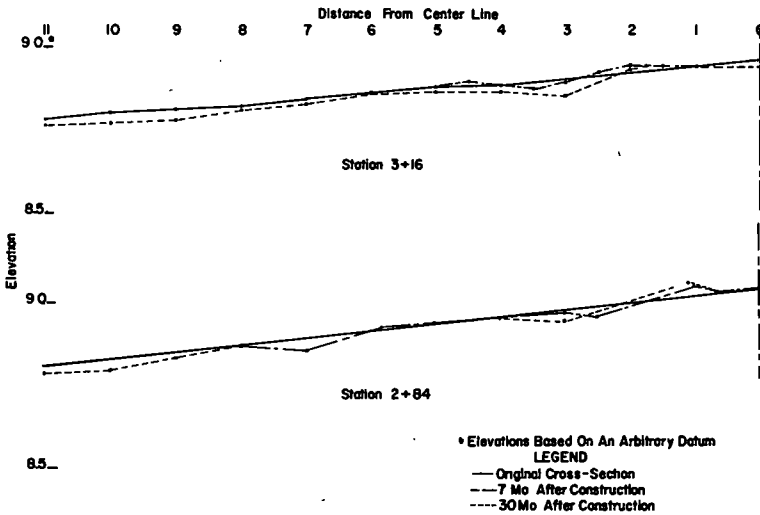
Figure 9. Distortion of Tyler Street section without reinforcement.

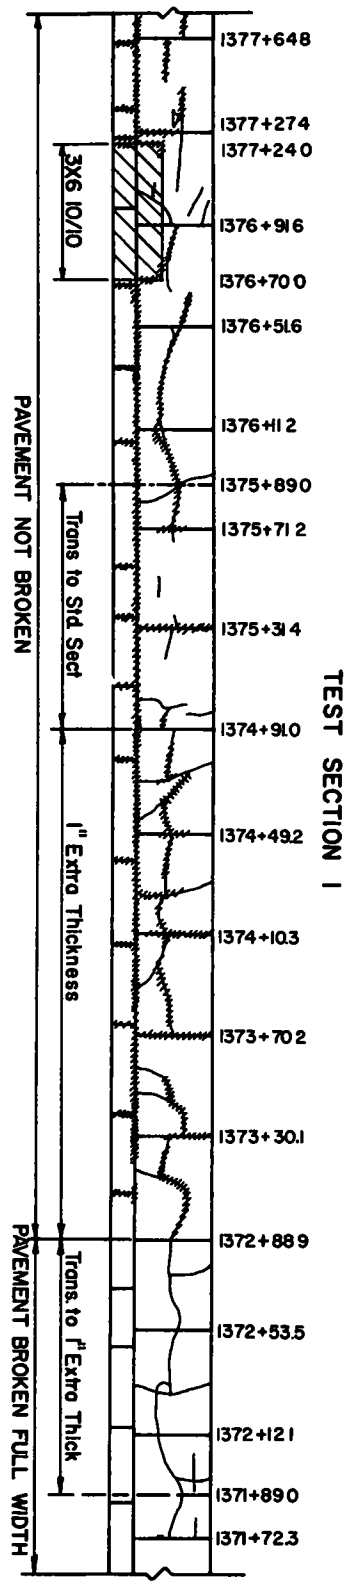
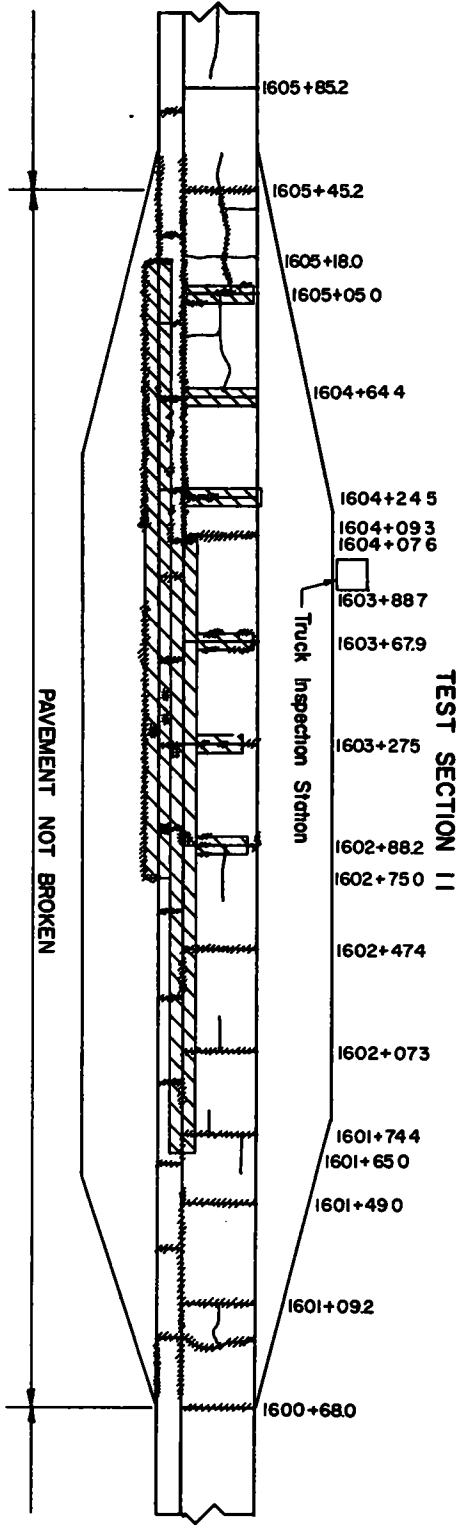
Figure 4. Plan view of test sections.

Figure 4 shows that the 1-in. extra pavement thickness has not retarded reflection cracking. This indicates that an extra pavement thickness of 1 in. is unwarranted for the purpose of controlling reflection cracking.

The 54 ft of reinforced overlay in test section I has no reflected cracks within the area of reinforcing. However, Figure 4 shows that cracking has occurred over the edge of fabric in some areas. Despite the limited area that is reinforced, the fabric appears to be controlling or at least retarding the reflection cracking in this area. This is particularly true for the longitudinal joint between the widening strip and the old pavement. Also, the only transverse joint in the widening strip of test section I which has not reflected through the overlay is within this reinforced section.

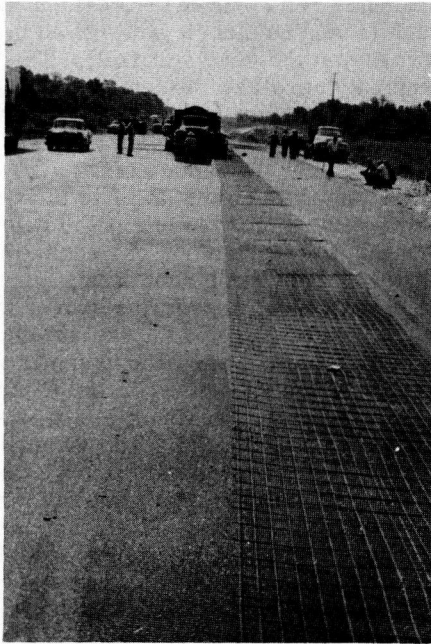
Two rolls were used at a time to reinforce a strip 250 ft long. As the fabric was unrolled, it would not lay flat due to bulges along one edge. Figure 5 shows the bulging of one strip of fabric and Figure 6 shows this same strip after the surface course had been placed over one-half of it and the bulges were removed by crimping. At first the adjoining ends of the 125-ft rolls were lapped with the trailing end of the first roll placed over the leading end of the second roll. The "recoil" tendency of the fabric caused the lapped end to push up through the fresh surface course as can be seen in the center of Figure 6. This was remedied by wiring the lapped ends of the rolls together.

Figure 5. Strip of fabric reinforcement in proper position before placement of surface course; bulging along edge of fabric nearest edge of pavement.

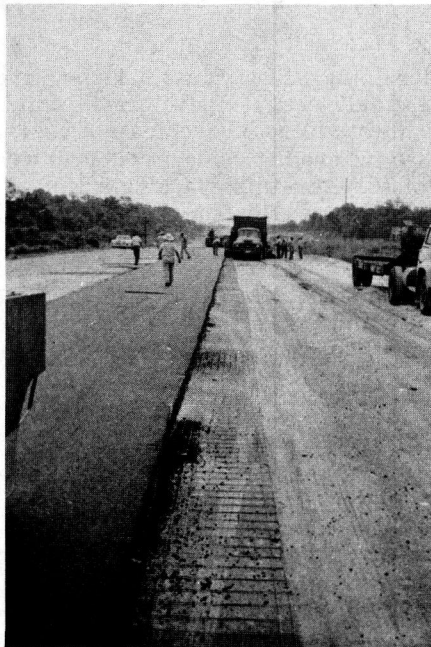
Figure 6. Same strip of fabric (Fig. 5) after surface course has been placed over one-half of it. Practically all bulges have been removed by crimping; evidence of cracking in the fresh surface course seen near exposed fabric in foreground. Note end of strip protruding through the surface course in center of photograph.
