## PROGRESS REPORT ON BRICK ROAD EXPERIMENTS IN OHIO

## SYNOPSIS

DESCRIPTION OF THE FILLERS AND THEIR  
PRESENT CONDITIONS, AFTER  
ONE YEAR'S SERVICE

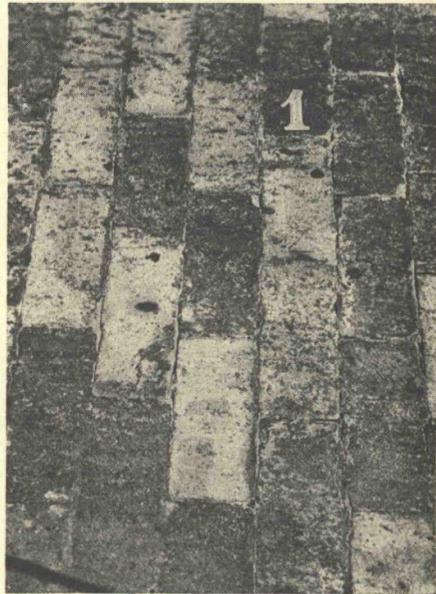
Figure 1. Filler No. 1

brick is badly broken. Although at the present time the section is in serviceable condition, these broken areas are increasing in extent with the result that the test section as a whole is considered unsatisfactory. (Fig. 1)

1: Portland cement grout (one part cement and four parts sand by volume). While most of the section is in a very satisfactory condition, numerous small areas exist in which the bond of grout to

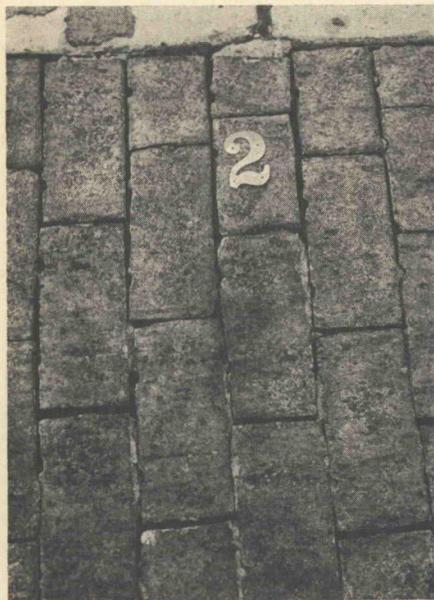
Figure 2. Filler No. 2

2: Bituminized grout (one part portland cement, two parts asphalt emulsion and three parts sand by volume). In this section several large areas exist in which the filler has broken out and is entirely lost. In the remaining area,

the filler top, due to loss, is  $\frac{1}{8}$  to  $\frac{1}{4}$  in. below the brick top. This filler must be considered unsatisfactory. (Fig. 2)

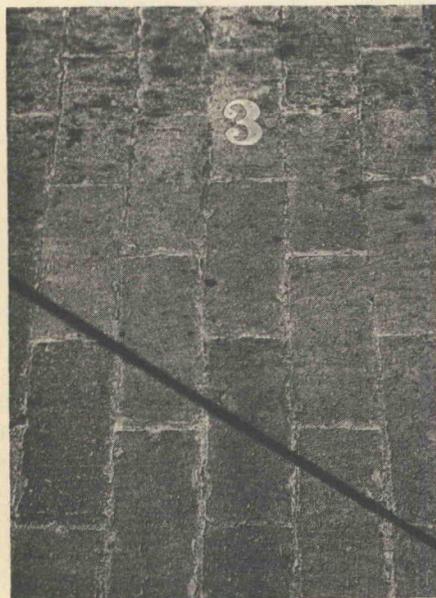
Figure 3. Filler No. 3

3: Plasticized sulfur Type A. This filler is composed of approximately 60 per cent sulfur, 30 per cent of a graded mineral aggregate and 10 per cent plasticizer (Thiokol), and the resulting filler joint resembles hard leather in consistency. With the exception of about 10 per cent of the total area, the section is in excellent condition and seems unchanged by one year's service. The excepted area contains filler which was damaged by overheating in the melting kettle.

Under summer temperatures the damaged filler exuded a small amount of oil

(a product of the breaking down of the Thiokol due to overheating) and the

filler appears lifeless. While this filler must be considered very satisfactory, the success is somewhat limited by the continued presence of an obnoxious odor. (Fig. 3)

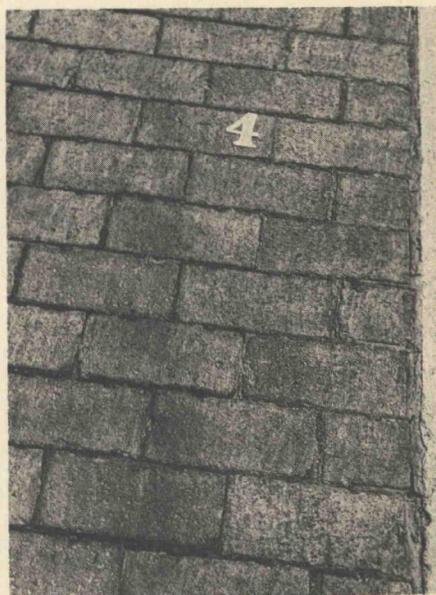
Figure 4. Filler No. 4

4: Plasticized sulfur Type B. This filler is a mixture of approximately 60 per cent asphalt and 40 per cent sulfur. In physical appearance it resembles a straight asphalt filler. The section shows no evidence of either exuding or receding and is considered very satisfactory. (Fig. 4)

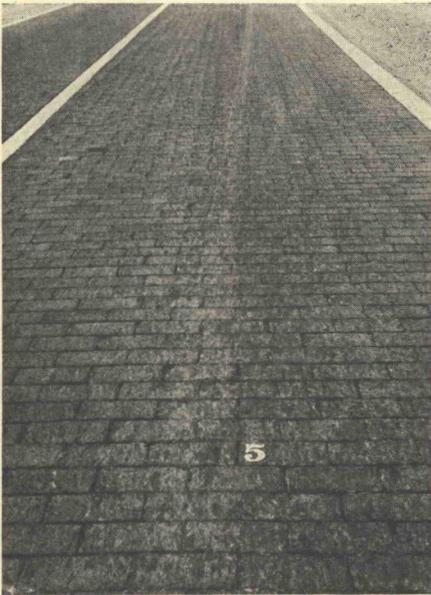
Figure 5. Filler No. 5

5: A mineral-filled blended asphalt of the low temperature susceptibility type, the asphalt being 65 per cent mid-continent base and 35 per cent asphaltic base to which is added about 25 per cent finely divided mineral matter. The filler shows no evidence of receding and little or no evidence of exuding, and the section is considered very satisfactory. (Fig. 5)

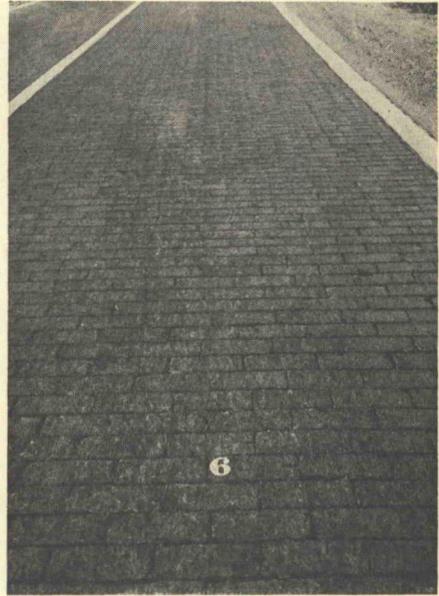
Figure 6. Filler No. 6

6: A blended asphalt very similar to No. 5 but with no added mineral matter. The condition of the section is identical

with that of Filler No. 5 and is very satisfactory. (Fig. 6)

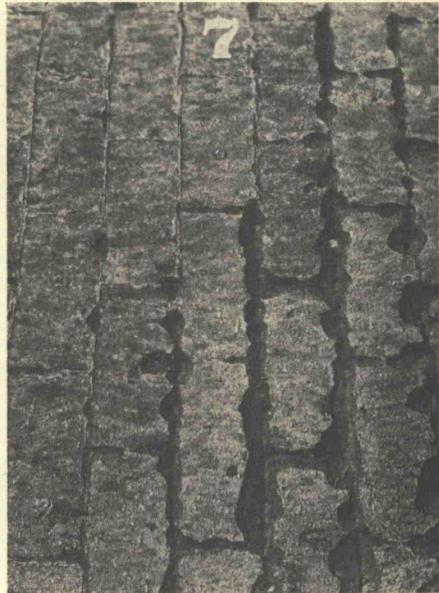
Figure 7. Filler No. 7

7: A mastic filler consisting of 60 per cent Ohio Highway Asphalt Filler F-1 and 40 per cent of 30 to 100 mesh sand, by volume. During construction of this section it was possible to keep the constituents perfectly mixed. Further evidence of this lack of homogeneity is now shown by the spotty exuding. Exuding is heavy in areas in which the asphalt content is too large while no exuding has

occurred in the high-sand areas. Unless some means can be devised to prevent segregation, this mastic must be considered unsatisfactory. (Fig. 7)

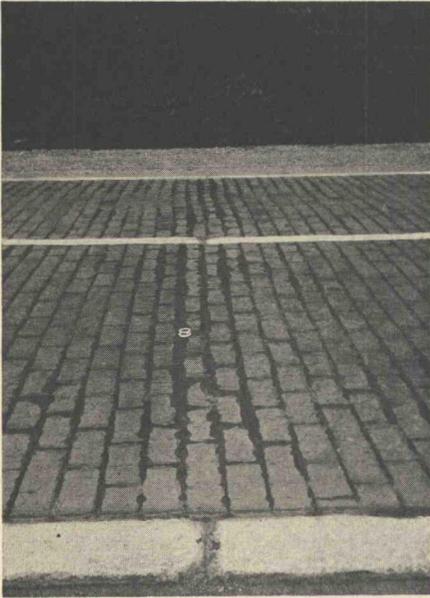
Figure 8. Filler No. 8

contraction joints the filler has exuded heavily but somewhat less than in Sec-

8: Ohio Highway Asphalt Filler F-1, in this case with the brick laid on mastic cushion. In the areas between the base

tion 8A where the bricks are laid on sand cushion. Directly over the base con-

traction joints, however, the exuding is markedly greater. (Fig. 8)

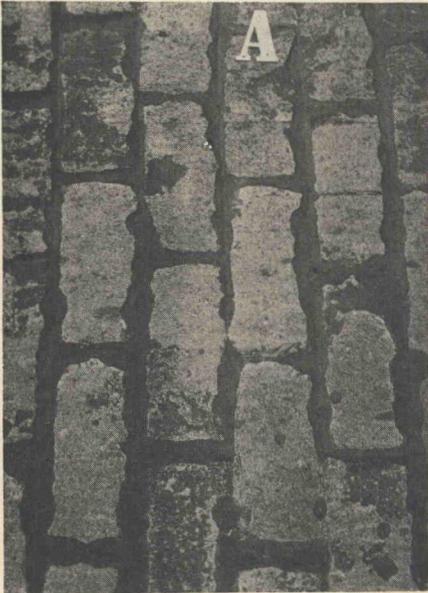
Figure 8A. Filler No. 8A

8A: Ohio Highway Asphalt Filler F-1 on sand cushion. This asphalt filler has a softening point of not less than 75°C and is from a mid-continent base crude. Over the entire section the filler has exuded heavily. (Fig. 8A)

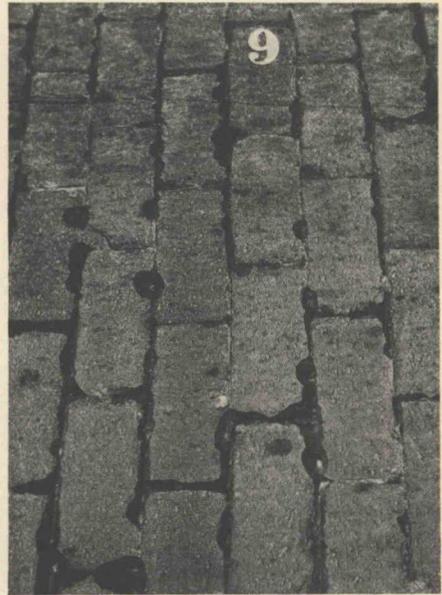
Figure 9. Filler No. 9

9: This asphalt filler meets the same specifications as Filler 8 but is from a 100

per cent asphaltic base crude. Exuding in this section might be designated as medium and is not equal to that exhibited by No. 8. (Fig. 9)

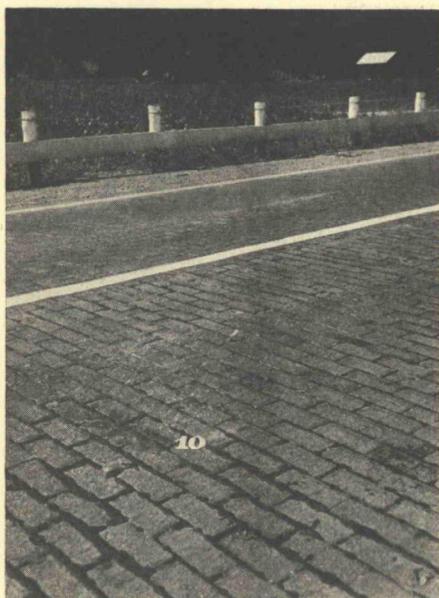
Figure 10. Filler No. 10

10: This asphalt has a softening point of 85° to 96°C and is from a mid-continent base crude. Exuding in this case might be designated as moderately heavy but not uniform. (Fig. 10)

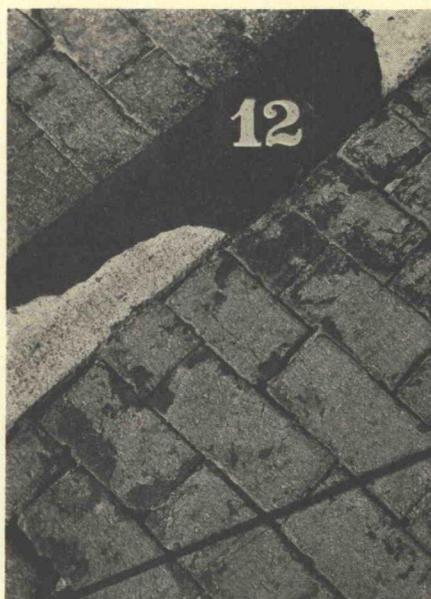
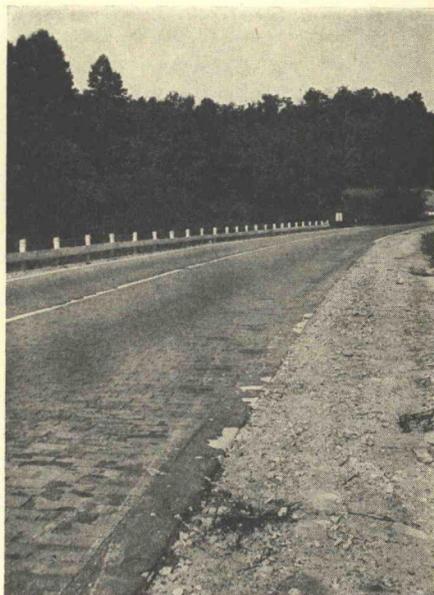
12: Natural Lake Asphalt. The filler is very soft at summer temperatures. On that part of the section which is super-elevated, the filler has flowed from the high curb (leaving joints depressed  $\frac{1}{2}$  to  $1\frac{1}{2}$  in.) to the low curb which in extreme cases is covered with filler. On that part of the section which is level, the joints are uniformly depressed  $\frac{1}{4}$  to  $\frac{1}{2}$  in. This filler must be considered unsatisfactory. (Figs. 12 and 12A)

has been sufficient to show that, in their present form, the two grout fillers, the Natural Lake Asphalt and the asbestos filled pitch are not satisfactory, and they will be removed from the test road as a maintenance step. The Ohio State Highway Department, basing their selection on satisfactory behavior in the test road for one year, have designated Fillers 4, 5, 6 and 16 for more extended use and further trial in brick pavement projects.

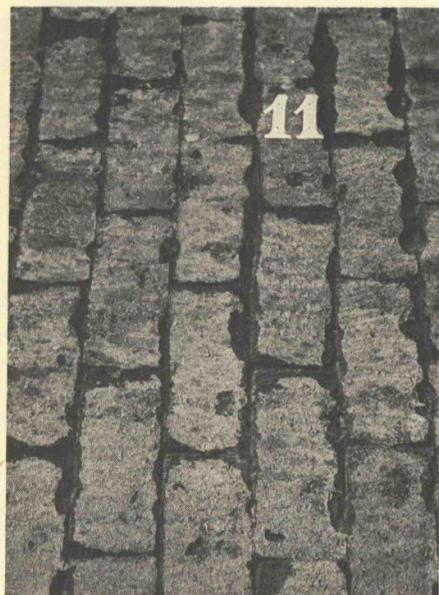
Figure 11. Filler No. 11

11: This asphalt filler meets the same specifications as Filler No. 10 but is from a 100 per cent asphaltic base crude.

Exuding in this case might be designated as moderately heavy, being similar in amount to that of No. 10. (Fig. 11)

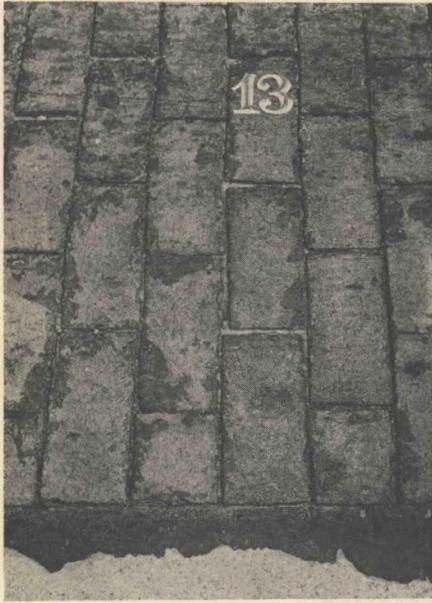
Figure 13. Filler No. 13

13: A special pitch filler of softening point 45° to 50°C and containing 5 per

cent asbestos. During construction of this section, poor filling and removal were obtained due to softness of the filler.

After one year's service the filler shows a tendency to creep onto the side curbs. Joints are uniformly depressed about  $\frac{1}{2}$  in. This filler must be considered unsatisfactory. (Fig. 13)

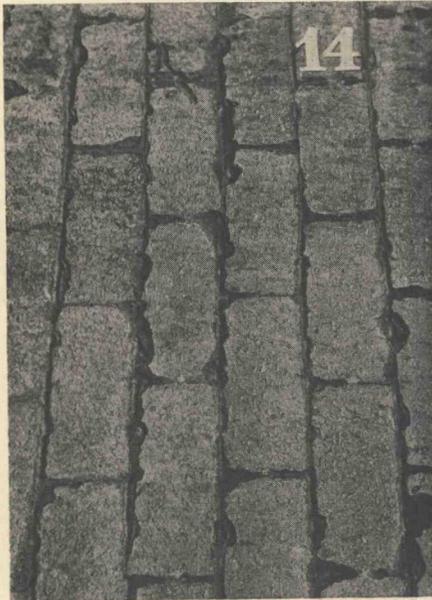
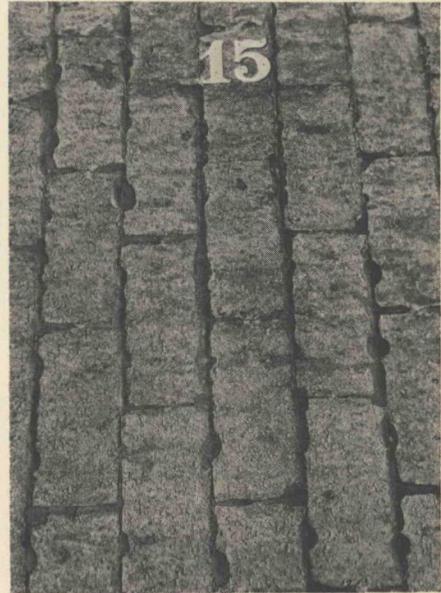
Numbers 14 and 15: Pitch fillers, one designated as a brick filler and one a crack and joint filler. Both exhibit exuding of medium to heavy degree. (Figs. 14 and 15)

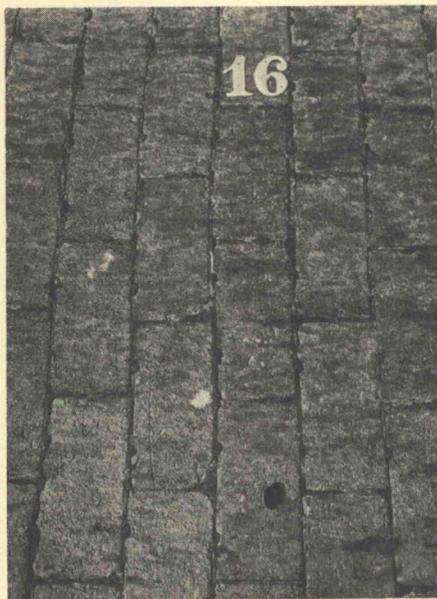
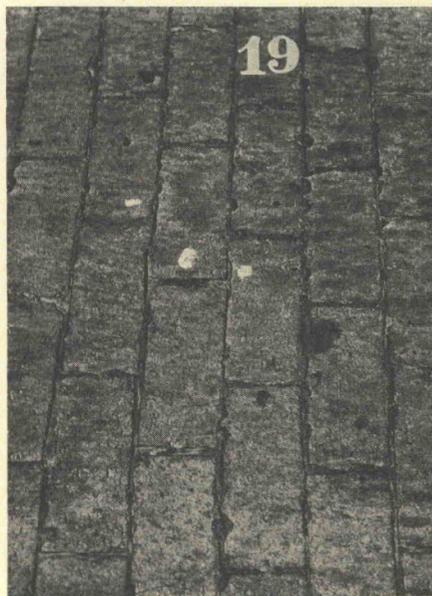
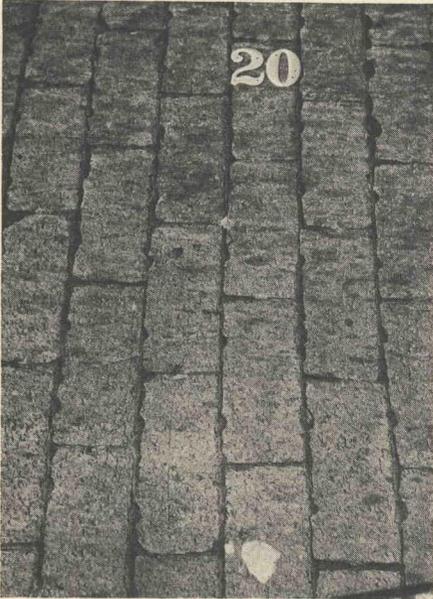
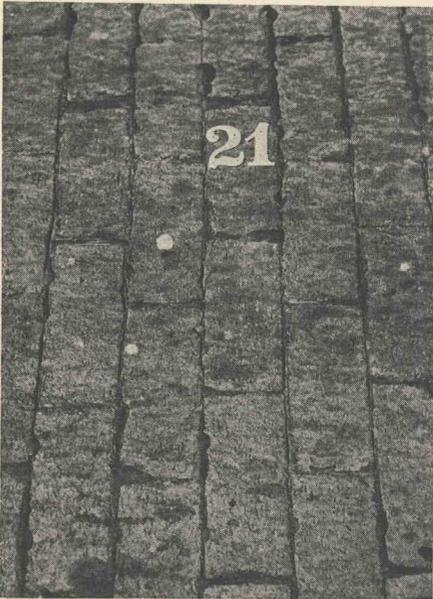
pitch fillers and, while the last three named have exuded to a light or medium

Fillers 16, 19, 20 and 21: These are all

degree, No. 16 is practically free from exuding and its section is in excellent condition. (Figs. 16, 19, 20, 21)

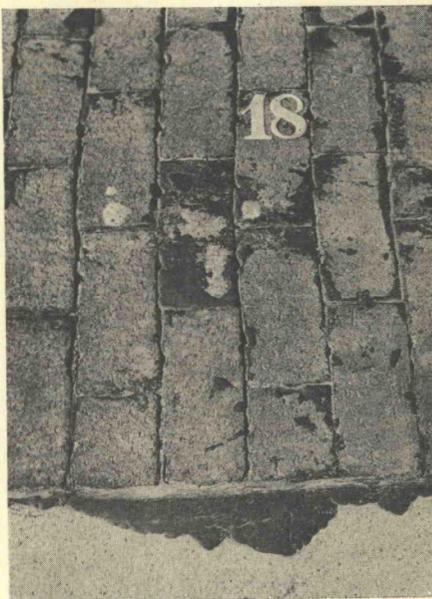
Figure 18. Filler No. 18

18: An asphalt filler containing about

38 per cent slate flour. The filler has receded in the joints and has some

tendency to flow to the low side of the pavement. (Fig. 18)

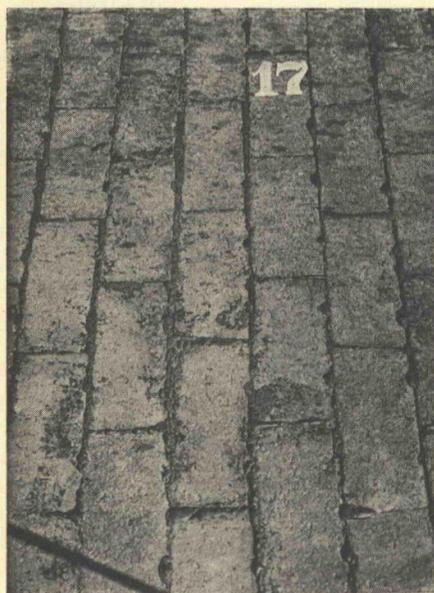
Figure 17. Filler No. 17

17: A very hard pitch filler. Areas in which a slight movement of the brick is possible, such as that adjoining the first sponge rubber expansion joint of the cement grout section, have exuded heavily. There is also some slight evidence of filler breaking out probably due to brittleness in cold weather. In general, however, the filler has not exuded. (Fig. 17)

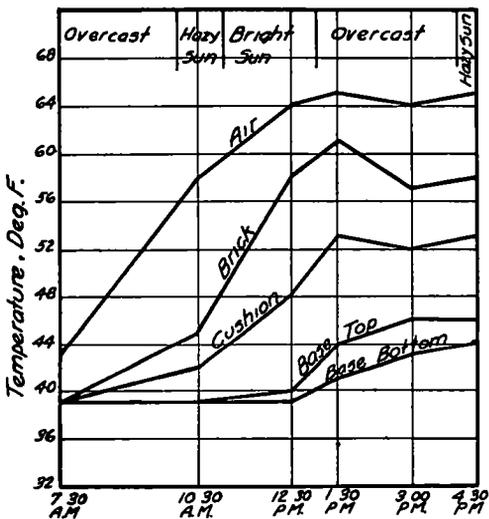
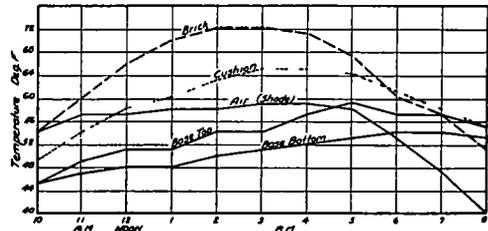
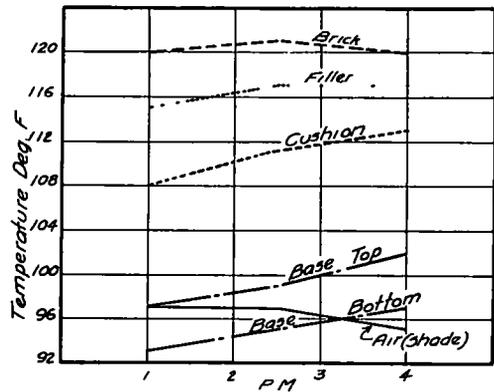
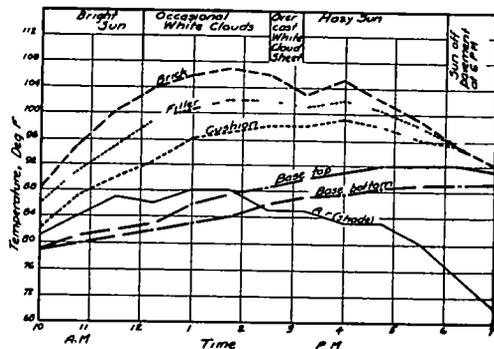
During construction of this filler test road seventeen thermocouples were permanently installed in the sub-grade and over the pavement cross section (locations shown on Figure 23). Readings taken over the past year (see Figs. 24-27) revealed the following:

1. The brick surface course temperature was very sensitive to changes of air temperatures and to sun rays. In one instance (July 13), under the influence of bright sun, the brick temperature ( $121^{\circ}\text{F}$ ) exceeded the air temperature ( $97^{\circ}\text{F}$ ) by  $24^{\circ}\text{F}$ . This rather closely verified the previously estimated figure of  $130^{\circ}\text{F}$

2 Temperature fluctuations of the brick surface course were transmitted to the concrete base slowly and in lesser degree

3 The temperature of the cushion was a mean of the brick and base temperatures

4 Over the one-year period the range of the sub-grade 30 in below the pavement extended from a minimum temperature of 28°F to a maximum temperature of 82°F, this range being expanded for the lesser depths
