# REPORT OF DEPARTMENT OF MATERIALS AND CONSTRUCTION

## REPORT OF COMMITTEE ON FILLERS AND CUSHION COURSES FOR BRICK AND BLOCK PAVEMENTS

J. S. CRANDELL, *Chairman*

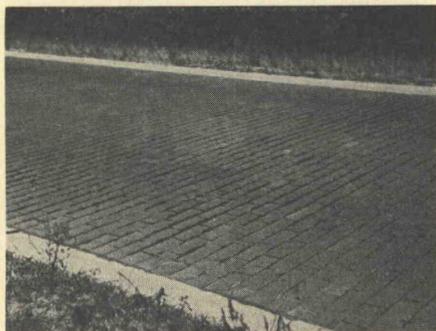
If a joint was built in the concrete base, very pronounced exudation of filler is apparent.

Figure 1. Typical View Over Base Expansion Joint. Project 26

However, over each base expansion joint there is a heavily exuded area for the full pavement width and extending back some three feet on each side of the joint (Figs. 1 and 2).

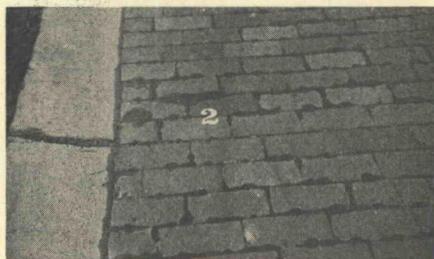
Figure 2. Typical Closeup Over Base Joint. Project 26

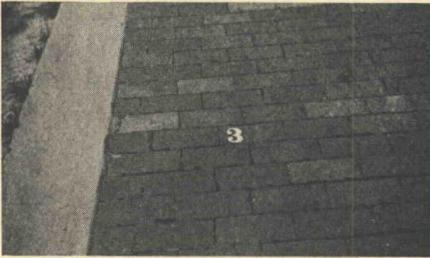
In general the exuding of filler is very

Figure 3. Typical Closeup Between Base Joints. Project 26

light (Fig. 3). In fact some areas appear almost as good as the Robertson section of the Hocking County Filler Test Road.

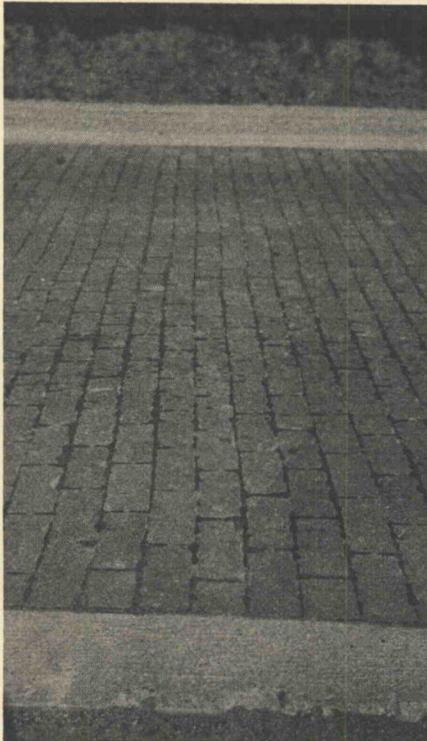
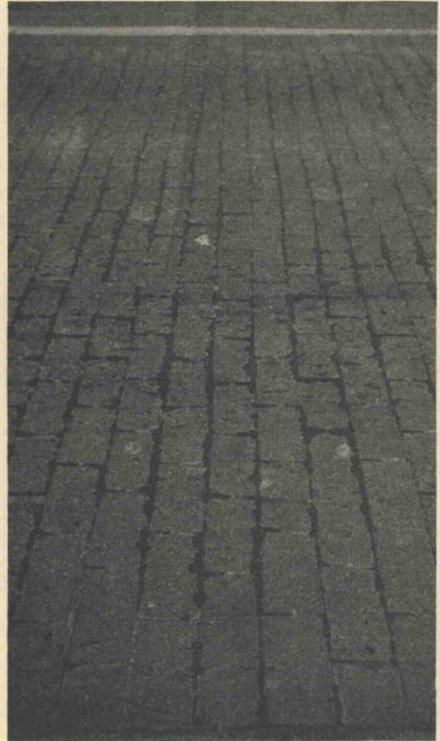
Figure 4. Project 41

and one depot entrance. Bricks are shattered badly in the center of each traffic lane; lug marks on the berms parallel to and two or three feet from each curb indicate that passage of tractors is common. Bricks have settled badly over the base contraction joints.

Filler exudation varies from very light

to medium and a mottling of light and medium (Fig. 4).

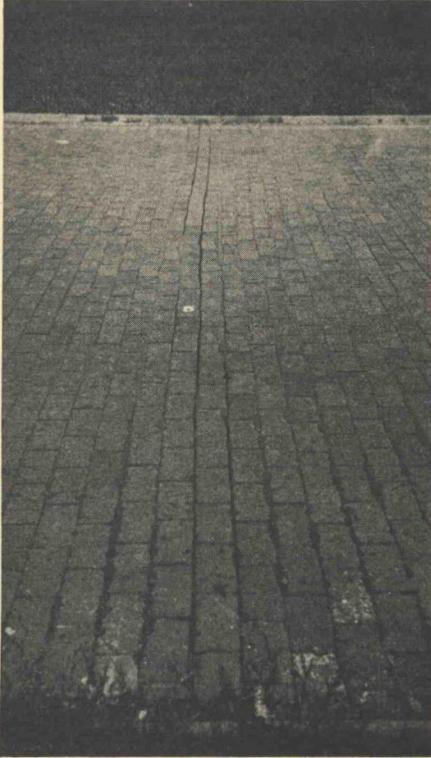
Figure 5. Typical View Over Base Joint.  
Project 42

Over each transverse base contraction joint is an area mottled with medium filler exudation (Figs. 5 and 7), each area being full pavement width and approximately five ft. long. Otherwise, the

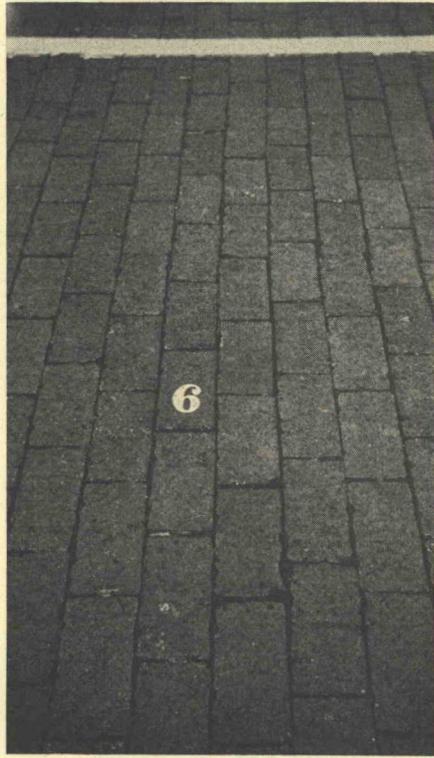
entire pavement exhibits a uniform light exudation of filler (Figs. 6 and 8).

Figure 6. Typical Closeup Between Joints.  
Project 42

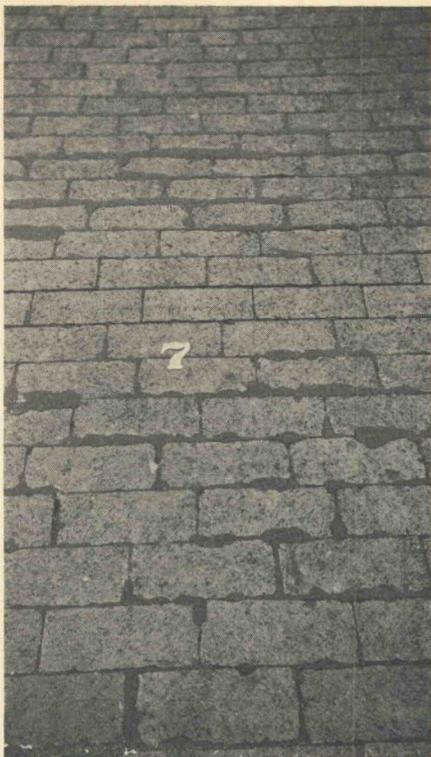
Figure 7. Typical Closeup Over Base Joint.  
Project 42

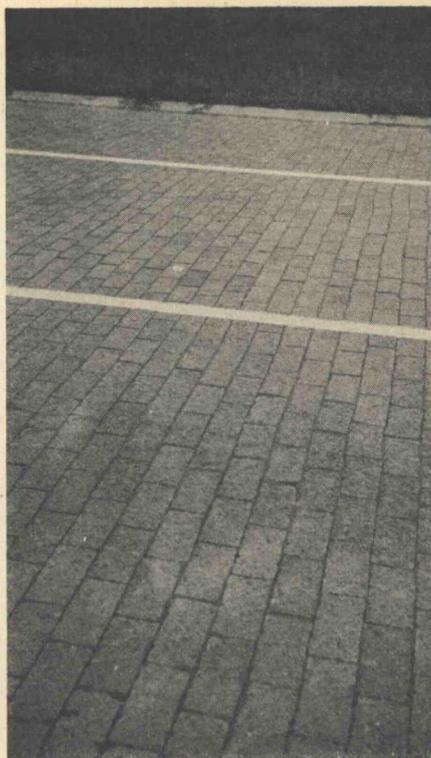
Figure 8. Typical View Between Joints.  
Project 42

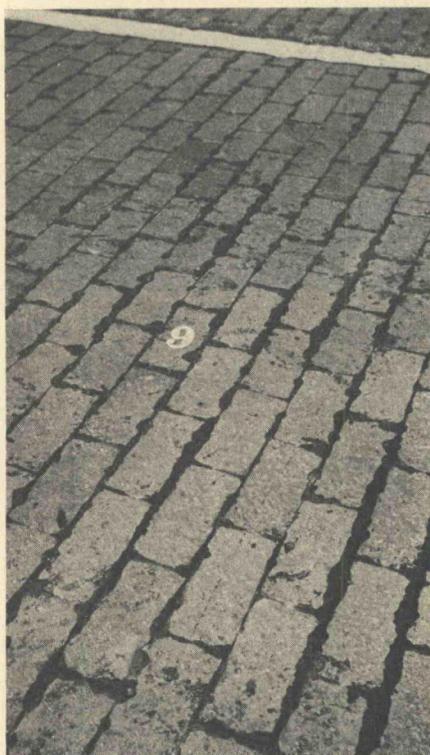
Figure 9. Project 20

Filler exudation on the north lane varies from medium (Fig. 9) to heavy

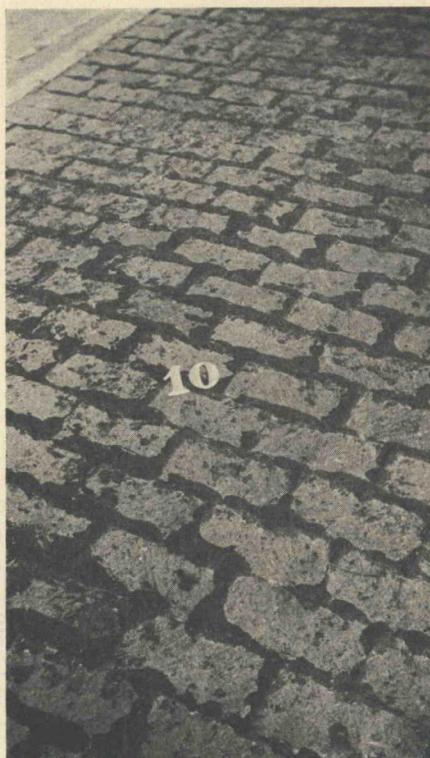
Figure 10. Project 20

(Fig 10) over the entire pavement length Filler exudation on the center lane is light but the surface had not been well cleaned Filler exudation on the south lane is light (Fig 11) except for a short length near each end of the pavement where exudation is medium

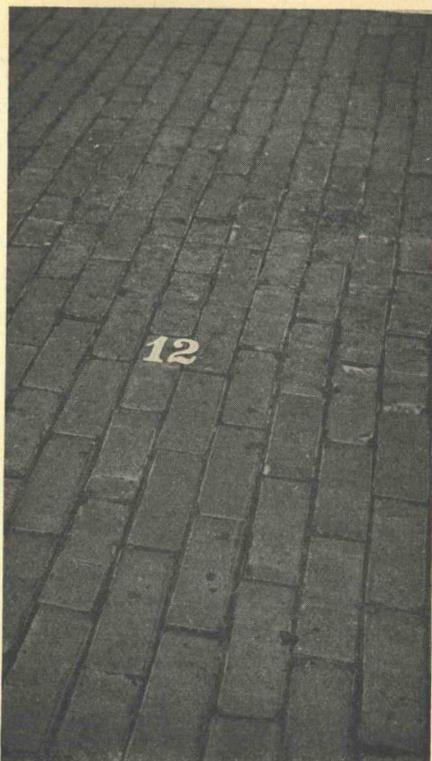
Figure 12. Project 24

Filler exudation is very light on the relaid part (Fig 12) and exudation is not exaggerated over the base joints In general filler exudation on the new brick part is light (Fig 14) and, of all projects inspected, most nearly equals in appearance the Robertson section of the Hocking County Filler Test Road However, over each base contraction joint medium exudation exists for an area of full pavement width and five foot length (Fig 13)
