THE PREPARATION OF NATURAL SOIL FOUNDATIONS AND SOIL SUBSTRUCTURES

BY HENRY C. PORTER

Engineer of Research, Texas State Highway Department

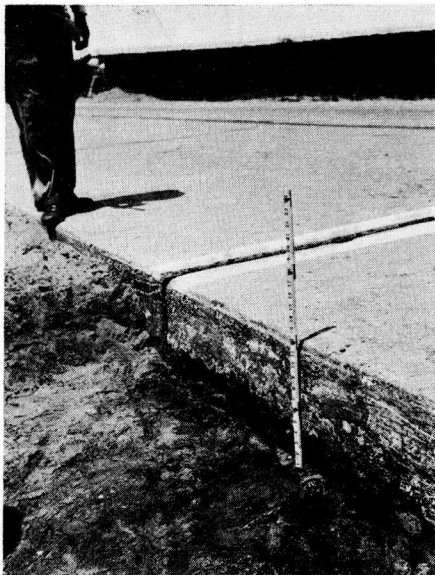
laid than was the soil on Project "A." Figure 3 shows the expansion joint between the two projects. There are no dowel bars in this joint.

During an unusually long period of dry weather in the summer of 1934, the pavement on Project "A" subsided as much as $2\frac{1}{2}$ in. more than did the pavement on Project "B."

Figure 3. Expansion Joint between the North End of Project A, Shown in the Fore-ground, and the South End of Project B, in the Background.

The uneven joint between the two sections was built up with bituminous material to prevent a traffic hazard. After the following winter rains it was noted that these slab-ends were gradually returning to equal elevations. By the end of the spring rains there was practically no difference in the elevations of the pavement on each side of the expansion joint.

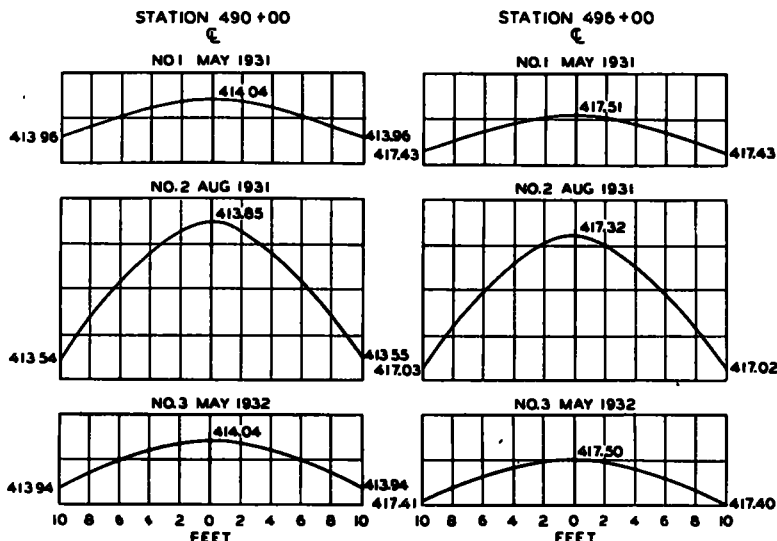
Figure 6. Cross-sections

sectional movements often occur due to a variation of the moisture content of the soil under the center line and under the edges of the pavement. Data taken on Project "A" illustrate these movements, as shown in Figure 6.

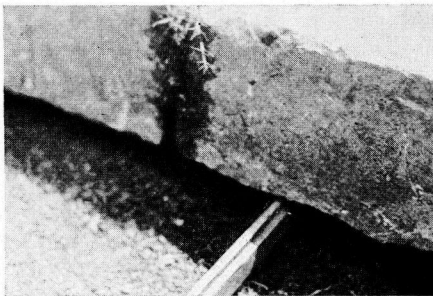
tiated by other observations and data. Figure 7 shows a picture taken in 1937 during an unusually dry period of weather on a project in a different part

Figure 7. A 2½-in. Rod Extending 5 ft. under the Pavement

In order to overcome this mechanical defect, the roadway shoulders should be constructed so as to maintain, as nearly as practicable the moisture content and volume that existed in the natural soil foundation and soil substructure at the time of the laying of the pavement as will be discussed hereafter.

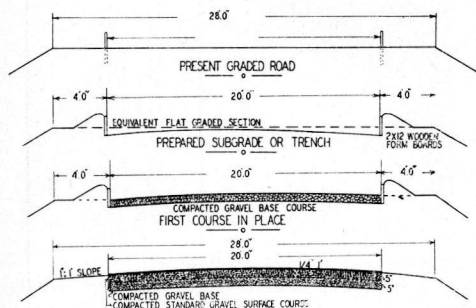
Figure 8 shows the cross-section plans of a section of highway which called for coarse grained base material (crushed gravel conglomerate) to be placed in a trench cut in the top of impervious, highly expansive, and plastic clay soil.

Figure 8. Typical Cross-section of Plan Specifying Coarse-grained Material Placed in a Trench Cut in a Crown of Clay Soil.

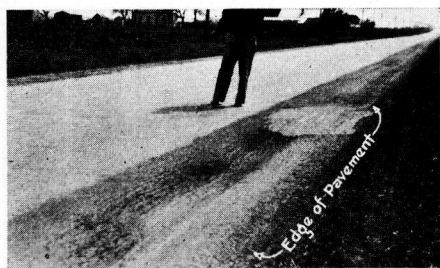
Figure 9. Showing Failures and Patching along the Edges of a Pavement Where the Crushed Conglomerate Base Material Was Placed in a Trench Cut in the Tight Clay Soil.

Figure 9 is a typical view of this highway taken in 1935, approximately five years after its completion, and gives an idea of the large number of failures that developed in the riding surface. Figure 10 shows impounded rain water along the edges of the base material. The line of least resistance to the flow of this water is into the large voids in the base material. The water is impounded on the underlying clay soil until it eventually

penetrates it enough to cause it to become plastic and move appreciably under traffic loads.

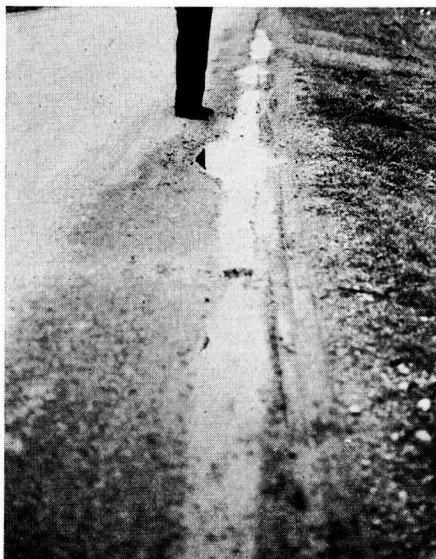
Figure 10. Showing Rain Water Accumulated in a Rut in the Shoulder Soil at Edge of Pavement. When this water first accumulated, the line of least resistance to its movement was into the large voids of the base material.

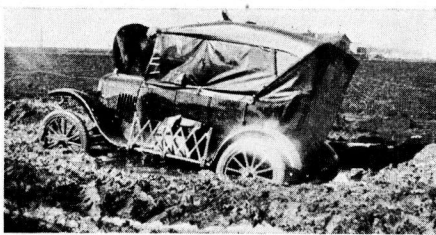
Figure 11. Exaggerated Subsequent Ill Effects of Placing Coarse-grained Material in a Trench Cut in Tight Highly Plastic Clay Soil.

Figure 11 shows the subsequent ill effects of gravel surfacing material placed in a trench cut in tight clay soil (without appreciable maintenance). Water was impounded in the gravel in the trench until it finally penetrated the underlying highly expansive and plastic clay soil.

Traffic pushed the gravel down into the soft clay and the clay came to the surface. At the time this picture was taken (1923) no gravel could be found at the surface of the roadway.

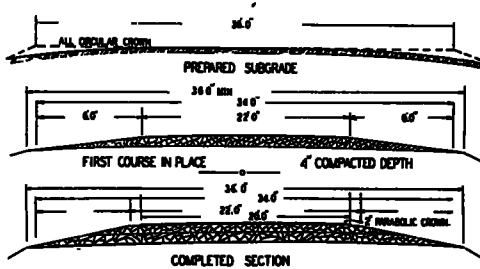
Figure 12. Typical Cross-section of Crowned Clay Soil with Coarse-grained Material Placed as a Blanket Entirely Across the Crown.

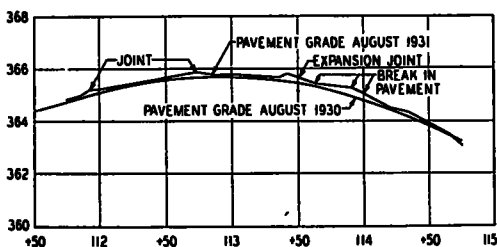
in 1930, as is illustrated in Figures 16 and 17. Figure 16 shows the profile of one section of this pavement at the time it was completed in August, 1930, in comparison with its profile one year later. The season at the time pavement was laid was very dry. The top of the soil was supposed to have been wetted to a

Figure 16. Sketch Showing Changes in Pavement Grade. This section of pavement, poured during the dry summer of 1930 is located at the crest of a small hill. The pavement was placed on a comparatively dry subgrade with the surface wet approximately 10 to 12 in. There was a large amount of rain during the following fall and winter, at which time surface irregularities developed.

depth of 10 to 12 in. During the following winter there was a great deal of rain and the pavement rose throughout its entire length, more so at the expansion joints than elsewhere. The soil did not contain so much moisture when the pavement was laid as it attained eventually.

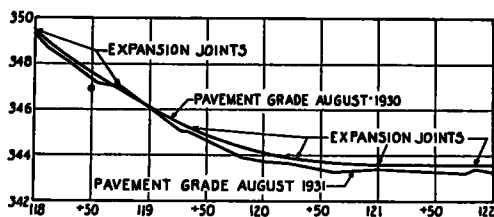
Figure 17. Sketch Showing Change in Pavement Grade. This pavement was constructed on subgrade that was ponded and jetted about 3 weeks prior to paving.

on an embankment of the same type of highly expansive clay soil as that of Figure 16. The embankment on this section was jetted and ponded with water three weeks prior to laying pavement. In one year's time enough of the excess moisture was lost from the soil to cause it to shrink in volume and lower appreciably the elevation of the pavement, as shown by the two profiles in Figure 17. It is noted that the pavement

did not subside so much at the expansion joints where the moisture perhaps was replenished by leakage of rain water from time to time, as elsewhere. In this instance the soil was wetted and expanded prior to laying pavement to a higher degree than it would hold under normal weather.

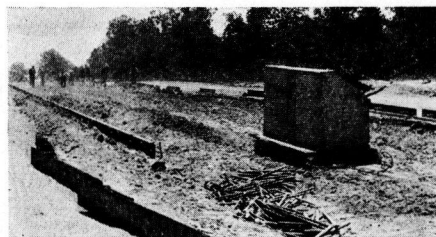
Figure 21. Effect of Setting Side Forms for Pavement so That the Wetted Excess Soil between the Side Forms Could Be Excavated to the Proper Subgrade Elevation without Appreciably Disturbing the Underlying Soil.

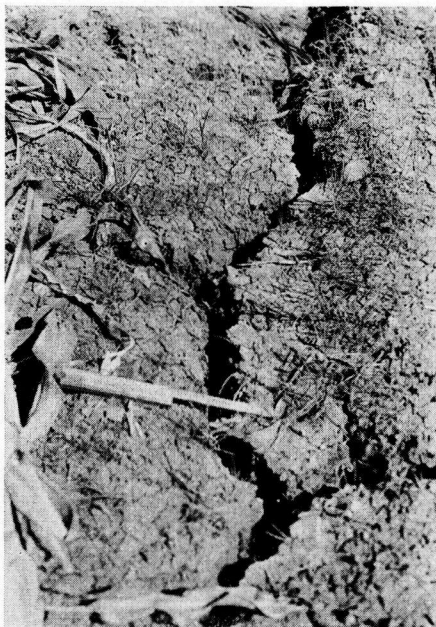
Figure 23 shows large cracks that formed during dry weather in a corn field that had not been plowed for several weeks. Figure 24 shows mulched topsoil in an adjoining cotton field only

Figure 23. Large Cracks in a Corn Field Which Allow Dry Winds and Sun to Rob the Subsoil of Its Moisture.

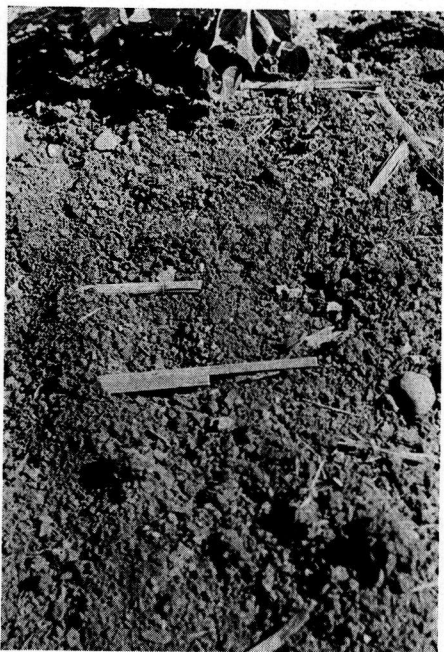
Figure 24. Showing Mulched Top Soil That Covered the Ground Cracks and Retarded the Loss of Subsoil Moisture to Dry Winds.

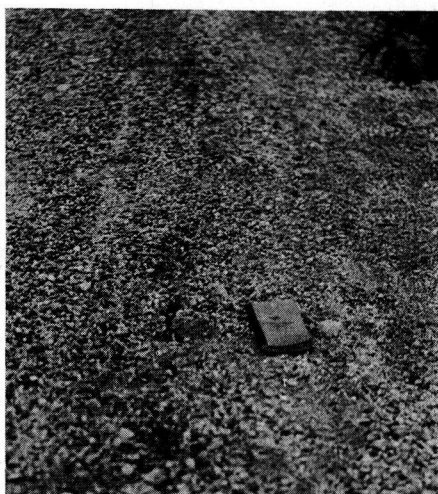
tory service. The natural soil-foundation and soil-substructure of the project shown in Figure 12 is highly expansive and plastic black waxy clay. Figure 25 shows the largest shoulder crack that has ever been found on this project.

In this case because the top of the clay soil-substructure was made to slope from the centerline and the pervious crushed stone was placed entirely across the crown to intersections with the roadway sideslopes, no large amounts of rain water

Figure 25. The Largest Shoulder Crack That Has Ever Been Found Where the Roadway Shoulders Are of Crushed Stone on Highly Expansive Clay Soil.

have been impounded on the clay eventually to penetrate and appreciably expand it during wet seasons. This, of course, materially decreases the tendency for the soil to shrink and crack during dry weather.
