EFFECT OF EXPERIMENTAL SUBGRADE TREATMENTS ON PAVEMENT FAULTING AND PUMPING

By E. A. HENDERSON, *Graduate Assistant*

Joint Highway Research Project, Purdue University

SYNOPSIS

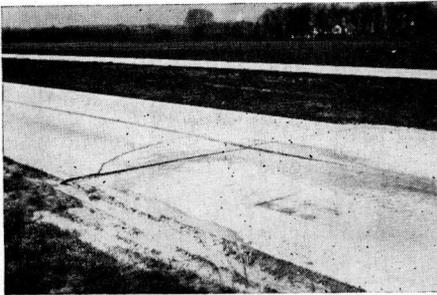
Figure 1. Pavement Pumping, U.S. Highway No. 30. Note mud stains and cracks.

ment due to pumping action; namely, heavy traffic, fine-grained subgrade soils, and wet subgrade conditions. In 1940 pumping action (Fig. 1), which has resulted in a large number of structural failures in the concrete pavement, began.

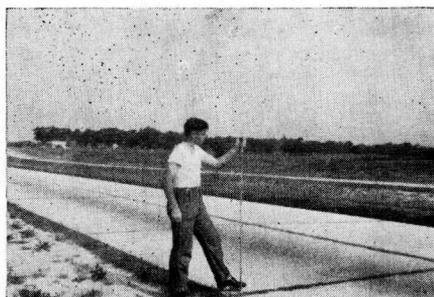
Figure 7. Measurement of Faulting at an Expansion Joint

Readings at an expansion joint were taken at four locations, namely, at both edges of the inner and outer slabs. Considerable variation was found in the amount of faulting at the edges of any one slab. The maximum value was not always at the outside edge as might be expected. Therefore it was decided for the purpose of this report to define the faulting of a slab as the average of the two readings.

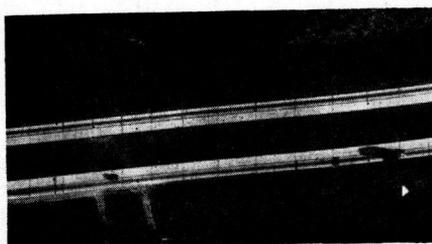
Figure 8. Aerial Strip Map of a Portion of U. S. Highway No. 30 West of the Test Sections. The subgrade soils are silty clay and neither lane has received treatment. The lane at the bottom of the photograph is the eastbound lane.

Figures 8 and 9 are representative views of U. S. 30 in silty clay soil areas where neither lane has received subgrade treatment. They show that there is more cracking in the eastbound than in the westbound lane especially in the area east of the test sections.

Figs. 8 and 9 are representative views of portions of U.S. 30 constructed on silty clay where neither lane has received subgrade treatment. The views illustrate the generally poorer condition of the eastbound lane.

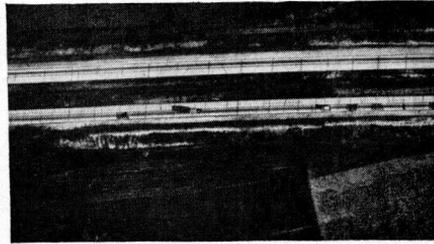
Figure 12. Aerial Strip Map of a Portion of the Test Section with a 12-in. Water Saturated Subgrade Treatment. The eastbound lane, which contains the treatment, is at the bottom of the photograph. The westbound lane is untreated.

saturated subgrade test section appears in far poorer condition than the pavement on the opposite untreated lane. Although the pavement on the test section with the stabilized material base course is in much better condition than the pavement on the opposite untreated lane, it does not appear so in the aerial map because each lane has about the same number of cracks. When viewed directly the
