# TREATMENT OF PUMPING PAVEMENTS WITH CEMENT-SLURRY MIXTURES

By F. H. GREEN, *Research Engineer, Joint Highway Research Project, Purdue University*

This is a report of experimental treatments for correction of pumping pavements on three test sections in Indiana, using a mixture of portland cement and calcium aluminate cement as a filling material. The experimental use of a mechanical pavement jack, in connection with the slurry treatments to correct faulted joints, is also reported. Cost records were maintained on most of this work.

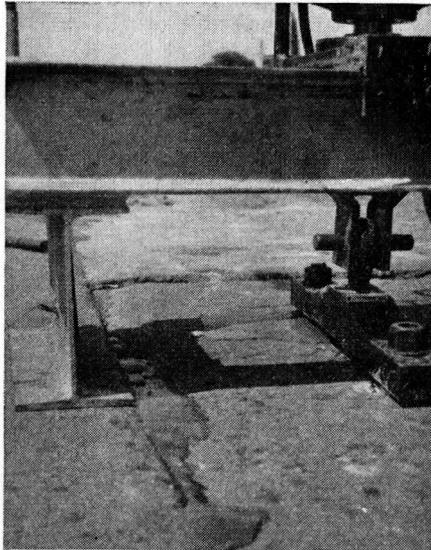
Figure 5. Slurry Flowing from Lifted Joint During Treatment Operation

When it is decided that a faulted joint is to be re-aligned before the treating material is placed, the pavement jack is used. The expansion anchors are placed in the 2-in. holes, and connected to the cross-bar extending between the two holes. The jack frame is then placed over the lower slab, with one end supported by the higher slab immediately adjacent to the joint, and the lower end supported by the pavement at a point 10 ft. ahead of the joint. The hydraulic jack, which rests upon the frame, is then fastened to the cross-bar, and the entire assembly is tightened. The hydraulic pump is then operated, and the lower slab is lifted into alignment. Usually a pressure of 10 to 12 tons is sufficient, but occasionally pressures as high as 18 tons have been used. This pressure represents the differential lifting force required to re-align the joint, plus a relatively small force which represents the actual weight of the slab. These large forces indicate the resistance offered by the internal structure of the joint, as the damaged load transfer devices come into play in reversed stresses. (Figs. 4 and 5.)

After the slab has been lifted, the cement slurry is placed in the regular manner. The mud-jack equipment is then moved on to the next joint, and the jack is left in place for 15 min., in order that the slurry can harden sufficiently to support the weight of the slab.

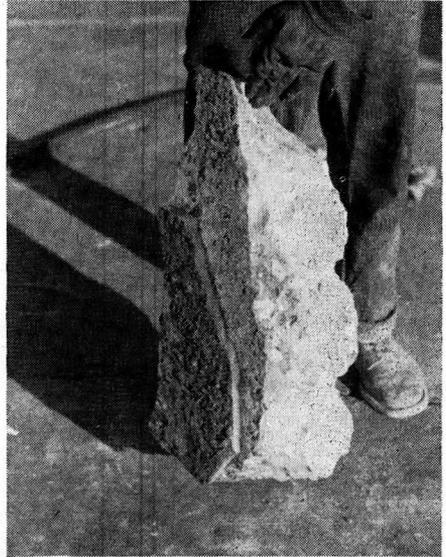
*U S 52, Lafayette By-Pass.* The first joint to be lifted by the pavement jack and treated with cement slurry was faulted 0.75 in. This joint has been subjected to heavy truck traffic for approximately two years, and is now faulted less than  $\frac{1}{8}$  in. Other joints which were faulted approximately 1 in. were lifted and treated in November, 1946. These joints are still in service, and the amount of faulting is negligible. At one of the joints, it was decided that the pavement was so badly broken that it should be removed and replaced by a concrete patch. In order to test the distribution characteristics of the slurry, this joint was treated in the regular manner but without lifting the slabs. The pavement was then removed as a regular repair operation. It was found that the slurry had completely covered the subgrade for a minimum distance of 10 ft. in each direction, and had completely filled the existing void. Although approximately 30 ft. of the pavement lane was removed, it was found that the slurry had been forced under the remaining pavement, extending for some unknown distance at each end of the opening. Near the edges of the area, the mixture had set up in a continuous layer only  $\frac{1}{16}$  to  $\frac{1}{32}$  in. thick. The material was dense, with no evidence of bleeding, and appeared to be structurally sound. (Figs. 6 and 7.)

Figure 6. Cement Slurry Attached to Underneath Side of Slab

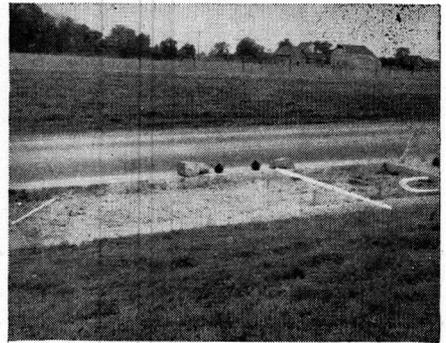
Figure 7. Subgrade After Removal of Pavement at Joint Which had been Previously Treated. White lines at ends show extent of coverage by cement slurry. Joint and locations of holes for treatment are indicated by white line and stakes.
