REPORT ON EXPERIMENT WITH CONTINUOUS REINFORCEMENT IN CONCRETE PAVEMENT—NEW JERSEY

WILLIAM VAN BREEMEN, *Engineer of Special Assignments, Research, New Jersey State Highway Department*

This paper reports the observed behavior and performance of two sections of continuously-reinforced concrete pavement constructed in New Jersey in 1947. These sections, which are each approximately one mile long, carry relatively heavy truck traffic. Some of the significant observations are as follows:

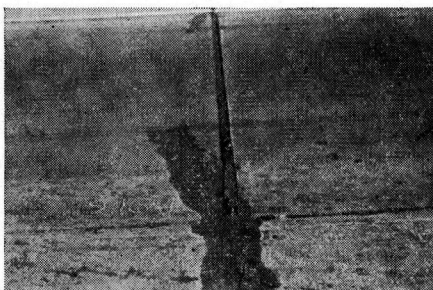
Figure 3

extent this process will continue remains to be seen. Despite these infiltrated conditions there has, however, been no apparent breakage of the concrete at any of the end joints. A picture of the joint at the north end of the outside lane of the 10-in. section, taken Nov. 1950, is shown in Figure 3.

A careful inspection of the end joints has disclosed that this displacement is due principally to the infiltration of large amounts of incompressible sandy materials into the end joints. In view of the large amounts that these joints open during cold weather, such infiltration is practically unpreventable. These materials have, in turn, resulted in the compression of the filler to the point where it resists any further compression, at least at some of the joints. This combination of infiltrated materials and compressed filler has naturally prevented the normal closure of the end joints during warm weather, with the result that the adjacent slabs have been pushed outward to new locations. To what

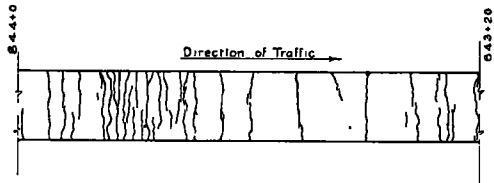
Figure 4. Crack Pattern—8-in. Section—Inside Lane—Nov. 1950.

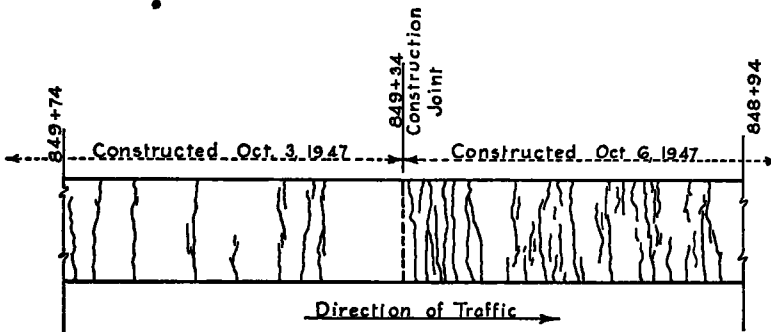
Figure 6. Crack Pattern—8-in. Section—Outside Lane—Nov. 1950

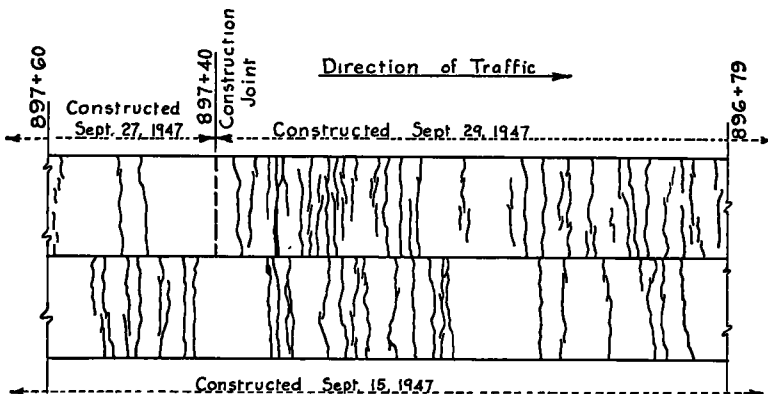
Figure 7. Crack Pattern—10-in. Section—Nov. 1950

pavement at this joint is shown in Figures 14 and 15, the cracks having been delineated by yellow keel. Figure 15 shows in greater detail the cracks just north of the joint, considerable ravelling being in evidence. The results of a detailed crack survey extending for 40 ft. on each side of this joint are shown in Figure 6. As will be noted, there is a very much closer spacing of the cracks on the north side. This crack pattern is typical of the cracking adjacent to a number of other construction joints, as will also be noted in Figure 7.

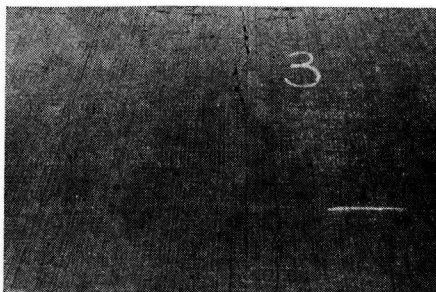
Figure 12

Typical spalled cracks are shown in Figures 12 and 13. Of particular interest and significance is the crack shown in Figure 12, which is typical of many other cracks. It will be noted that at certain points this crack becomes divided into two cracks which form small islands. In the course of time, especially under the action of heavy traffic, these islands tend to shatter and become dislodged, leaving holes in the surface. The extent to which this form of deterioration will progress remains

unknown—but the indications are that it will progress. Actually, the division of the cracks in such a way as to form small islands susceptible to being shattered and broken out may constitute one of the most serious objections to this design. Whether or not this is preventable by the installation of a larger amount of steel, or steel of a different design, is not known.

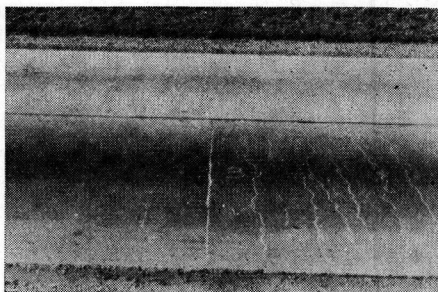
Figure 14

Rather serious cracking has, however, occurred in the immediate vicinity of several of these joints, over a distance of from 6 to 10 feet, but only on the northerly side of the joint—the direction of construction being from south to north. The most serious cracking of this kind is adjacent to a joint in the outside lane of the 8-in. section, at 849 + 34, between the pavement laid on Oct. 3 and Oct. 6. The

Of several possible causes, the indications are that this severe form of cracking is due to

in the event of a large drop in temperature. Based on the behavior of these sections, the safer course would appear to be the installation of joints between each day's construction, despite the fact that this would largely defeat the main objective of the design—that is, a completely jointless pavement.

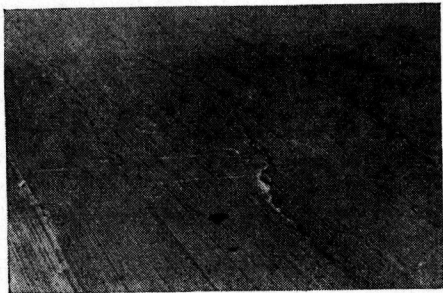
Failed Area—During very early life, rather severe cracking was observed at a point in the outside lane of the 10-inch section, approximately 1425 ft. from the southerly end. This cracking did not appear to become serious until the spring of 1949, at which time there were indications that there might soon be a break-up. Beginning in May 1949, pictures were taken periodically at this location in

Figure 16. May 27, 1949

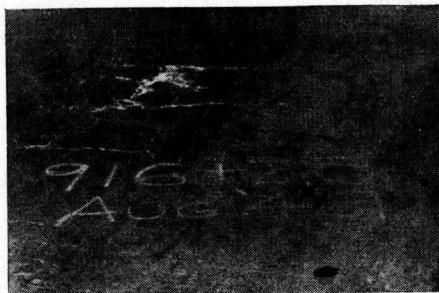
Figure 17. August 16, 1949

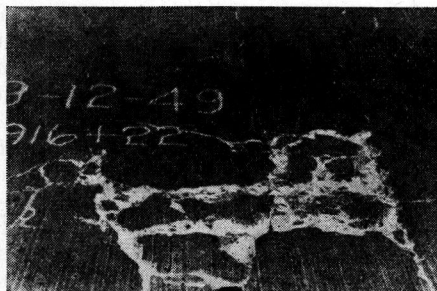
Figure 18. September 12, 1949

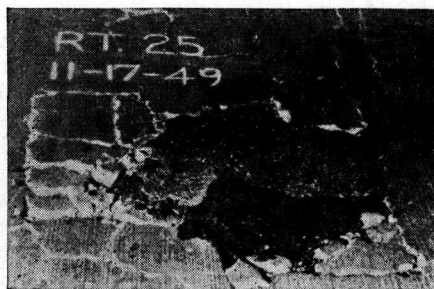
Figure 21. November 17, 1949

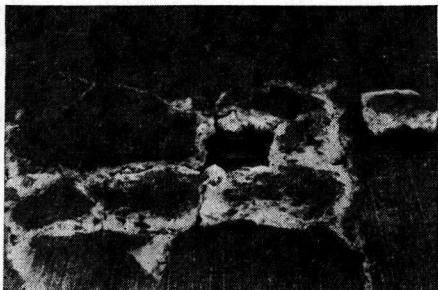
As will be noted in Figure 19, on Sept. 15 the failure had advanced to the point where the upper 3 in. of concrete had become shattered and broken loose from the underlying concrete. On that date the shattered concrete was removed and replaced with cold-patch material. The conditions immediately prior to the placement of the cold-patch are shown in Figure 20. It will be noted that the failed area has progressively increased in size. At present (Dec. 1950) it is approximately 8 ft. square.

Figure 19. September 15, 1949

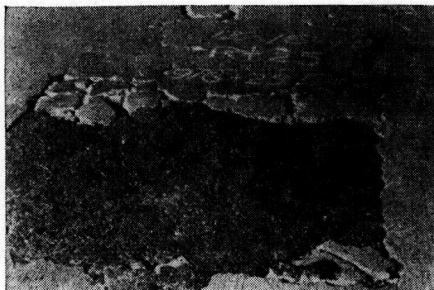
Figure 22. December 16, 1949

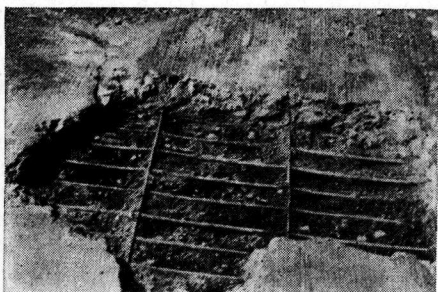
Figure 20. September 15, 1949

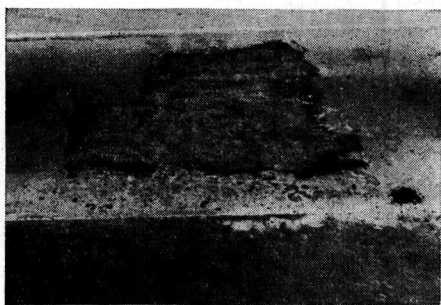
Figure 23. December 7, 1950

cal procedure appears to be the introduction of a joint, in conjunction with the replacement of the shattered concrete with new concrete. The cause of this failure remains obscure. However, the indications are that the concrete at this point is of inferior quality, especially the layer between the upper and lower lines of reinforcing steel. The records kept during construction mention that, when placed, the concrete in this layer, at this particular point, was very "soupy", there being considerable free water on its surface after being struck off. When the upper 3 in. were removed this layer

was found to be soft and spongy. The batch from which it was derived may have been accidentally deficient in cement. There is, however, the possibility that the close spacing (3 in.) of the longitudinal members may have created a plane of separation.

Thus far there does not appear to have been any material pulling-apart of the pavement at this point, but this appears imminent. With this probability in mind, transverse reference lines have been established on each side of the break. Actually, the deterioration has now advanced to the point where major repairs will soon be necessary. The only practi-
