THE PERFORMANCE OF CONCRETE RESURFACING IN INDIANA

D. W. LEWIS, *Research Engineer, Joint Highway Research Project, Purdue University*

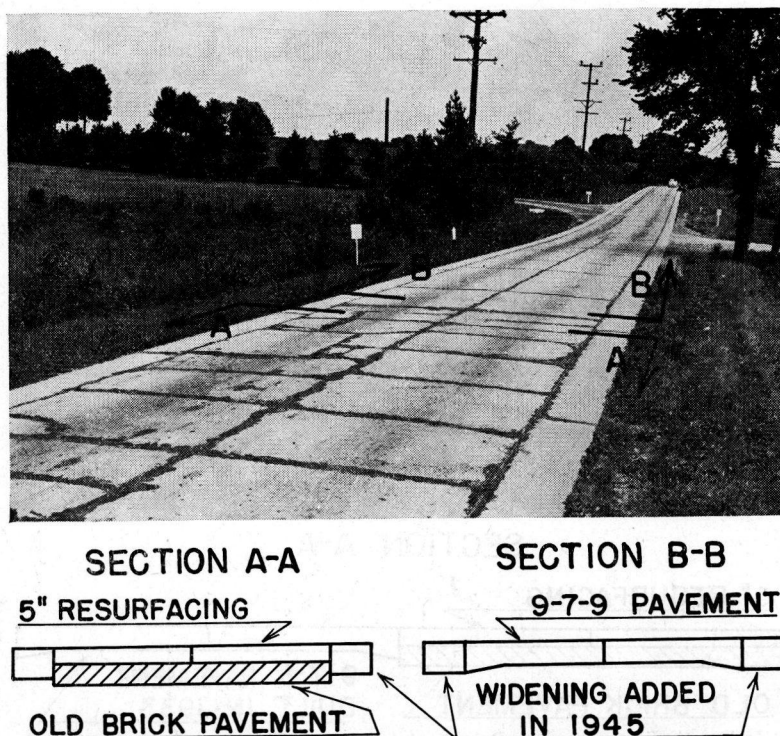
Project 125—S. R. 37, Sec. L
Date Built—1929

125, built in 1929, is shown in Figure 3. Even greater contrast in performance was found in projects 207 and 201 (both 20 years old), where deterioration of the resurfacing was pronounced. In both of these projects, several times as many blowups occurred in the resurfacing as in the full-depth pavement. Project 201 was patched extensively with con-

Figure 3. Contrast in Appearance of Resurfacing and Full-Depth Pavement on a 21-Year Old Project

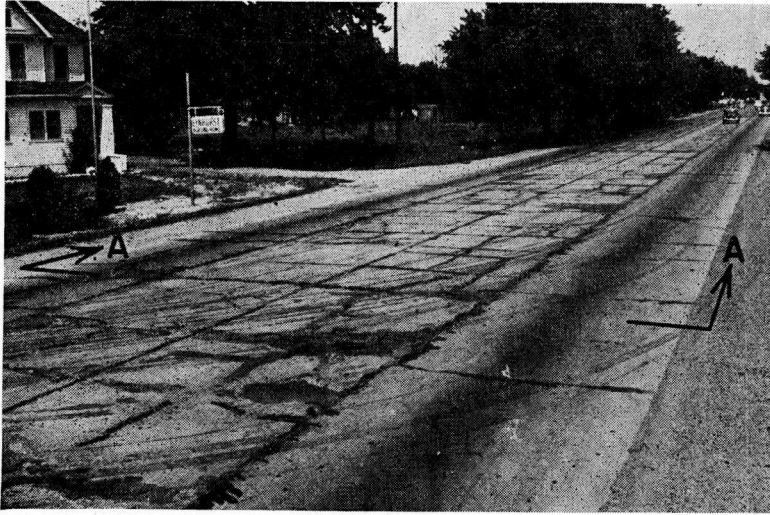
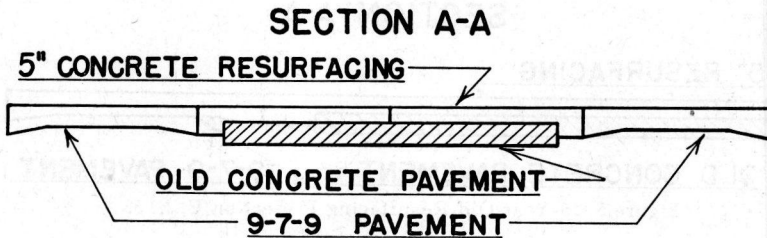
crete and resurfaced with a bituminous mix in 1950. In patching the badly deteriorated areas in the resurfacing, it was found that the old pavement underneath was still sound and it was left in place. A typical view of the four lane portion of this project is shown in Figure 4.

Figure 4. Typical Appearance of Project 201 After 20 Years
Project 201—U. S. 40, Sec. L
Date Built—1930

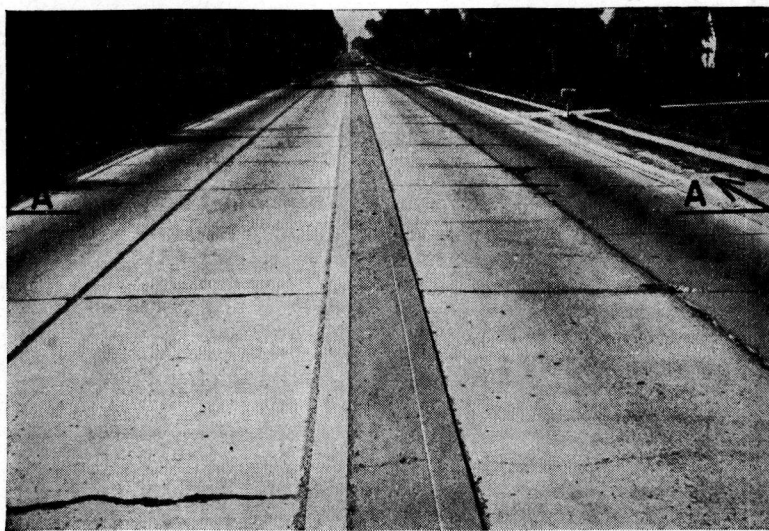
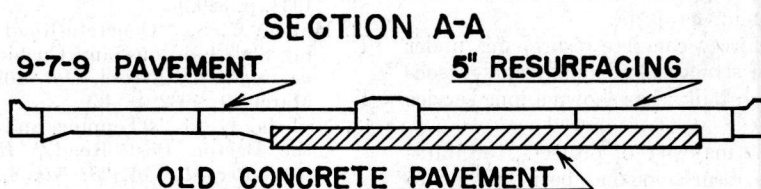
in the concrete resurfacing than in the adjacent full-depth pavement. Figure 6 shows the appearance of one of the projects, FA 13 F, built in 1937. This difference was not as pronounced as in some of the older projects discussed above, probably because of the shorter time of exposure. Considering all of the projects inspected, one-third of those 8 to 14 years old show accelerated deterioration

Figure 6. Typical Appearance of Project FA13F After 13 Years
Project FA13F—U. S. 40, Sec. M
Date Built—1937

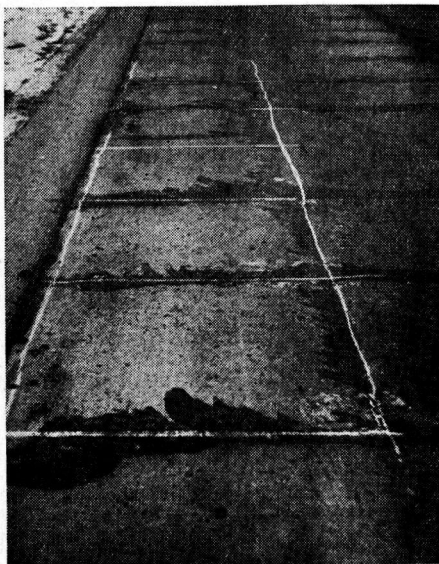
Figure A. Transverse Cracks Over Bar Mat Reinforcing—White lines show planned location of bars. Project 125

Reinforcement.—The four oldest projects, reinforced with bar-mats, have shown unusual transverse and longitudinal cracking. Many of the bars, placed at or near the surface, induced cracking and accelerated ravelling and deterioration. The difference in crack interval between the resurfacing and the full-depth pavement, which had only smooth longitudinal edge bars, is caused by the bar-mats. Severe deterioration at many of these cracks is represented by the unusual number of blow-ups reported. Similar performance was observed by Fleming in California. Figures A and B show the cracking induced by this type of reinforcement in Project 125. Figures C and D illustrate excellent durability in Project FA-61, now 27 years old, where exposure has not been increased.

With regard to the cracking of the early projects in which bar mat reinforcement was used, a major portion of the cracks did form over the bars, resulting in a very short transverse crack interval. However, the relative durability of the resurfacing and full-depth concrete was studied on the basis of the percentage of cracks affected and the severity of the deterioration, and not on the total amount present. It is believed that such a rating method gives a true picture of the relative

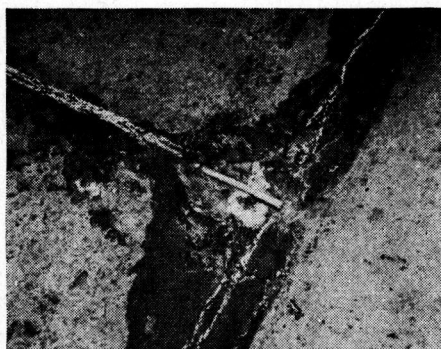
Figure B. Deterioration Around Bar Placed Within $\frac{1}{2}$ in. of Surface—Cracks Over Bonded Edge Bars Shown Next to Pavement Widening—Project 125

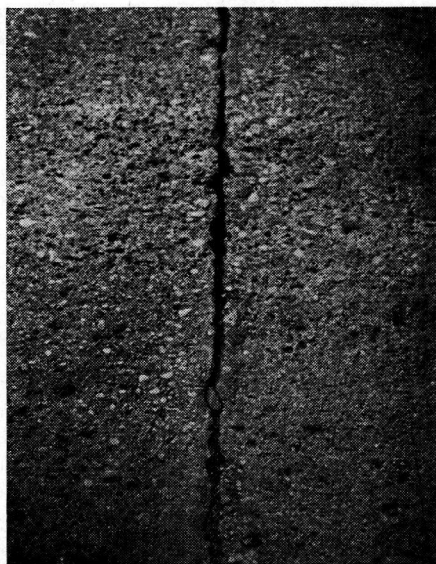
Figure C. Construction Joint in 27-Year Old Resurfacing, Showing Excellent Durability and Freedom from 'D'-Cracks—Project FA-61

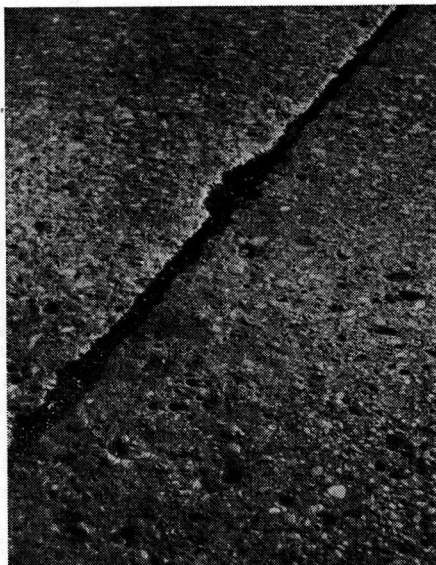
Figure D. Expansion Joint in 27-Year Old Resurfacing—Excellent durability has accompanied freedom from structural defects. Project FA-61

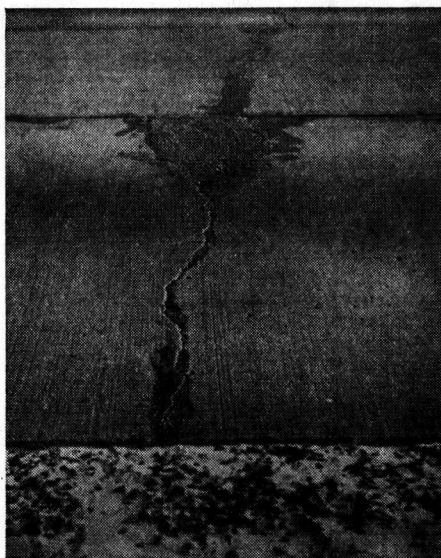
Transverse joints have shown average performance. Exceptions exist, however, in most of the projects constructed in 1935. These have many expansion and contraction joints which are inoperative because of misaligned or frozen dowels. This has resulted in mid-panel cracks with fracture of the mesh reinforcement in both the resurfacing and full-depth pavements. Wide opening of the cracks disengaged aggregate interlock which resulted in severe pumping of the full-depth slabs placed on soil subgrades or additional structural breakage of the weakened resurfacing. Figure E illustrates an open mid-panel tension crack which has caused shattering at the longitudinal joint of a 5-in. resurfacing. Figure F is a

Figure E. Open Mid-Panel Tension Crack, Caused by Frozen Dowels, Which has Created Weakness at the Longitudinal Joint of a Five-Inch Resurfacing—Project NRH 263B, A1

misaligned dowels. This defect is reported as a blow-up, although it is not caused by inferior durability. Damage resulting from misaligned and frozen dowels can be prevented by careful installation of a stable dowel support of the type now generally employed.

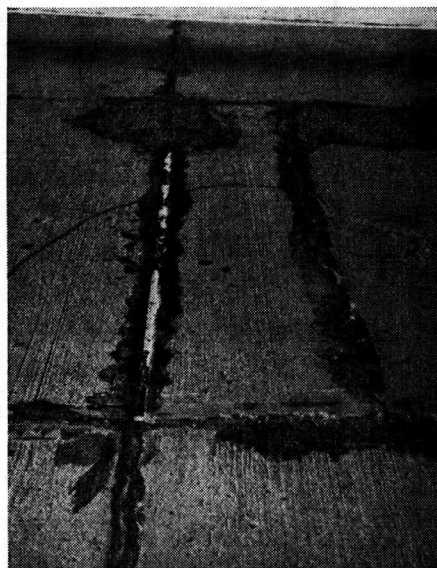
Figure F. Push-Up Caused by Frozen Dowels and Horizontal Splitting in the Plane of the Reinforcing—The concrete is in excellent condition and free from 'D'-cracks. This defect is not related to inferior durability. Project NRH 263B, A1

push-up at an expansion joint in Project NRH 263B, A1 resulting from restraint due to

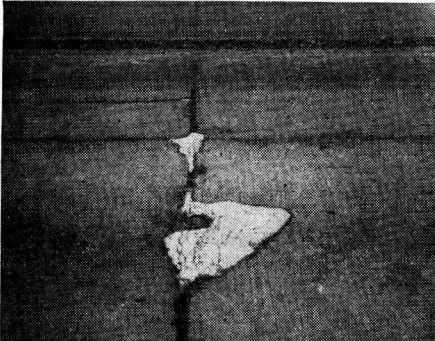
Figure G. Ice Frozen from Water Ejected Through Open Transverse Joint in Unbonded Resurfacing—Note exfoliation at point of ejection. Project FA13F

A field check of performance has shown that water may accumulate in the separation plane between resurfacing and base. The water is ejected intermittently by the passage of heavy wheel loads. This action increases the winter exposure and has accelerated the rate of deterioration along the longitudinal and trans-

verse joints in the resurfacing. Similar action was not observed on adjacent full-depth pavements where the soil subgrade afforded more positive drainage, or where paper separation was not used with the resurfacing. Figures G, H, and I show ice accumulations on Project FA13F formed from water originating in the separation plane under a 5-in. resurfacing. It can be concluded that thin separating courses are detrimental and should be avoided in the interest of providing greater slab strength and of reducing exposure.

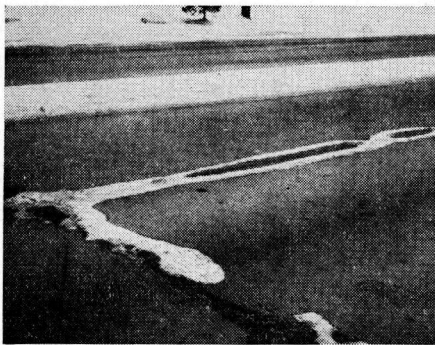
Figure H. Ice Forming Along Longitudinal Joint in Unbonded Resurfacing—Water is ejected from separation plane under resurfacing. Project FA13F

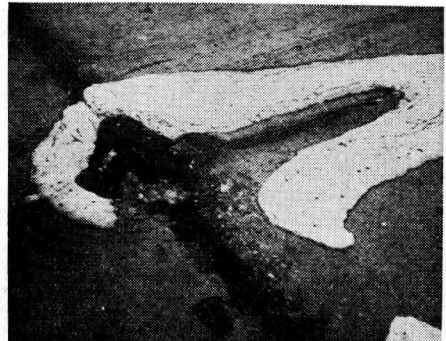
Figure I. Ice Forming at Intersection of Transverse and Longitudinal Joints in Unbonded Resurfacing—Mechanical breakage due to freezing is in progress. Project FA13F
