DEPARTMENT OF MAINTENANCE

Field Experimentation with Bituminous Undersealing Materials

W. E. CHASTAIN, SR., *Engineer of Physical Research*, and
JOHN E. BURKE, *Assistant Engineer of Physical Research*
Bureau of Research and Planning, Illinois Division of Highways

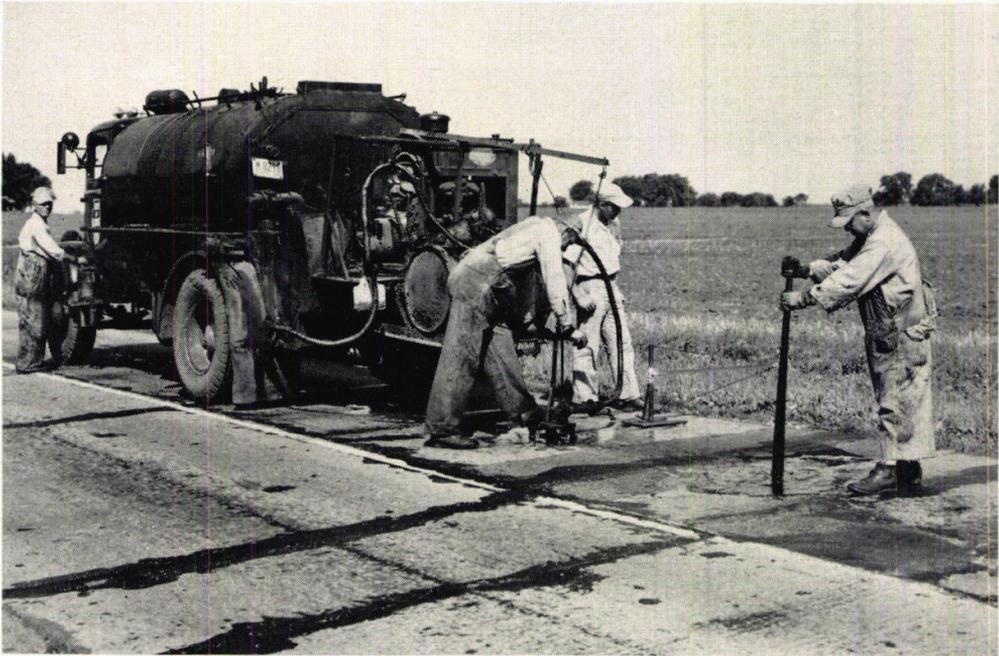
Figure 1. Type of undersealing-application equipment generally used in Illinois.

unnecessarily the roughness of joints and induce additional cracking of the slabs. Figure 1 shows application equipment of the type normally used in underseal operations in Illinois. In the right center of the picture is the lever-arm arrangement used to determine pavement rise. Similar equipment was used for measuring pavement movement in the study described in this report, in which definite limitations were placed on the allowable pavement rise.

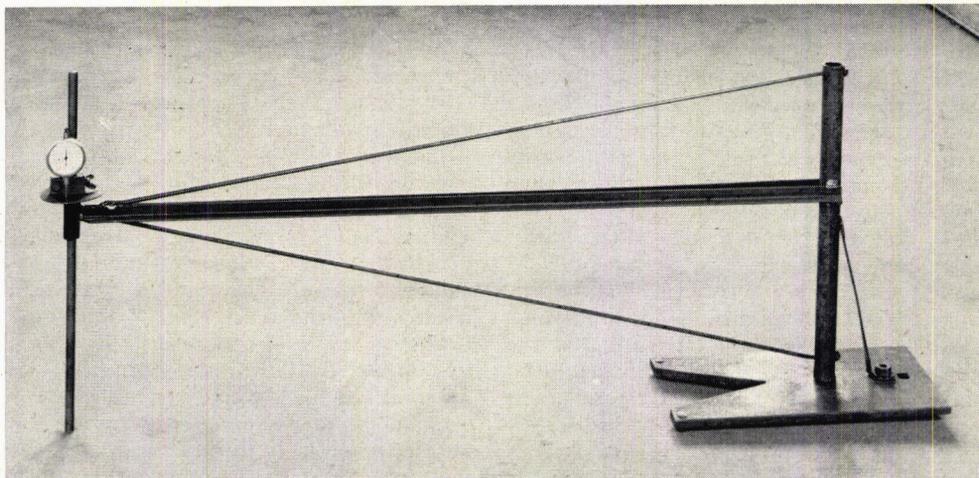
Figure 4. Ames dial and lever-arm arrangement for measuring pavement rise.
