EFFECT OF REINFORCEMENT IN WASHINGTON STATE HIGHWAYS

SUMMARY OF REPORT

By E R HOFFMAN

Washington State Highway Department Olympia Washington

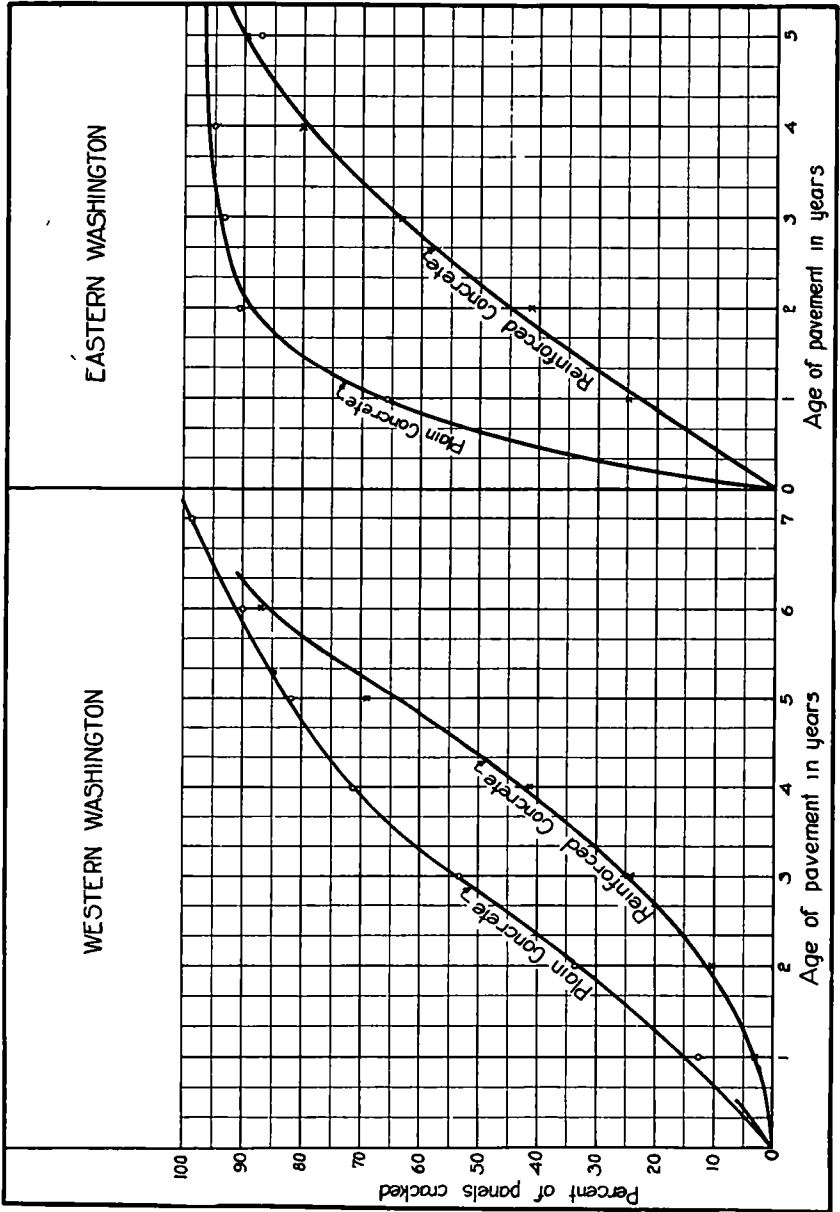
Figure 95—Influence of age and climate on slab condition—Washington State Highways

Relative percentages of plain and reinforced slabs (6-7½-6 section, 20 feet wide and 30 feet long) which contained cracks are shown in Figure 95.

The curves which represent about 165 miles of road show

- (1) Cracking increased consistently with age
- (2) Notwithstanding the adverse condition to which they were subjected, reinforced slabs showed less cracking than the plain concrete sections
