REPORT OF COMMITTEE ON CHARACTER AND USE OF ROAD MATERIALS

REPORT ON GUARD FENCE RESEARCH

H S MATTIMORE

Engineer of Materials, Pennsylvania Department of Highways

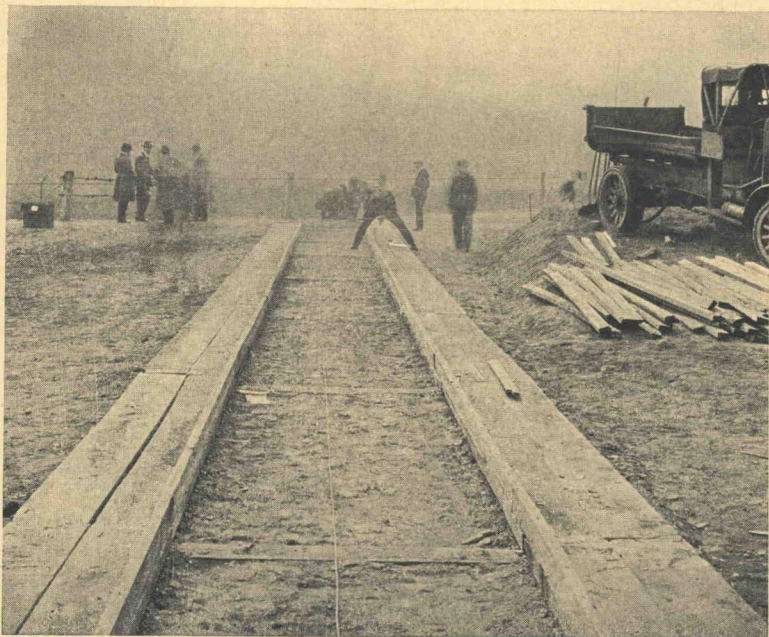
Figure 3 shows the lower part of the runway and the guard fence before impact.

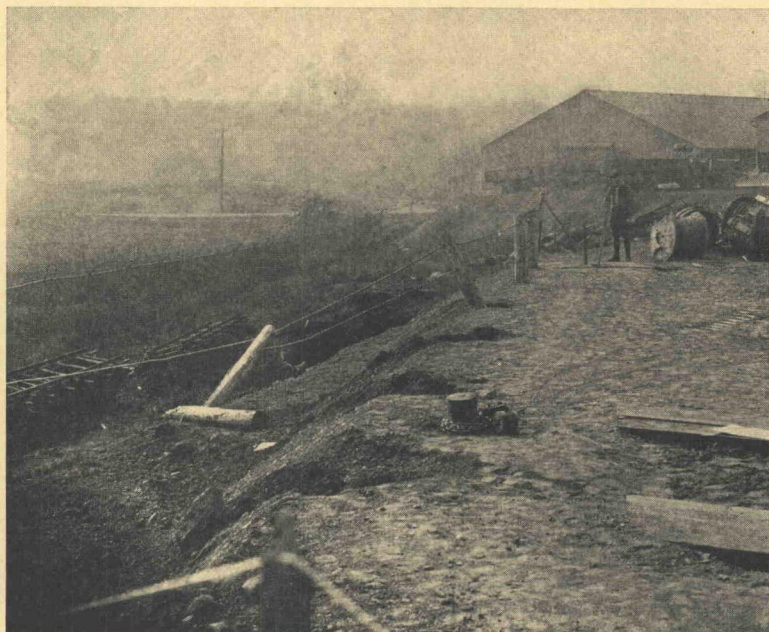
Figure 4 is an illustration of the guard fence after impact. In this test the truck hit the fence at an angle of fifty degrees, and at a speed of thirty-six miles an hour. The speed was greater than intended, and this phase of control was regulated in additional tests.

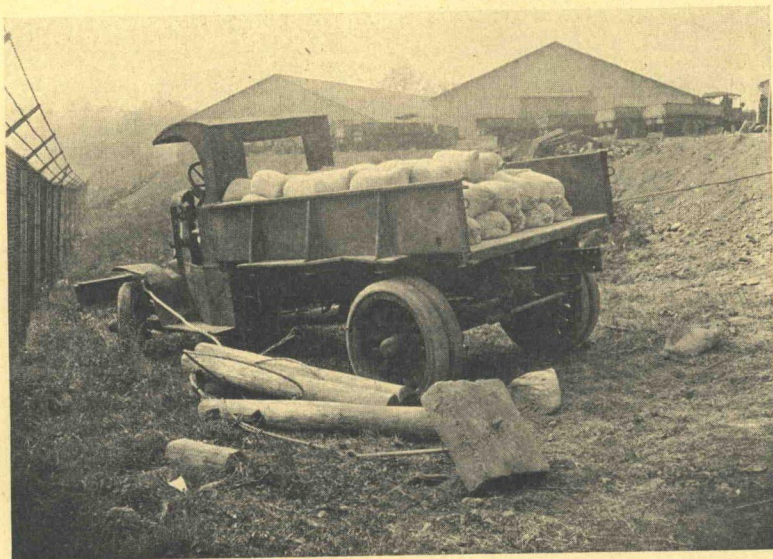
Figure 5 shows the position of the truck after having passed through the guard fence as illustrated in Figure 4. Note the concrete deadman which was pulled from the ground and hurled fifty feet as a result of the

impact. A detailed examination demonstrated that the back fill over the deadman was not properly compacted. This phase of construction has been corrected where possible by placing the deadman without disturbing the ground between the deadman and the end posts, as shown under Figure No. 5.

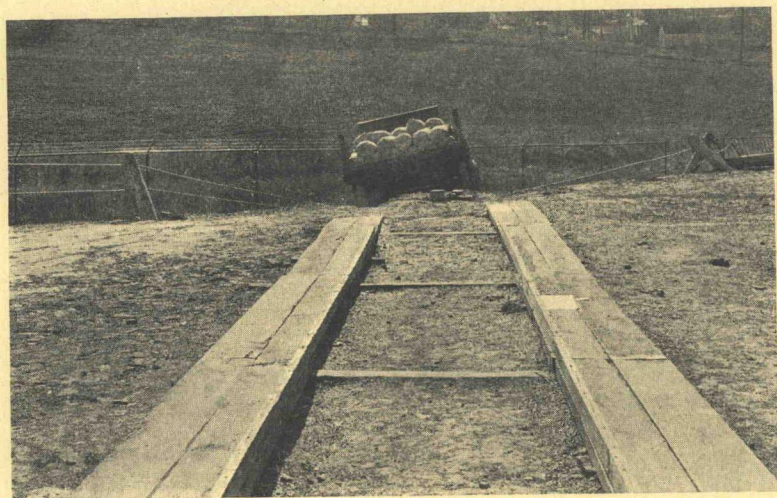
Figure 6 shows the failure of a fence. The truck in this case attained a speed of thirty miles an hour, and the failure was due to the breaking of the guy from the end posts to the deadman. This failure shows the necessity for larger size guy rope.

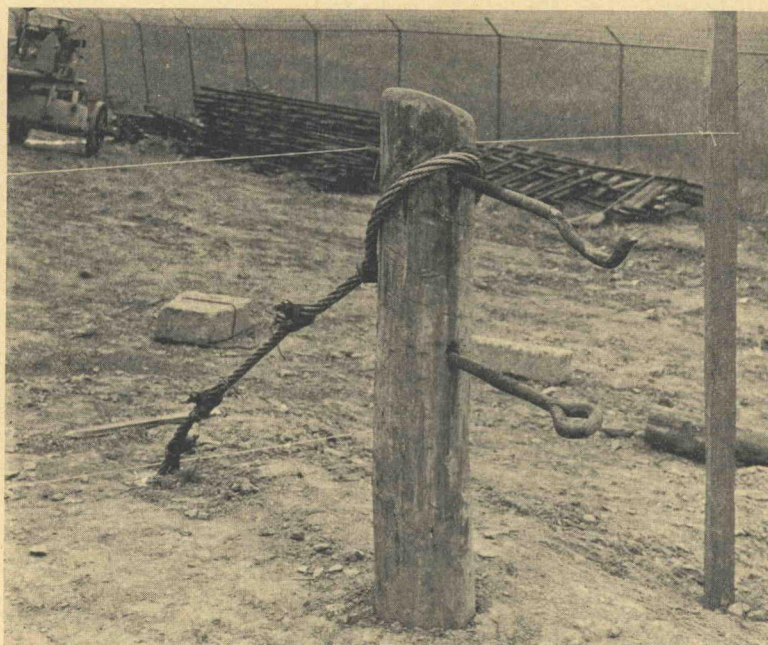
Figure 7 illustrates a failure due to the breaking of the eye-weld on

the eye bolt, connecting the top rope to the end post. In this test the speed of the truck was twenty-four miles an hour. This result demon-

strates that safe construction requires drop forged eye bolts. The failure of the top eye bolt also shows the greatest stress on the top rope.

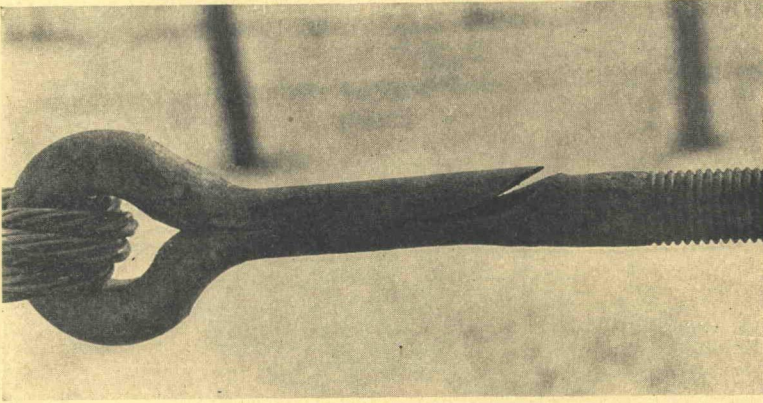
Figure 8 shows another failure in a welded eye bolt on the top rope connection. The speed of the truck was ten miles an hour.

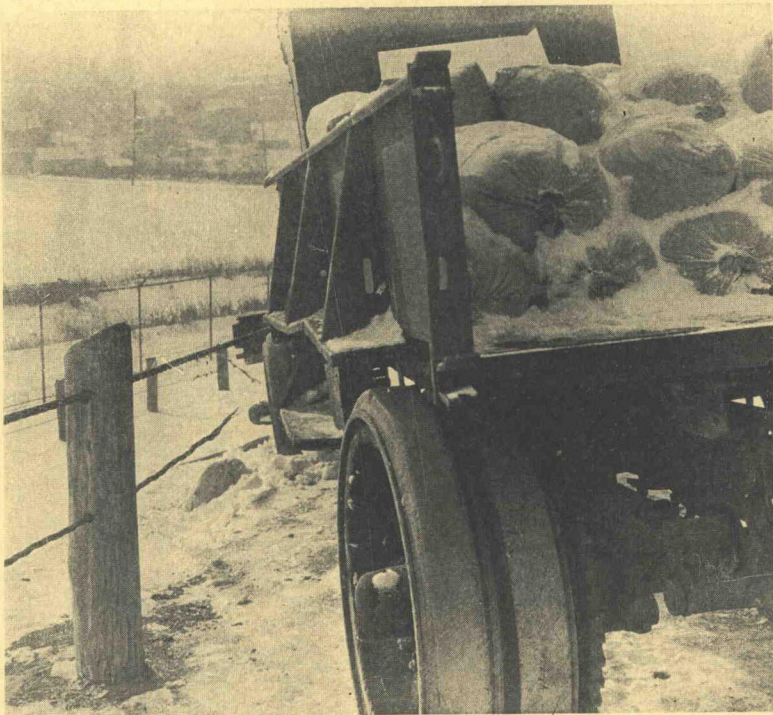
Figure 9 illustrates the position of truck after impact. Note that the $\frac{3}{4}$ inch bottom rope had failed and the truck which had a speed of ten miles per hour was held by the top 1 inch rope.

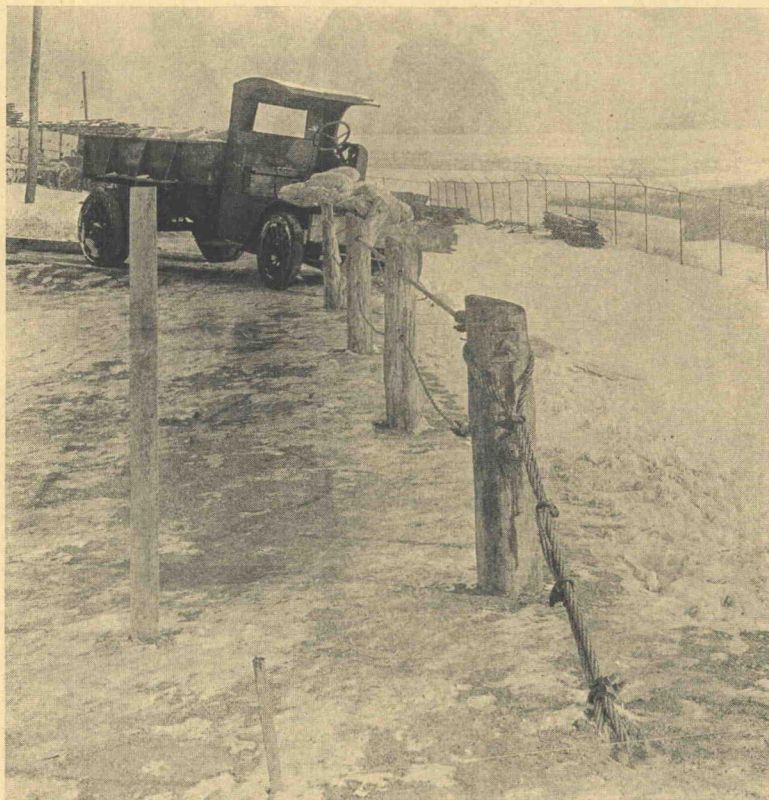
Figure 10 shows a truck held by the guard fence. Note the destruction of wooden posts under frozen ground conditions; two posts were

broken off at the ground line while several others were shattered. Speed of truck ten miles per hour.

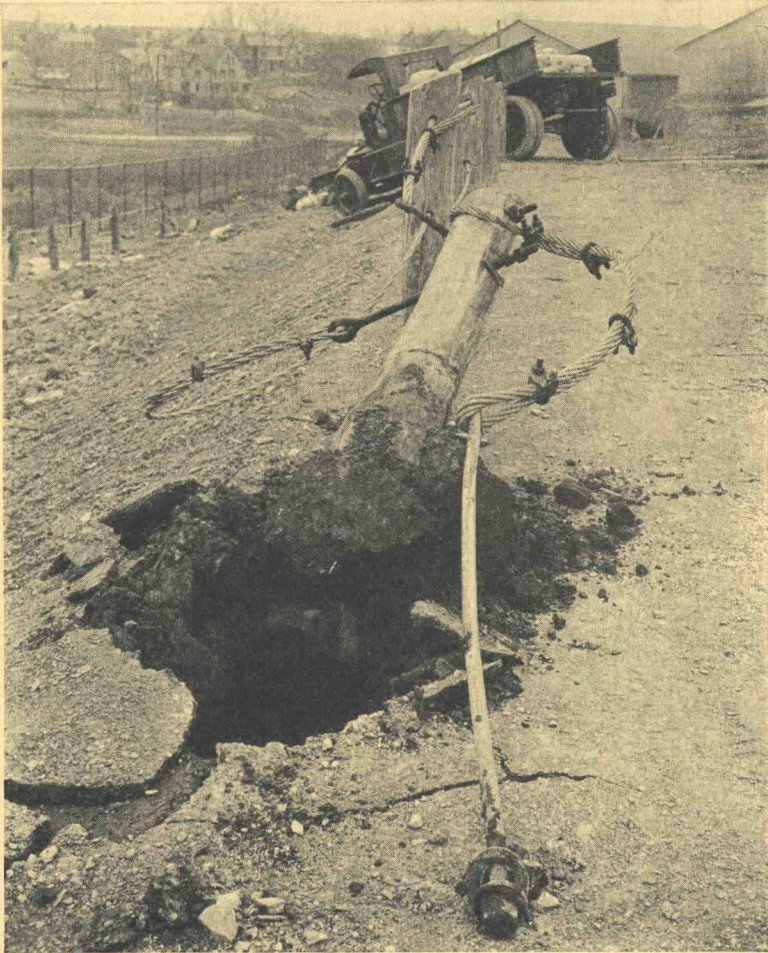
Figure 11 shows a failure of the anchorage, which detailed examination disclosed was due to the shattering of the plain concrete block used as a deadman. This was corrected by using a reinforced concrete deadman, and also by increasing the size of the bearing plate in the eye bolt connection to the deadman, as illustrated in Figure 20. The speed of the truck was fifteen miles per hour.

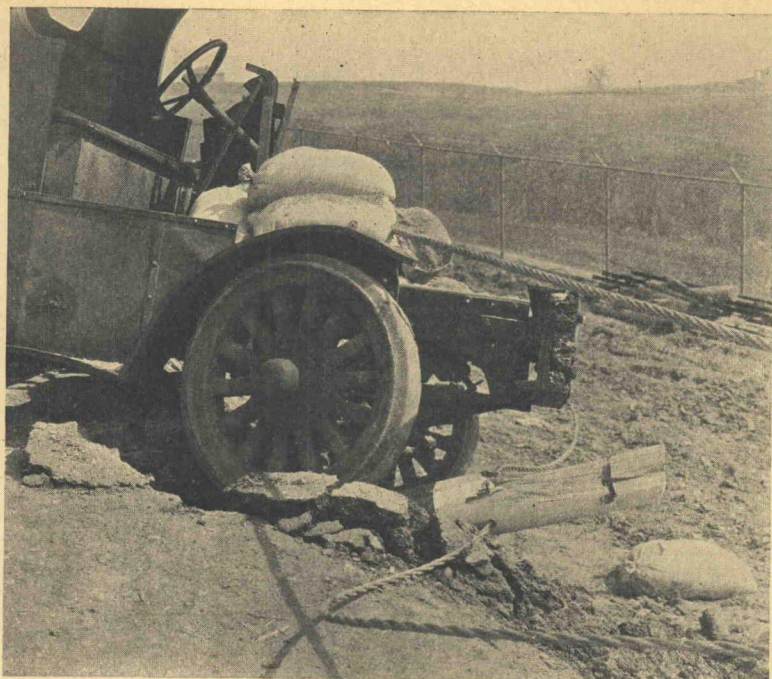
Figure 12 illustrates the weakness of threading the wire rope through

the post line, and also emphasizes the safety feature of a 1 inch top rope. Speed of truck twelve and eight tenth miles per hour.

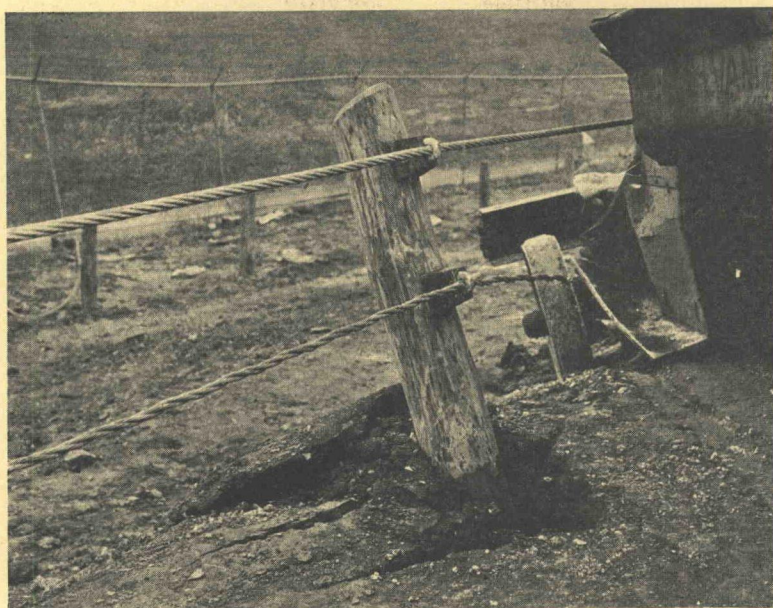
Figure 14 shows this new designed guard fence at the point of truck impact. Note that the shock was sufficient to dislodge some posts, but no shattering or breaking of the posts resulted, such as happened when rope is threaded through the posts. The speed of the truck for this test was twenty-two miles per hour.

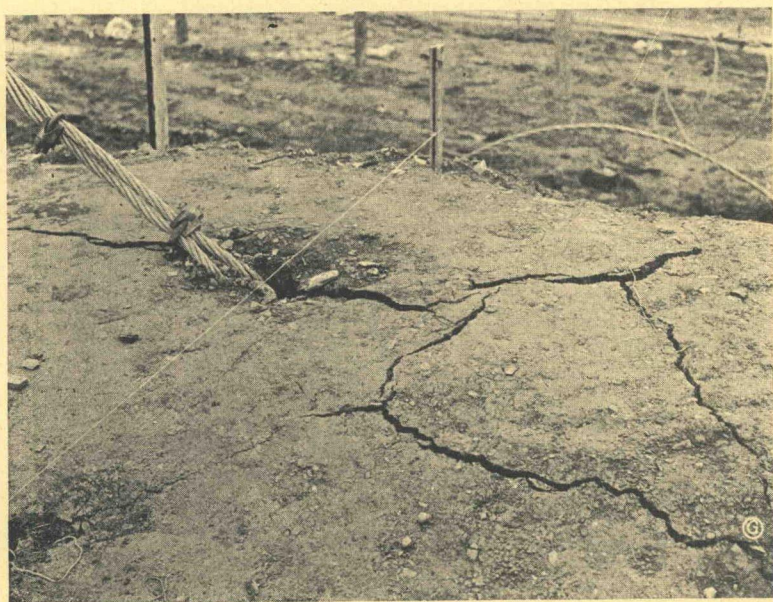
Figure 15 illustrates the heave of the ground surface above the dead-

man after impact, the speed of the truck being twenty-two miles per hour. A more detailed examination indicated that the concrete deadman had moved to the extent indicated in Figure 16. In this test the deadman was installed as shown in Figure 21.

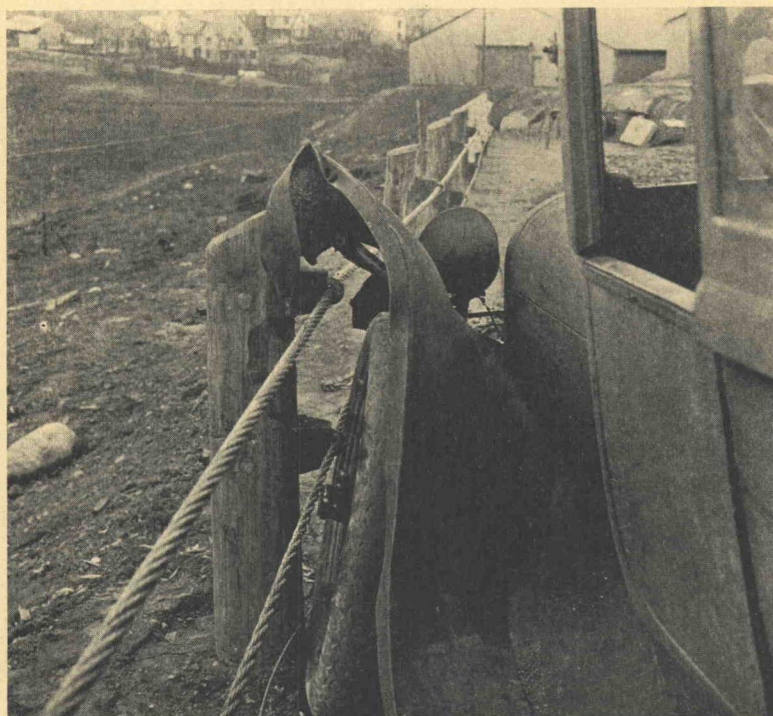
Figure 17 shows the efficiency of the offset on the guard fence. It will be noted that the hub of the wheel does not have an opportunity to

come in contact with the post. The main damage to the car after striking at a speed of twenty-two miles an hour was a destruction of the fender as illustrated.

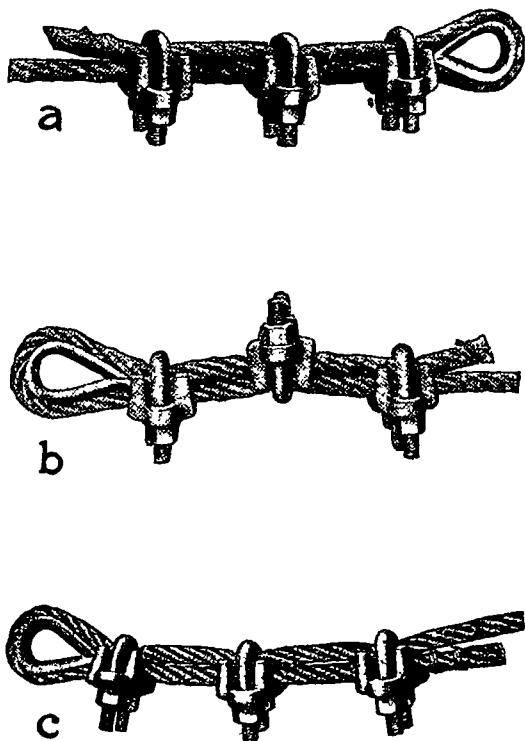
Figure 1. How to Attach Wire Rope Clips

A wire rope clip consists of two parts, the U-bolt and the forged steel "roddle" or base. When making a wire rope fastening the roddle should be in contact with the long end of the rope and the U-bolt in contact with the short end. The catalogs of wire rope manufacturers emphasize this point by illustrating the correct and the incorrect way to attach clips. One of these illustrations is shown in Figure 1. Probably most of those seen on our highways are attached incorrectly. Apparently

- A. Correct way. U-bolt of all clips on dead end of rope,
- B. Incorrect way. Do not stagger clips.
- C. Incorrect way. U-bolt of all clips on live end of rope.

the number of clips on highway guards and the way in which they are attached are left to the whim of the workman. Even if for highway guards it could be proven that the way in which the clips are attached makes little difference, our highways are a great educational influence and should not be allowed to teach unsafe practices which it is impossible to counteract by the efforts of safety organizations. If we are to be successful in our efforts to establish and maintain safe conditions in this

It is believed that if the importance of attaching wire rope clips correctly is brought to the attention of highway engineers, the present situation will soon be remedied
