PROGRESS REPORT  
EXPERIMENTAL STABILIZED TURF SHOULDERS FOR  
NEW JERSEY PARKWAYS

Oliver A. Deakin, Parkway Engineer  
New Jersey State Highway Department

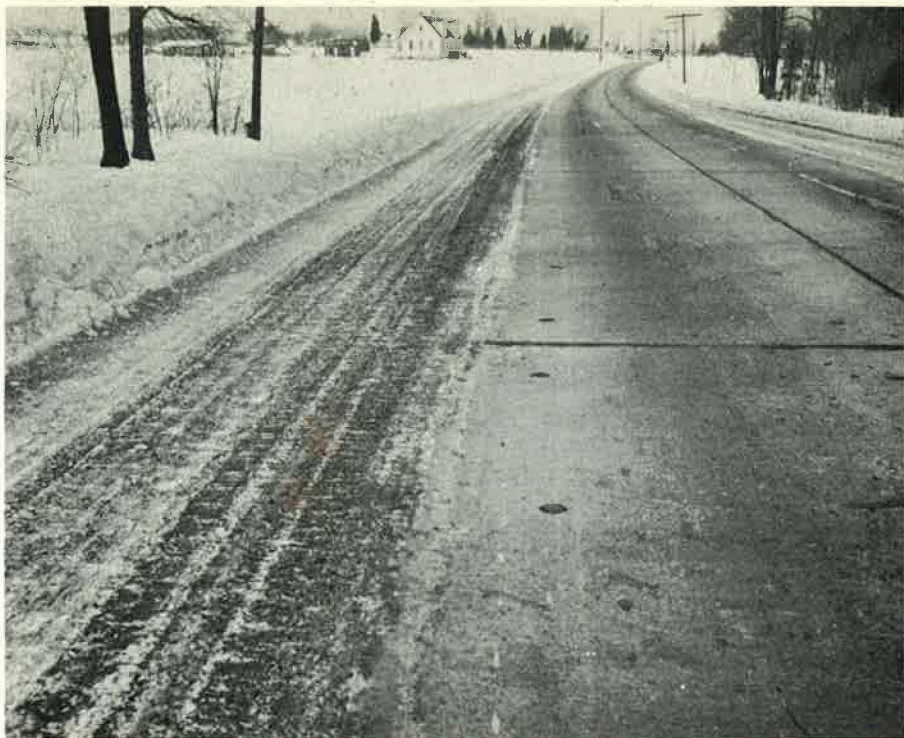
Snow Removal: The question of how the stabilized turf shoulder would stand up under winter traffic and periodic snow plowing was of great interest to the Parkway, Soils, and Maintenance Divisions. By raising the height of the snow plow blade approximately 5-in.-6-in. above the turf, it was possible to plow the stabilized shoulder without doing any damage. The three (3') foot bituminous concrete shoulder also helped a great deal in keeping the snow plow from scraping up the turf. On January 27, 1948, the turf shoulders were inspected and they were found to be plowed full width with no evidence of damage. Wheel tracks indicated that considerable traffic had used the shoulder area without damage. Figure 2 illustrates this clearly.

Figure 2. Wheel Tracks Indicated that Considerable Traffic Had Used Shoulder.  
Jan. 27, 1948.

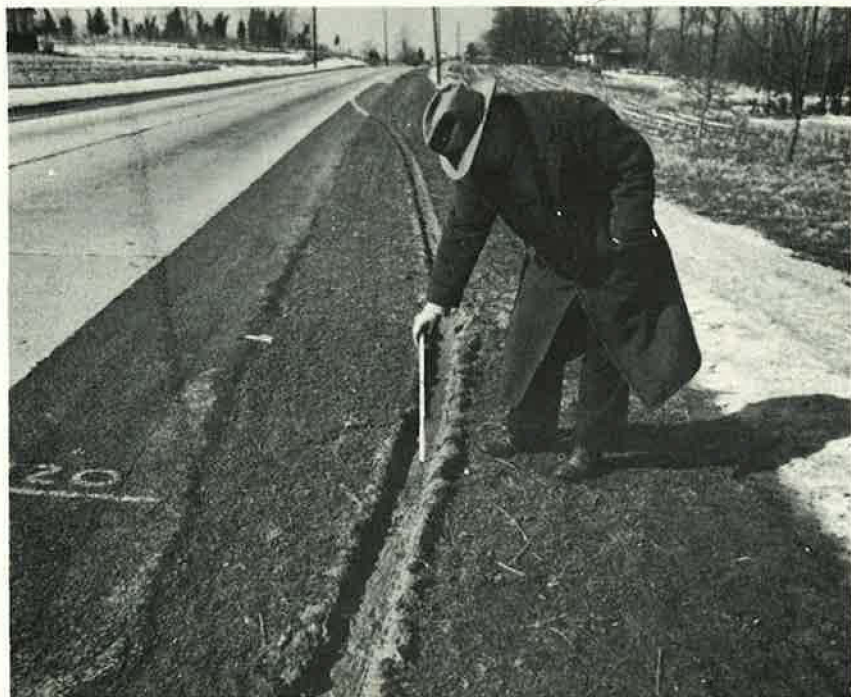
3. It was found that the stabilized turf shoulder during the critical period of the spring thaw rutted when traveled on by trucks or passenger vehicles. The depth of rut varied from 1-in.- $1\frac{1}{2}$ -in. Temperature for the day was 52°-55°F. As soon as the car tire cut through the layer of soil and struck the stone aggregate, the tire didn't penetrate any deeper. The stabilized turf shoulders proved safe for occasional traffic use even though they rutted.

Figure 3. Rutted Turf Shoulder After Period of Thawing. Rut  $1''-1\frac{1}{2}''$  deep.  
Feb. 19, 1948.

4. It is recommended that the stabilized turf shoulder be rolled, topsoiled, fertilized and overseeded in the spring in order to repair the spring thaw damage to the turf and to assure a good strong turf growth. It was found the maintenance repair cost was five (5¢) cents per square yard. This was after one of our most severe winters on record.

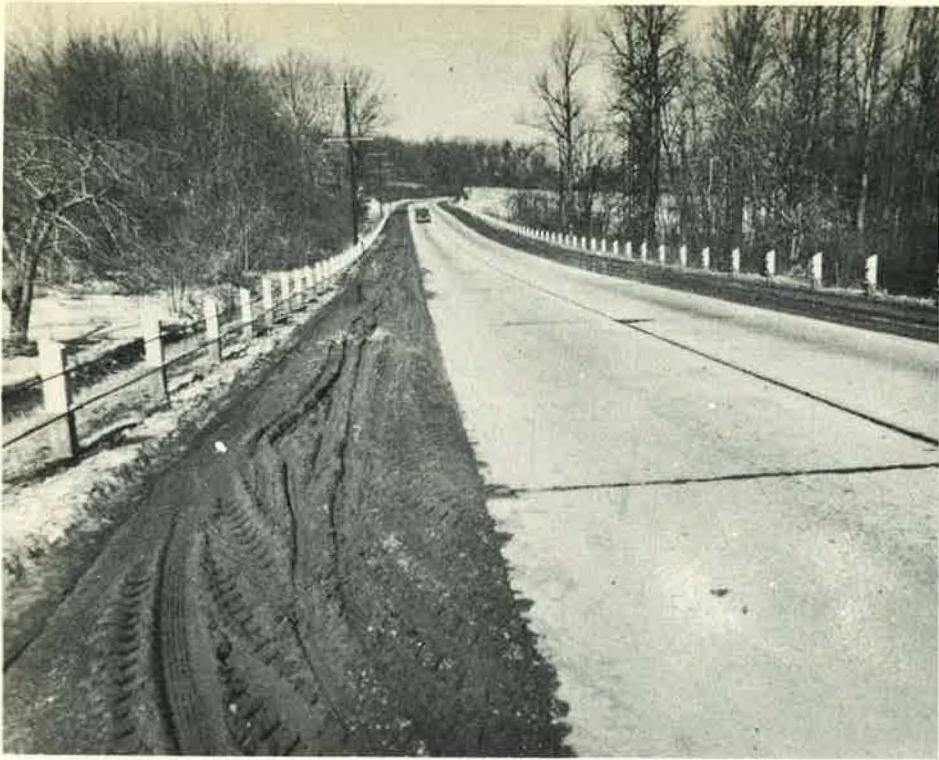
just about shows up through the soil. In spite of this rutting, the shoulders proved that they were safe. This critical period lasted five days. Other shoulders in this vicinity that were considered to be of an improved type were just about impassable during the same period. See Figure 4. By March 22nd very little evidence of winter damage could be seen.

Figure 4. Other Highway Shoulder of an Improved Type Almost Impassable. Feb. 19, 1948.

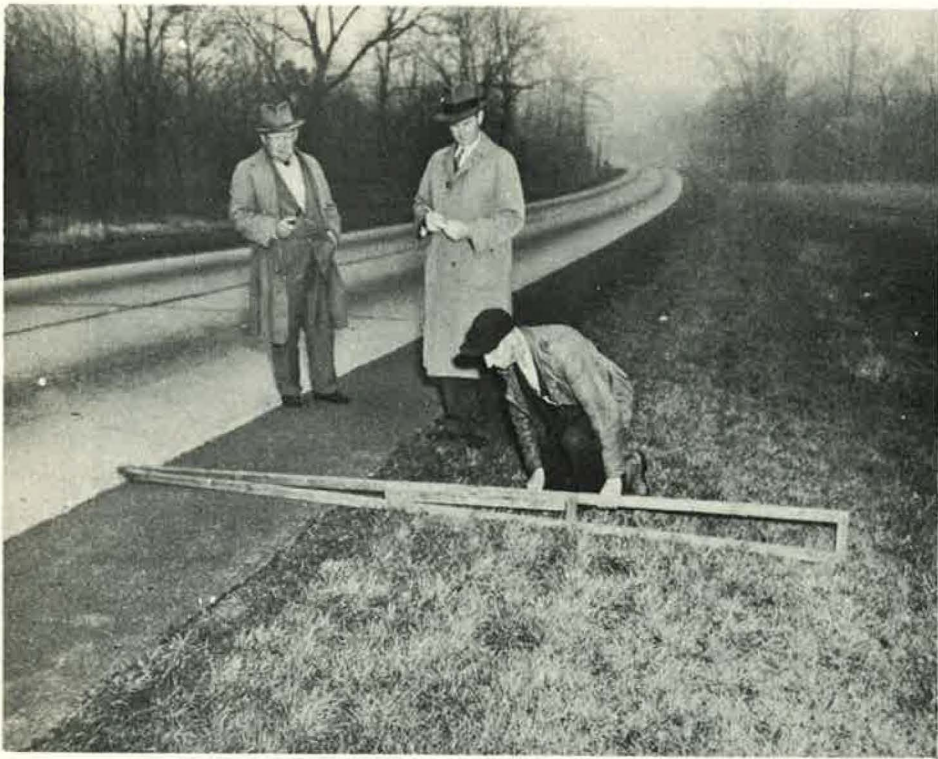
Method: The cross slope was checked with a wooden templet which had a level built into it. This same templet was used when the cross slope of 5 percent was determined during construction. Figure 5 indicates the type of templet used. On November 19, 1948, the cross slope of the shoulders were checked and no "build-up" was observed. Grass clippings had been allowed to remain on the turf during two growing seasons. Shoulders hadn't changed in elevation since they had been rolled in the spring of 1948.

Figure 5. Checking Turf "Build-Up" With Wooden Template. November 19, 1948.

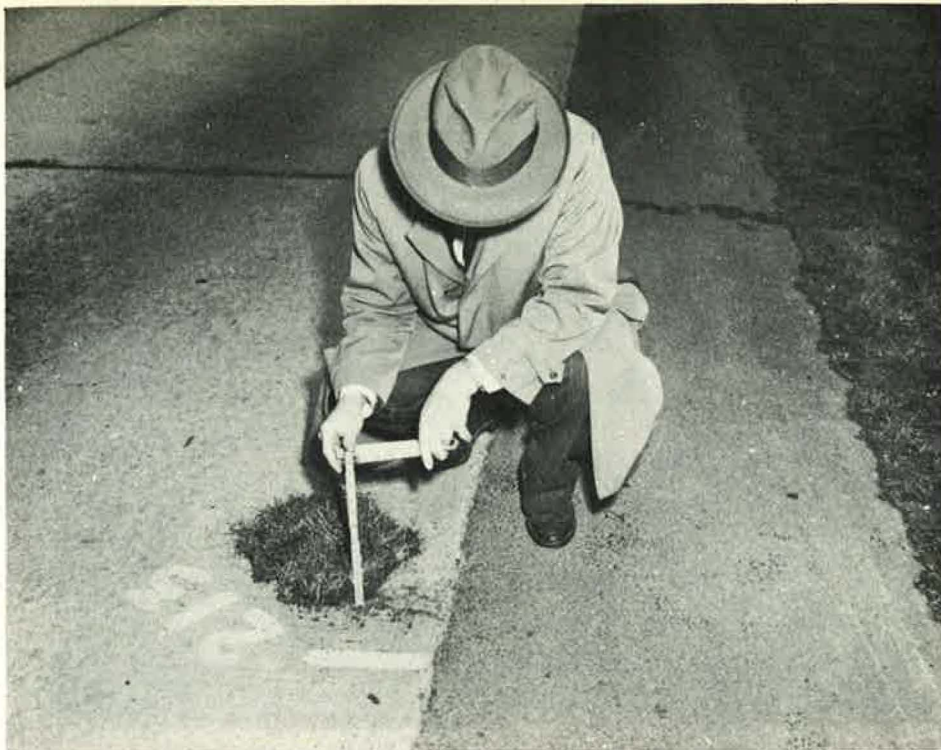
Turf Root Growth: Sample test hole was made at Station 213/0 and eight feet right of pavement edge. After removing the sod, it was found to measure .12 of a foot, in thickness. Figure 6 shows clearly the fine thick sod that was developed. It was found that the roots of the grass were very dense and tough penetrating through the top course of soil, bankrun sand, and  $2\frac{1}{2}$ -in. stone aggregate .97 of a foot or nearly one foot into the stone area. The stone area was approximately .85 of a foot thick. The total material had a wet density of 126 lbs per cubic foot; moisture content, 6.9 percent; and dry density, 118 lbs per cubic foot. Dry density of grass roots, 32.5 lbs per cubic foot. Figures 6-15 furnish the results of the latest tests made by the Soils Division and the Laboratory.

Figure 6. Good Thick Sod .12 of a Foot. November 15, 1948.

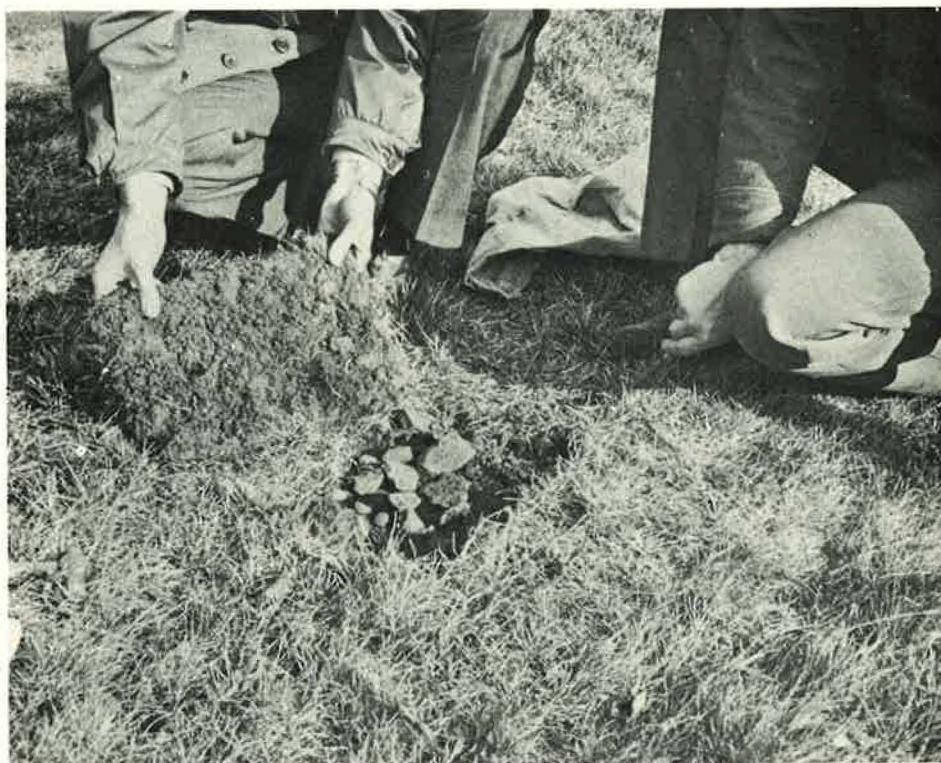
Figure 7. Removing Sod and Stone Aggregate From Test Hole - Station 213/71 R.  
Nov. 15, 1948.

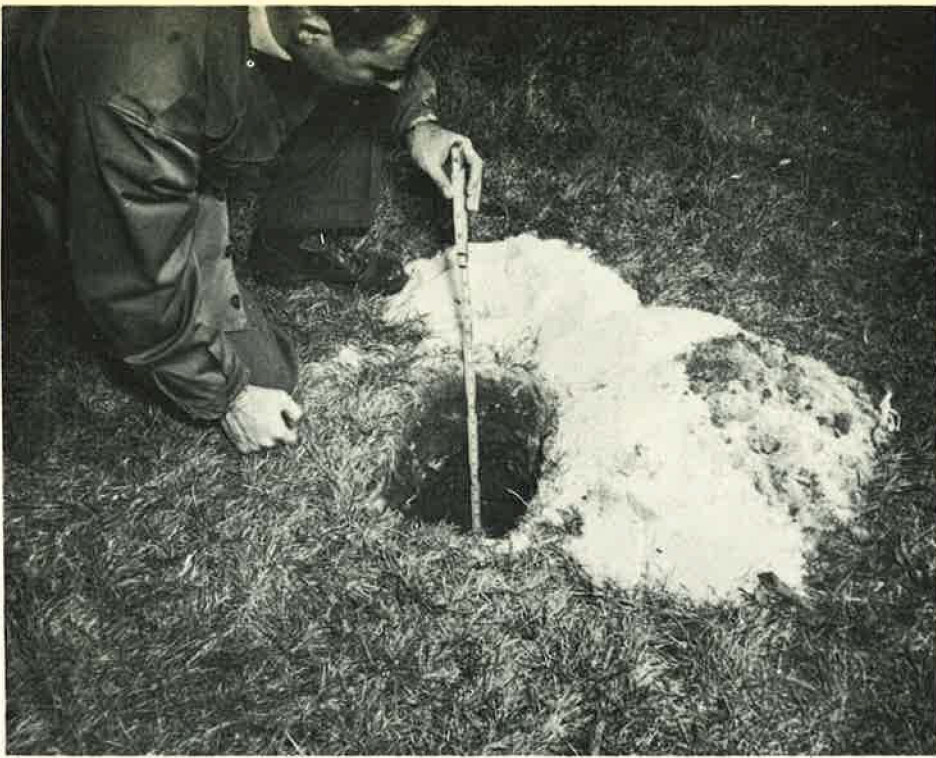
Figure 8. Test Hole Station 21370 - Total Depth of Stabilized Materials 1.20'.  
Nov. 15, 1948.

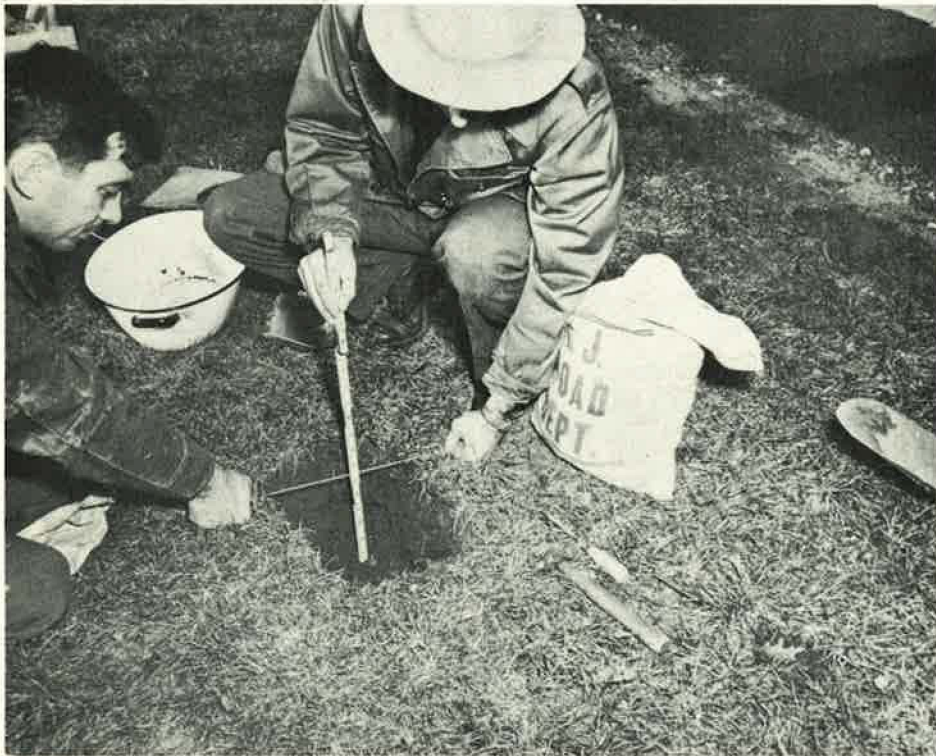
Figure 9. Sample Test Hole Station 217709. Depth of Top Course .65 Ft.  
November 15, 1948.

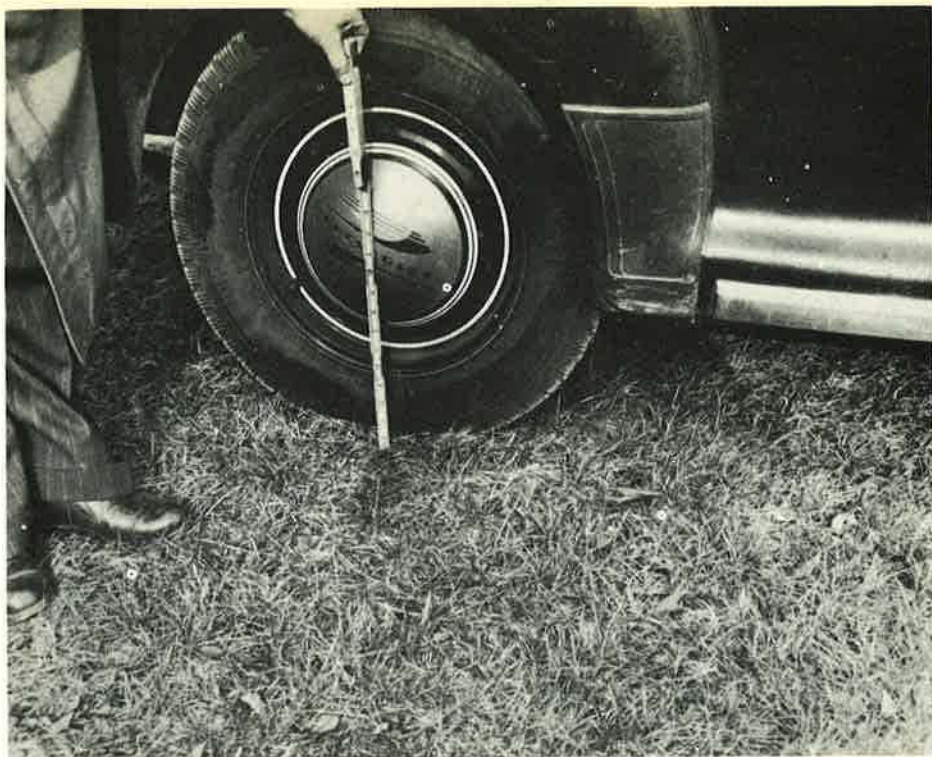
Figure 10. No Depression Caused By Passenger Car Tire. November 15, 1948.

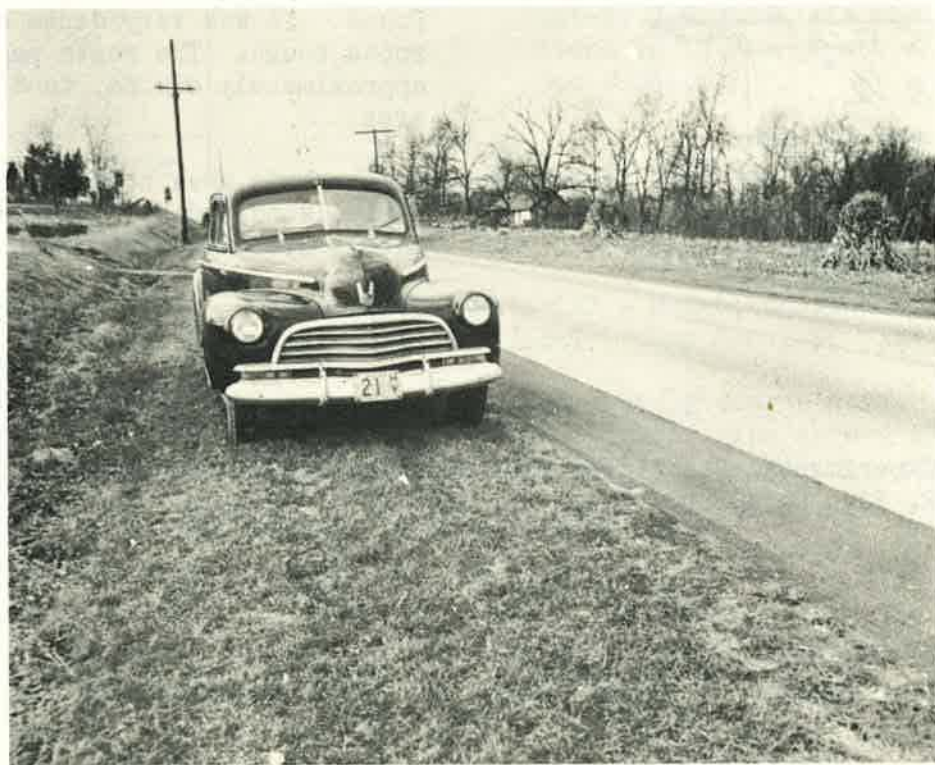
Figure 11. Passenger Parked On Stabilized Shoulder. Nov. 15, 1948.

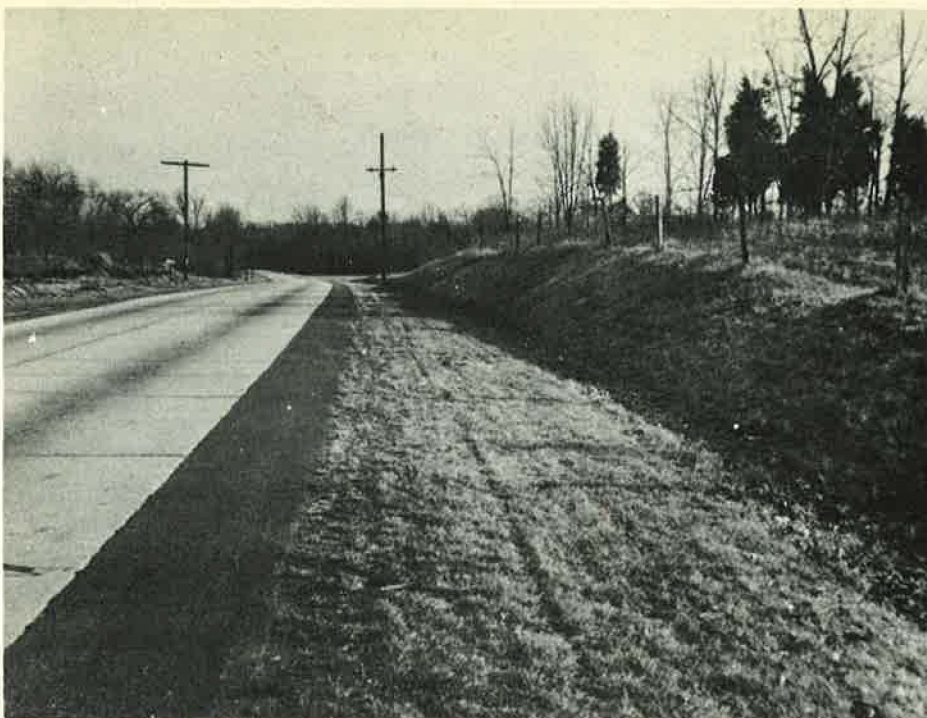
Figure 12. Stabilized Turf Shoulder Cover With a Dense, Tough, Growth of Vigorous Grass. Station 213/0. November 15, 1948.

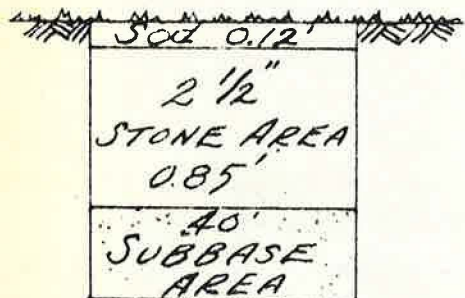
Figure 13. Experimental Stabilized Turf Shoulder Study. Station 213/0. 8 ft. R. Edge Pavement. Route 30, Woodsville-Lyndale. Nov. 15, 1948.

1. Sod: A sod cushion of average 0.12 ft. was found. It was very dense and the roots tough. The roots penetrated approximately one ft. into the stone area.

2. Stone Area: This area consisted of  $2\frac{1}{2}$ -in. stone, sand and soil. It was approximately 0.85 ft. deep.

Wet Density: 126 lb. per cu. ft.  
 Total Material - Moist. Content: 6.9 percent  
 Dry Density: 118 lb. per cu. ft.

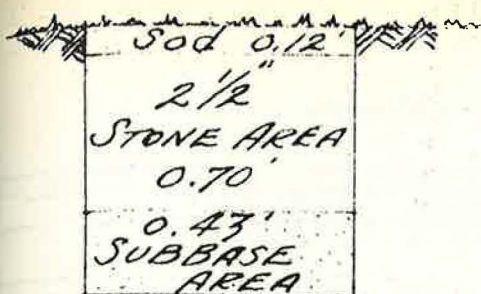
Figure 14. Experimental Stabilized Turf Shoulder Study. Station 213/71. 8-Ft. R. Edge Pavement. Nov. 15, 1948. Route 30, Woodsville-Lyndale.

1. Sod: A sod cushion of average 0.12 ft. was found. It was very dense and the roots tough. The roots penetrated approximately 0.82 ft. into the stone area.
2. Stone Area: This area consisted of 2 1/2 in. stone, sand and soil. It was approximately 0.70 ft. deep.

Wet Density: 142 lb per cu. ft.

Total Material - Moist. Content: 12.3 percent

Dry Density: 126 lb. per cu. ft.

3. Subbase Area: The subbase material is a clean gravely coarse sand. It was moist and dense. The 6 in. bleeder pipe appeared in good working order.

Wet Density: 122 lb. per cu. ft.

Total Material - Moist. Content: 11.8 percent

Dry Density: 108 lb. per cu. ft.

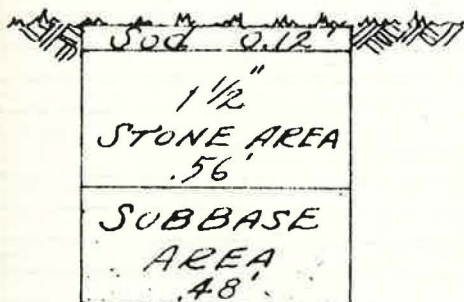
Figure 15. Experimental Stabilized Turf Shoulder Study. Station 217/09. 9 Ft. R. Edge Pavement. Nov. 15, 1948. Route 30, Woodsville-Lyndale.

1. Sod: A sod cushion of average 0.12 ft. was found. It was very dense and the roots tough. The roots penetrated approximately 7 inches into the stone area. Stone in this area was embedded in the Sod Cushion.

2. Stone Area: This area consisted of 1 1/2-in. stone, sand and soil. It was approximately 7 inches deep.

Wet Density: 137 lb. per cu. ft.

Total Material - Moist. Content: 7.3 percent

Dry Density: 128 lb. per cu. ft.

3. Subbase Area: The subbase area is a clean gravely coarse sand. It appeared moist and dense. The 6-in. bleeder pipe showed evidence of good working order.

Wet Density: 122 lb. per cu. ft.

Total Material - Moist. Content: 8.8 percent

Dry Density: 112 lb. per cu. ft.
