## TESTS on RUTTING of SHOULDERS

R. S. DuBois  
Principal Highway Design Engineer  
Bureau of Public Roads

## SYNOPSIS

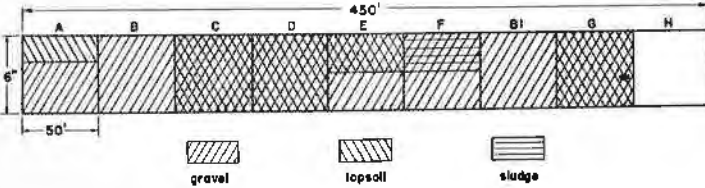
Figure 1.

- A 4 inches of gravel under 2 inches of topsoil.
- B and BI 6 inches of gravel.
- C Mixture of 2/3 gravel and 1/3 topsoil.
- D Mixture of 4/5 gravel and 1/5 topsoil.
- E 3 inches of gravel under 3 inch mixture of 2/3 gravel and 1/3 topsoil.
- F 3 inches of gravel under 3 inch mixture of 2/3 gravel and 1/3 sludge.
- G Mixture of 3/4 gravel and 1/4 topsoil predetermined to bring P.I. to 9.
- H Existing shoulder.
