Bridge Deck Repair Techniques on the New Jersey Turnpike

ORRIN RILEY, Project Engineer; Howard, Needles, Tammen and Bergendoff

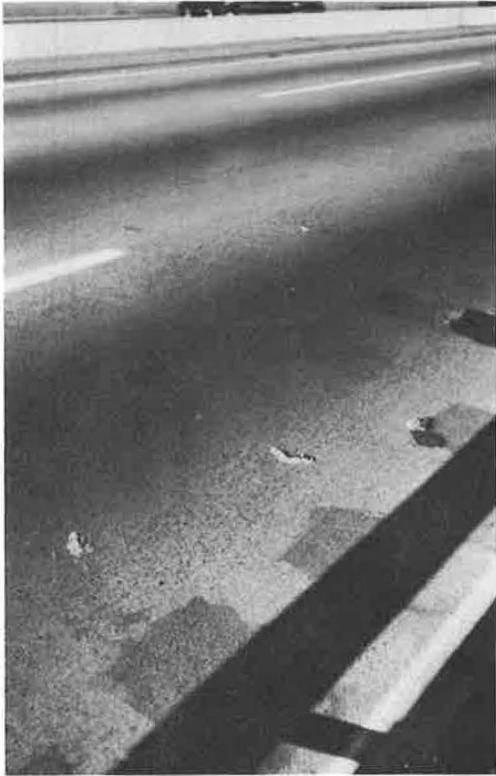
Spalling first appears as a small pock mark, generally not much larger than one's fist (Fig. 1). Usually, the appearance of a spall corresponds with the appearance of rust on the surface directly over a reinforcing bar. By tapping the area around these spalls with a small chipping hammer, a dull, hollow sound is often noted indicating that there is a much larger ring of unsound concrete surrounding the spall. Over a period of several weeks, and particularly during the winter, these spalls will grow rapidly in area and somewhat in depth until relatively large areas of reinforcement steel are exposed (Fig. 2). It is not uncommon for a spall to grow into a pothole 2 ft in diameter and 2 in. deep in one month's time. Normally, about 200 sq ft of new spalled areas are discovered each month, although twice, during wintertime, new spalls were created at the rate of over 1,200 sq ft per month.

Figure 1. First stage spalling.

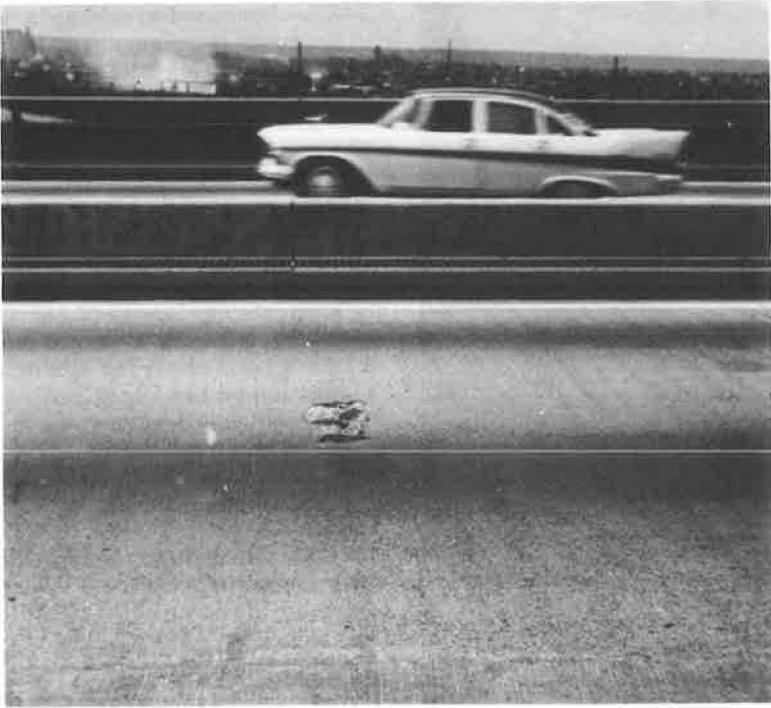
Figure 2. Second stage spalling.

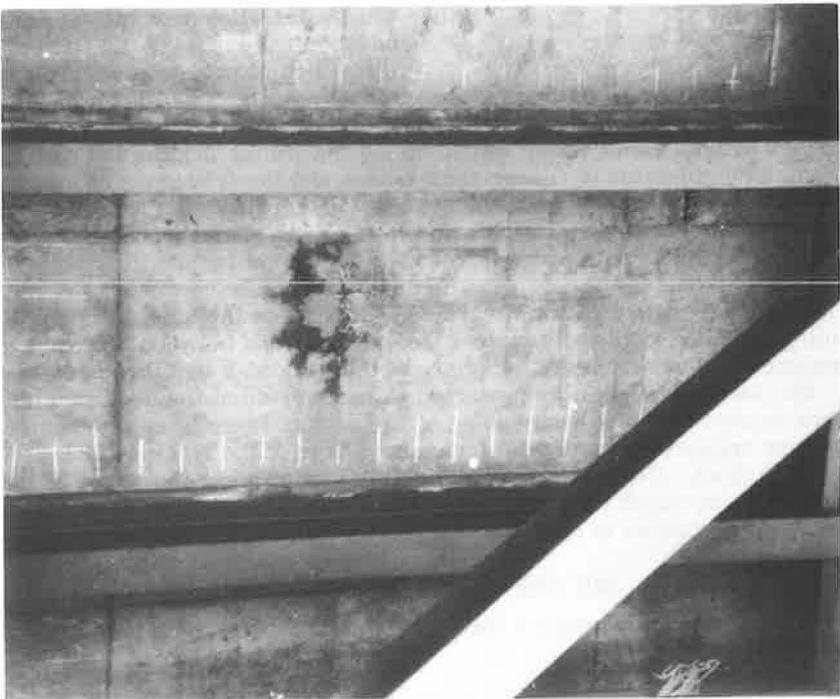
Checkerboard cracking is a phrase used to describe the phenomenon of underside cracks appearing with uniform spacing in both a longitudinal and transverse direction and showing efflorescence (Fig. 3). The passage of surface water through these checkerboard cracks during rain storms verifies that they are fractures through the slab. The spacing pattern conforms to the spacing of the lower mat of reinforcement steel. As many as twenty separate new areas of checkerboard cracking, varying in size from 1 to 60 sq ft, have been observed during one monthly inspection on the Passaic River Bridge. This condition is rarely encountered on other structures. Invariably, checkerboard cracking occurs beneath existing spalled areas or beneath patches made to repair old spalls.

Figure 3. Underside checkerboard cracking.

The criterion used for determining full deck replacement is the existence of under-side checkerboard cracking. It is clear both from the history of slab failures and from plain common sense that a large area of fractured concrete beneath a deep pothole will not remain intact for long in a dynamically loaded deck. Therefore, each spring for the past three years all such slabs have been completely removed and replaced while keeping at least two lanes open to traffic in each direction.

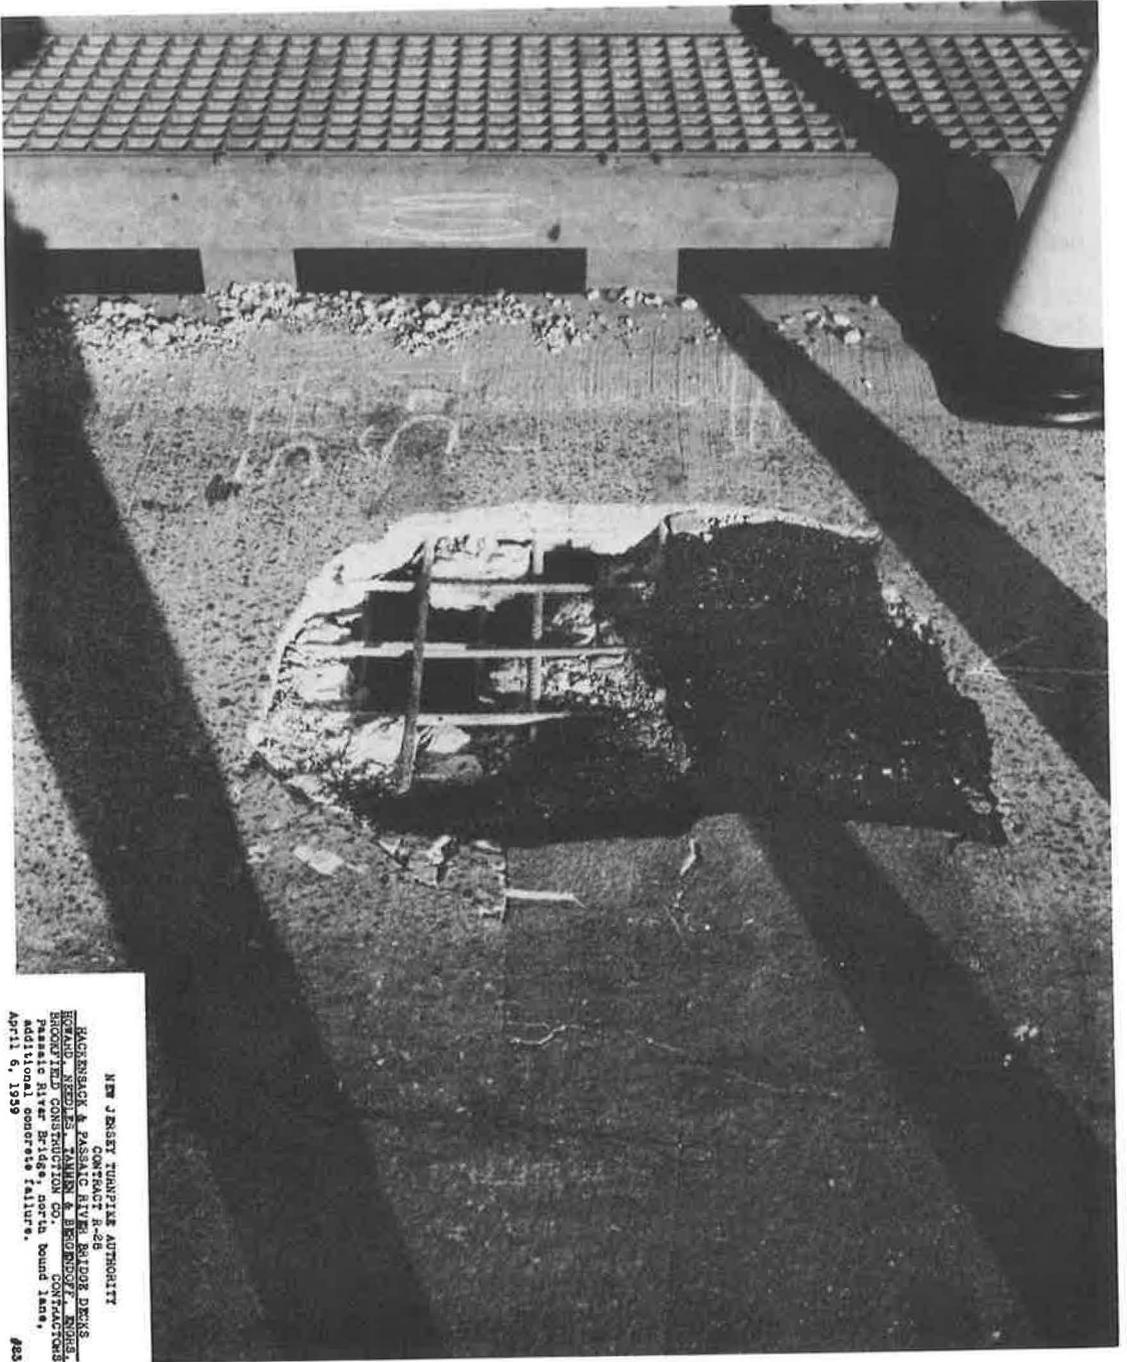
Full slab failures have developed on four separate occasions. These have always occurred directly in the wheelpaths and in areas of checkerboard cracking. They are best described as holes about the size of a desk with chunks of broken concrete wedged between the two mats of reinforcement steel (Fig. 4).

Figure 4. Slab failure.

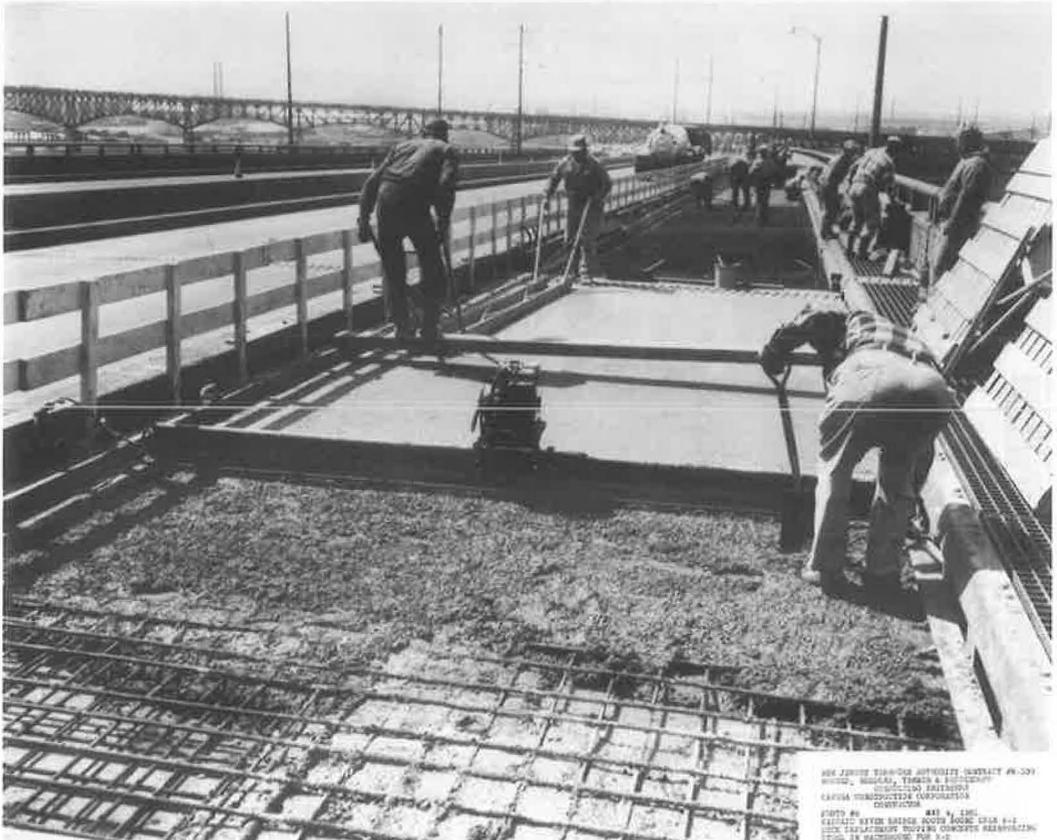
Figure 5. Nonshrinking concrete being placed over fresh conventional concrete.

On the whole this design proved quite satisfactory. However, after a year's time some of the replaced areas showed evidence of hairline cracks along the longitudinal joint between the new and old concrete. In addition there was a tendency for transverse cracks in adjacent old slabs to project across the new one. To offset this, a special metallic aggregate (Embeco), non-shrinking concrete topping was designed for use in later contracts. This new scheme called for concrete of conventional design to be placed in the lower 5½ in. of the new slab. Then, while the lower portion was still in a plastic state, the top 2 in. was filled with the metallic aggregate concrete and finished in accordance with standard practices (Fig. 5). The specially prepared metallic aggregate used in the concrete mix has the unusual quality of expanding in volume during the setting and curing stages to form a void-filling, shrinkage-compensating system. The resulting concrete is strong, dense, waterproof, and elastic--precisely the characteristics sought for in bridge decks. The new concrete system has shown a remarkable resistance to the projection of cracks, and no defects have been noted to date. So far, about 20 percent of the old concrete deck has been replaced in this manner.

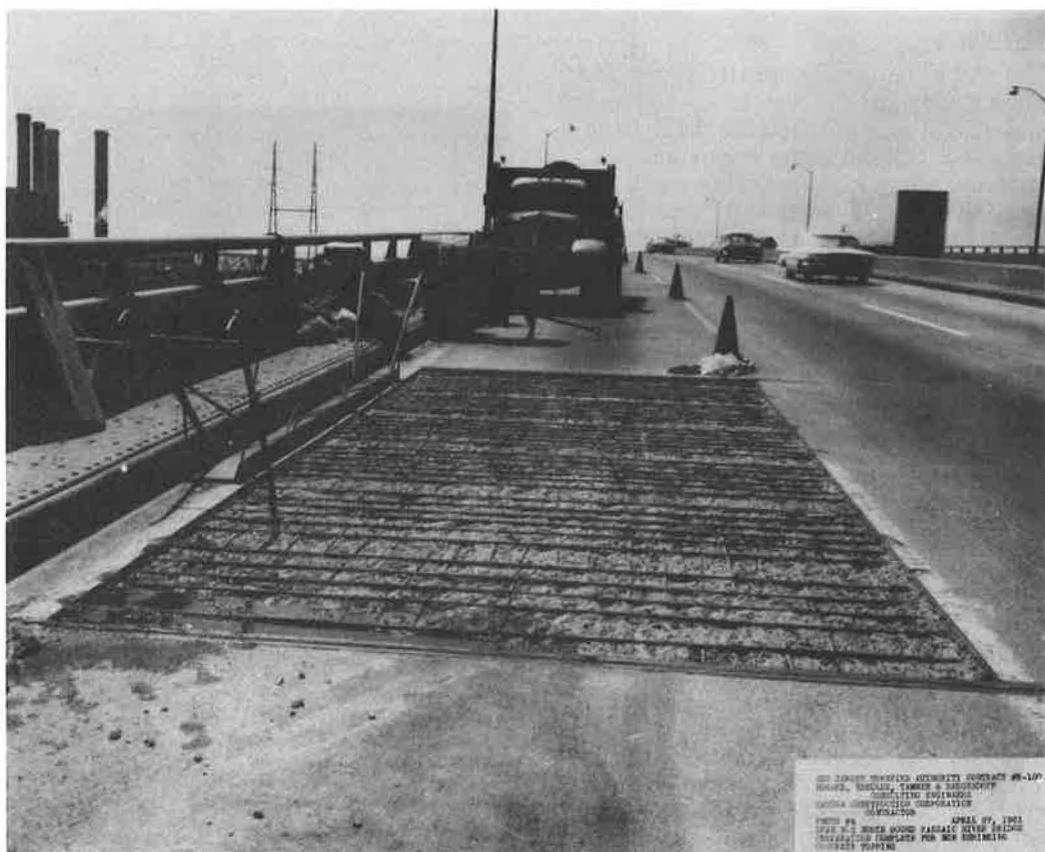
Figure 6. Excavated surface ready for nonshrinking concrete topping.

In areas where surface spalling has been extensive but where there is no checker-board cracking, an intermediate technique called topping is often used. This technique requires the excavation of a large surface area, defined as something greater than 20 sq ft, down to a depth of 2 in. (Fig. 6). Great care must be taken in these larger topping areas to avoid damage to the reinforcing steel and to avoid overzealous use of cutting hammers which could break through the base concrete. With prudent care, however, this topping method can be much more economical than the making of many small patches because it requires less saw cutting, allows more productive use of mixing equipment, and permits the use of mechanized finishing equipment.

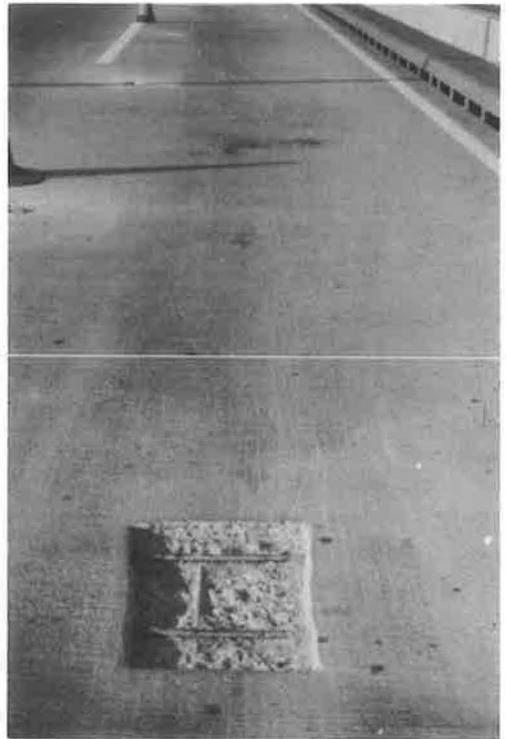
The second most important requirement is saw-cutting of the patch edges. On the Passaic River Bridge, the rate of failure of feather-edged patches is from five to ten times higher than those made with saw cut edges (Fig. 7).

Figure 7. Pothole well prepared for patching.

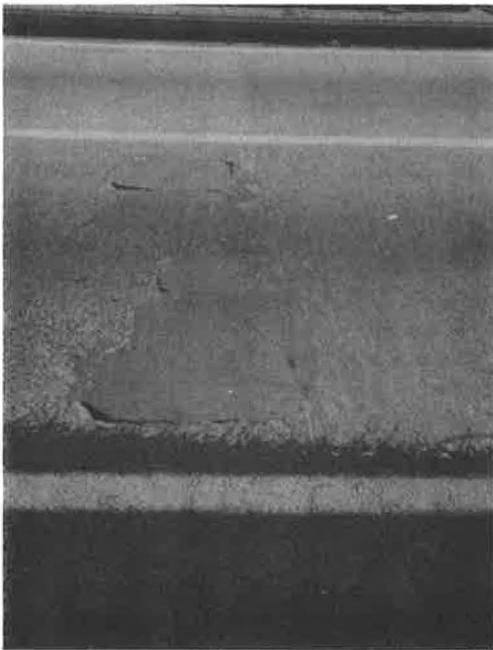
At first, experience with epoxy resin patches was rather unhappy, with one notable exception. Epoxy resin patches showed a rate of failure of 50 percent during the first year of traffic. In nearly all cases of such failure, peripheral cracks first appeared around the edge (Fig. 8). The patches then loosened and began to break apart under impact. This failure was caused by the inherent brittleness of many of the epoxy formulations used and by the different coefficients of expansion between epoxy and concrete. The development of peripheral cracks can be reduced by adding a flexibilizer to the epoxy formulation, but most of these flexibilizers tend to increase greatly the curing time and thus cancel one important benefit of using epoxies.

Figure 8. First stage of epoxy patch failure.

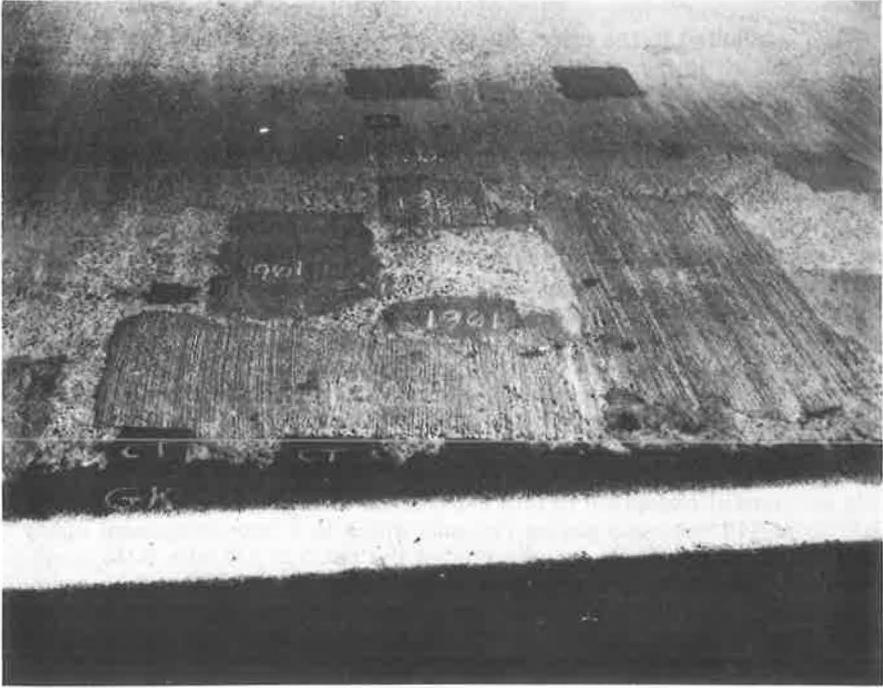
Figure 9. Group of successful patches made from nonshrinking concrete and coal-tar epoxy.

available. Where lanes can be closed down overnight or where concrete deck replacement is being made elsewhere within a lane, the portland cement material is used because the curing time is of no concern and the cost is slightly lower. But where lanes can be closed for only a few hours, coal-tar epoxy resin patches are used (Fig. 9).

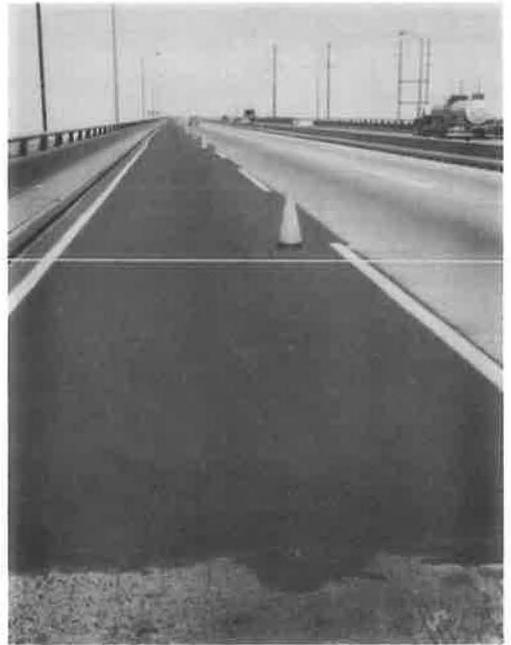
This latter type of treatment has markedly reduced the rate of spalling in the old concrete. To date, an 80 percent reduction has been realized in the rate of new spalled areas created. As a further note, at least one-half the spalls that did occur under the resinous paving cement were

Figure 10. Coal-tar epoxy resin roadway surfacing.

Two years ago, a coal-tar epoxy resin roadway surfacing material was laid on 3,000 linear feet of one lane. This material was a two-component epoxy resin mixed and applied to a sand-blasted deck surface from a specially designed distributor truck at the rate of 3 lb per sq yd. While the epoxy was still wet, emery grit was sprinkled over the entire area to produce a tough, skid-resistant surface (Fig. 10).

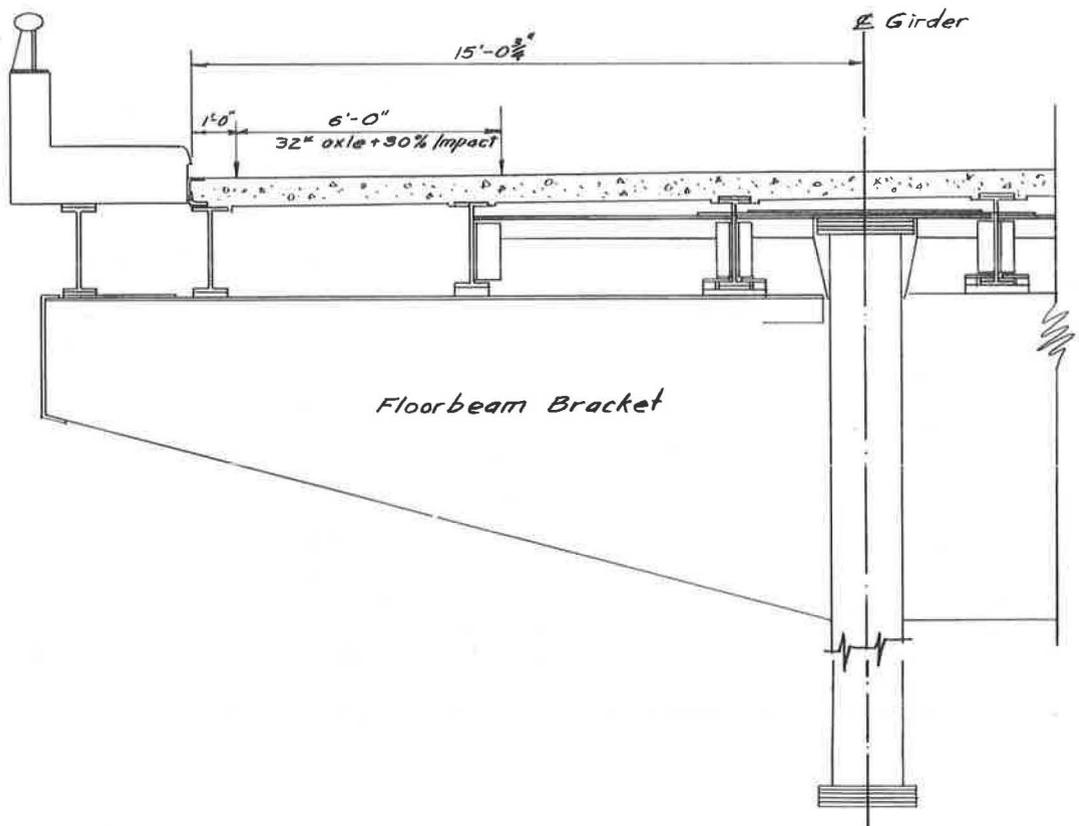
Figure 11. Cantilever bracket detail of floor beam.

Figure 11 shows the cantilever bracket detail of the floor beam. The outside lane is fully carried by this cantilever. Because of the high traffic count of heavy trucks that run in the curb lane, it is very likely that the floor beam bracket receives almost the full design load many times a day. This is very unlike most structural elements used in bridge construction. In this condition and because of the details selected, it is not unlikely that the bridge slab tends to act as a partial tension flange for the floor beam. Axial tension stresses in the transverse direction would no doubt be very detrimental to the performance of this slab.

Approximate computations indicate a possible transverse axial tensile stress of about 70 psi in the slab due to a truck load in the curb lane. This stress was obtained assuming that the slab acted as a tension flange and the bottom flange of the bracket as a compression flange. With dual axles and a higher impact than 30 percent, this stress could be higher. Contributing to the problems of concrete placed under rather adverse construction conditions, over finishing, improper placement of reinforcing steel, and inadequate slab thickness, is the matter of the interaction of the slab in both longitudinal and transverse bending. The provision made in the steel details for minimizing the longitudinal interaction may have caused secondary problems not contemplated.
