Rehabilitation of Two Concrete Arch Bridges

VERE P. MAUN, Principal Civil Engineer (Design), New York State Department of Public Works

During 1962 the extensive repairs being made to two long concrete arch bridges at Troy, and Glens Falls, N. Y., were completed. This paper discusses the extent of the damage encountered, the methods used to repair and protect the concrete, and the unit costs of the various contract items.

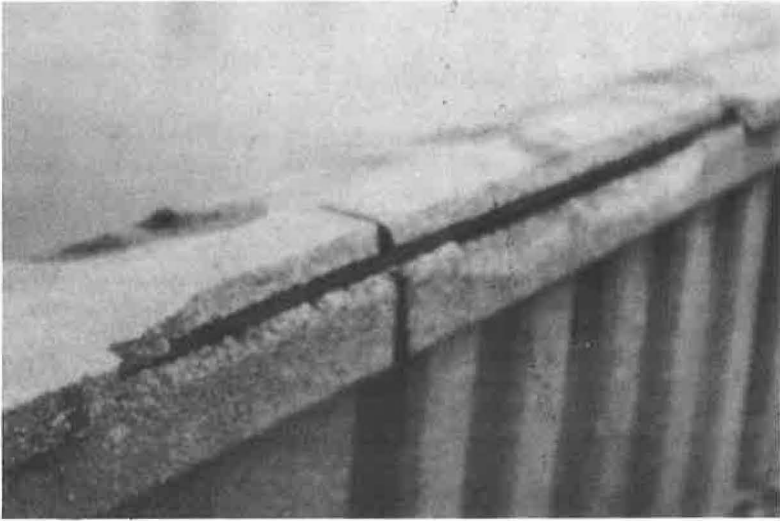
1. The concrete fill under the roadway was breaking up.
2. Curbs were badly disintegrated.
3. Sidewalks had large areas of spalled surfaces.
4. Railings and pylons had many disintegrated places on them (Fig. 1).
5. Retaining walls and vertical spandrel walls were spalled and unsightly (Fig. 2).
6. The exposed bottom surface of the arch barrels had holes and other disintegrated areas showing.
7. Many of the steel plates on the bascule span needed replacing, having been eaten away by corrosion.
8. The timber block floor on the bascule span was disintegrated and broken up, plus being slippery in wet weather, causing many accidents.

Figure 1. Sidewalk railing before repair, 112th St. Bridge, Troy.

bad concrete removed, then were coated with an epoxy bonding compound before applying gunite (Fig. 4). The proper outlines were restored by use of shooting strips, rubber trowels, and other means known to guniting operators. Finally, all concrete surfaces were sprayed with two coats of a waterproofing bakelite paint (Penetryn). The second coat had a color to it which made all concrete surfaces have the same color and which greatly dressed up the concrete in appearance (Fig. 5).

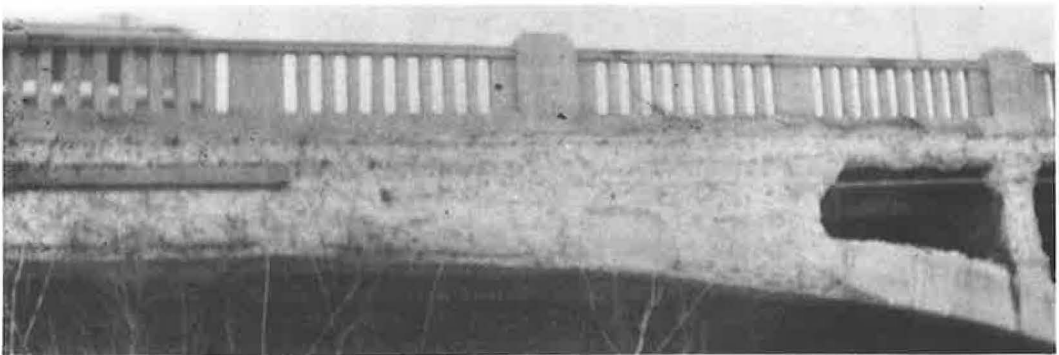
Figure 2. Spalled arch ribs before repair, 112th St. Bridge, Troy.

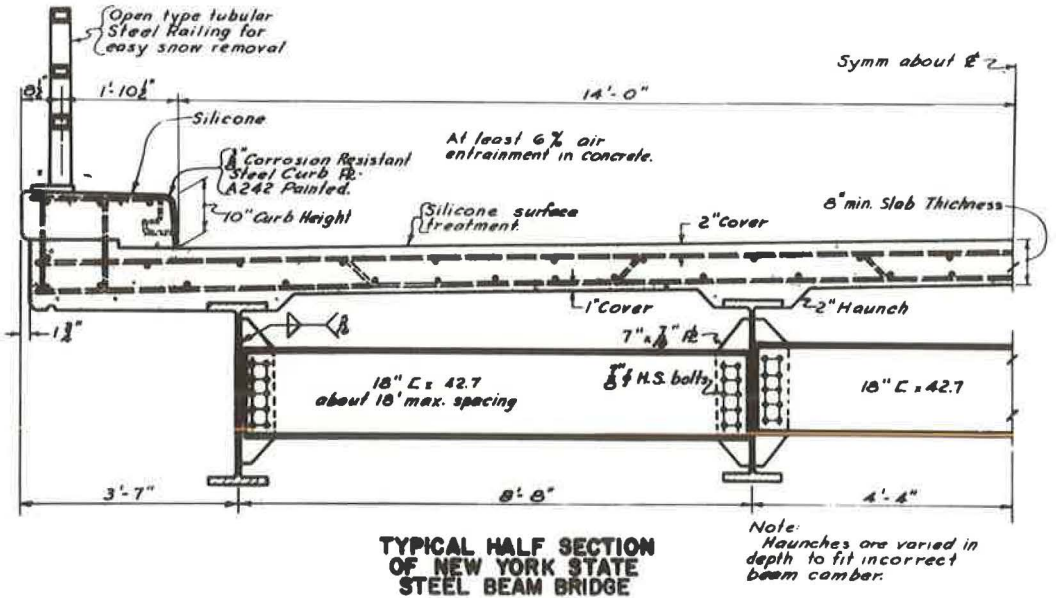
Figure 3. Method used to protect steel I-beam bridge decks from salt damage.

It was estimated that it would cost over \$300,000 to rehabilitate the bridge, and a contract was let to do the work. When work started, about 12 in. of fill concrete, wearing surfaces, and old steel ties were removed down to the arch slabs. A new air-entrained concrete fill was poured with the proper crown. It was then covered with silicone and then fiberglass coating. Over the fiberglass coating was placed 2½ in. of asphaltic concrete as a wearing surface. The curbs were cut back with saws and jack hammers and replaced by granite curbs. Damaged areas were sawed and removed by jack hammers to a depth of about 2 in. and repaved with new concrete rich with air entrainment. This new concrete and all old sidewalk areas were covered with epoxy bonding compound and then sprinkled heavily with silica sand. The epoxy was to protect sidewalk surfaces from salt damage and the sand was added to give pedestrians good traction, as epoxy is slippery without sanded surfaces (Fig. 3).

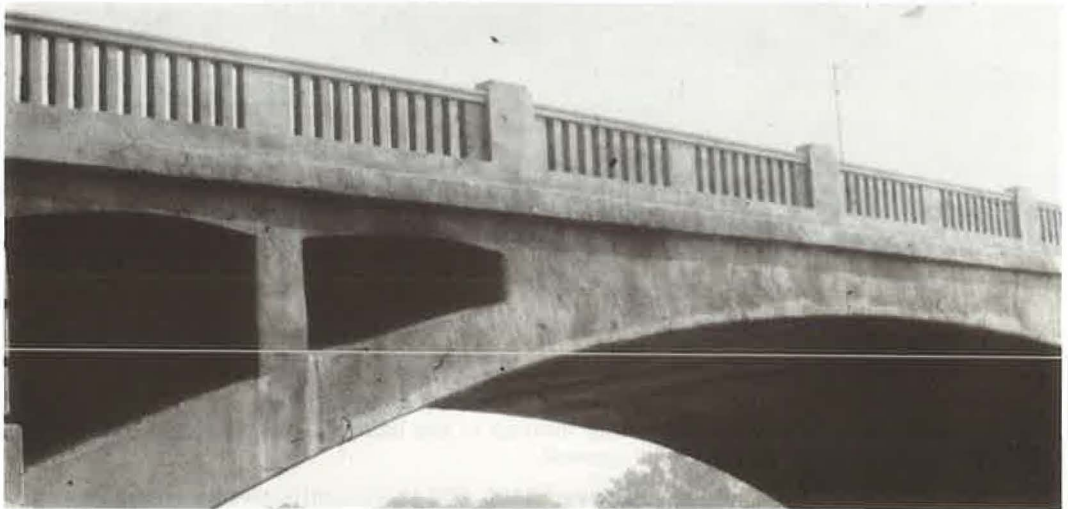
Figure 4. Railing after repair with gunite and waterproofing paint, 112th St. Bridge, Troy.

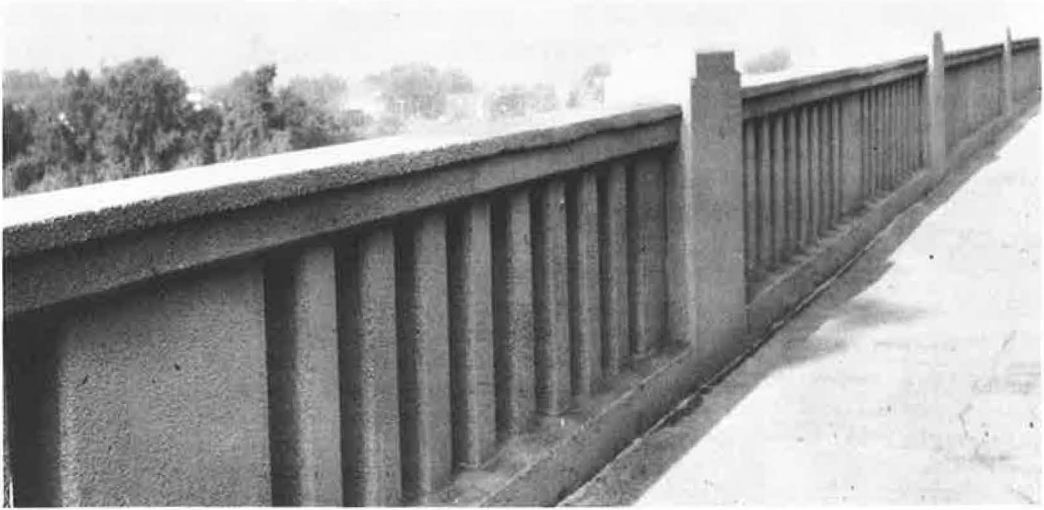
Figure 5. Arch rib after repair with gunite; waterproofing paint not yet on, 112th St. Bridge, Troy.

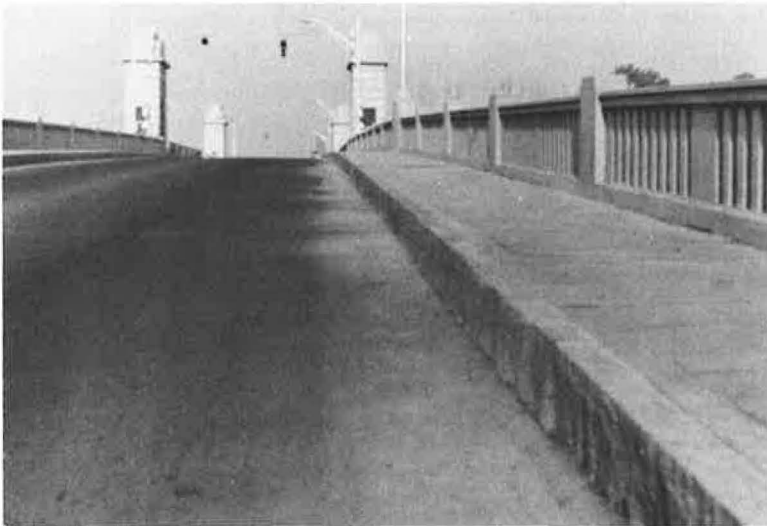
Figure 6. 112th St. Bridge, Troy, after repair; new roadway slab and steel grating on bascule span, new granite curbs, sidewalks repaired and protected by epoxy bonding compound covered with silica sand for traction, all concrete repaired and waterproofed.

The steel in the bascule span was repaired, cleaned, and painted. A new 5-in. steel grating floor was placed on the roadway using steel channels for curbs. A 1-in. grating floor was placed on the sidewalk and this grating was filled with lightweight concrete. New steel railings were put on the bascule span (Fig. 6). All machinery and electric motors were cleaned and rehabilitated. New light standards and lights were put on the bridge and new electric gates were installed for halting bridge traffic when the bascule was open.

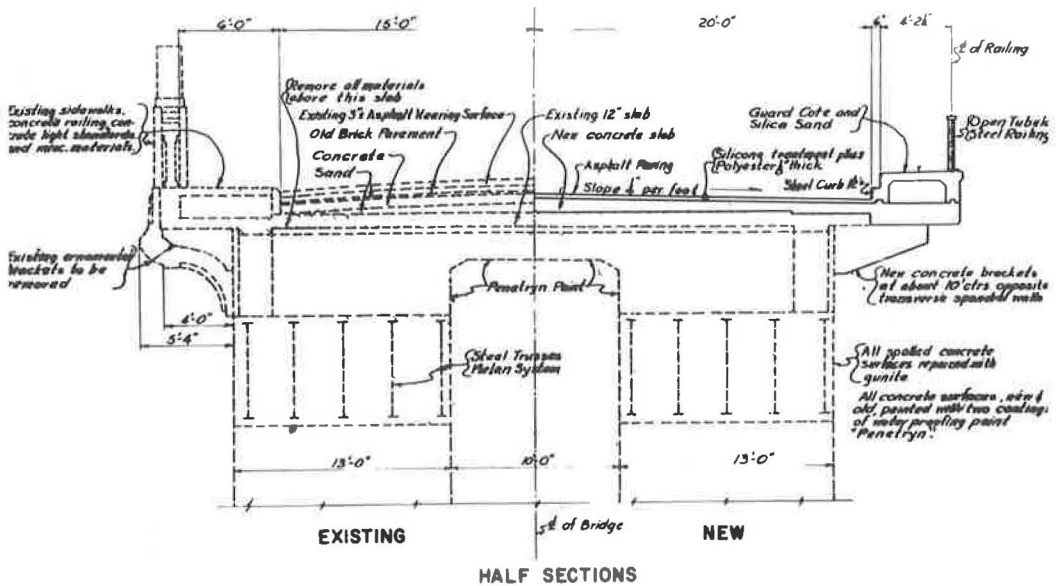
Figure 8. Rehabilitation of Glens Falls Bridge: left half, how bridge was built; right half, how bridge was repaired and widened.

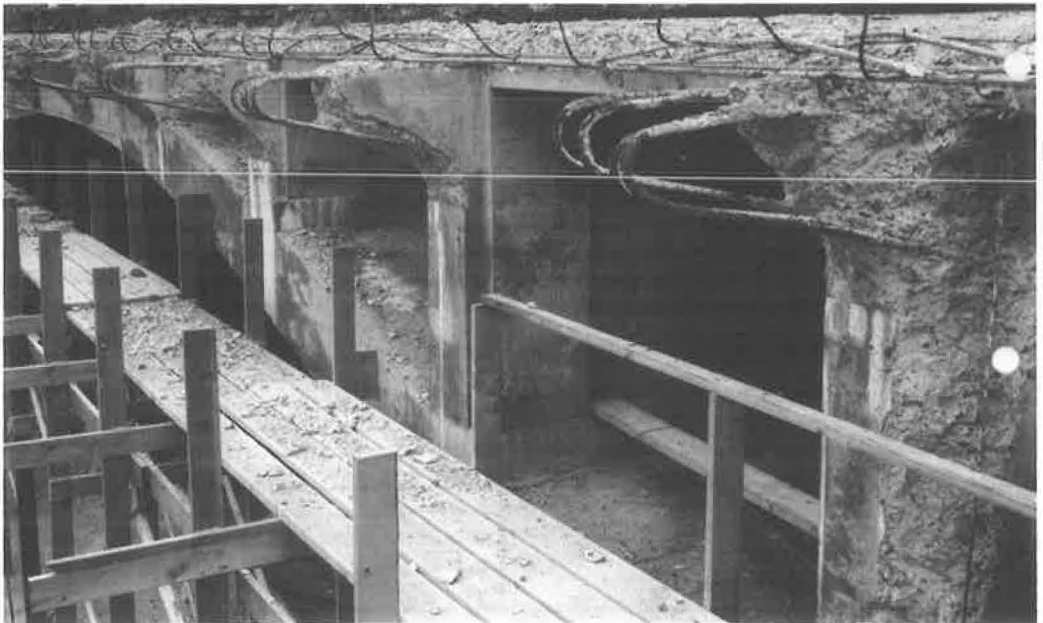
Figure 9. Glens Falls Bridge concrete arches, deteriorated concrete being removed.

above the bridge; the sulfides appear to have also acted to deteriorate the concrete along with the chlorides applied by salting.

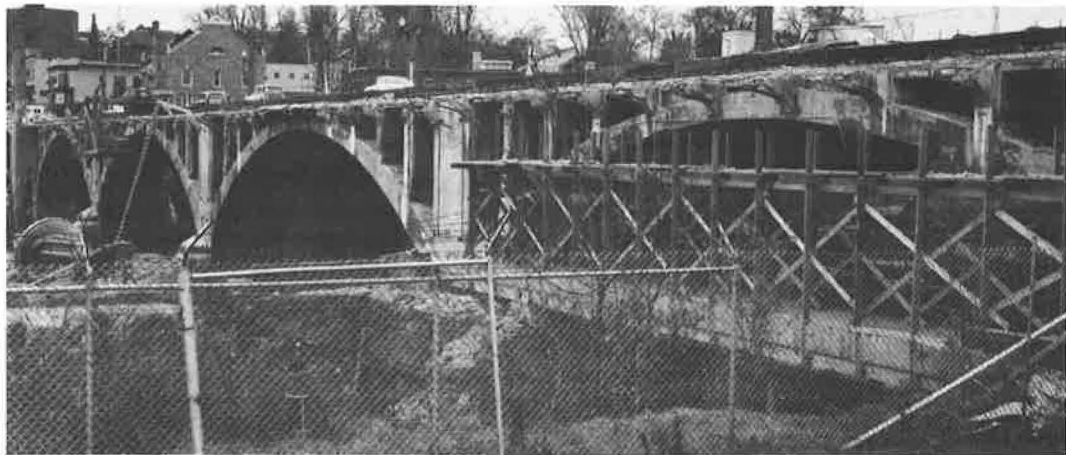
Figure 10. Glens Falls Bridge concrete arches after railings and wearing surfaces have been removed preparatory to repair and widening.

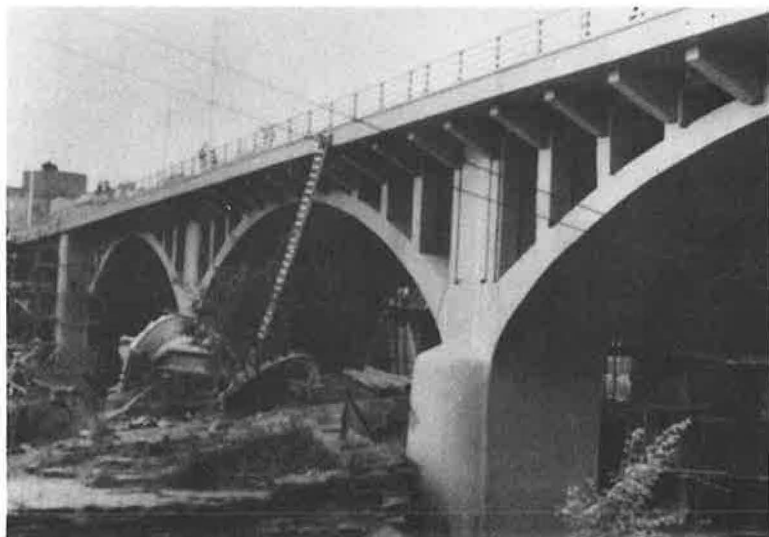
Figure 11. West side of Glens Falls Bridge after being repaired and waterproofed.
