New Mexico's Semiannual Condition Surveys

Effect Changes in Geometric and Structural Designs

CHARLES W. JOHNSON, Engineering Director, New Mexico State Highway Commission

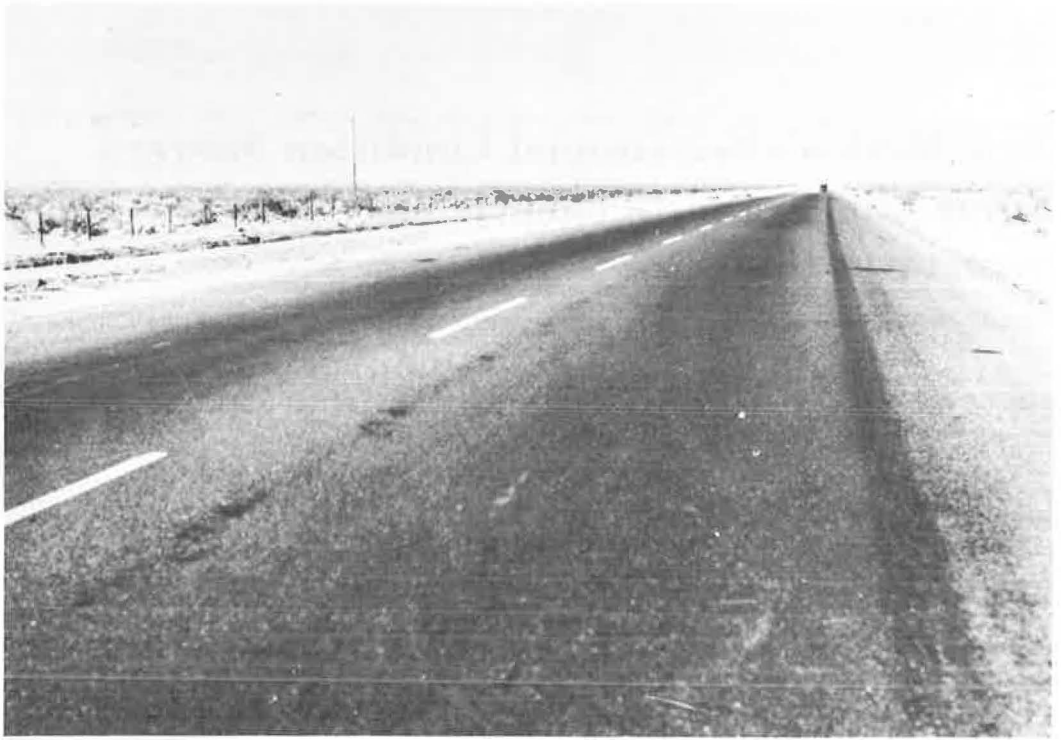
Figure 1. Pavement constructed with crushed limestone, showing little cracking 3 yr after placement.

In contrast, a 12-mi project constructed in 1958 was found on a post-condition survey to be in excellent condition, without any cracking, 7 yr after construction. The coarse aggregate used in the hot mix was crushed limestone; it indicated a very low volumetric change due to temperature. Although cracking is widespread in New Mexico, this project indicates that through careful control of material and placement, cracking can be greatly alleviated. Comparison of pictures taken at the same location (Alamogordo Orogrande) 4 yr apart shows little change (Figs. 1 and 2).

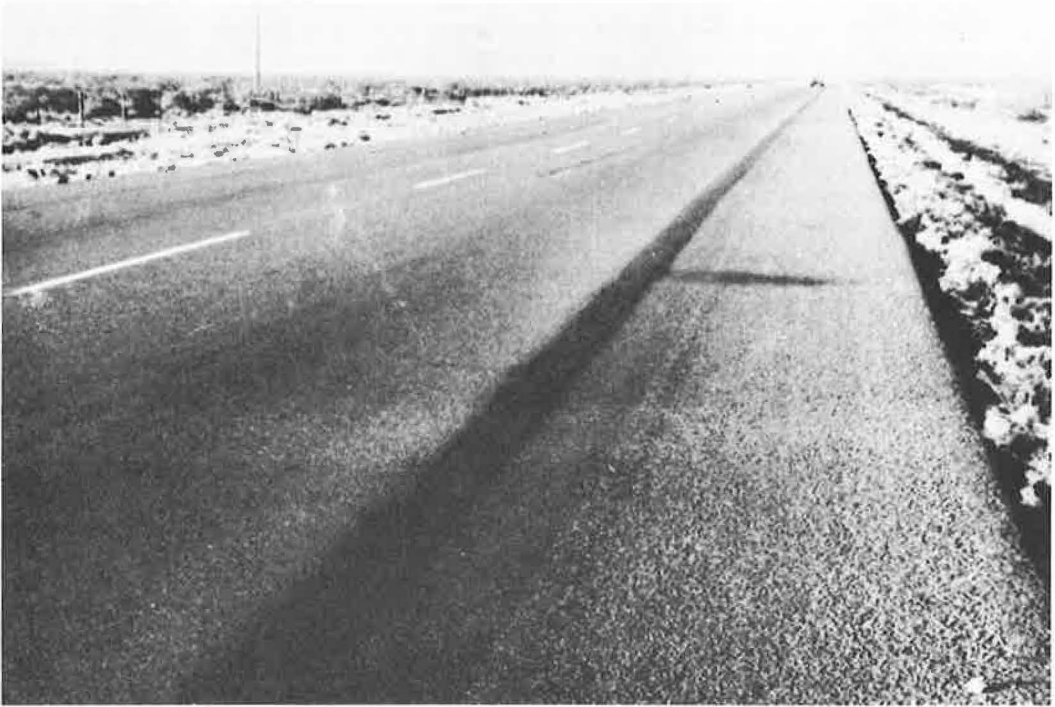
Figure 2. Pavement constructed with crushed limestone, showing little cracking 7 yr after placement.

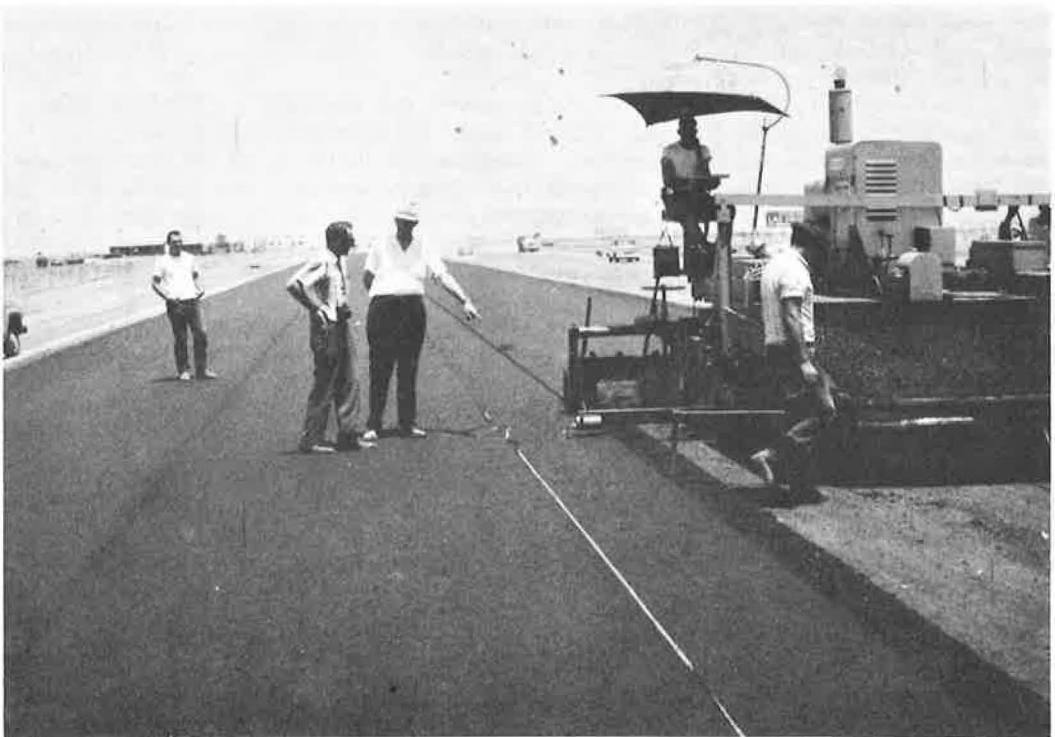
Joint cracking at a point adjacent to a preceding hot-mix lay is probably due to internal stresses, and develops frequently in the Southwest. Past practice in New Mexico was to lay the shoulder more or less vertical. Present practice is to lay the longitudinal joints on a slope and leave the slope uncompacted until the adjacent lane is placed. With this procedure a more homogeneous mass is produced, instead of a potential cleavage plane (Fig. 3).

Figure 3. Longitudinal shoulder joints being laid on slope which is compacted after adjacent lane has been placed.

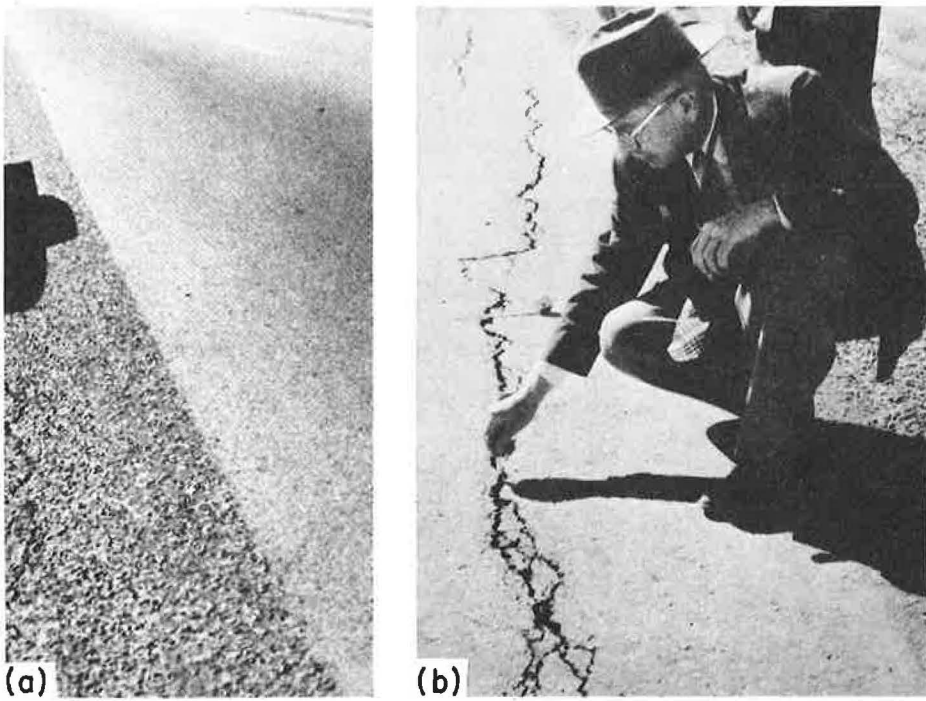
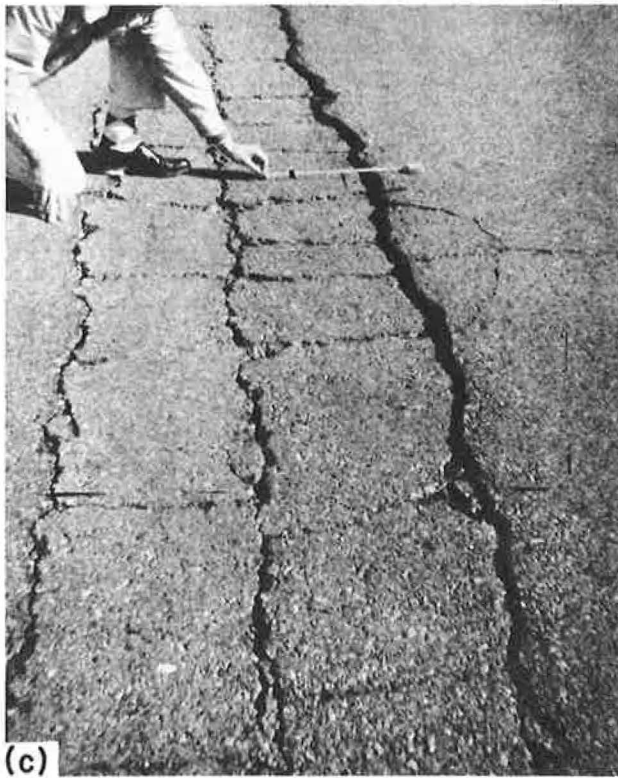
The first cracks to appear in the paved shoulders are probably the result of soils movement in the subgrade. In the Southwest there are alternating cycles of moisture and extreme drought which in turn cause a swelling and shrinkage of the soils beneath the pavement. The susceptibility of the soils to moisture varies over a wide range; consequently, cracking patterns vary accordingly. When cracks begin to open up they permit entry of surface water and the condition becomes progressively worse (Fig. 4).

It is quite noticeable that the worst conditions are more pronounced in fills with relatively steeper side slopes. The westbound lane adjacent to the project under discussion was constructed in 1943 with much flatter slopes. There is no indication of similar distress, although the embankment was constructed of the same type of borrow and traverses the same terrain.

Figure 4. Typical progressive deterioration from shoulder cracking: (a) early shoulder cracking; (b) progressive cracking into driving lane; and (c) ultimate failure.

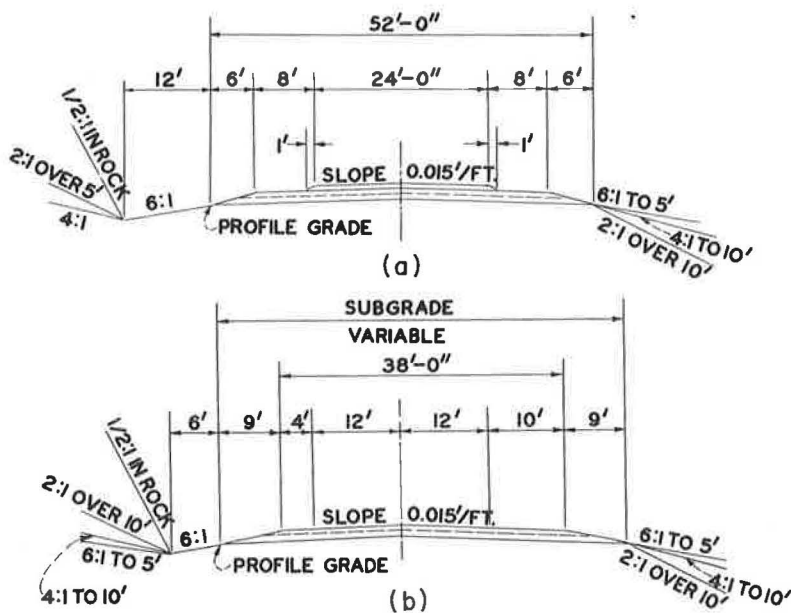
Figure 5. (a) Old and (b) new typical sections.

Early in 1965 the New Mexico State Highway Department changed the standard design of slopes from a minimum of 4-to-1 to a minimum of 6-to-1 for a distance of 9 ft beyond the paved shoulder (Figs. 5 and 6).

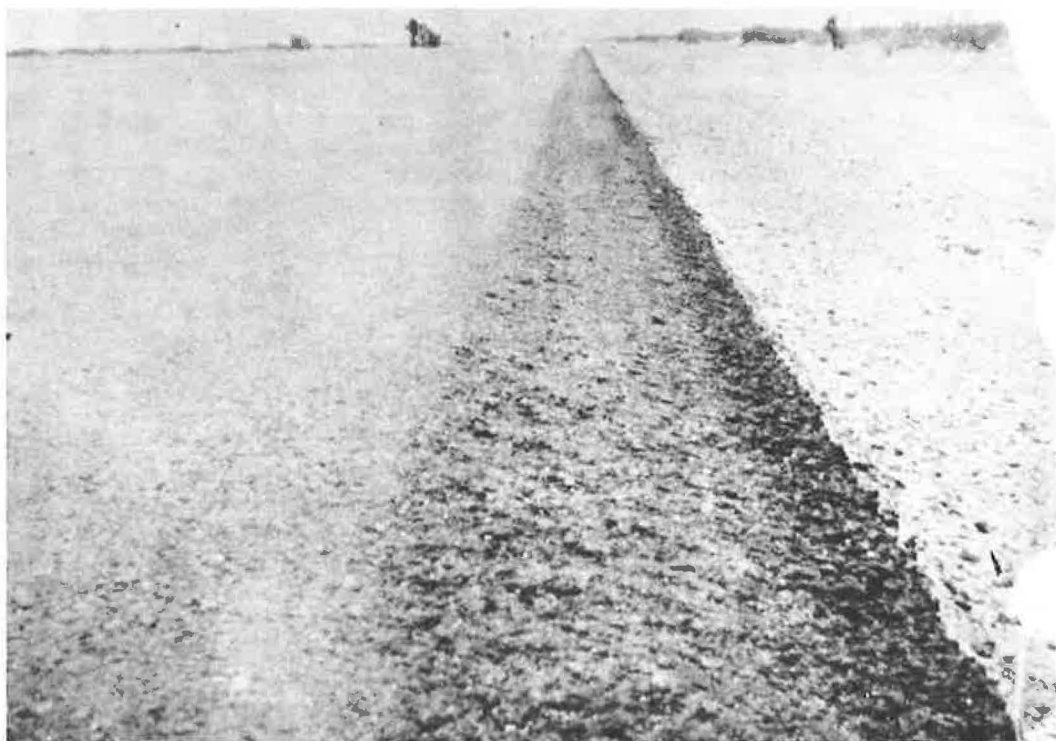
Figure 6. New design shoulder slope, June 21, 1965.

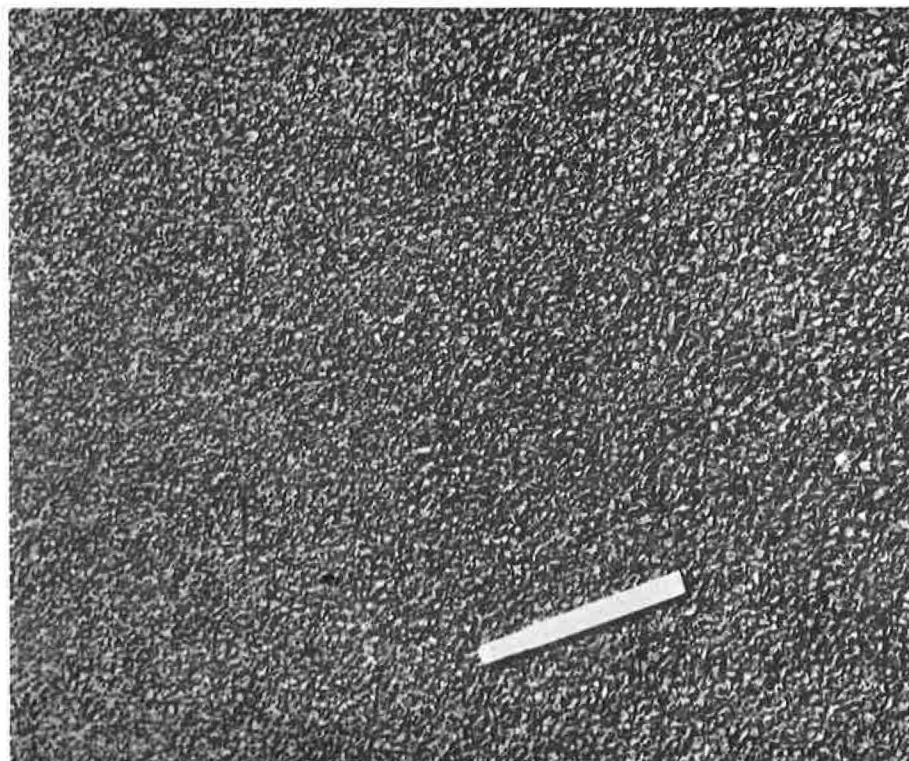
For some unknown reason, surfaces constructed with this design and tested with the U. S. Bureau of Public Roads roughometer show a lower reading (by about 20 in. per mile of deviation) than the normal hot-mix surface. The mix when properly laid has a dense terra cotta effect and provides an excellent nonskid surface. Allowance is made for the $\frac{1}{2}$ -in. layer in the final thickness determinations (Fig. 8).

Figure 8. PI mix seal; Arizona state line—road forks.

Recently a $\frac{1}{2}$ -in. plant mix seal coat was used on numerous projects with satisfactory results. The specifications require a minimum of 75 percent of the material retained

The key to a successful seal with this mix is the asphaltic content. New Mexico uses $6\frac{1}{2}$ to 7 percent of 60 to 70 or 85 to 100 asphalt cement by weight of the total mix. It is necessary to lay the mix at lower temperatures than the usual asphaltic concrete mixes to retain a thick film over the aggregate particle. The asphalt flows gradually down to the surface of the mat and completes the seal. Warm weather and traffic are necessary to accomplish the best results.
