Preliminary Studies of Effect of Studded Tires on Highway Pavements

P. A. JENSEN and G. R. KORFHAGE

Respectively, Research Engineer, and Research Project Engineer, Materials and Research Section, Minnesota Department of Highways

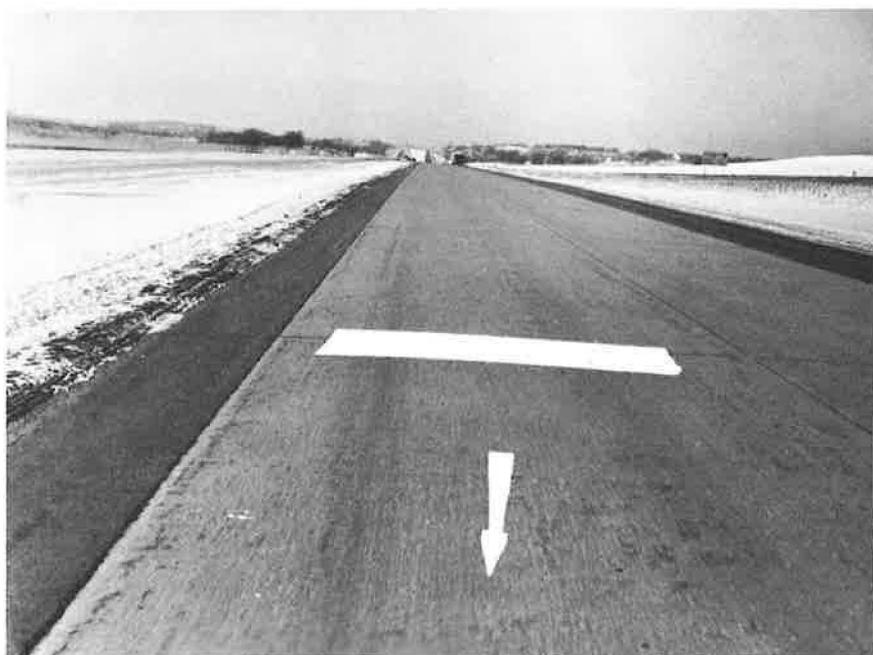
Normal Stops.—The location of the test section where normal stops were made on the concrete pavement is shown in Figure 3. The white bar in the picture indicates the location of a hypothetical stop sign. The vehicle approached this section at 30 mph, traveling in the direction indicated by the arrow and braked to a complete stop at the white bar. The surface condition of the concrete pavement after 210 normal stops is shown in Figure 4. There was little or no apparent difference in the surface condition of the pavement in the wheelpath (area to the left of pencil in Fig. 4) and the untested concrete pavement (area to the right of pencil). The dark spots evident on the pavement surface in this picture are oxidized residues from snow plow blades. There was no visible change in the condition of the concrete surface after 310 normal stops.

Normal Starts.—After the vehicle had completed a normal stop at the location shown in Figure 3, a normal start was made. The condition of the pavement surface after 310 normal starts was similar to that of the section where the normal stops were made. Although the studs left visible short, scratch-like marks on the concrete in both test sections, there was no apparent abrasive loss of the concrete surface.

Figure 3. Location of normal stopping and starting tests on concrete.

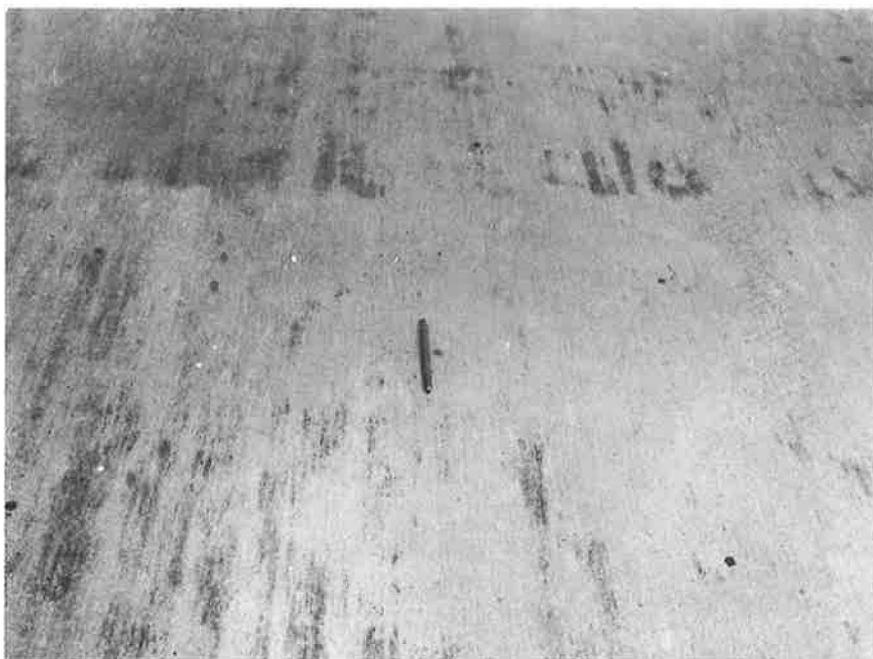
Figure 4. Surface of concrete after 210 normal stops.

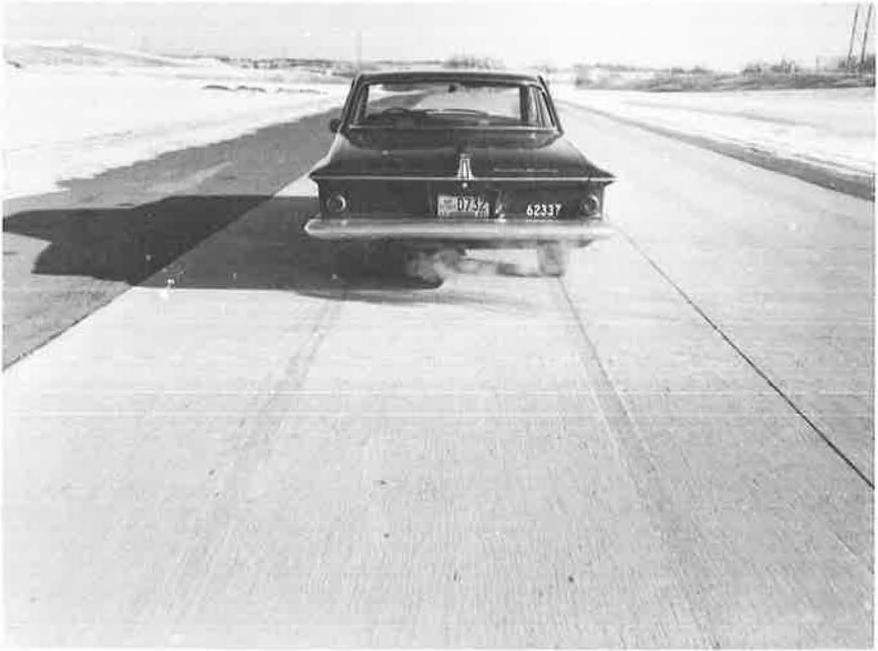
Panic Stops.—At the beginning of this study, panic stops were made from speeds of 10, 20, 30 and 50 mph. Figure 5 shows the concrete surface after a single panic stop from 30 mph at a location where no other tests had been made. The skid marks and the scratches left by the studs are visible in the foreground.

Figure 5. Concrete surface after single panic stop.

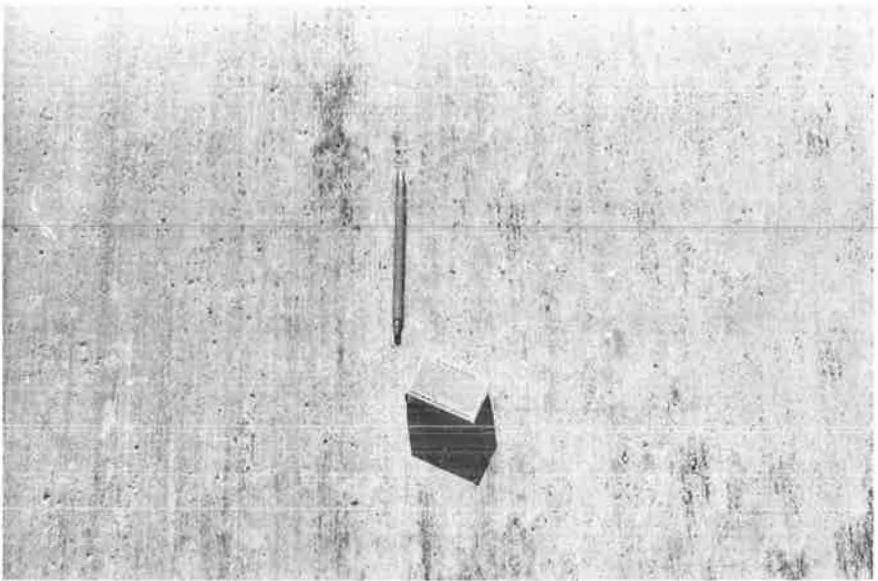
Figure 6 shows the condition of the concrete surface after 310 panic stops had been made from a speed of 20 mph. The wheelpath is shown on the left in the picture and the

Figure 6. Surface of concrete after 310 panic stops.

untested surface on the right. The concrete had become quite polished in the wheelpath but the abrasion was limited to loss of the surface finish produced by the burlap drag. There was no measurable amount of rutting evident when a straightedge was laid across the wheelpath.

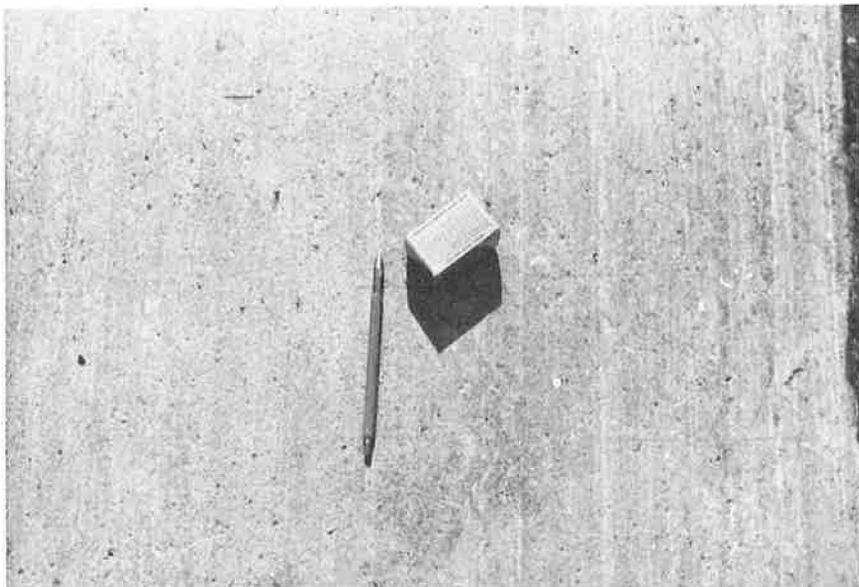
Figure 7. Surface of concrete after 310 rapid starts.

Rapid Starts.—Rapid starts had about the same effect on the concrete as did the panic stops. The surface became quite polished and the burlap drag surface finish was lost. There was no measurable rutting. The condition of the concrete surface after 310 rapid starts is shown in Figure 7. The wheelpath is on the right in this picture.

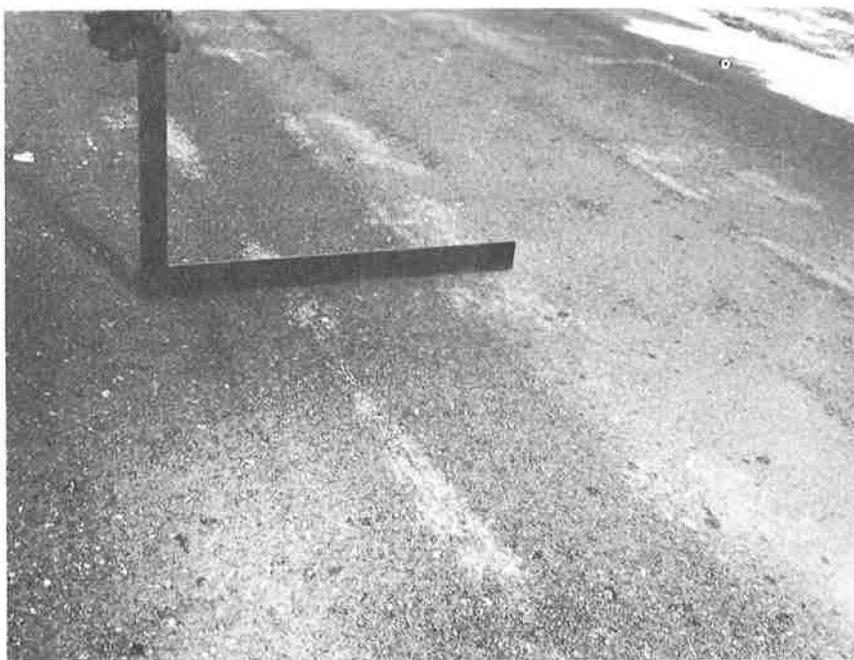
Figure 8. Surface of bituminous pavement after 210 normal stops.

Normal Stops.—No significant damage was done to the bituminous surface after 310 normal stops, although the first signs of some surface abrasion were beginning to appear. In Figure 8, little difference can be detected between the condition of the surface in the wheelpath (covered by the carpenter's square) and the untested surface to the left, but there is a difference in surface texture of the untested surface to the right of the wheelpath. The carpenter's square, placed across the wheelpath, shows that no rutting occurred.

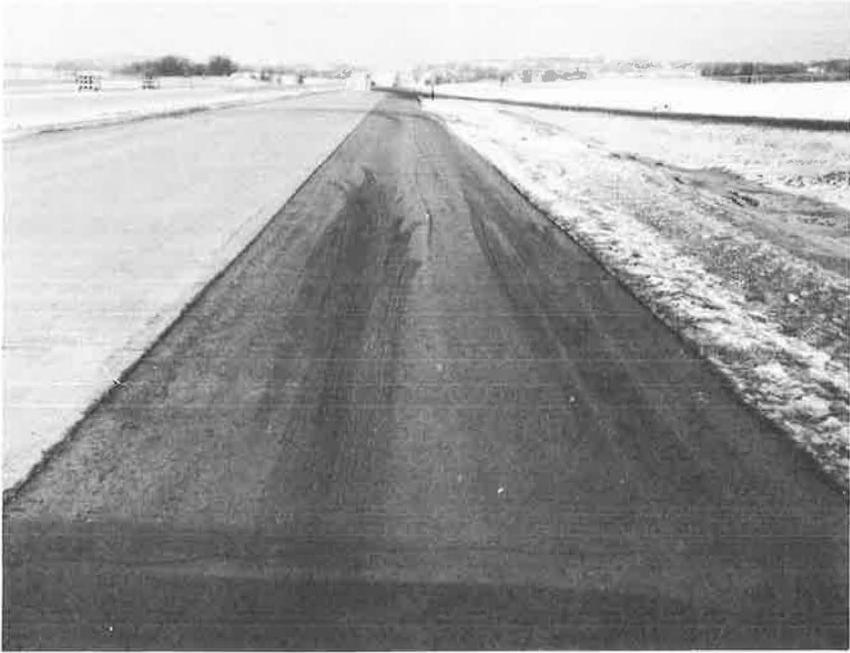
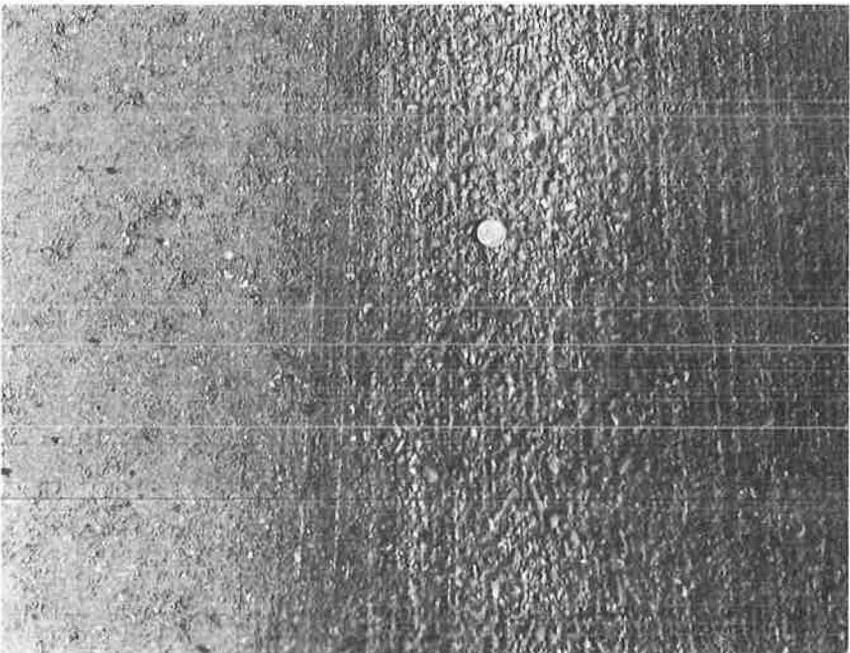
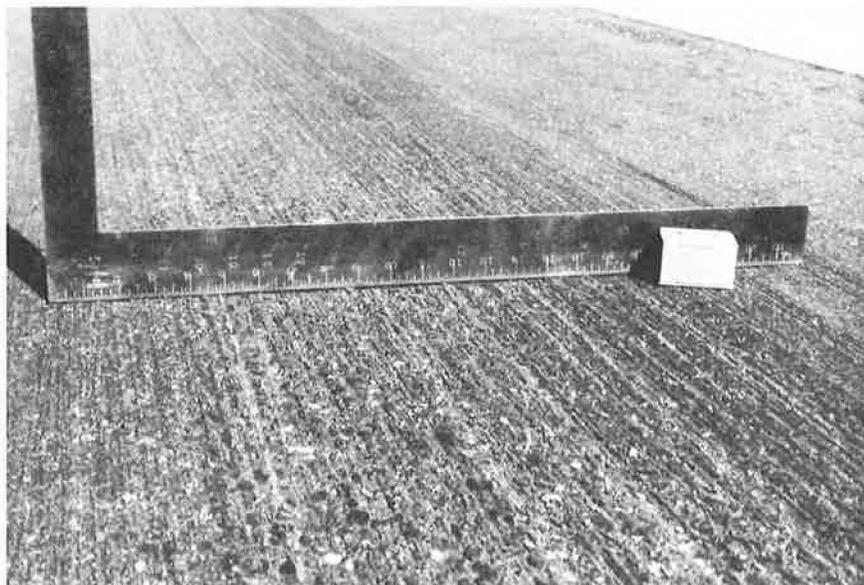
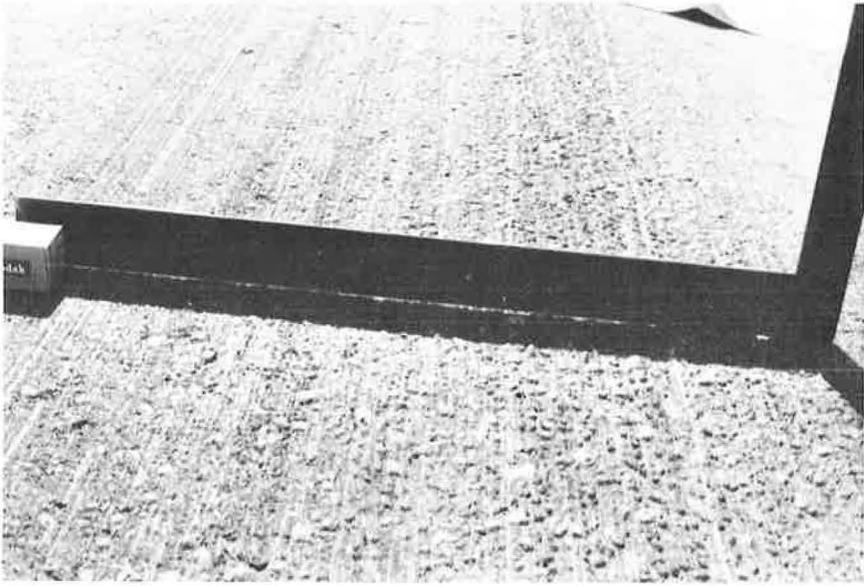
Figure 9. Bituminous surface after 210 panic stops.

Figure 10. Bituminous surface after 210 panic stops.

Figure 11. Bituminous surface after 310 panic stops.

Panic Stops.—The bituminous pavement was significantly damaged from repetitions of panic stops. The damage progressed from single gouges produced by each of the four rows of studs in each tire to severely abraded wheelpaths. Figures 9 through 12 show the condition of the bituminous surface after 210 and 310 panic stops from a speed of 20 mph. The abrasive damage was principally loss of fine aggregate and bitumen from between the coarse aggregate particles leaving a very rough, open-textured surface. There was little, if any, actual rutting (Fig. 12). Many of the coarse aggregate particles are still touching the straightedge.

Figure 12. Bituminous surface after 310 panic stops.

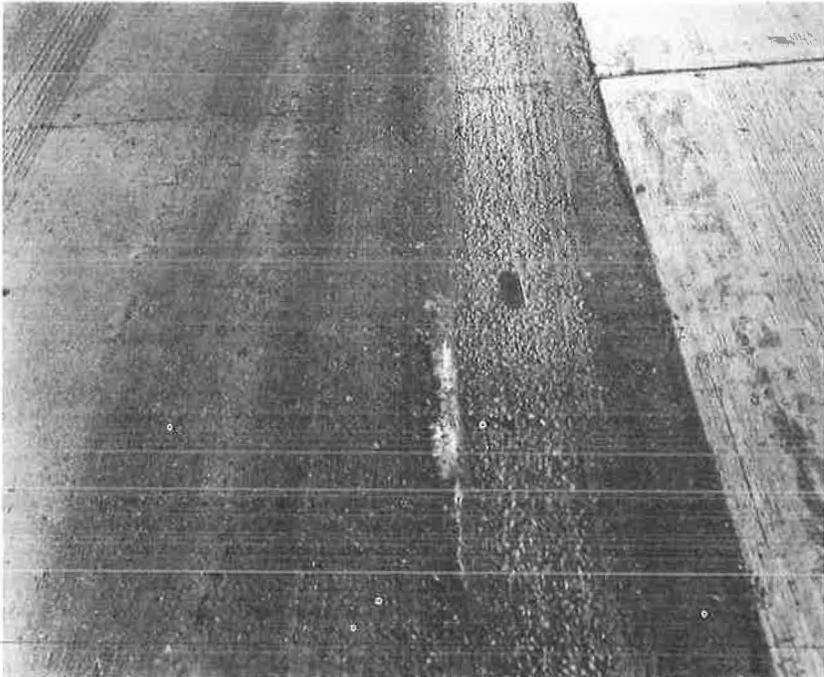
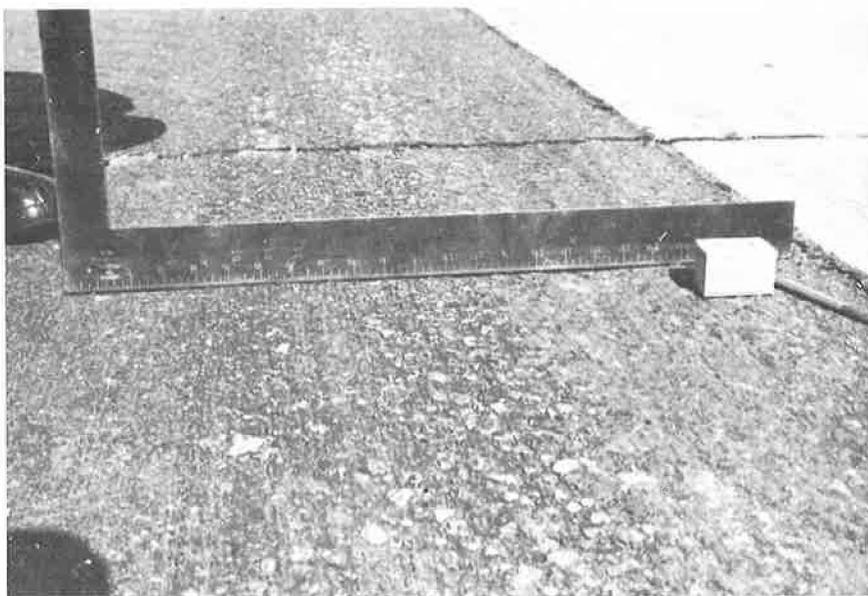
Rapid Starts.—There was a significant amount of damage to the bituminous pavement from repetitions of panic starts. The damage started and progressed similarly to that produced by the panic stops. Figures 13 and 14 show the condition of the bituminous surface after 210 and 310 rapid starts, respectively. In Figure 13 the pencil is lying in the wheelpath where most of the repetitions were made. To the left of this main wheelpath is an area where only a few rapid starts were made. The damage to the surface from this test was very similar to the damage done in the panic stop tests. Although in Figure 14 it appears that some very shallow rutting has occurred, this is not positive, since it is not known whether the surface was a true plane at this location before testing started.

Figure 13. Bituminous surface after 210 rapid starts.

Figure 14. Bituminous surface after 310 rapid starts.

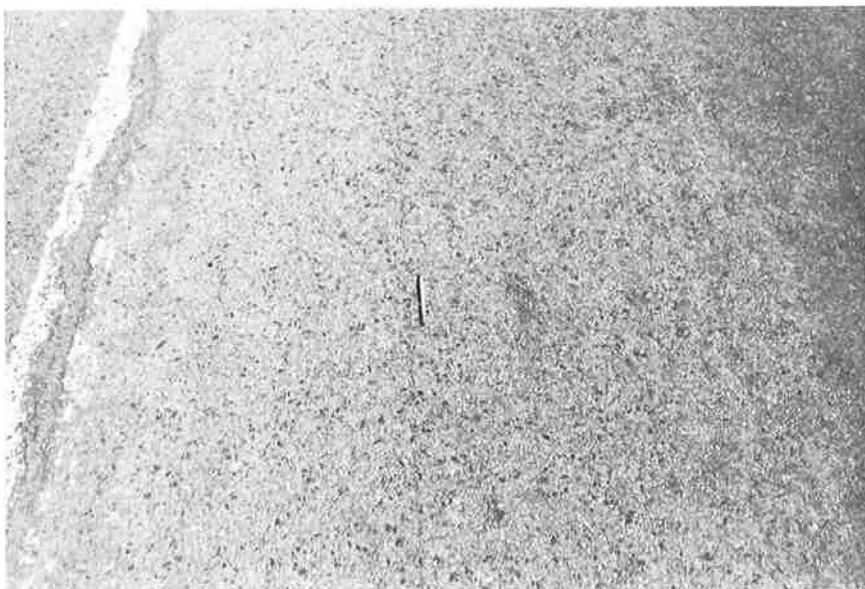
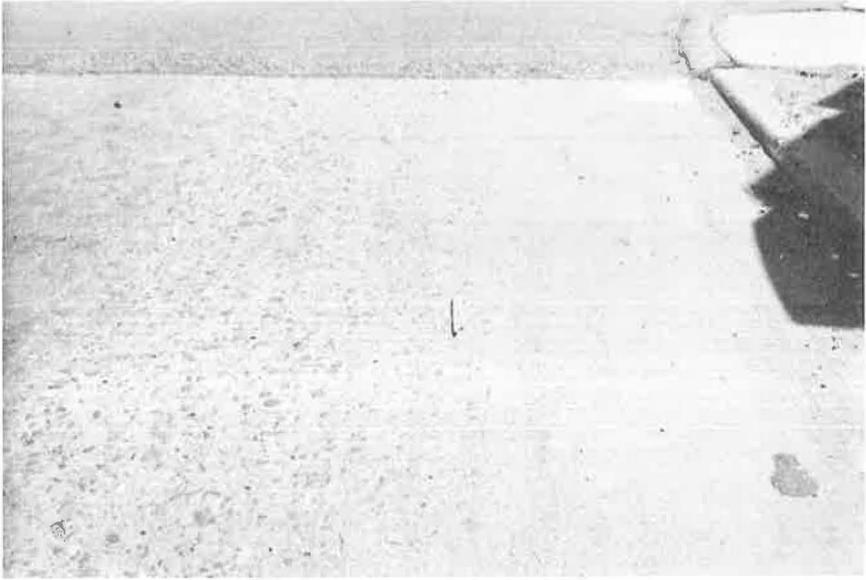
Figure 15. Condition of bituminous surface at typical intersection.

Figure 16. Condition of concrete surface at a high volume intersection.

Abrasive damage at controlled intersections is not a new problem. Damage to pavements has long been evident, particularly at intersections, from the abrasive action of normal traffic and sand commonly used in winter maintenance. Figure 15 shows the condition of a 7-yr-old bituminous pavement at a typical signalized urban intersection. The damage at this location is not unlike that which was done by the studded tires in the panic stop and rapid start tests. Figure 16 shows the abrasive damage that a 10-yr old concrete pavement has sustained at a typical high traffic volume urban intersection.

maintenance at signalized or controlled stop intersections. The extent of damage would probably not be so great as to make the required maintenance or repair an impossible task. These localized areas could undoubtedly be restored or repaired using regular or, if necessary, special maintenance techniques and materials.

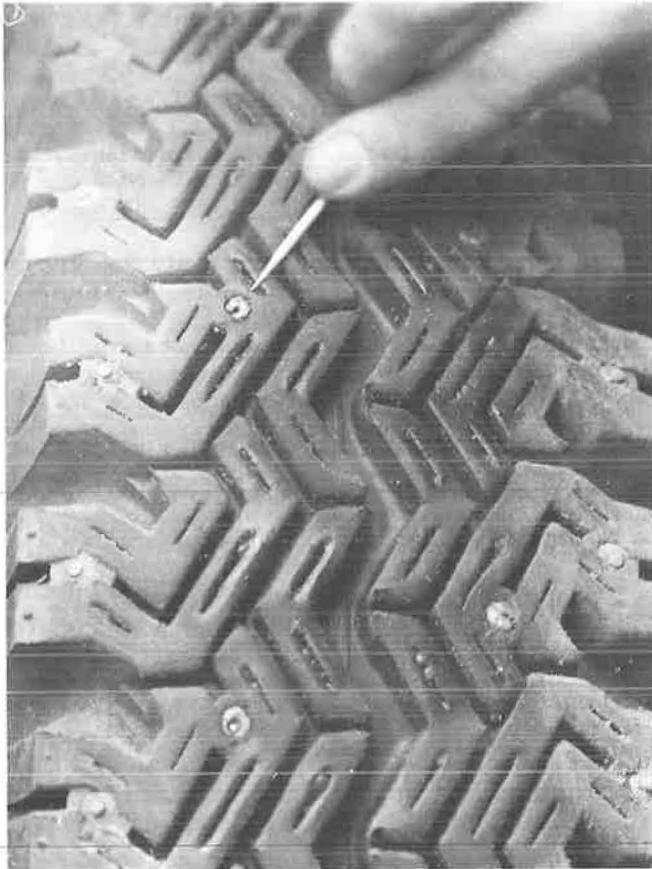
Figure 19. Condition of plastic encasement type studs after 21 series of stops and starts.

Plastic Encasement Type. — After 21 series of stops and starts (168 panic stops from various speeds and 63 rapid starts), a total of five cores was missing from the right rear tire (the tire on which plastic encasement type studs were used). All of these were from the inner two rows. In some cases, only the tungsten carbide core was missing, but in other cases, the plastic encasement was gone also. A number of other cores were thrust part way through the side wall of the plastic encasement. The cores which were not missing had rounded-off edges but were still in fair condition. At this

time, these tires had been driven less than 400 miles. However, it must be remembered that during this period the tires were subjected to much more severe use than would be encountered in normal driving. Figure 19 shows the condition of some of the plastic encasement type studs.

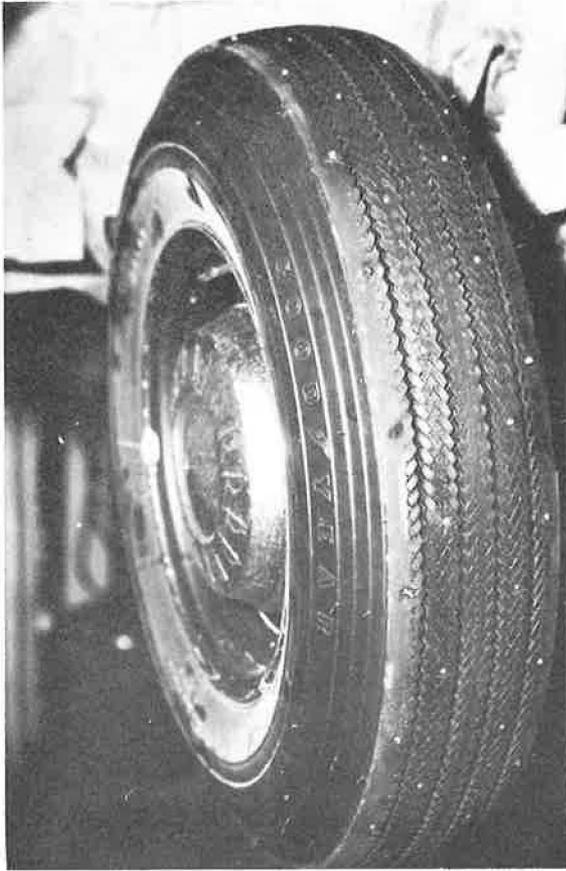
Figure 20. Condition of steel encasement type studs after 21 series of stops and starts.

Steel Encasement Type.—No studs or cores were missing from the right front or left rear tire after 21 repetitions of stopping and starting at each test site. However, one stud had been lost from the left front tire. A number of cores, especially those

in the outer rows of the front tires, had developed a sharp point. Most of the other studs appeared to be in good condition. Figure 20 shows the condition of the studs in the left front tire. The outside edges of the front tires had worn down about $\frac{1}{4}$ to $\frac{3}{8}$ in. during this short period (Fig. 21).

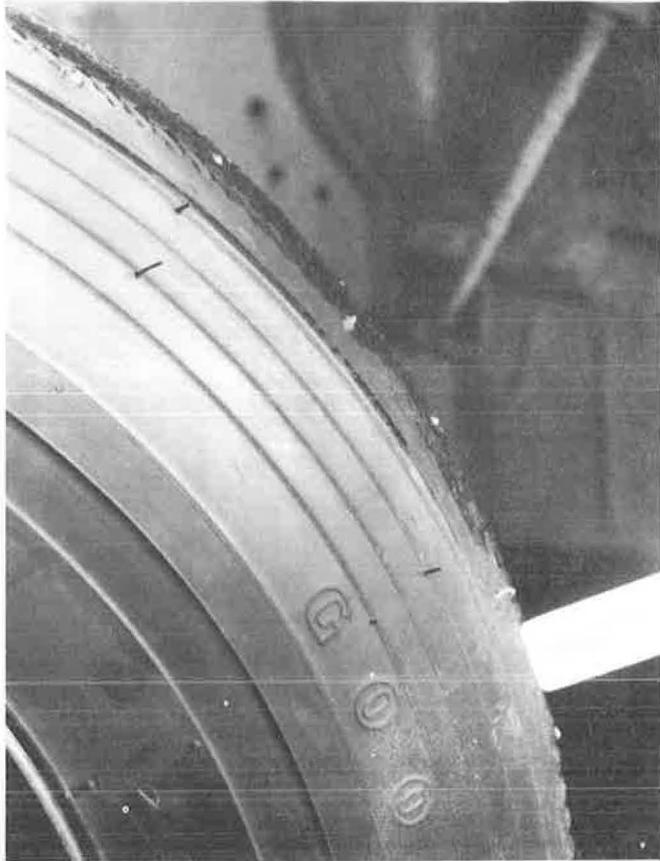
Figure 21. Wear on front tires after 21 series of stops and starts (400 mi total travel).
