Restoration of Joint and Spall Failures on PCC Pavement

J. O. KYSER, District Engineer, and
C. E. RICE, Research Engineer, North Dakota State Highway Department

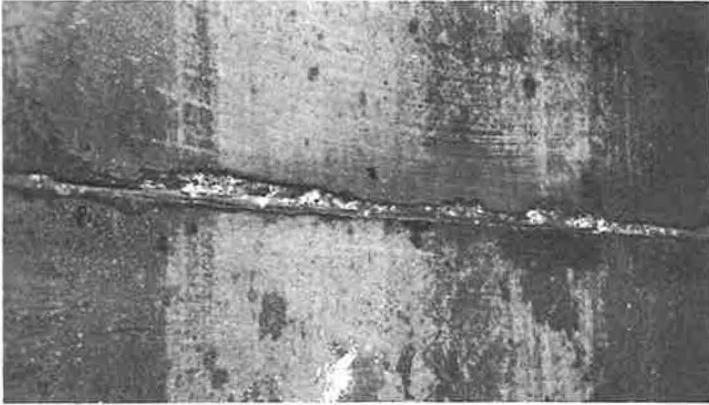
During 1962 and 1963 the spalls became larger, deeper, and more numerous. Joint seals had failed entirely and were allowing incompressible material to enter the joints. This added to the stresses on the pavement joint edges as the slabs expanded in hot weather (Fig. 1). Two years after the pavement was constructed, some joints had spalled so deeply that the dowel bars were visible. Some spalled areas 1 to 2 ft wide extended the full width of the street and were becoming traffic hazards (Fig. 2).

Figure 1. Slab expansion in hot weather.

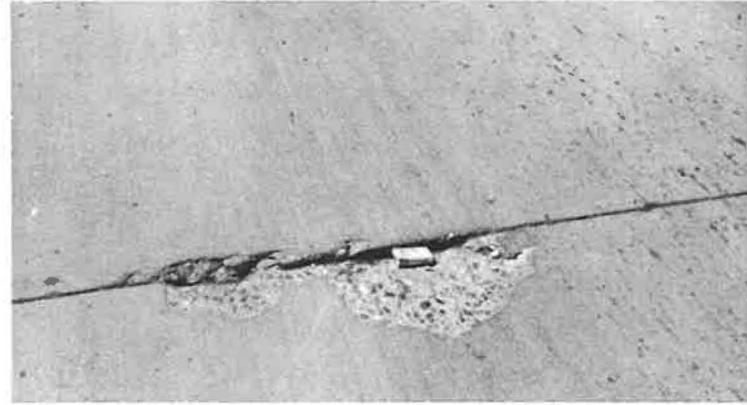
In the spring of 1962, areas of the pavement began to scale. By midsummer joints began to spall as the pavement expansion stressed the edges of the joints. Spalled areas showed evidence of salt concentrations in the plane of the spall indicating that the early application of salt had had a damaging effect on the pavement.

Figure 2. Spalled area at joint 2 years after construction; notice cigarette pack for reference.

Our research department was enlisted to determine a course of action. After studying available literature and making a physical inventory, it was decided that all transverse joints on the project would be resawed and resealed. All spalled areas would be restored to their original condition insofar as possible.

The physical inventory showed that the spalled areas varied in size from small chip-like areas to areas 2 ft wide, 4 to 4 $\frac{1}{2}$ in. deep with some areas extending the entire width of the pavement. It was decided to separate the spalled areas into two categories as to type of repair. Spalled areas up to 36 sq in. were to be patched with an epoxy mortar and all spalled areas over 36 sq in. were to be patched with a portland cement mortar (Fig. 3). It was estimated there would be 127 sq ft of epoxy patching and 3,429 sq ft of portland cement patching.

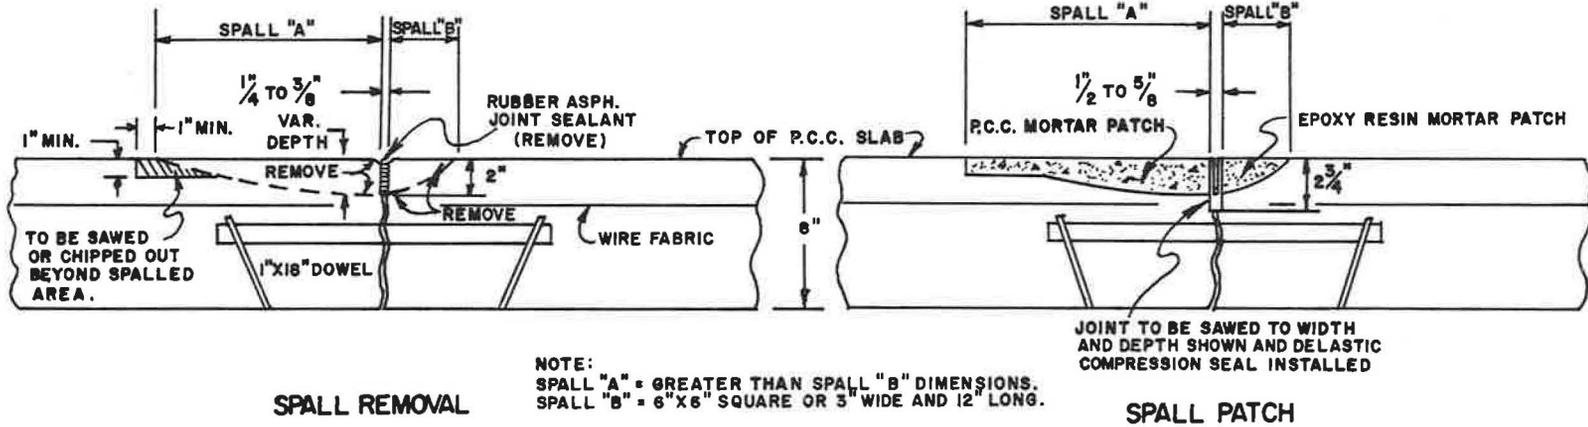
Figure 3. Spall and joint repair detail.

The decision was made to resaw all joints to a width of $\frac{5}{8}$ in. and seal with 1 $\frac{1}{4}$ -by 1 $\frac{3}{4}$ -in. neoprene compression seal. (It was proved later that the joints had to be sawed to $2\frac{1}{32}$ in.)

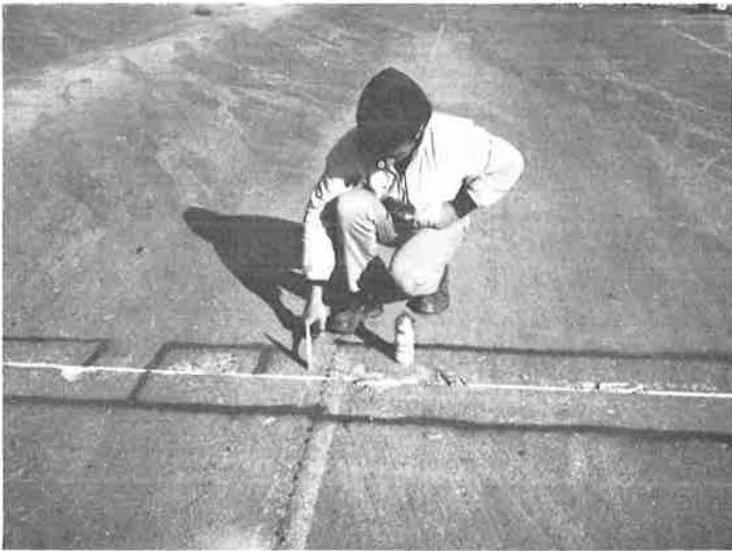
Figure 4. Painting outline of unsound concrete.

In August 1964, a contract was let for this restoration work at a contract price of \$41,700.00. The engineer's estimate of the cost of the work was \$28,000.00. After awarding contract, the first step in the work was to locate and outline all unsound, or loose concrete in the area of each joint. The loose portions of concrete were easily detected by a hollow sound when rapped with a hammer. The outline of each area was then painted (Fig. 4) on the pavement. The joints were then sawed to the dimensions required for the preformed neoprene seal. A 1-in. deep saw cut was made following the painted outline of the spalled areas.

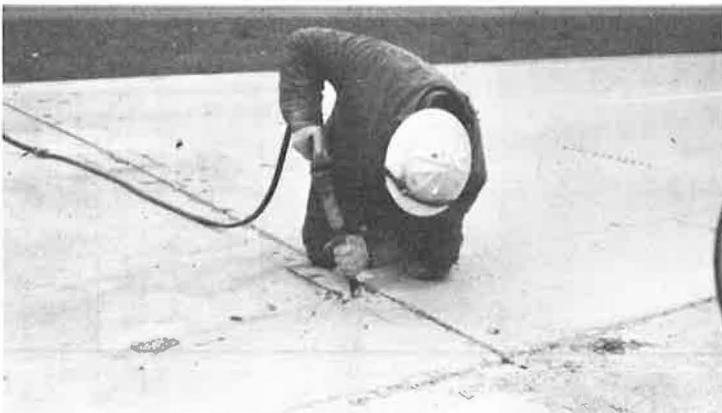
Figure 5. Using a small chipping hammer in small, shallow areas.

All unsound or loose concrete within each saw cut area was removed to a minimum depth of 1 in. Jack hammers were used to remove this concrete in the larger areas. A small chipping hammer was used in the small, shallow areas (Fig. 5). The resulting

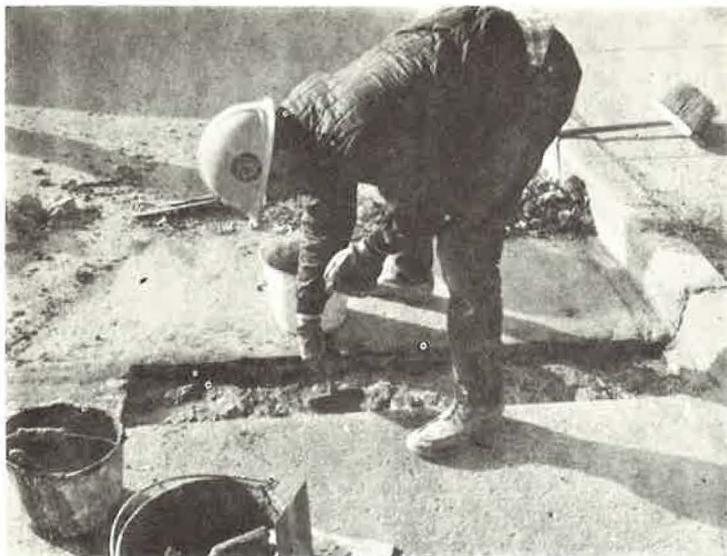
Figure 6. Applying brush coat of epoxy adhesive.

A coat of epoxy adhesive was carefully brushed onto each face of the exposed area (Fig. 6). Then each depression was filled with mortar. The mortar was tamped into place. The surface was troweled and a light dusting of portland cement applied so that the surface color blended with the surrounding pavement. Before placing a patch, a wooden form was placed in the joint to form a wall of the joint (Fig. 7). The forms were not removed for 72 hours or more until the patches cured enough to allow traffic over them.

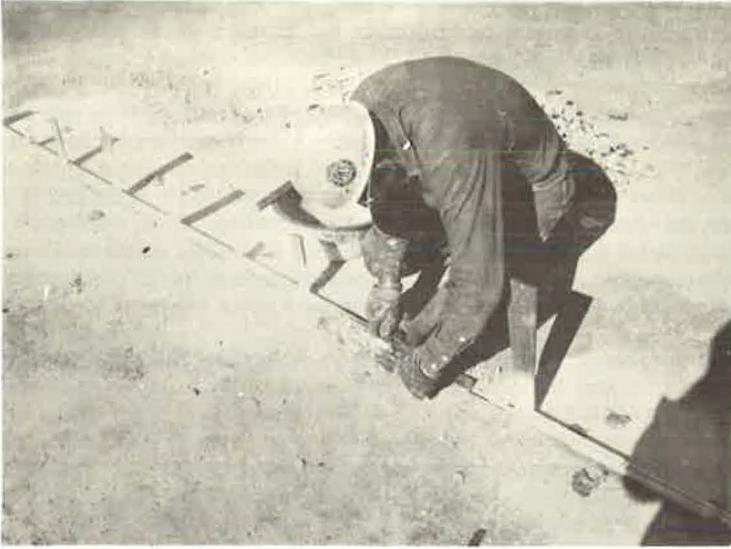
Figure 7. Placing wooden form.

one percent of the cement was added to the mortar as an accelerator. Three-day compressive strengths of this mortar exceeded 3,000 psi. Prior to placing these patches, forms were placed in the line of the joint to form the joint wall. The patch area was painted with a portland cement grout, consisting of 1 part cement to 1 part sand. The grout was applied with a stiff brush to be sure it was scrubbed into every indentation of the area. The patching mortar was then tamped into the patch (Fig. 8), finished to blend in with the surrounding pavement surface, and sprayed with a white, liquid curing agent. All forms were removed in 72 hours after the patch was placed. The area was then opened to traffic.

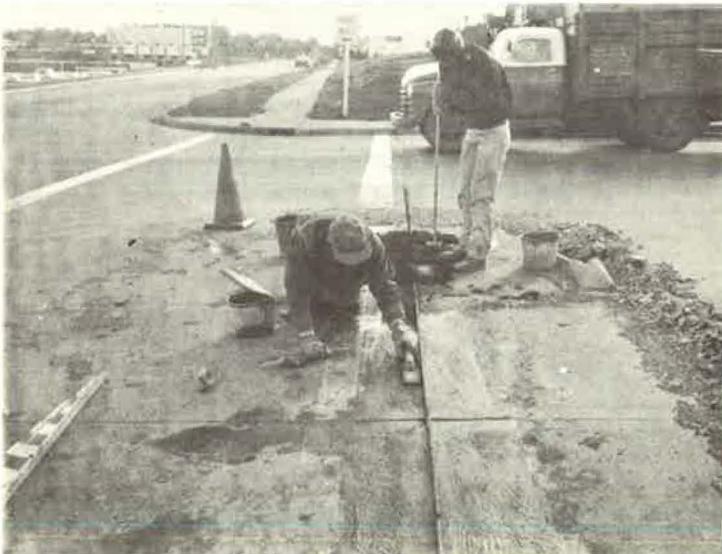
Figure 8. Tamping mortar into patch.
