Structural Failure of Western Highways Caused by Piping

GARALD G. PARKER and E. A. JENNE, United States Geological Survey, Denver

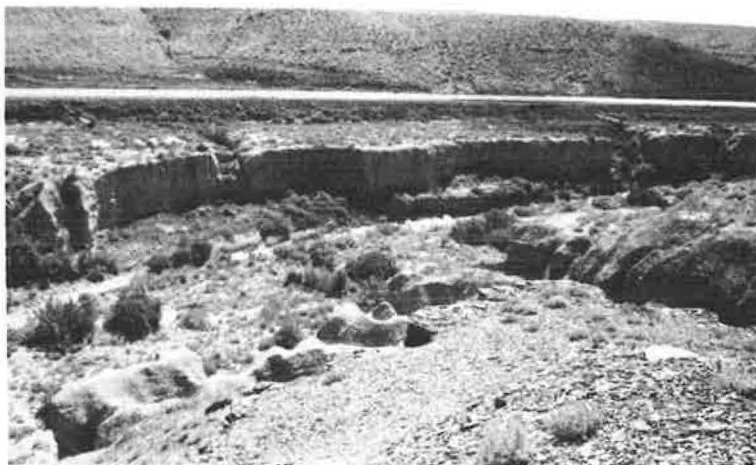
Figure 1. Aztec Wash showing pseudokarst developed in trenched and piped alluvium. Two culverts which discharge near north base of roadway fill are visible. Concentration of drainage runoff at edge of roadbed accelerates piping and gullying and contributes directly to undermining of highway. Tableland in background would provide excellent roadway in lieu of present location (see Figs. 13, 18, and 19).

An entire 6-mile stretch of US 140 is currently imperiled by piping. This section of road was built on Aztec Wash alluvium and is located southwest of Cortez, Colo., in the 4-Corners area (Fig. 5). This section of US 140 was only put into service in 1963, but already it is being undermined by pipes in several places (Figs. 13 and 14). Already, highway maintenance crews are making repairs to the new highway as it settles and cracks, especially on the arroyo side. The view in Figure 17 is fairly typical and shows settling and cracking of the roadbed as a result of piping and subsidence in the subjacent alluvium on the side of the road nearest to the arroyo. This figure also shows a large patch needed to restore the damaged road surface. In other places along this 6-mile stretch, several large asphalt repair patches have been emplaced one atop the other where settlement of the roadbed is even more rapid than at the site pictured.

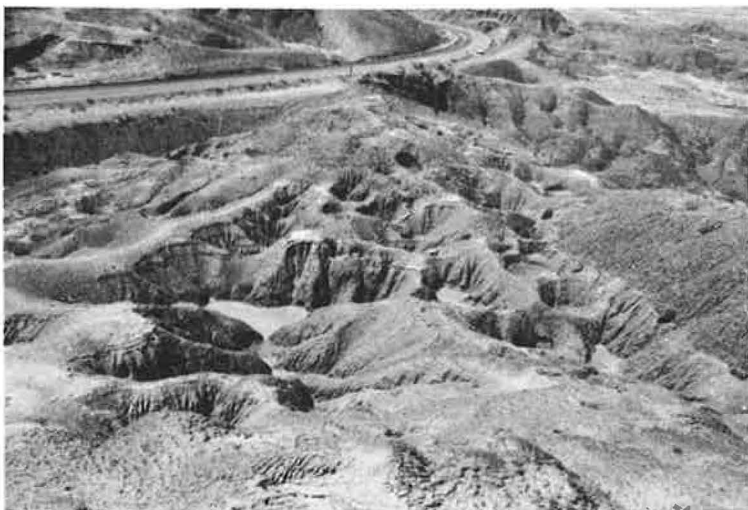
Figure 2. Pseudokarst developed in dense, consolidated shaly bedrock of triassic Chinle formation; in this area it is largely derived from volcanic ash falls, weathered to red, green, and white bentonitic shales. Undrained, plugged sinkholes are partially filled with water from recent rainstorm.

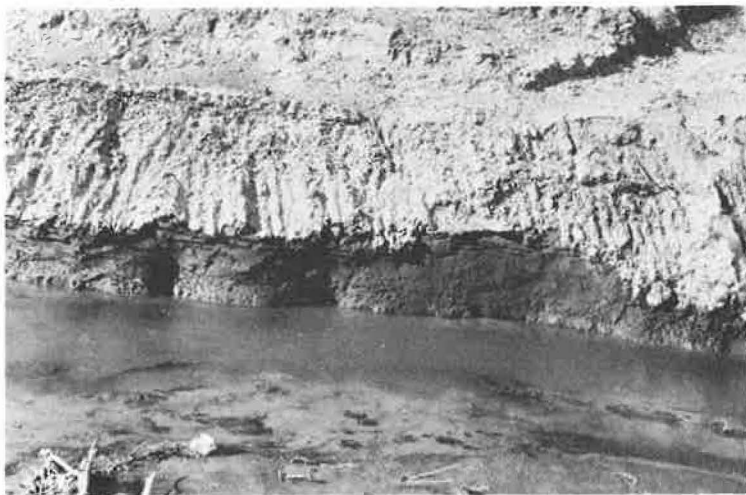
The development of pipes away from a gully wall, without visible inlets, may also occur where a gully or drainage ditch intercepts a water table (Fig. 3). Several such instances have been noted in the irrigated areas of Wyoming and Nebraska. As the pipes grow in length and diameter, settlement of the overlying material may take place, particularly after an extended rain or snow melt which may wet the alluvium well below the surface. The water adds to the overburden weight and decreases the crumb strength as previously noted. Subsequently, surface runoff collects in the subsidence depressions causing either further subsidence or development of vertical pipes down to the more or less horizontal subsurface pipes by: (a) colloidal erosion, i.e., carrying out dispersed fines; (b) enlarging a desiccation crack; (c) enlarging a stress crack (resulting from subsidence); or, rarely (d) enlarging an animal burrow or rotted-out root

Figure 3. Pipe outlets near base of gully wall. Subsidence caused by irrigation return underflow may be responsible for development of these pipes in Oligocene Brule formation White River group.

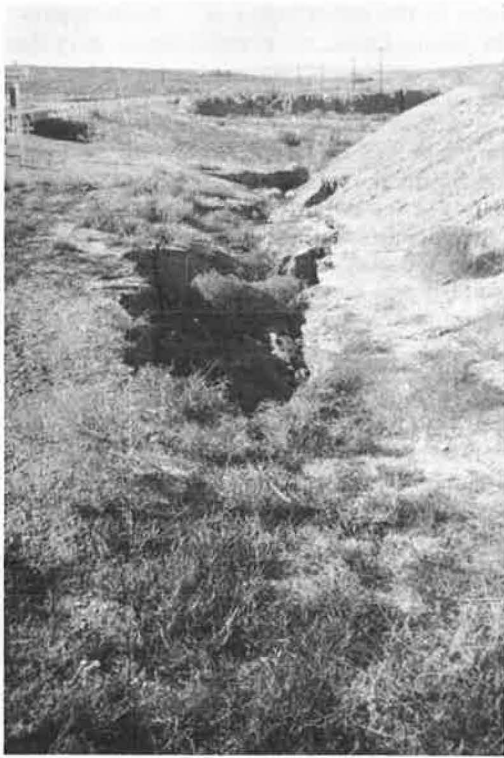
Figure 4. Drainage ditch showing result of piping and subsidence. Ditch resulted from heavy rainstorm. Materials affected are greenish-gray silty alluvium derived from cretaceous Mancos shale.

tube. In places it appears that whole gullies have formed from the collapse of pipes of the variable permeability-subsidence type. In some situations, it appears probable that both subsidence and desiccation-stress cracks combine to facilitate piping. The drainage ditch shown in Figure 4 may have formed in this manner.

Drainage ditches, even when lined with concrete, commonly fail in areas where piping occurs. A seriously piped, unlined drainage ditch is shown in Figure 4. A similar fate of a concrete lined ditch is shown in Figure 10. This is only one of several such cases where piping has destroyed the usefulness of lined drainage ditch structures.

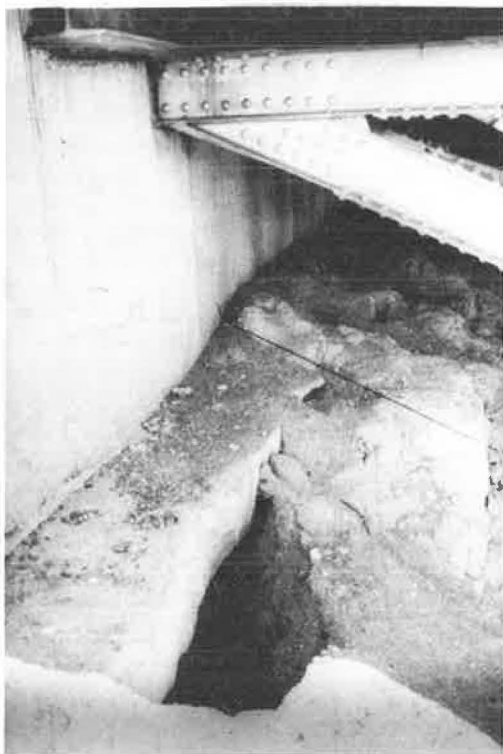
Figure 6. Pipe intakes beginning to undermine abutment. Most water that gains access to abutment slope runs down abutment wall through crack between bridge deck and road surface. As pipes become enlarged, roofs collapse leaving gaping holes beneath and beside abutment.

practices initiate piping in the abutment slope as shown in Figures 6 and 7 for the Meadow Valley Wash bridge. The initial result, as well as the first indication of piping on an abutment slope, is the crack-

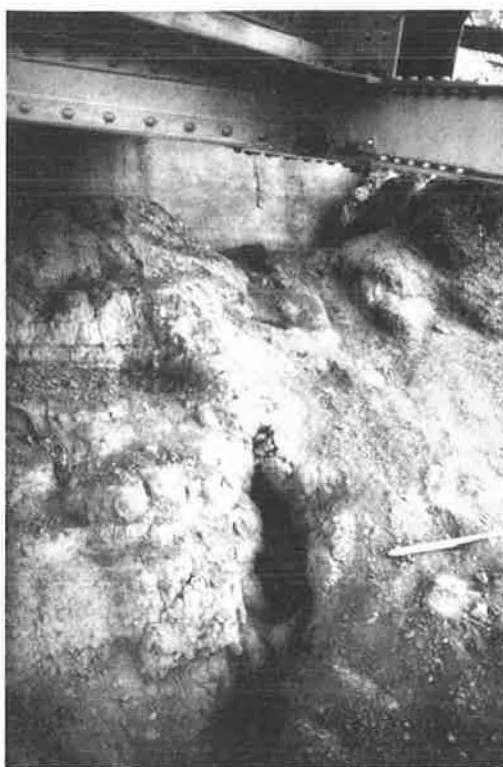
Figure 7. Outlet of pipe, one of whose intakes is shown in Figure 6.

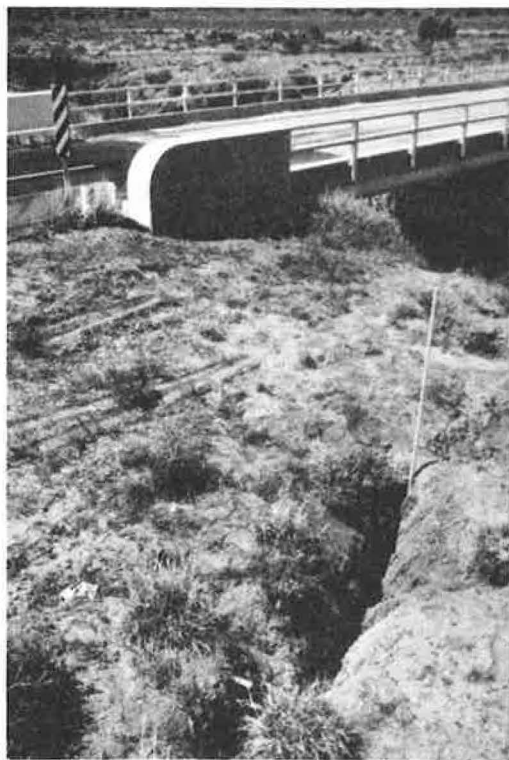
Figure 8 shows the location of a pipe which is endangering the wingwall of US 666 Zuni Wash bridge. As this pipe enlarges and its roof collapses, stress-desiccation cracks will appear between the pipe and the bridge. These cracks can then be expected to develop into secondary pipes which will undermine the wingwall and abutment (Arizona Highway 264 Polacca Wash bridge, Fig. 9).

Figure 8. Elongate pipe intake of piping system endangering abutment.

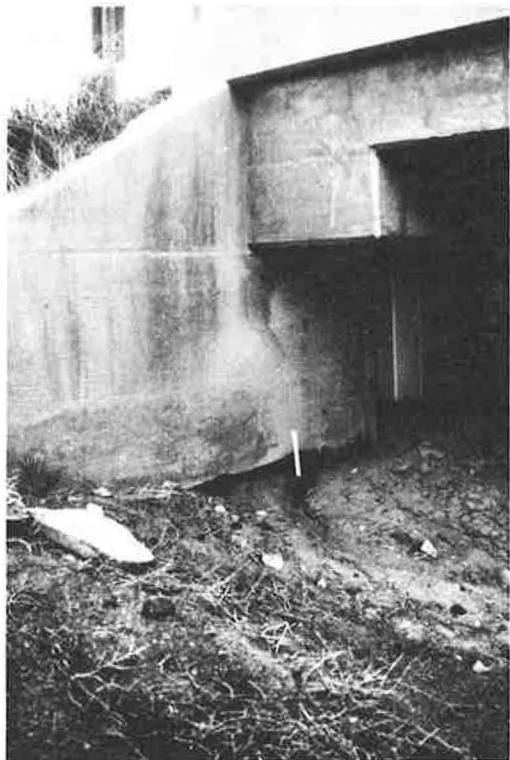
Figure 9. Abutment and wingwall showing outlet of pipe undermining wingwall. Larger and deeper pipes are found elsewhere under abutments of bridge.

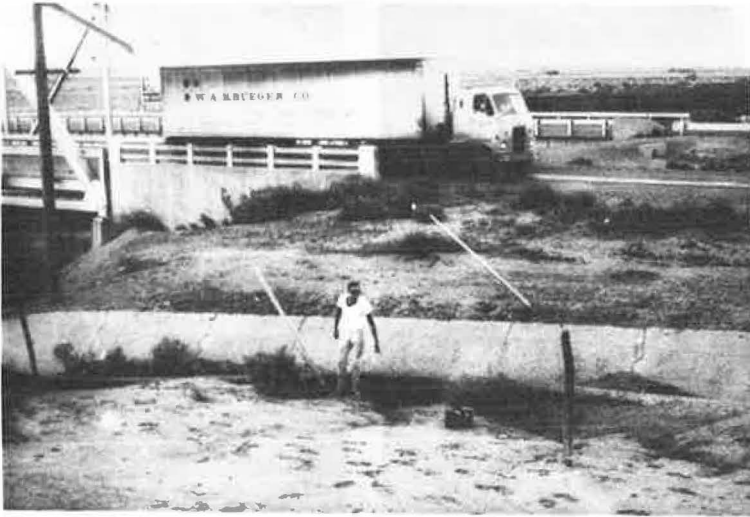
Figure 10. Concrete-lined highway drainage ditch, which failed due to piping. Concrete liner is now totally useless for intended purpose.

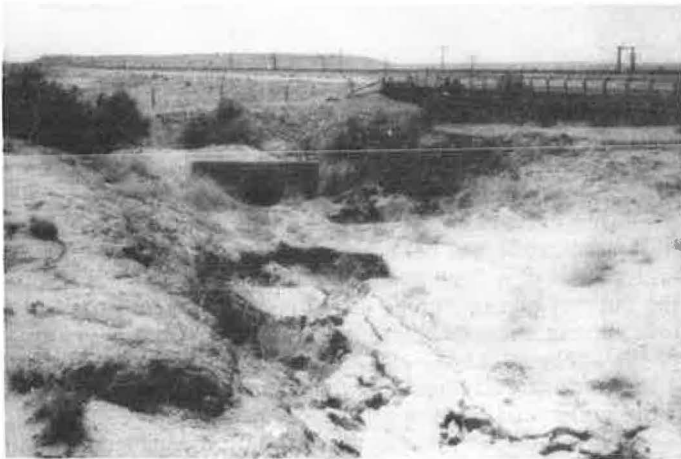
Figure 11. Culvert and drainage ditch are undermined by piping. Note collapse of ditch bed into underlying pipe. This is the beginning phase of a deep gully. Piped material is alluvium derived from triassic Chinle shale.

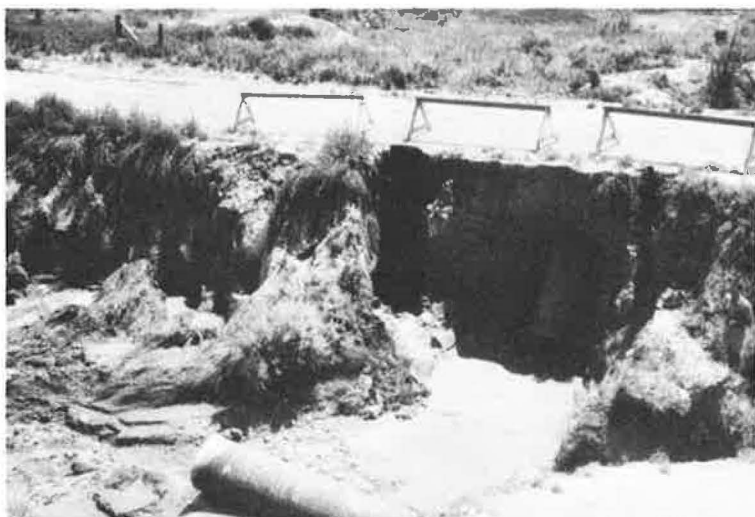
Figure 12. Runoff from intensive storm exceeded culvert capacity so that water overtopped road and piping developed around culvert. Culvert would have failed due to piping even if no overtopping of road had occurred as nearby road drainage ditches piped extensively.

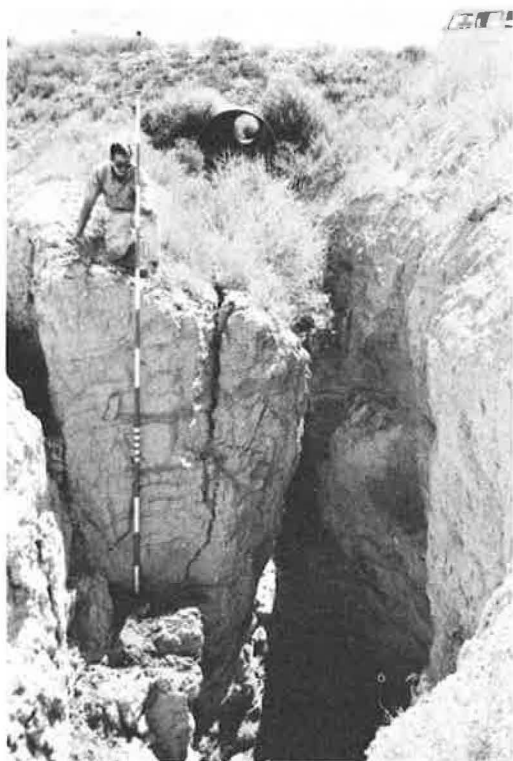
Figure 13. Culvert-concentrated drainage spill has created gully by piping and subsidence, which seriously threatens stability of roadway. (See Figs. 18 and 19, which graphically depict the conditions at this site.)

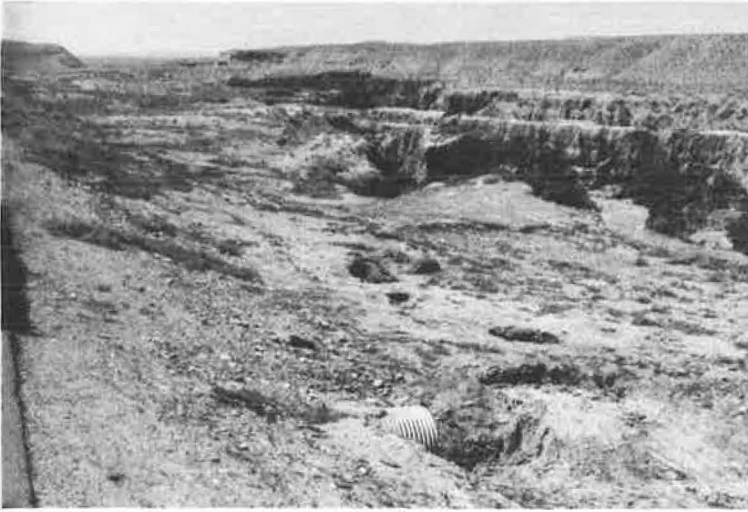
Figure 14. Sink, or pipe inlet, developed at toe of highway embankment as a result of spilling the collected drainage onto ground at culvert outlet. Note pipe inlets (center foreground) of culvert outlet. Note also edge of big asphalt patch in road pavement emplaced to repair damage caused by pipe subsidence.

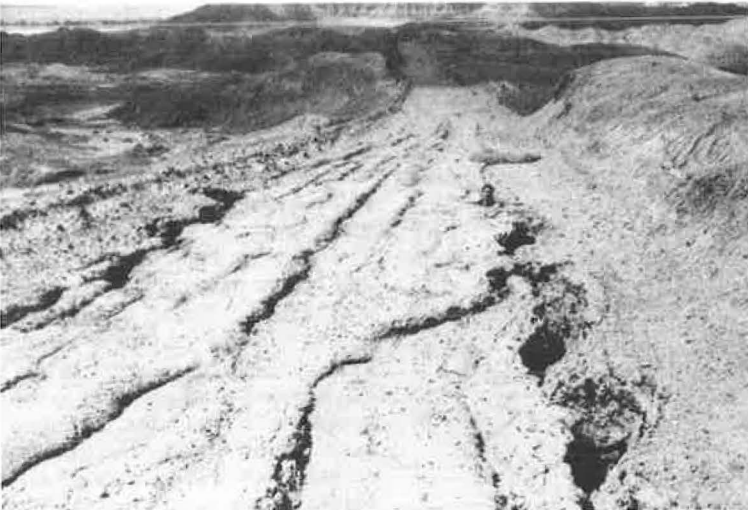
Figure 15. A six-ft tall man is standing on ledge in pipe 10 ft from bottom of pipe inlet. Materials are red and green shale of the triassic Chinle formation. Both piping and subsidence are responsible for the erosion shown here.

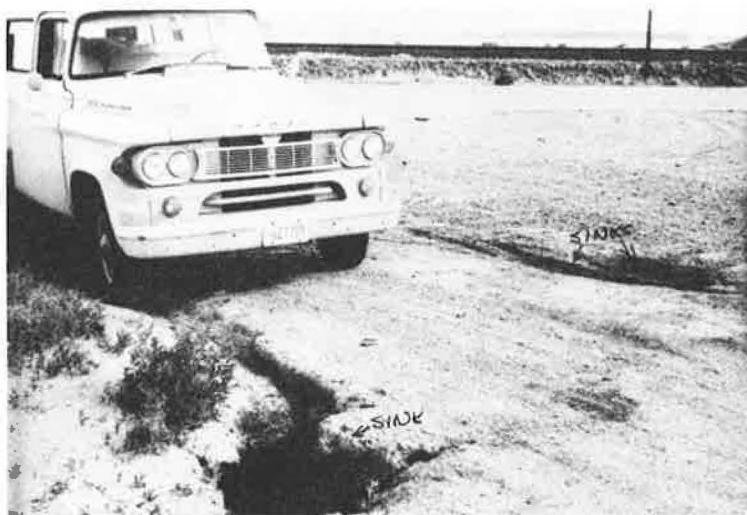
use, but that requires continuous maintenance because of piping, is shown in Figure 16.

Figure 16. Old US 66 is in center of photo and mainline track of Southern Pacific Railroad, which itself is undermined by piping in this area, is just beyond highway. Pipe intakes beside road in front of truck are 2 to 3 ft deep.

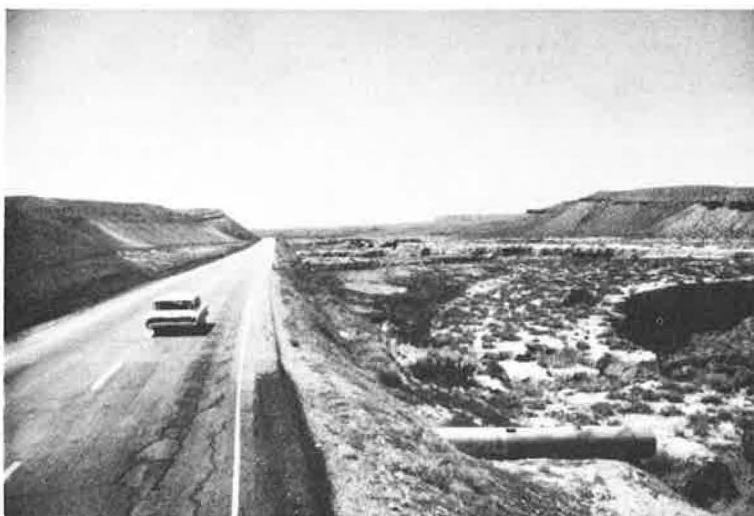
Figure 17. Cracks reflect settlement of roadway shoulder in response to piping and subsidence in subjacent alluvium on which highway was constructed. In the future, this roadway can be maintained only at greatly increasing costs. An alternative and cheaply maintained right-of-way may be found on stable bedrock upland on either north or south side of Wash.

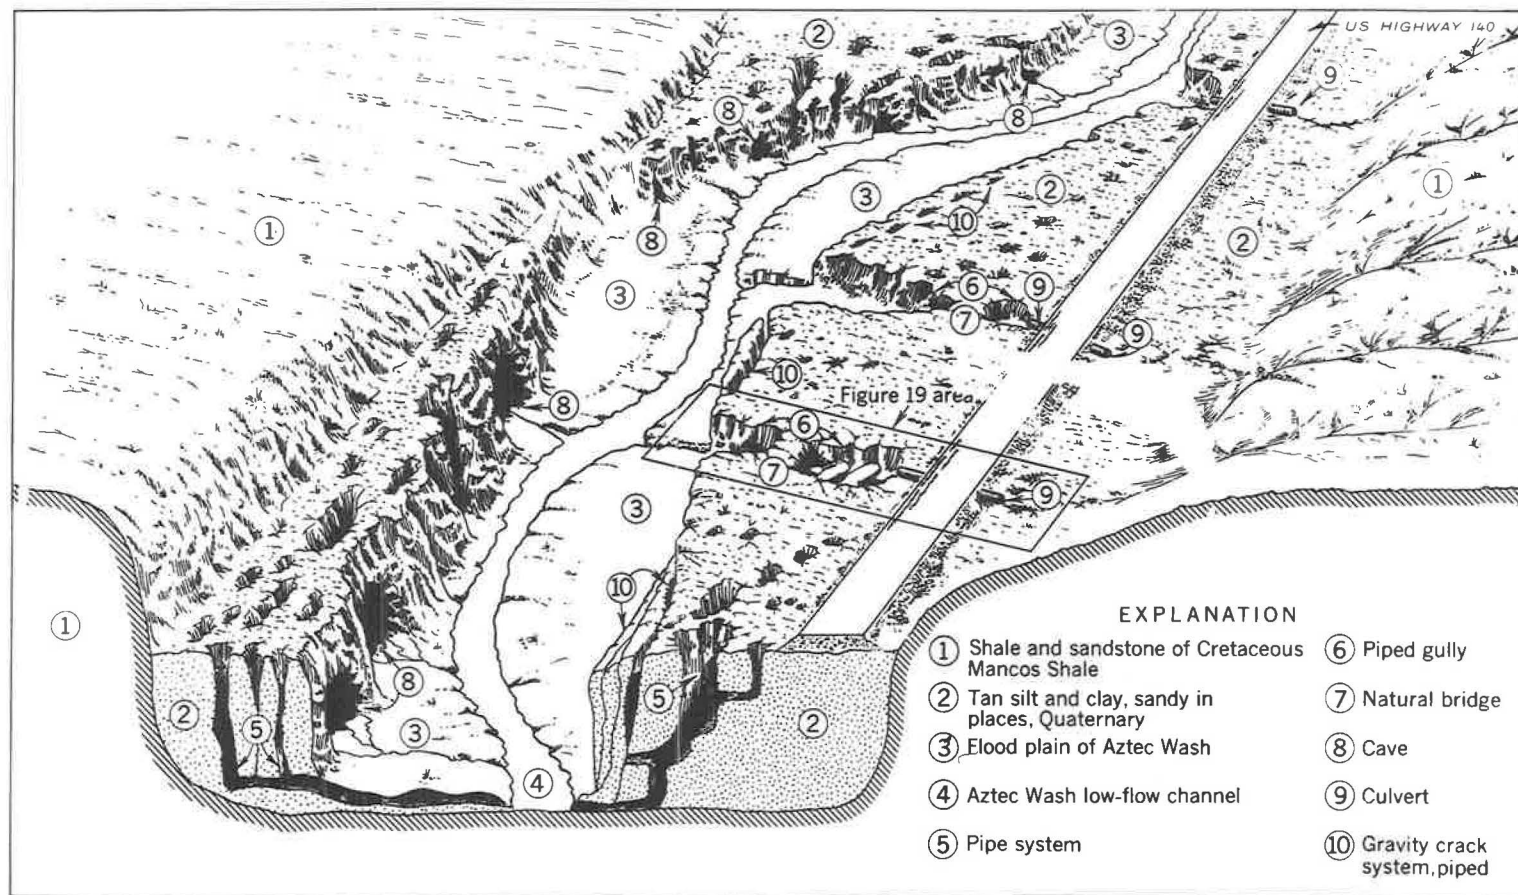
The results of the desiccation-stress crack piping process as well as the destructive effect of piping on roadways are shown in Figures 18 and 19. The medial gully of Aztec Wash meanders from side to side in the alluvial fill of this bedrock

Figure 18. Idealized block diagram of Aztec Wash showing dissected and extensively piped valley fill, old bedrock surface and channel, highway, and drainage system. (See Figs. 1, 13, and 19.)

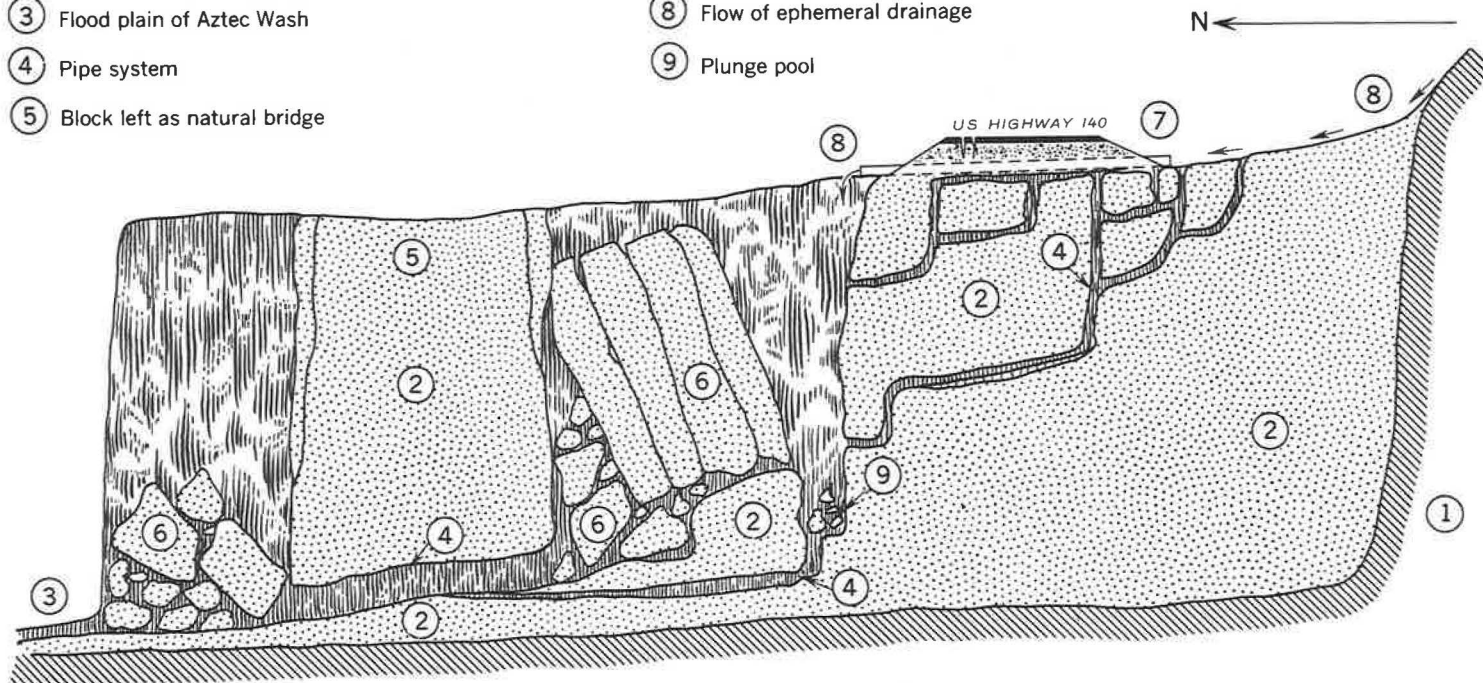
Figure 19. Idealized north-south cross section under US 140 built on Aztec Wash valley fill. Note incipient piping system beneath roadway. See Figure 18 for setting.

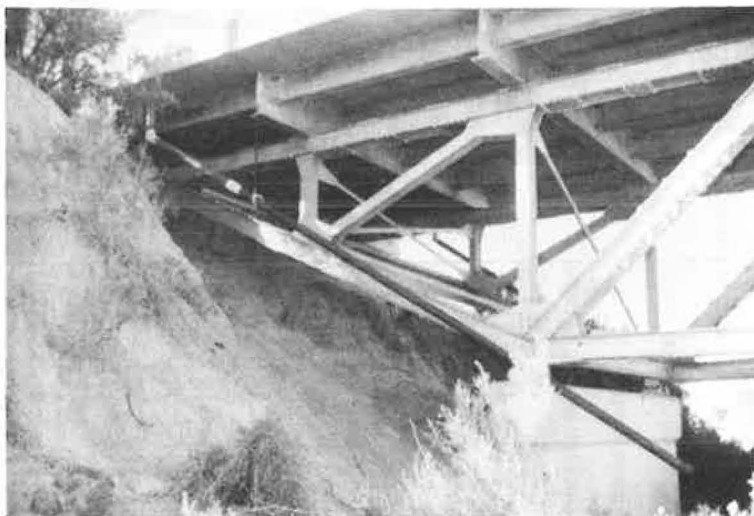
Figure 20. Metal pipe is carrying bridge-deck discharge directly into channel where it can do no harm instead of allowing it to drop onto abutment slope. Note companion discharge pipe on opposite side of bridge.

Bridge deck and adjacent roadway drainage should be collected and dropped into the channel by means of drains similar to the gutter downspouts on houses. Such a successful device is shown in Figure 20. A different, but more expensive, approach which appears to have been successful is to box the abutment slope with planking (Fig. 21).

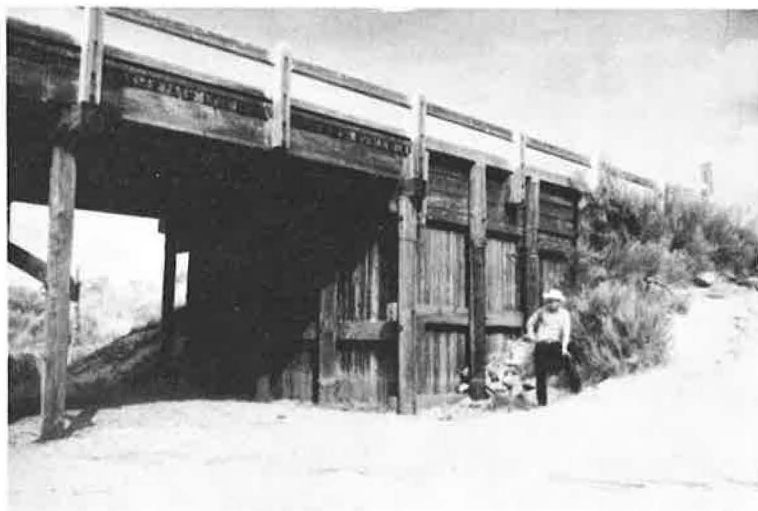
Figure 21. Successful engineering design for combating piping under bridge abutments in area of severe and destructive piping.

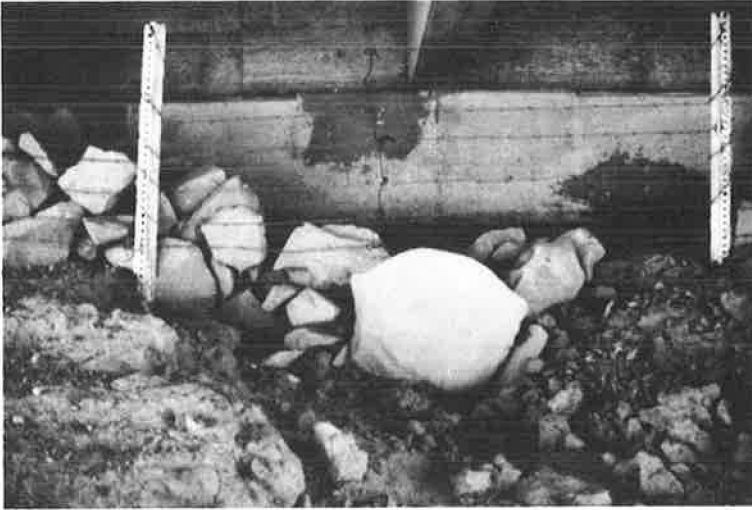
Two unsuccessful attempts to arrest and control piping at the Arizona Highway 264 Jeddito Wash bridge on the Navajo Reservation are shown in Figures 22 and 23. As shown in Figure 22, steel fence posts and barbed wire strands were emplaced on a line parallel to and about 2 ft away from the abutment wall. This enclosure was then filled with boulders, but the piping continues unabated and the boulders are now funneling vertically into the ever-enlarging pipe system. To stop this piping, the supply of water from the overlying bridge deck and roadway pavement must be intercepted and led to the arroyo channel in downspout conduits. Grout or slurry pumped into the boulder-filled pipes would help stabilize the abutment slope. Instead of leading bridge-deck drainage to the arroyo channel through conduits at the Jeddito Wash bridge as was done at the Meadow Valley Wash bridge (Fig. 20), shallow concrete troughs were constructed to intercept the drainage at the land-slope surface and conduct it to the

Figure 22. Abutment showing unsuccessful attempt to control piping. Pipes continue to enlarge and boulders fall into pipe inlets.

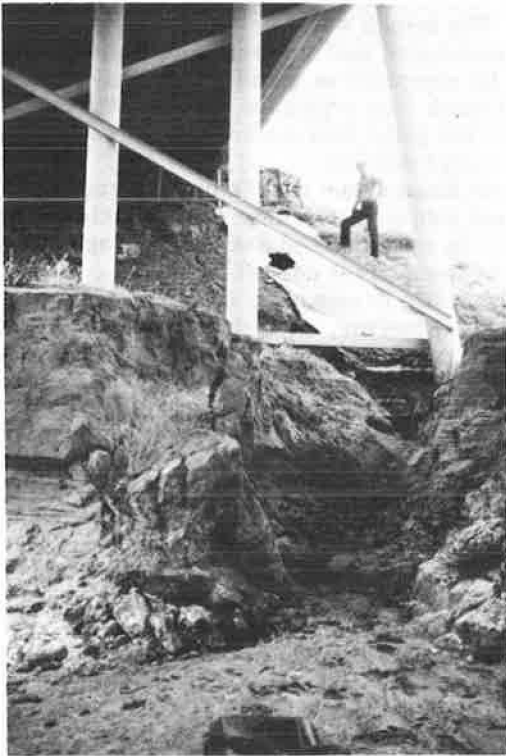
Figure 23. Unsuccessful use of concrete trough to intercept surface runoff and bridge-deck drainage, and conduct it to arroyo channel. Hole about one foot in diameter has broken through the trough to the underlying pipe. Outlet of pipe system is hidden behind bridge pier in right foreground but is undermining pier.

channel (Fig. 23). Piping continues, however, and a hole has been broken through the trough, probably by livestock crossing the slope. Asphaltting the total area enclosed within a 50- to 100-ft area of culvert inlets could be expected to reduce greatly the damage currently being done to culvert installations. Extension of culvert outlets to a nearby gully channel would also greatly decrease the damage being done.
