Dynamic Tests of Five Breakaway Lighting Standard Base Designs

E. F. NORDLIN, W. H. AMES, and R. N. FIELD,
California Division of Highways

A study to determine the effectiveness of five breakaway lighting standard base designs in reducing the severity of vehicle impacts is reported. Ten head-on full scale dynamic tests were conducted on 30-ft lighting standards mounted on the various frangible or slip base designs. All of the standards were steel except for one aluminum design. The tests were conducted on a 6-in. high cast aluminum insert base, a notched bolt insert design, a multi-directional steel slip base design developed by Texas Transportation Institute, a 20-in. high aluminum transformer base, and an aluminum standard fitted and epoxy-cemented to an 18-in. high cast aluminum sleeve type base.

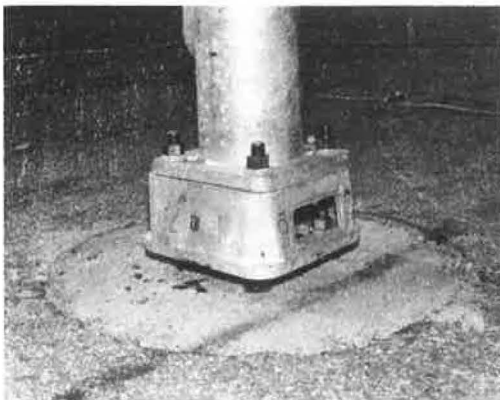
Figure 1A.

Test 182 was conducted at 40 mph on an unmodified cast aluminum insert with the hand hole facing away from the traveled way. Figure 1A and Plate 5 show design details. As the base failed on impact, the standard was kicked up and ahead of the test vehicle (Figure 1B). The lower portion of the pole shaft hit the roof as the test vehicle progressed under it. The top of the pole shaft came to rest about 30 ft beyond the foundation. The force of impact not only collapsed the front end of the test vehicle about 24 in. but the pole shaft was damaged beyond repair with a 30-deg bend at the point of contact. In addition, the foundation anchor bolts were bent approximately 30 deg away from the direction of impact.

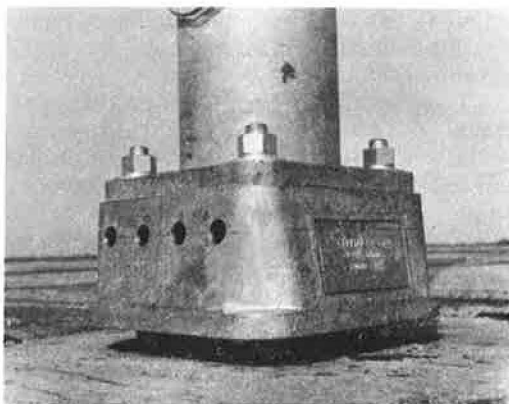
Figure 2A.

Test 183 was conducted at 40 mph on a cast aluminum insert base modified by drilling a series of four 1-in. diameter holes at $2\frac{1}{2}$ -in. centers in each of the three side walls (modification 1) and the hand hole was oriented toward impact. Figure 2A and Plate 5 show design details. It was anticipated that the base would fracture through this weakened cross section, thus reducing the impact resistance. However, upon

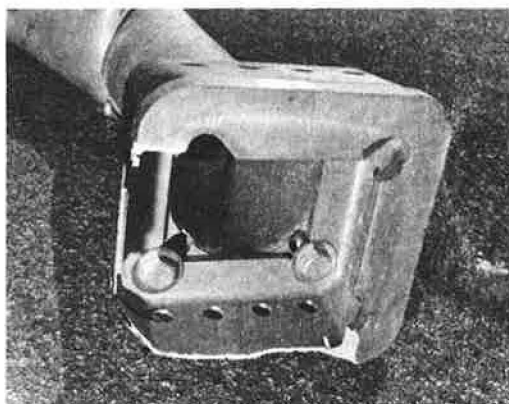
Figure 2B.

impact, the base failed through the base flange in much the same manner as in Test 182. There was no evidence of fracture through the weakened plane of the drilled holes (Fig. 2B). The lighting standard was kicked ahead and up, clearing the vehicle by 3 ft as it passed through the impact zone. It settled to the pavement with the top approximately 35 ft beyond the anchorage. The shaft was bent to approximately 25 deg at the point of first contact and was damaged beyond repair. The anchor bolts were bent approximately 30 deg. Vehicle damage was much the same as sustained during Test 182, with a 20-in. deformation to the front end.

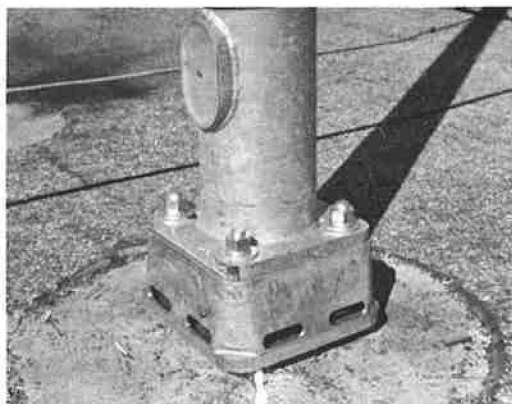
Figure 3A.

Test 191 was conducted at 48 mph on the cast aluminum insert base mounted on the same anchorage as was used for Test 182 (the previously damaged bolts were repaired by straightening and welding on new studs). In a further effort to reduce the impact resistance noted in Tests 182 and 183, two 1-in. by $3\frac{1}{4}$ -in. slots were milled through the three side walls near the base flange (modification 2) where the fracture occurred in the insert bases in the preceding two tests. Figure 3A and Plate 5 show design details. The hand hole was oriented facing away from the traveled way. Upon impact, the aluminum insert again failed in a combination of shear and tension with the fracture taking place through the milled slots as anticipated (Fig. 3B). The two right-hand bolts were bent 30 deg and the two left-hand bolts were sheared off at the surface of the concrete foundation. The lighting standard was kicked ahead and up, clearing the vehicle by 7 ft as it passed through the impact zone. The top of the pole settled to

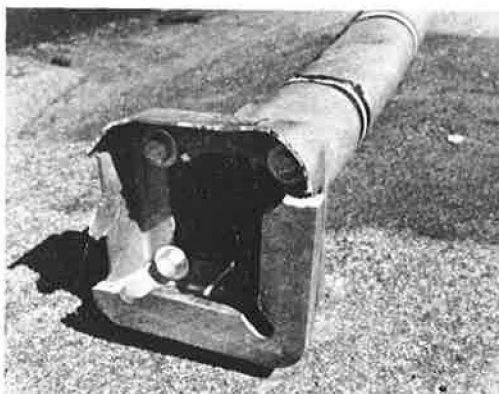
Figure 3B.

the pavement 25 ft beyond the anchorage. The shaft was dented 2 in. and was not considered salvageable. The vehicle sustained the least front end deformation (19 in.) observed in the three frangible aluminum insert tests.

The performance of the 6-in. cast aluminum insert with the second modification as in Test 191 under moderate impact was satisfactory. However, due to concern over the loss of side-wall cross section induced by the slots, it was concluded that this device should not be adopted as a design standard unless subsequent cyclic vibration tests are performed to insure that wind loads would not cause premature operational fatigue failure. Such tests were not within the scope of this research study.

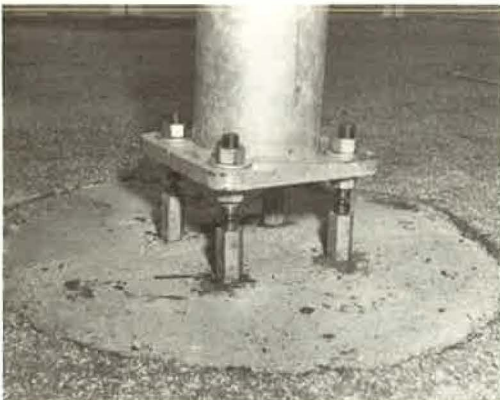
Test 181 was conducted at 40 mph on the assembly shown in Figure 4. Upon impact the lighting standard was kicked ahead and up and cleared the vehicle by 6 ft as it passed through the impact zone. The top of the pole came to rest 16 ft beyond the anchorage. Damage to the lighting standard consisted of a minor dent at the point of contact with the vehicle. Although the A-307 anchor bolts bent 30 deg, they were successfully straightened for use in a succeeding test. Vehicle deformation (18 in.) was less than sustained during any of the frangible aluminum insert tests. From the standpoint of impact resistance at 40 mph, the notched bolts performed efficiently and dummy driver decelerations were almost negligible. However, there is some concern as

to the possibility of stress corrosion cracking occurring in this material in a 950 deg heat-treatment condition after extended exposure to wind loading and accompanying vibration. It was therefore agreed that the heat-treatment temperature should be increased to improve the fatigue characteristics. However, since an increase in treatment temperature also increases the impact resistance, another proof test was conducted using the revised heat treatment.

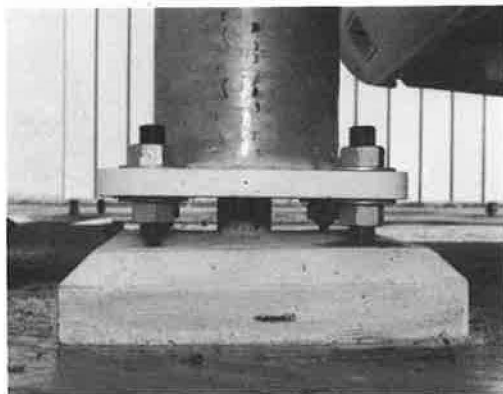
Figure 5.

Test 192 was conducted at 40 mph on the same notched bolt insert design as was used for Test 181 with the following modifications: (a) heat treatment was increased from 950 deg to 1050 deg and (b) a 3-in. high grout pad was cast around the sleeve nuts and epoxy-bonded to the con-

crete foundation (Fig. 5). Upon impact the notched bolts failed as before and the standard was kicked ahead and up 4 ft over the vehicle as it passed through the impact zone. The standard came to rest with the top approximately 12 ft beyond the anchorage. The point of impact was off-center on the vehicle bumper and close to the supporting brackets. Consequently, the vehicle sustained only very minor damage, consisting of a $1\frac{1}{2}$ -in. dent in the bumper and a slight dent in the grill and hood. The light standard was bent 10 deg and the steel pole base plate was deformed. The grout pad was damaged and broken out around the right sleeve nut. No discernible decelerations were recorded in the unrestrained dummy. Because of the off-center point of impact by the vehicle on the reinforced section of the bumper, no valid correlation could be made between the results of Tests 181 and 192 concerning the increase in impact resistance presented by the notched studs with the higher temperature treatment.

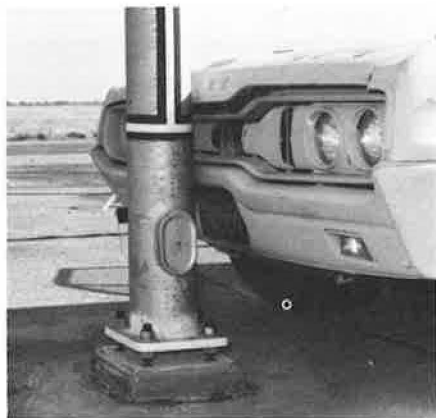
Figure 6.

Test 194 was conducted on the same notched bolt design as was used for Test 192 (1050-deg treatment and 3-in. grout pad around sleeve nuts) but with a 15-mph vehicle impact speed and the ignition cut off prior to contact (Fig. 6). Upon impact, the bolts failed primarily in tension and the standard remained vertical and in contact with the car, "walking" for 6 ft before falling forward and to the left. The pole came to rest within 3 ft of the 18-ft offset line used to simulate the edge of pavement. The base of the standard remained under the front bumper, 18 in. from the anchorage. The vehicle sustained extensive damage (21-in. deformation) but the lighting standard was only slightly dented. The test results from this 15-mph test indicate the performance of this device as a breakaway design to be marginal under low-speed impact. Further research into the metallurgical properties of the 17-4 PH steel is necessary before

this concept could be accepted as an effective breakaway device for the inevitably wide range of operational impact conditions.

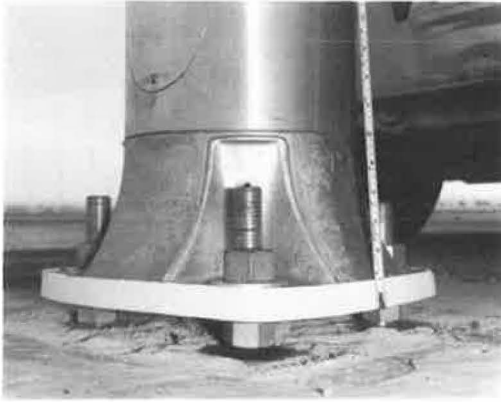
Figure 7A.

In this test the lighting standard consisted of a tapered, welded aluminum pole fitted and epoxy-cemented to an 18-in. high cast aluminum sleeve shoe base (Fig. 7A). The base extends 12 in. inside the aluminum pole. This serves not only as an effective structural connection but also reinforces the pole to resist collapse on impact and to transmit more effectively the impact load into the frangible base. Plate 6 gives design details.

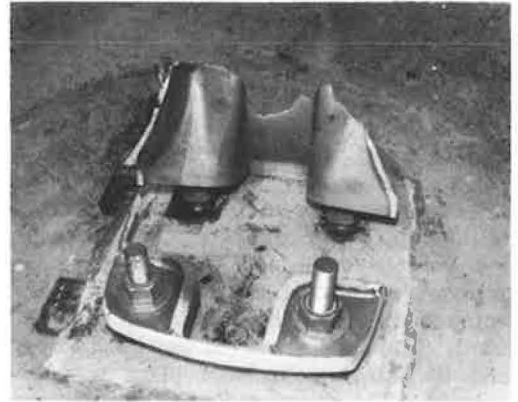
Figure 7B.

The vehicle impacted the pole head-on at 40 mph. Upon contact, the pole collapsed and bent to an angle of approximately 90 deg at a point

35 in. above the concrete foundation. As the cast aluminum base failed (Fig. 7B) the car bumper was deformed 19 in. into and back under the vehicle. The collapse and bending of the pole caused it to hang up under the bumper and remain in contact with the vehicle for a relatively long period of time. However, after releasing from the car, the pole cleared the vehicle by 4 ft and the top of the pole came to rest about 25 ft beyond impact. Vehicle decelerations were low and dummy decelerations were negligible. With the 22-in. bumper height (typical of most American passenger vehicles now in operation and production), the pole was contacted above the reinforced section. Consequently, as the pole collapsed, the load was transmitted to the base primarily in bending rather than in shear. The Texas Transportation Institute reported a more favorable breakaway action in a test on this base design using a 1958 model test vehicle with a 14-in. bumper height.

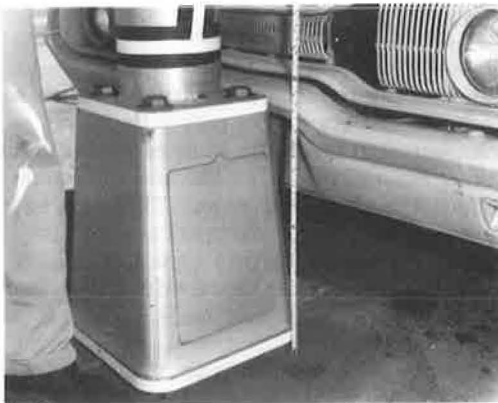
Figure 8A.

The 20-in. high tapered cast aluminum alloy transformer base tested conforms to the requirements of ASTM Designation B-108, alloy SG70A, heat treated to a T-6 temper. The top of the base accepts the 11½-in. bolt circle steel lighting standard base and the bottom requires a 15-in. bolt circle. Figure 8A and Plate 6 show design details.

The vehicle impacted near the top of the transformer base at a speed of 15 mph. The impact side of the base fractured but remained hung up on the anchor bolts. The

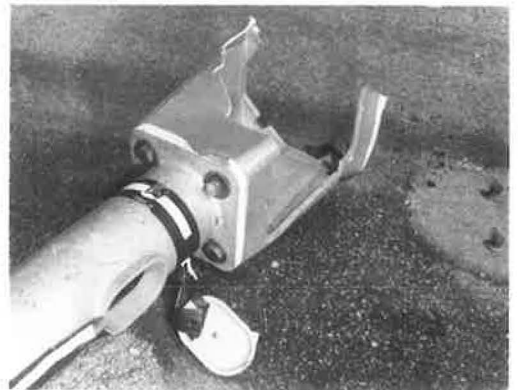
Figure 8B.

remainder of the base (Fig. 8B) and lighting standard remained in contact with the vehicle and was pushed along in the vertical position for about 10 ft before falling ahead and to the left of the vehicle. A portion of the pole and the entire mast arm protruded 16 ft beyond the 18-ft offset simulating the edge of the traveled way. This test illustrates, as did that on the notched bolt insert design, the significant increase in impact resistance that might be expected with any frangible system as the impact velocity is decreased from the 40-mph to the 15-mph range.

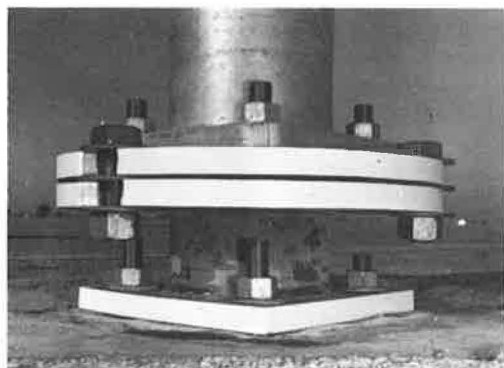
Figure 9.

The two 18 $\frac{1}{4}$ -in. diameter, 1-in. thick mild steel plates on the slip base were held together with three 1 $\frac{1}{4}$ -in. black bolts conforming to ASTM Designation A-307 (Figs. 9 and 10). Bolt torque was approximately 50 ft-lb, which is equivalent to about 2000 lb bolt tension. Each of the top washers was pinned to the upper 1-in. plate with two $\frac{1}{8}$ -in. shear pins to prevent the bolts from walking out of the slots due to wind vibration.

Test 195 was a 40-mph head-on impact. Upon contact, the base parted instantaneously and the pole kicked up and ahead, clearing the vehicle passing underneath by 5 ft. The luminaire broke loose from the mast arm and fell directly over the foundation. While falling, the mast arm rotated 180 deg in the clockwise direction and the pole came to rest approximately on line 25 ft beyond impact. Vehicle damage was mild with only a 9-in. penetration into the hood and bumper.

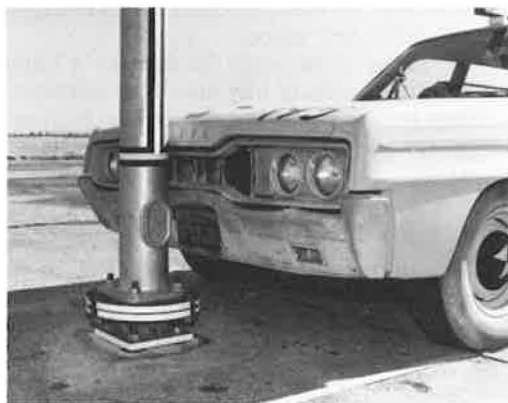
Figure 10.

As in the previous test, the base again parted instantaneously on impact with very little damage to the front of the test vehicle (3-in. bumper penetration). However, because of the low impact speed, the pole did not kick up high enough to clear the test vehicle and fell back on top of it as it passed under, denting the roof and cracking the windshield. As the car continued under the pole, the pole base struck the rear part of the roof, shattering the rear window. Judging by the minor extent of roof denting and by the broken glass, injuries to occupants of the vehicle, if any, would likely have been minor. This reaction (the pole falling on the vehicle), although not desirable, will doubtless occur with any breakaway device at certain critical low speeds.

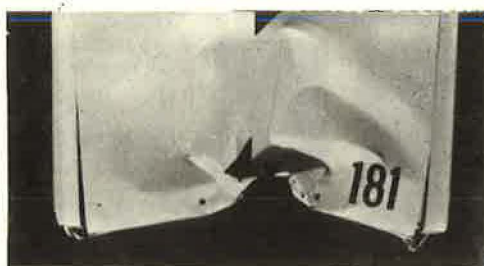
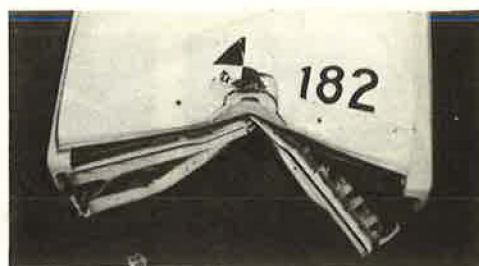
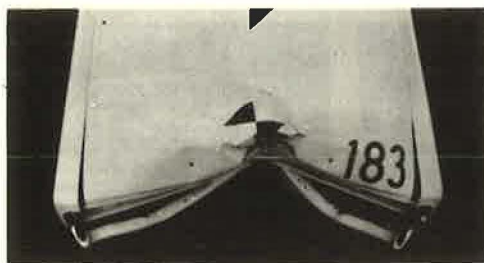
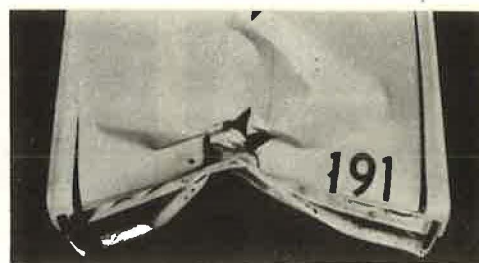
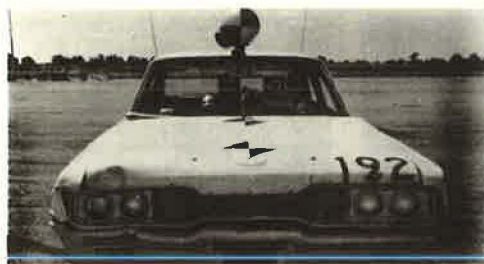
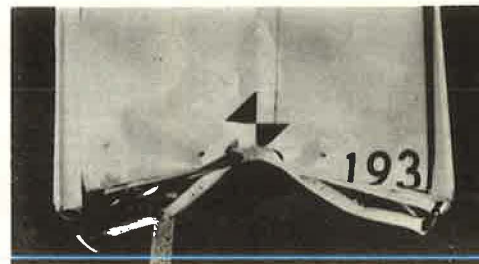
DEFORMATION OF VEHICLES

Although the depth of the deformation of the bumper and hood of the vehicles used in this test series is subjective and should not be used as the sole criterion for basing the relative effectiveness of the various breakaway base designs, a close examination of the damage indicates that this information generally correlates with the change in speed through impact, and particularly with the reaction of the dummy driver. The difference between 19-, 20-, and 21-in. deformation on the same model vehicle is important when observing the intimacy of adjacent collapsed parts and, particularly, the displacement of the engine and any localized buckling of the frame and body. Measurements indicate that a 20-in. deformation of the hood and bumper of the 1966 sedan is the maximum the vehicle can sustain before engine displacement and frame buckling occurs. For instance, the vehicle in Test 181, with 18-in. maximum deformation after impact, required only a bumper, grill, radiator, and fan to place it back in operating condition. Test vehicle 193, sustaining a 19-in. maximum deformation, required the same repair as 181 plus replacement of the water pump. The 21-in. maximum deformation of both hood and bumper resulting from Tests 194 and 197 displaced the engine and warped the frame, resulting in the total loss of those vehicles. Plate 3 shows relative deformation of the test vehicles for the various tests.

Consideration must also be given to the manner in which the lighting standard separates from the frangible base during impact. When the vehicle overrides the pole, such as experienced in Tests 182 and 193, extensive bumper deformation was noted, yet only moderate hood deformation and subsequent low dummy decelerations were recorded. Critical examination of the damage is therefore important and deformations reported in Table 1 must be interpreted subjectively along with photographs of the actual damage.

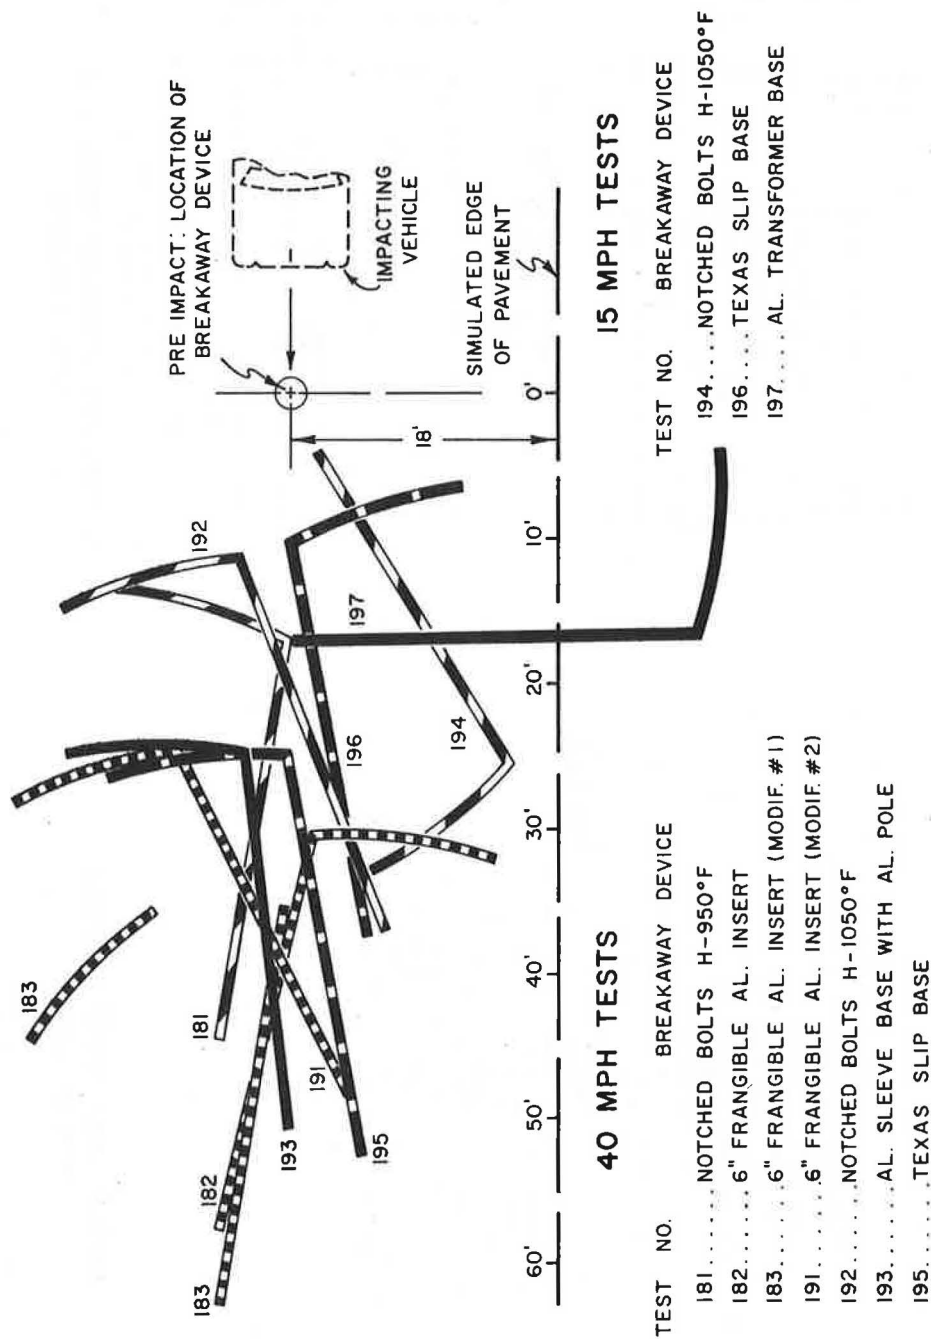
POLE LOCATIONS BEFORE & AFTER IMPACT

It was significant to note that with an 18-ft setback from the edge of pavement, just one of the three standards tested at low speeds would have fallen into the traveled way (Plate 4, Appendix). In general, the pole reactions in this test series correlate well with work by other researchers with mathematical models, dynamic tests, and field performance (2, 3, 4). Of particular significance is the post-impact position of the lighting standard supported on the slip base design for the 15-mph impact.
