Dynamic Tests of Short Sections of Corrugated Metal Beam Guardrail

ERIC F. NORDLIN, ROBERT N. FIELD, and J.J. FOLSOM,
California Division of Highways

The results of six full-scale vehicle impact tests into anchored short sections (less than 100 ft) of 27-in. high blocked-out corrugated metal beam guardrail are reported. Tests were performed on three free-standing sections using two different end anchorage systems. Tests were also performed on three simulated bridge approach guardrail flares using a cable anchor assembly on the upstream or approach end and a rigid attachment to the concrete bridge rail end post at the other end. The tests were conducted at speeds ranging from 56 to 63 mph and approach angles varying from 24 to 33 deg, using 1964 to 1966 sedans weighing approximately 4500 lb.

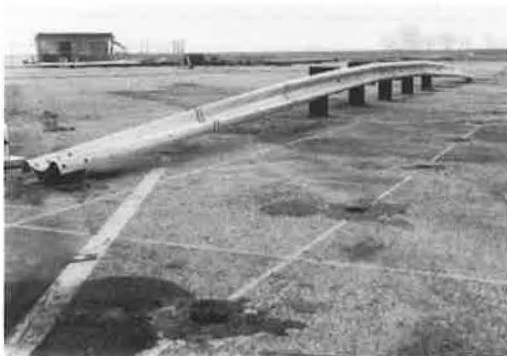
Figure 1.

Test 133—The first guardrail end anchorage design tested was developed by the Texas Highway Department and is referred to as the "Texas twist". The installation for Test 133 consisted of a 62.5-ft section of corrugated metal guardrail beam. The 25-ft long center portion of California standard guardrail was anchored at each end with 18 ft 9 in. of the beam section twisted 90 deg axially, bent down and bolted to fabricated steel posts cast in 18-in. diameter by 5-ft deep concrete cylindrical footings. The sloped end anchorage beam had no intermediate supports (Fig. 1).

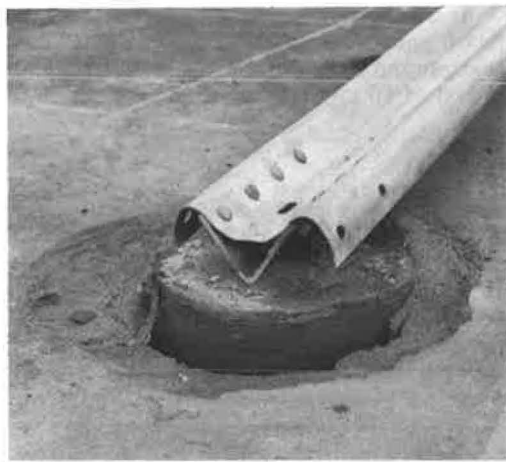
Figure 3.

All beam sections were damaged. A $\frac{3}{8}$ -in. wide crack was opened in the downstream concrete footing and the upstream footing was displaced approximately $2\frac{1}{2}$ in. toward impact (Fig. 3).

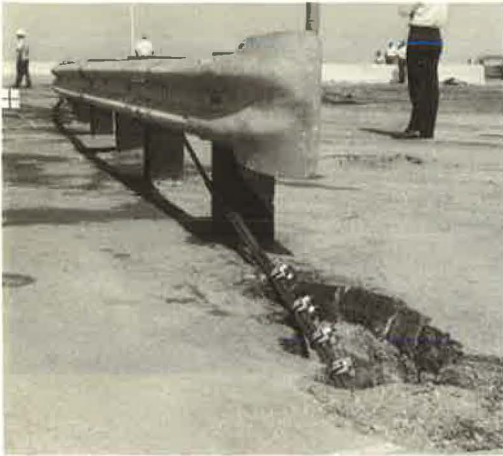
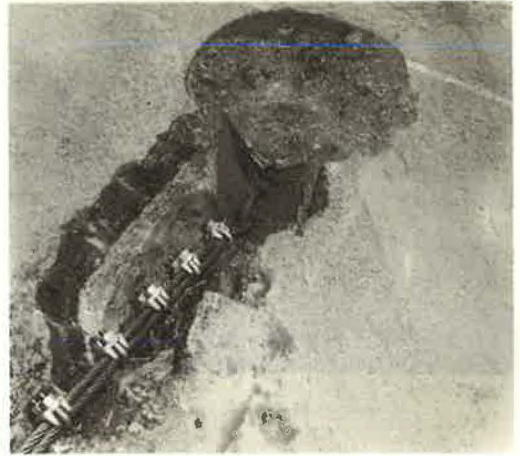
Test 135—In an attempt to provide adequate and efficient end anchorage, a cable end anchor system was developed which has subsequently been adopted as a California standard (see Exhibit 1, Appendix). Test 135 was the first test using this system of anchorage. The test installation consisted of a 50-ft length of corrugated metal beam guardrail constructed as a parabolic flare. In order to reduce the lever arm effect of the axial force acting about the posts, block-out blocks were not installed on the end posts and 4-in. thick blocks were used on the posts next to the end. Each end of the beam was secured with a $\frac{3}{4}$ -in. steel cable (breaking strength 21.4 tons) attached to the beam with a special fitting between the first and second posts (Fig. 6 and Exhibit 1). The other end of each cable was clamped to a $1\frac{1}{4}$ -in. eye-bolt cast in an 18-in. diameter by 5-ft deep cylindrical concrete footing (Figs. 7 and 8).

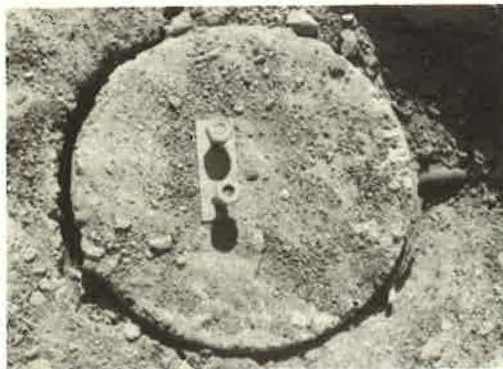
Figure 9.

mately 22 ft before being effectively redirected at an exit angle of 24 deg (Plate C). All beam sections were damaged and both anchors were displaced approximately $\frac{5}{8}$ in. toward impact (Fig. 9). The test vehicle sustained moderate front-end damage (Fig. 10).

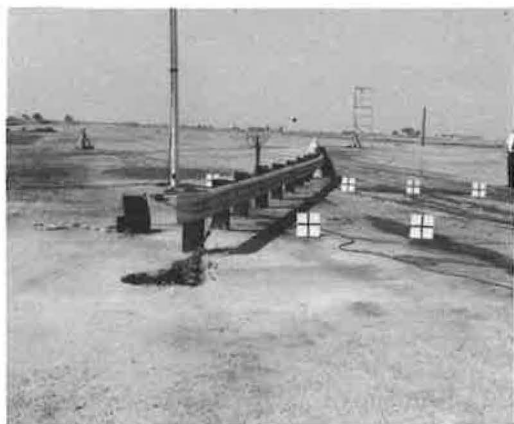
Figure 11.

The installation for Test 136 consisted of a 53-ft section of California standard guardrail with enough curvature in the first 12 ft from the bridge rail end so the remainder of the barrier could be placed on a straight line with a 4-ft end offset from a projection of the bridge rail line (Fig. 11). The downstream end of the guardrail beam

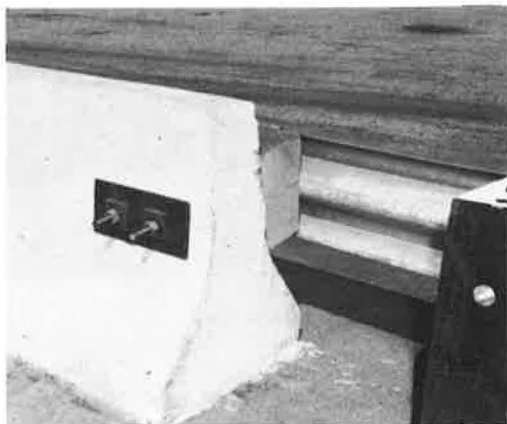
Figure 12.

was secured to a nonreinforced concrete simulated bridge rail with two 1-in. diameter high-strength bolts through 1 $\frac{1}{8}$ -in. diameter holes bored through the concrete. An 8 by 12 by 18-in. wood block was placed between the beam and the concrete (Fig. 12).

The block between the guardrail beam and the concrete end post was constructed of $\frac{1}{4}$ -in. steel plate rather than wood (Fig. 16 and Exhibit 2) to add rigidity to the system and prevent the crushing of the block that occurred in the previous test.

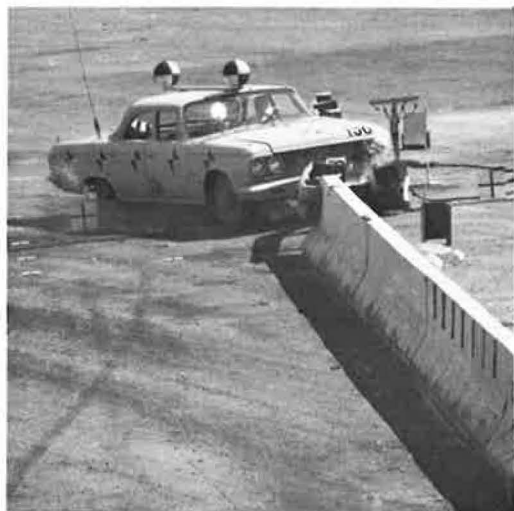
Figure 13.

The test vehicle impacted the guardrail at 60 mph and 33 deg 18 ft upstream of the end of the simulated bridge rail, pocketing the beam severely (Fig. 13 and Plate D). As the vehicle was being redirected, the nonreinforced concrete bridge rail failed through the connection holes, allowing the beam to pull free and permitting the vehicle to penetrate the barrier. As the vehicle progressed through impact, the right front wheel struck the end of the concrete rail, throwing the vehicle into a violent roll-over. The vehicle came to rest 45 ft beyond initial impact in an upright position. Two sections of beam were damaged, three timber posts broken off, and four block-out blocks shattered. The vehicle sustained major front, side and top damage and was considered a total loss (Fig. 14).

Analysis of the data film indicated that even if the concrete bridge rail connection had not failed, beam deflection and pocketing had already occurred to such an extent

that the vehicle would not have been redirected sufficiently to avoid an end-on collision into the concrete rail.

To minimize the pocketing noted in Test 136 and to provide a smooth transition from the semiflexible guardrail to the rigid bridge rail, the guardrail post spacing near the bridge rail was decreased from 6 ft 3 in. to 3 ft $1\frac{1}{2}$ in. and the size of the three wood posts immediately adjacent to the bridge rail was increased from 8 by 8 in. to 10 by 10 in. The upstream end of the guardrail was anchored with the same cable anchorage installation used in Test 136 (Exhibits 1 and 2).

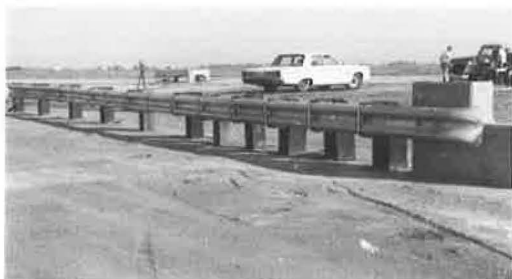
Figure 15.

Test 137—To correct the deficiencies noted in Test 136, several modifications were made for the Test 137 installation. To depict a typical installation more accurately, a simulated California standard Type 1 bridge rail end post was constructed of reinforced concrete in accordance with design details typical of current operational installations. A 50-ft section of metal beam guardrail was constructed on a straight line so that the upstream end was offset 4 ft from the projected bridge rail line (Fig. 15).

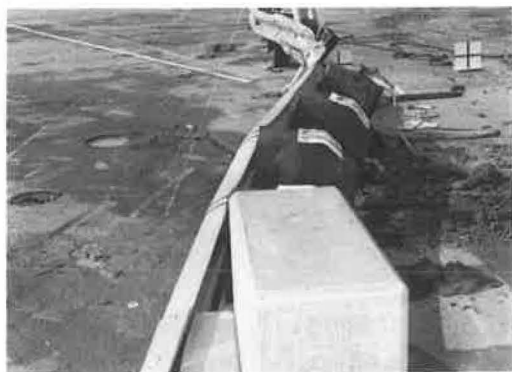
Figure 17.

The guardrail beam sustained a permanent deflection of 2.1 ft (Fig. 17). Although vehicle dynamics in this high-speed oblique angle collision were considered good through impact, the left front wheel was torn off and the vehicle sustained major front-end and undercarriage damage. The vehicle was considered a total loss (Fig. 18).

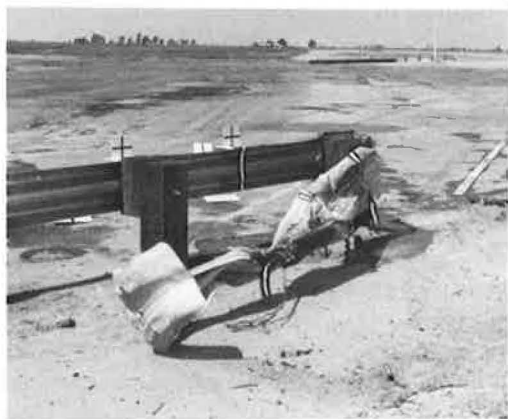
Figure 19.

are not great, the upstream cable anchorage system does present a potential hazard. In Test 138 (installation identical to Test 137) the vehicle impacted the guardrail at 61 mph and 25 deg into the end terminal section, upstream of the cable-to-beam connection. The beam bent, the left front wheel rode up and over the cable anchor eye-bolt, and the vehicle, straddling the cable, impacted post No. 1. The cable failed in tension as the vehicle, pushing the beam ahead of it, penetrated the barrier (Plate F and Fig. 19).

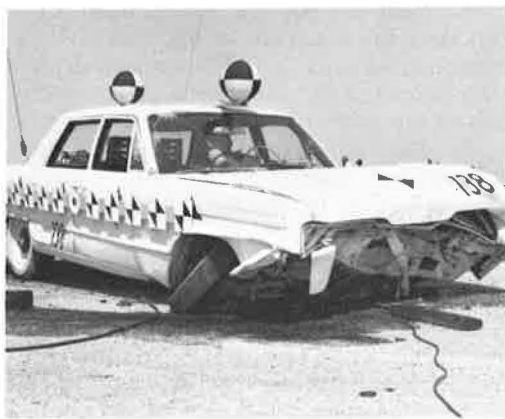
Figure 20.

The vehicle sustained major front-end damage, with both front wheels smashed back under the engine compartment, and was considered a total loss (Fig. 20). It is significant to note that, although the cable parted and the vehicle penetrated the barrier, there was no roll-over action and deceleration forces were no more severe than those recorded in the oblique angle impact of Test 137. However, the primary decelerating force was in the longitudinal direction (the more critical) rather than in the lateral direction as experienced in most oblique-angle barrier impacts.
