EFFECTS OF VARIOUS SEALING SYSTEMS ON PORTLAND CEMENT CONCRETE JOINTS

Delmont D. Brown, The D. S. Brown Company, North Baltimore, Ohio

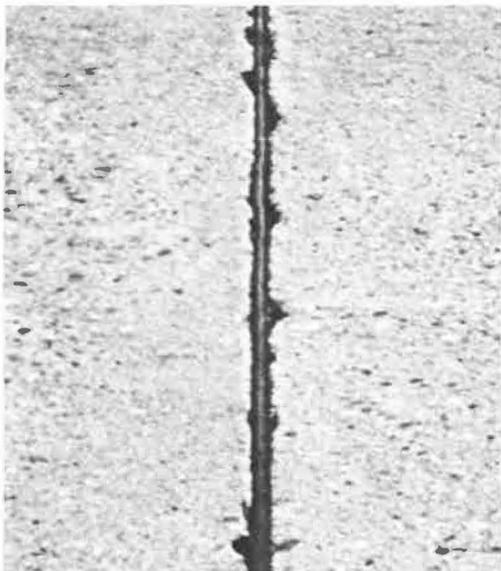
Figure 1. Polysulfide-sealed joint.

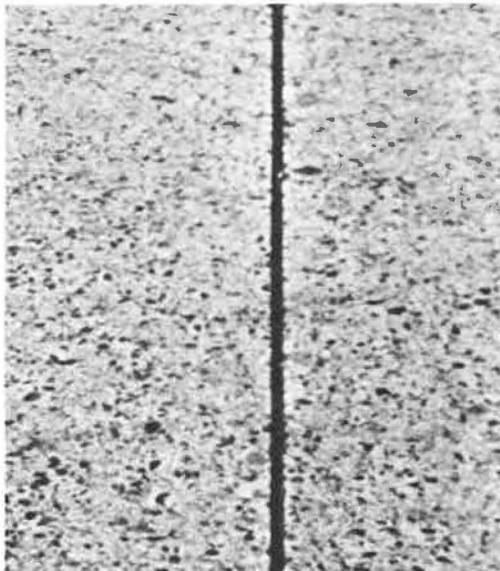
Figure 2. Neoprene-sealed joint.

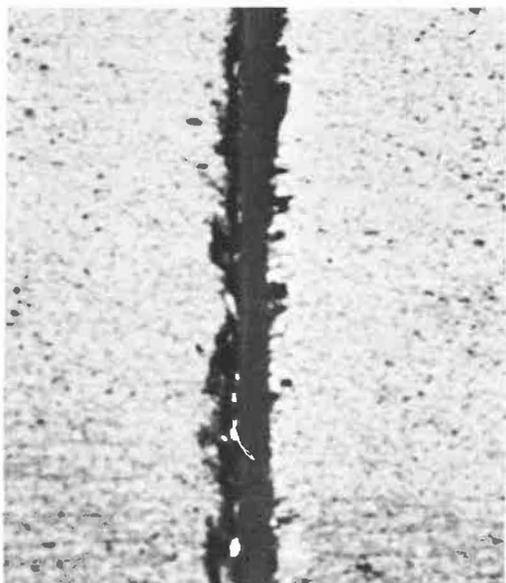
Figure 3. Polysulfide-sealed joint with spalls.

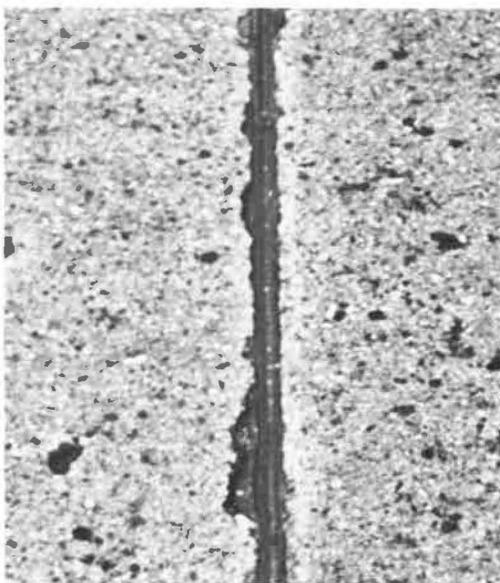
The first commercial neoprene compression sealed joints used in Minnesota highways were placed in the late fall of 1964 on I-90 in the westbound lanes starting at the west side of the Mississippi River Bridge and extending to Dresbach, Minnesota. The seals were installed manually. Both $1\frac{1}{16}$ - and $1\frac{3}{16}$ -in. materials were placed in $\frac{3}{8}$ -in. joints at $46\frac{1}{2}$ -ft spacings. Figure 1 shows a typical joint in the eastbound lanes sealed with two-component polysulfide material; Figure 2 shows a typical joint sealed with neoprene. All of the polysulfide-sealed joints show spalls where the faces of the joint break away (Fig. 3) because, although adhesion of the joint material is excellent in places, the extensibility of polysulfide joints is limited. The neoprene-sealed joints show slight raveling of the joint edges, particularly where the seal is installed deeper than $\frac{1}{8}$ in. below the pavement surface (Fig. 4).

Figure 4. Neoprene-sealed joint with ravels.

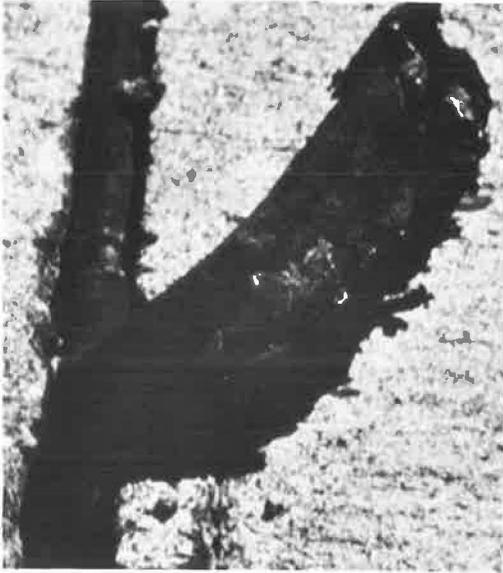
Figure 5 shows that polysulfide sealant material becomes embedded with incompressible stones and debris. Adhesion to the faces of the joint was nonexistent in most areas.

Figure 5. Polysulfide seal with embedded debris.

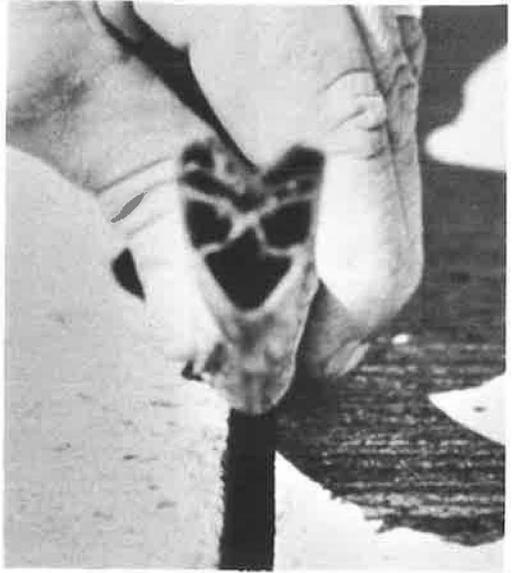
Figure 6 shows a neoprene seal after 7 years of service. The seal was of a tapered design and was replaced in later installations by a parallel-sided design that gave greater surface contact for holding the seal in the joint. Note that the joint below the seal is clean. The ruptured lubricant film has been forced to the bottom of the joint by the insertion of the seal in squeegee-like fashion.

Figure 6. Neoprene seal.

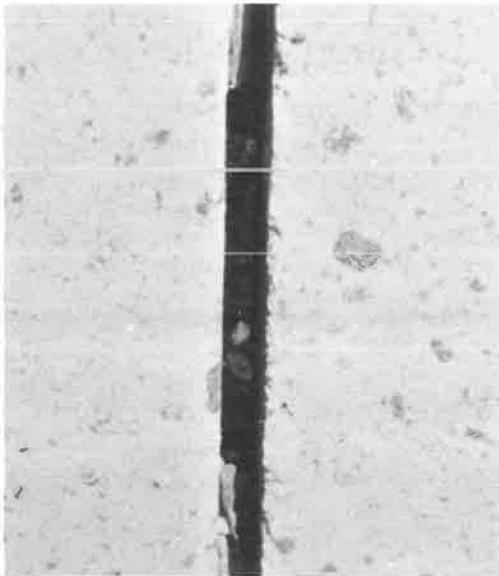
Care must be exercised in the placing of neoprene to prevent stretching of the seal. Figure 7 shows a typical break that was caused by excessive stretching of the seal due to manual methods. These openings allow incompressible debris to enter the joint.

Figure 7. Break in neoprene seal.

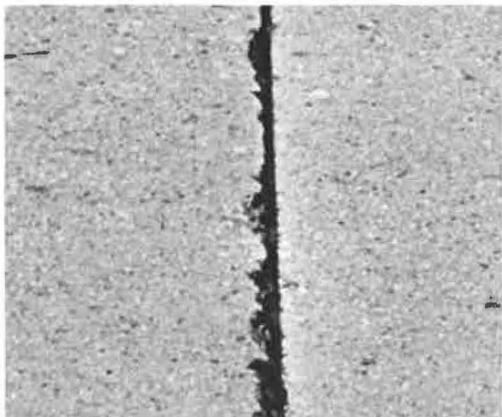
Figure 8 shows a hot-poured asphalt-sealed joint after 7 years of service. Figure 9 shows a neoprene-sealed joint of like service. Figure 10 shows a coal-tar epoxy joint that has spalls at intermittent points. Figure 11 shows a 1-in. wide liquid-sealed joint. A large sponge insert was used to gain a shape factor. Figure 12 shows a hot-poured joint that is full of incompressible material. This material contributes to the rapid deterioration of the joint faces.

Figure 8. Hot-poured asphalt-sealed joint.

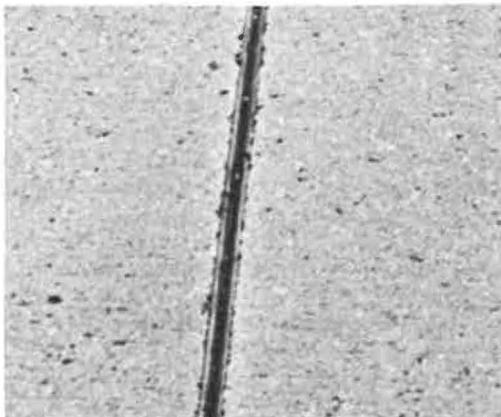
Figure 9. Neoprene-sealed joint.

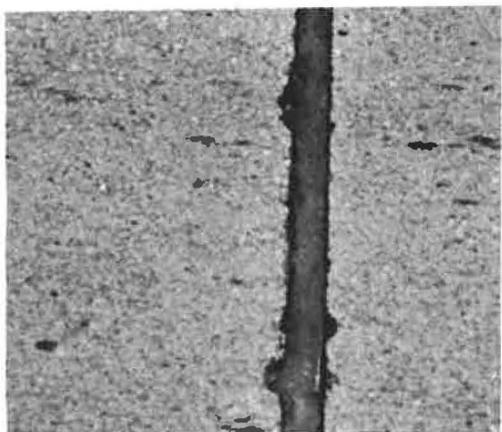
Figure 10. Coal-tar epoxy joint.

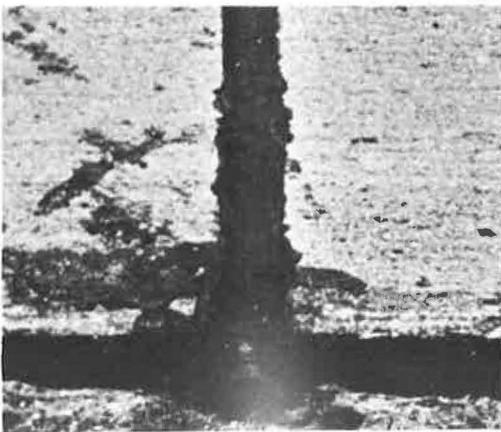
Figure 11. Liquid-sealed joint.

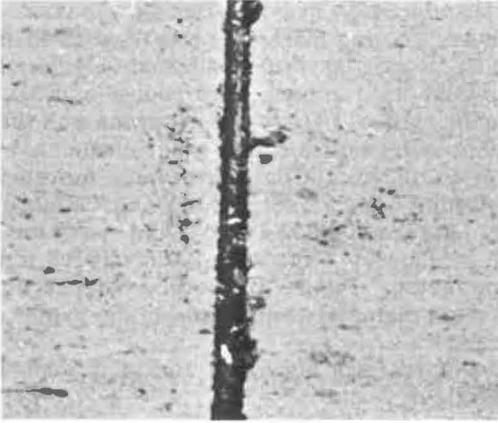
Figure 12. Hot-poured joint.

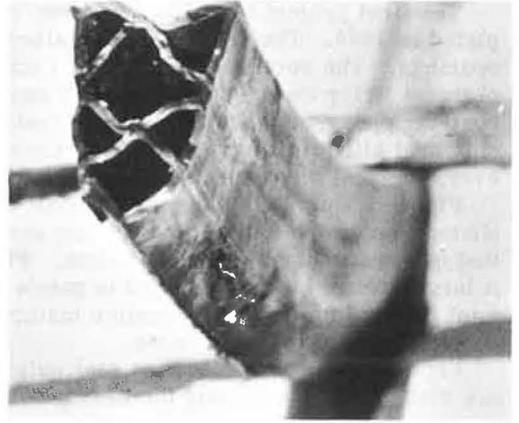
Figure 13 shows a neoprene seal pulled after 7 years of service. The joint faces are clean and smooth, and the seal is fully resilient.

Figure 13. Neoprene seal.

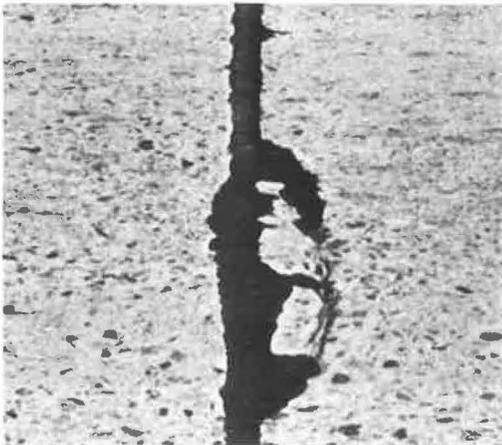
Prior to adopting neoprene compression seals as the standard seal for all jointed pavement in 1965, Michigan specified hot-poured rubber asphalt as the standard material. Figure 14 shows a typical asphalt joint that has been resealed with SAO asphalt; Figure 15 shows a section of pavement sealed with neoprene. A seal $1\frac{1}{4}$ in. wide was used in $\frac{1}{2}$ -in. styrofoam-formed joints at 71-ft joint spacings. This was the first major neoprene project in the state. It was accomplished by machine in the fall of 1964. Machine placement provides uniform depth control and eliminates stretching. It is defined as the placing of a seal from a roll or strip automatically into the pavement slab without manual or outside assistance (force).

Figure 14. Resealed asphalt-sealed joint.

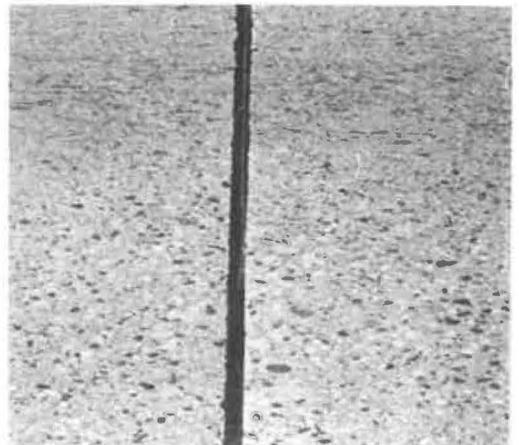
Figure 15. Neoprene-sealed joint.

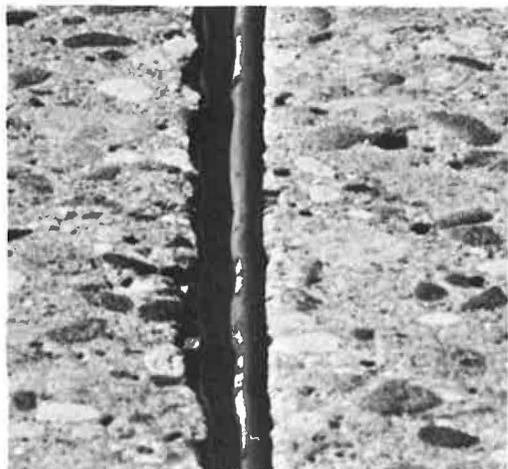
Figure 16 shows the ability of a neoprene compression seal of proper design and size to conform to small irregularities in the joint face. The pavement surface in this figure shows the effect of studded-tire wear. Figure 17 shows a joint with the compression seal removed. The joint is clean, and the plane-of-weakness crack is closed. There is no infiltration of debris.

Figure 16. Neoprene conforming to irregular joint.

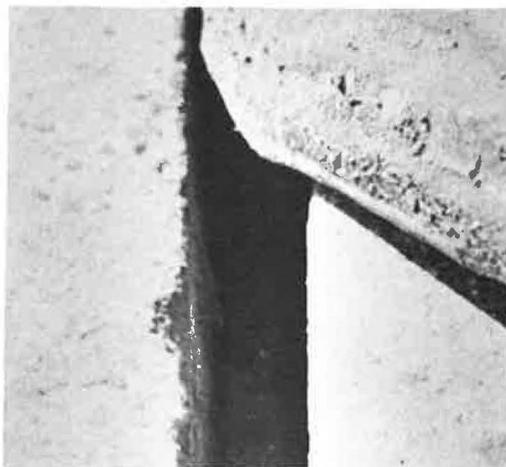
Figure 17. Clean joint with plane-of-weakness crack closed.

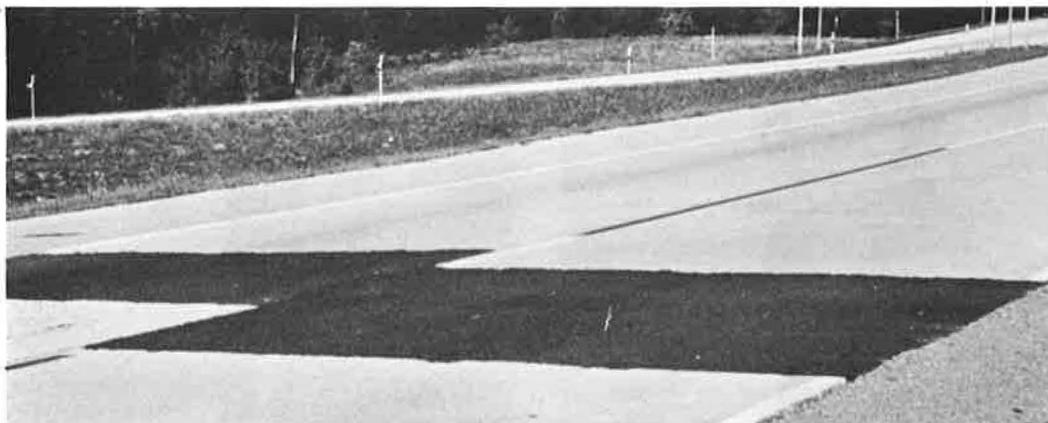
Figure 18 shows a blowup that was repaired in the asphalt-sealed section immediately adjacent to the neoprene-sealed section. No blowups have occurred in the neoprene-sealed sections.

Figure 18. Blowup patch.

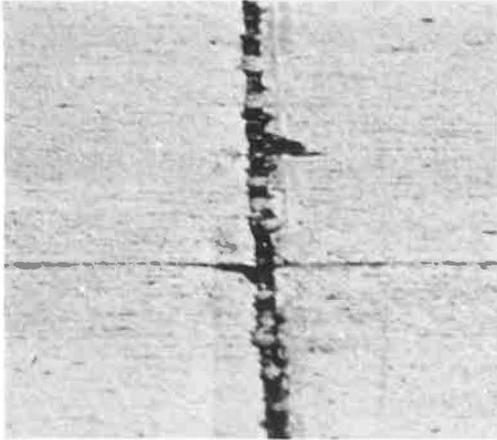
Figure 19 shows a liquid-sealed joint in the section of pavement adjacent to the neoprene-sealed section. Figure 20 shows a typical neoprene-sealed joint. The liquid-sealed section of pavement is approximately 1 year older than the neoprene section.

Figure 19. Liquid-sealed joint with spalls.

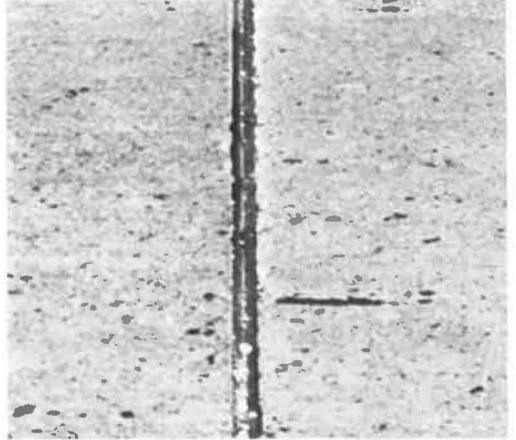
Figure 20. Neoprene-sealed joint.

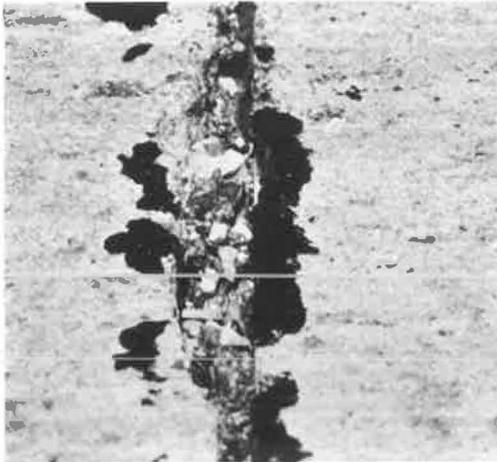
An inspection of the liquid-sealed joints shows a considerable amount of compacted debris in the joints, which causes substantial edge spalling of the joints (Fig. 21). Figure 22 shows that such an accumulation of debris in the neoprene-sealed joint is impossible because of lack of space. A longitudinal joint was sealed with neoprene; the joint shows no signs of spalling or deterioration (Fig. 23).

Figure 21. Incompressible materials causing spalls.

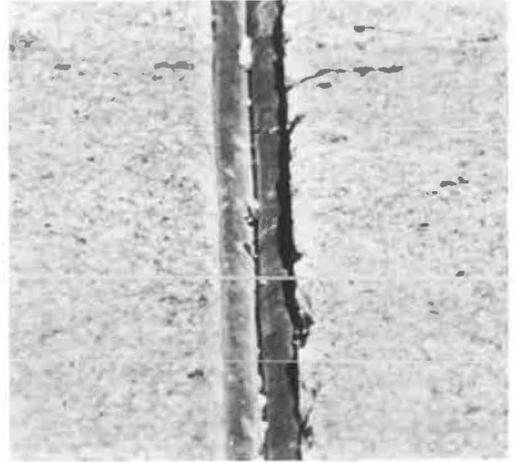
Figure 22. Neoprene-sealed joint at optimum depth.

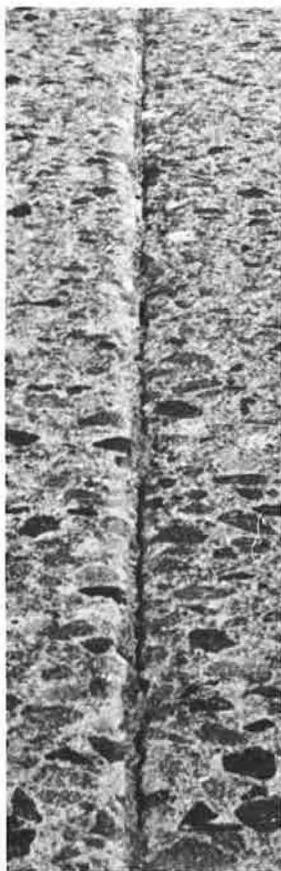
Figure 24. Unsealed joint (truck lane).

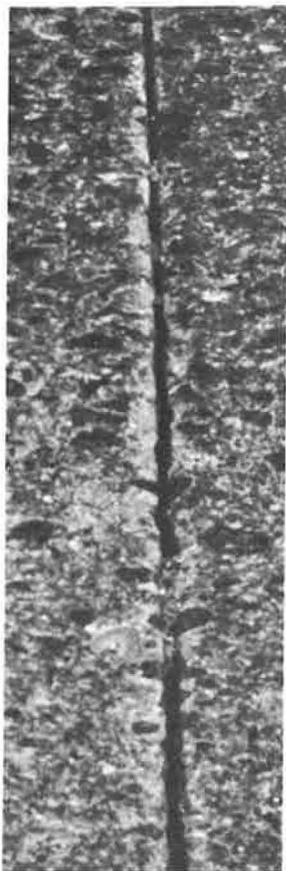
Figure 24 shows an unsealed joint in a truck lane. Figures 25 and 26 show polysulfide-sealed and neoprene-sealed joints in a truck lane. The loss of material at the joint edges exposed the neoprene to traffic that abraded the seal to the extent that the upper portions were shredded off. The polysulfide was completely pulled from the joints in places.

Figure 25. Polysulfide-sealed joint (truck lane).

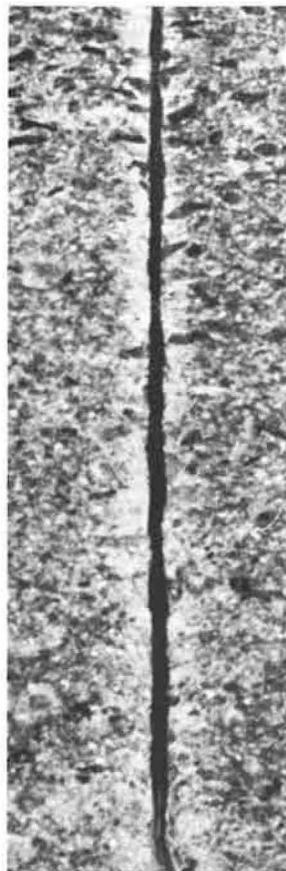
Figure 26. Neoprene-sealed joint (truck lane).

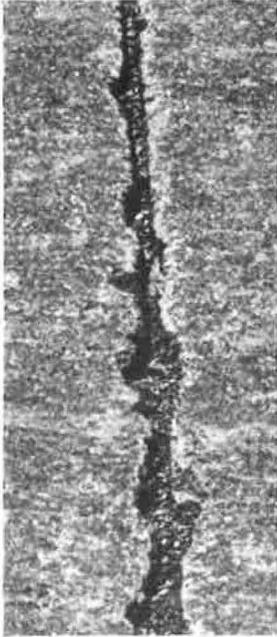
Figure 27 shows an unsealed joint in a passing lane. Although the joint edges are not rounded and worn, considerable damage has occurred to the joint as a result of compaction of incompressible material into the joint. The width of the joint, originally $\frac{1}{8}$ in., is now at least $\frac{1}{4}$ in. Without exception, all unsealed joints were twice the width

Figure 27. Unsealed joint (passing lane).

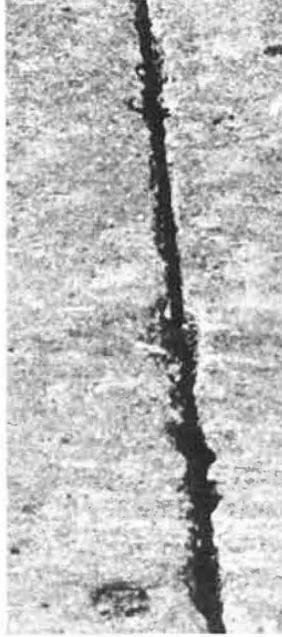
Figure 28. Polysulfide-sealed joint (passing lane).

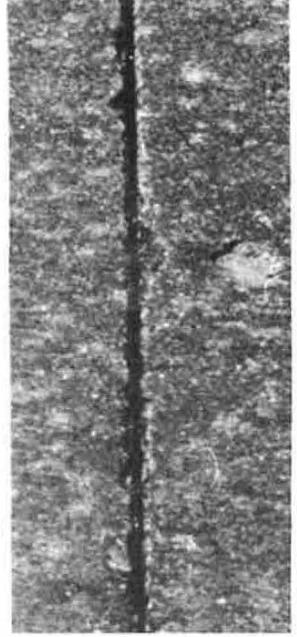
Figure 29. Neoprene-sealed joint (passing lane).

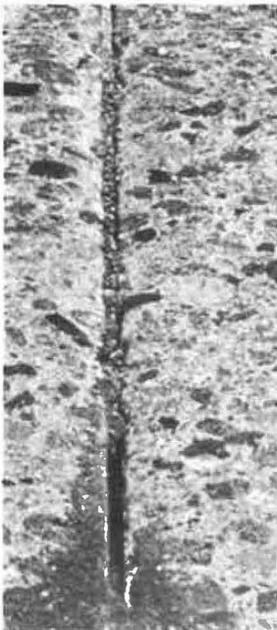
Figure 30. Close-up of unsealed joint (truck lane).

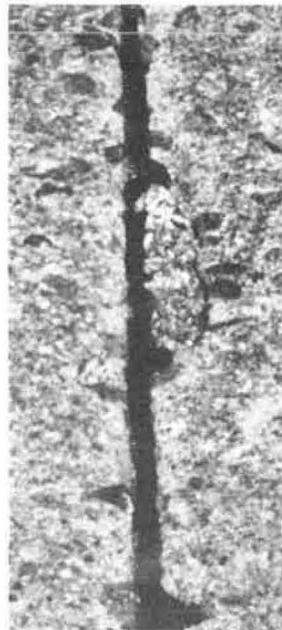
Figure 31. Close-up of polysulfide-sealed joint (truck lane).

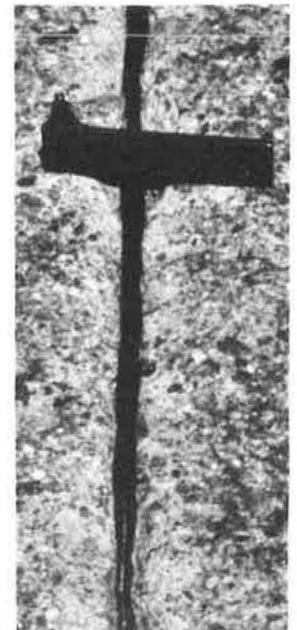
Figure 32. Close-up of neoprene-sealed joint (truck lane).

Figures 30, 31, and 32 show three types of joints in truck lanes: open or unsealed, polysulfide, and neoprene. The 3-in. rule across the neoprene-sealed joint indicates the extent of edge wear.

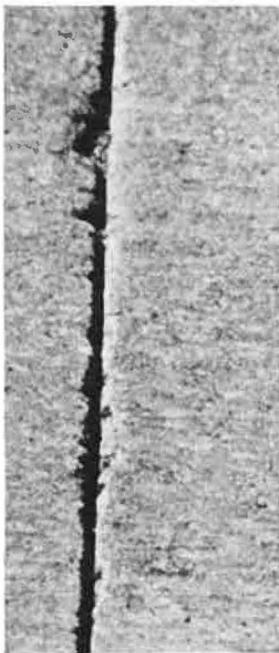
Figure 33. Unsealed joint prior to coring.

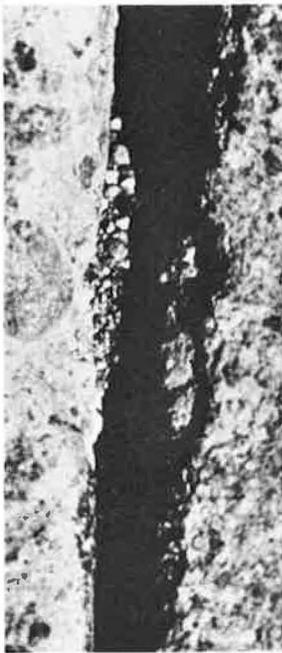
Figure 34. Close-up of core area (unsealed joint).

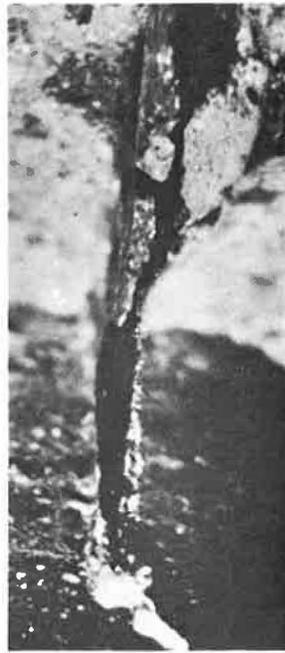
Figure 35. Damaged plane-of-weakness crack (unsealed joint).

Figure 33 shows an unsealed joint prior to coring; Figure 34 shows the core area. Incompressible material can be seen in the joint; however, much of this material was washed away during the coring operation. Figure 35 shows the core hole and the damage caused by the compaction of incompressible material at the bottom of the sawed joint following the plane-of-weakness crack. This accounts for the excessive width of the unsealed joints.

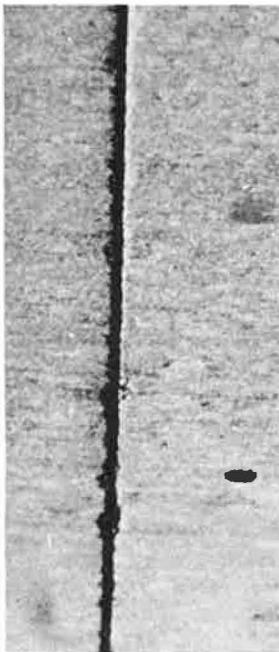
Figure 36. Polysulfide-sealed joint prior to coring.

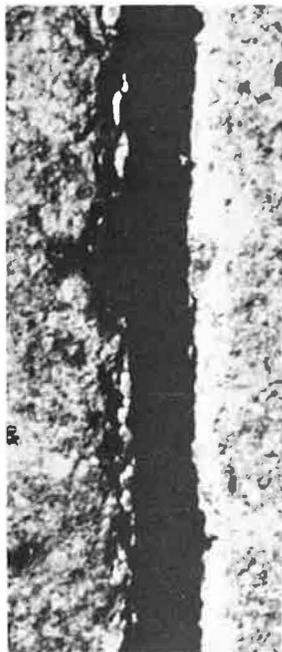
Figure 37. Close-up of core area (polysulfide-sealed joint).

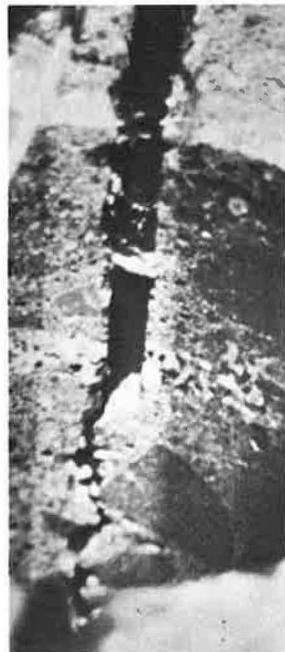
Figure 38. Plane-of-weakness crack (polysulfide-sealed joint).

Figure 36 shows a polysulfide-sealed joint prior to coring. Figure 37 shows the core area, and Figure 38 shows the hole with the core removed. Again, there is considerable infiltration, and the plane-of-weakness crack has been forced open.

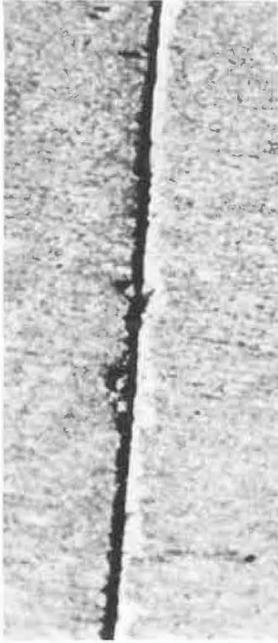
Figure 39. Neoprene-sealed joint with raveled edges.

Figure 39 shows a neoprene-sealed joint that is raveled along the joint edges. Although the upper edges of the seal are shredded (Fig. 40), the seal is still effective because incompressible material has been kept out of the plane-of-weakness crack (Fig. 41). The fact that the neoprene-sealed joints were tight and that the plane-of-weakness crack was able to close completely raises the question of whether much infiltration occurs from the bottom of the joint, especially with cement-treated subbases such as were used here.

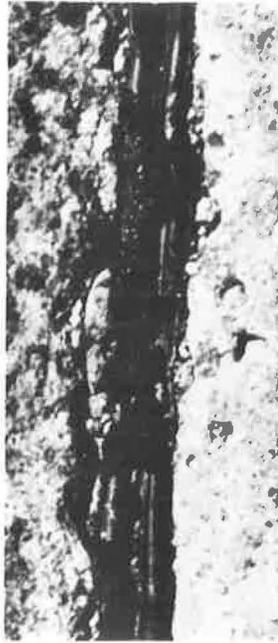
Figure 40. Close-up of core area (neoprene-sealed joint).

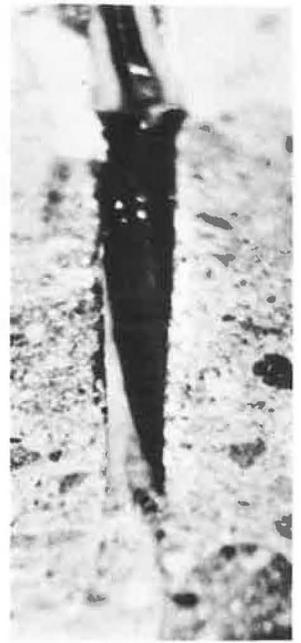
Figure 41. Undamaged core area (neoprene-sealed joint).
