# VEHICLE CRASH TEST AND EVALUATION OF MEDIAN BARRIERS FOR TEXAS HIGHWAYS

Edward R. Post, Teddy J. Hirsch, and Gordon G. Hayes, Texas Transportation Institute,  
Texas A&M University; and  
John F. Nixon, Texas Highway Department

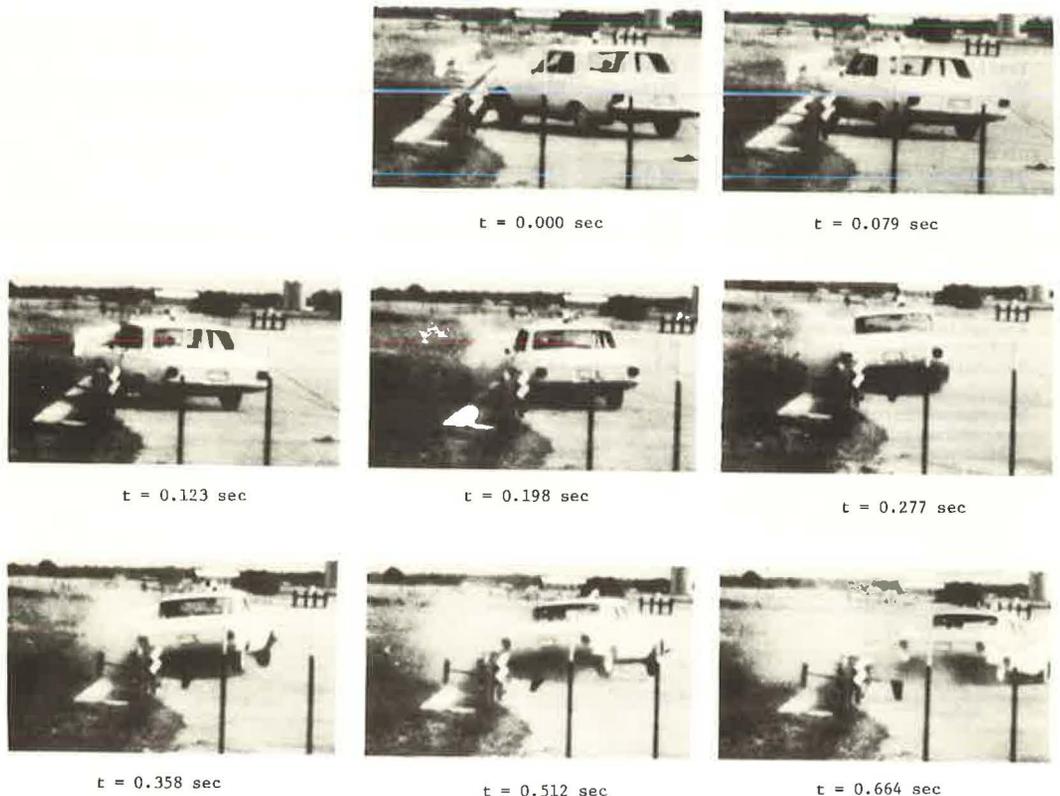
**Figure 4. MBGF test.**

The MBGF test was conducted at an impact speed of 57.3 mph and an impact angle of 25 deg using a 1963 Plymouth weighing 3,460 lb with instrumentation and dummy. The point of impact was near a support post.

A peak longitudinal deceleration of 12.8 g indicated that snagging on the posts was not severe. The change in heading speed of the vehicle during redirection was 25 mph, the

departure angle from the barrier was 20 deg, and the maximum dynamic lateral displacement of the barrier was 1.5 ft.

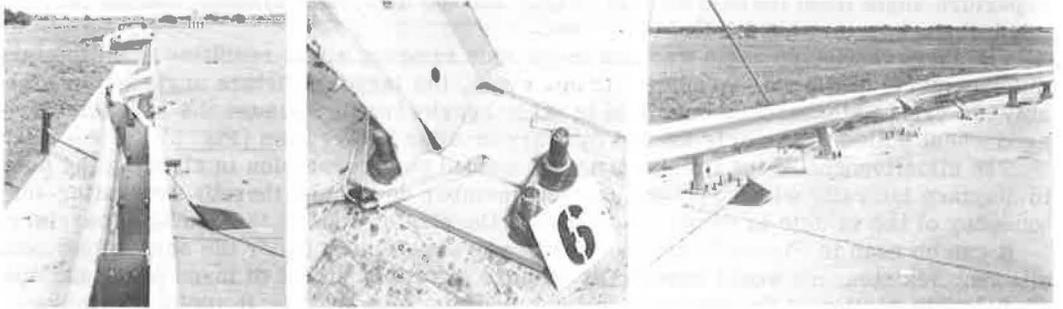
Figure 5. Damage to MBGF.

The large departure angle was due to the side ramping effect resulting from the large displacements of the rail member. In any event, the large departure angle would probably not create a hazardous condition to other nearby traffic because the severely damaged wheel pulled the vehicle toward the barrier after redirection (Fig. 5).

The effectiveness of the breakaway fillet welded post connection in allowing the posts to displace laterally without pulling the rail member down, and thereby preventing any tendency of the vehicle to ramp, is evident in the photographs of the damaged barrier.

It can be seen in Figure 5 that the MBGF remained intact under the severe test conditions. Maintenance would essentially require the replacement of three posts and one 25-ft length section of the two back-to-back W-beam guardrails. It appears that the damaged barrier would, prior to repair, be functional under a possible second low-angle collision.

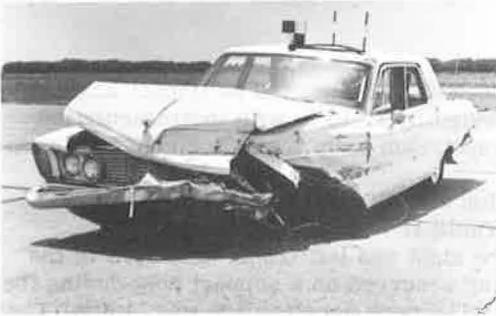
Figure 6. Vehicle damage after MBGF test.

The damaged test vehicle is shown in Figure 6. The left front quarter was damaged, but the windshield remained intact and the passenger compartment area was not warped.

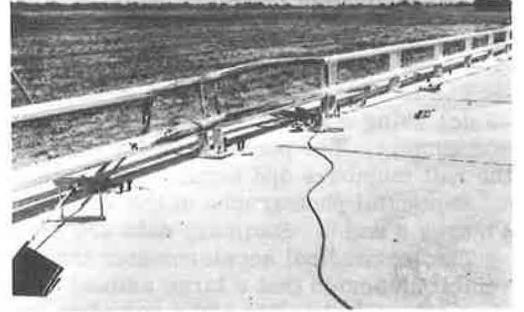
Figure 7. Damage to E-3 barrier.

The E-3 test was conducted at an impact speed of 59.3 mph and an impact angle of 25 deg using a standard-sized 1963 Plymouth weighing 3,610 lb with instrumentation and dummy. The point of impact was slightly upstream from the splice connections in the rail members and support post (Fig. 7).

It can be seen in Figure 7 that the barrier remained intact and was not extensively damaged under the test conditions. Maintenance would require the replacement of one 10-ft long upper rail member and straightening of one support post. It appears that the damaged barrier would, prior to repair, be functional under a possible second collision.

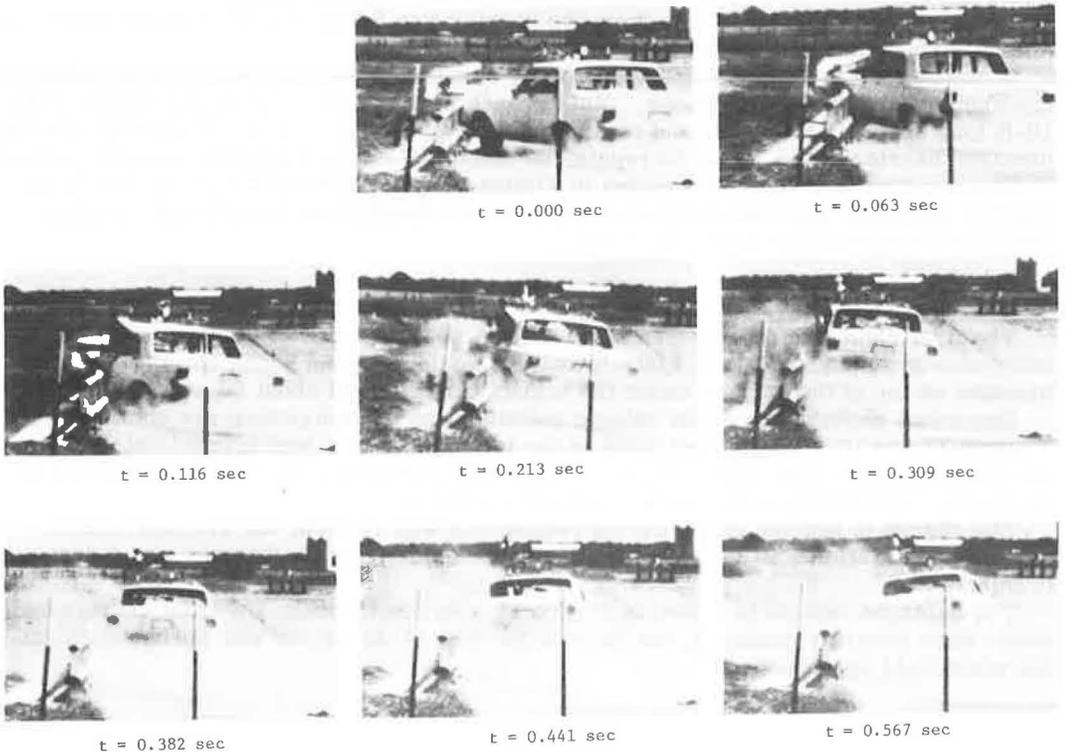
Figure 8. E-3 barrier test (rear view).

Sequential photographs of the vehicle collision and its redirection are shown in Figures 8 and 9. Summary data are given in Table 1.

The longitudinal accelerometer traces on the right and left frame members of the vehicle indicated that a large amount of snagging occurred on a support post during the time interval of 100 to 160 msec after impact. The peak acceleration was 21.3 g. The tire marks and the motion of the vehicle (Fig. 9) show that the vehicle had climbed on the lower rail member. It appears that the snagging on a post could be greatly reduced by placing the lower rail member higher.

As indicated in Table 1, the change in heading speed of the vehicle during redirection was 30 mph, the departure angle from the barrier was 9 deg, and the maximum dynamic lateral displacement of the top rail member was 0.7 ft.

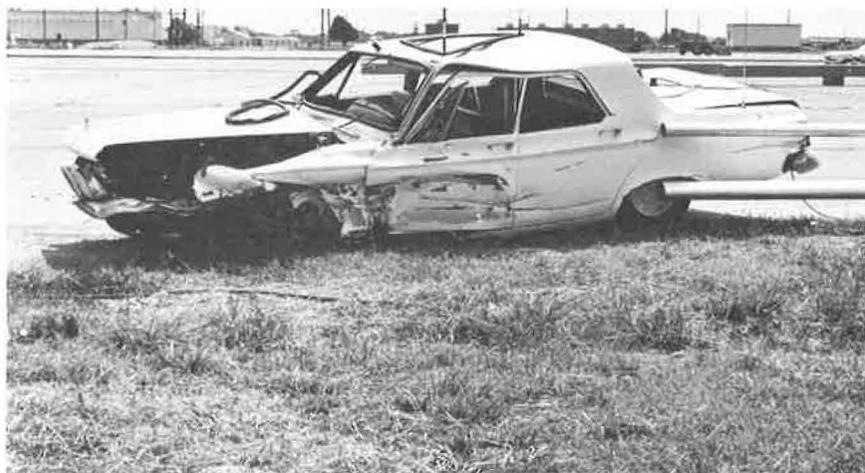
The damaged test vehicle is shown in Figure 10. It can be seen that the left front quarter and wheel were severely damaged, the windshield was knocked out, and the passenger compartment area was warped.

$t = 0.339 \text{ sec}$ **Figure 10. Vehicle damage after E-3 test.**

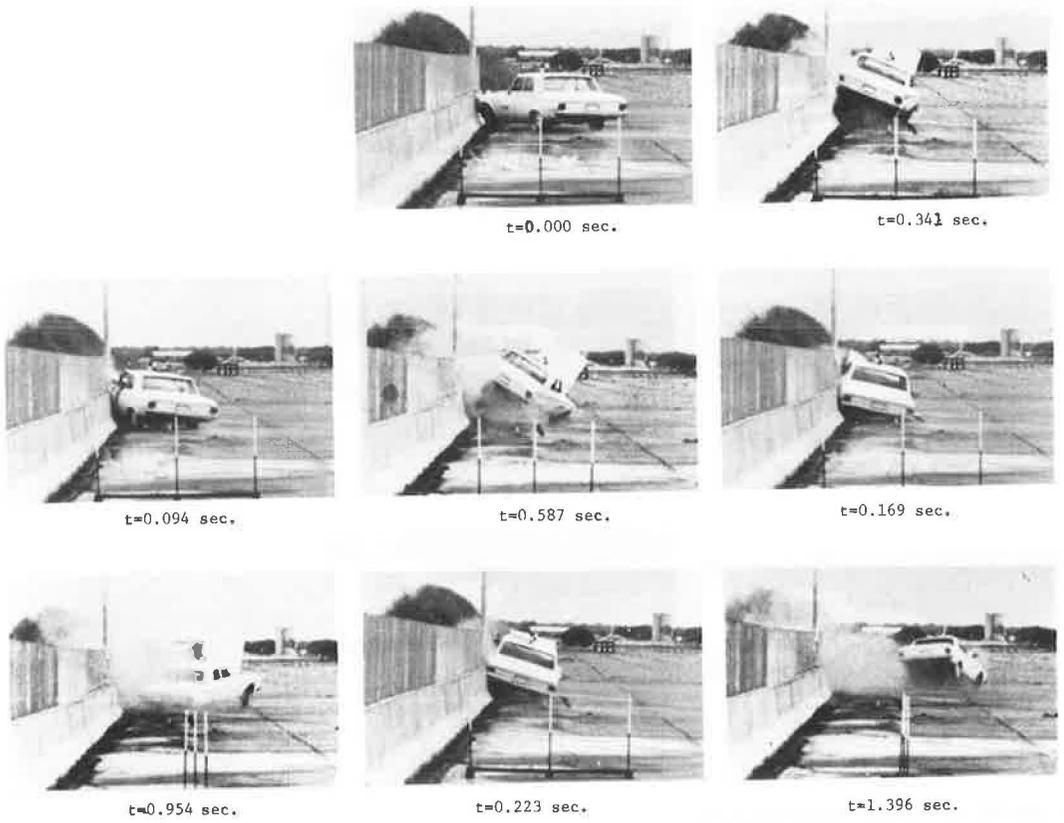
Figure 11. CMB-1 test (rear view).

Sequential photographs of the vehicle collision and its redirection are shown in Figures 11 and 12. The contact point of the left front fender was approximately 9 ft upstream from the light pole. As the vehicle was redirected, it climbed to the top of the barrier and lightly scraped the light pole and fence.

The change in heading speed during redirection was 15 mph, the average lateral vehicle deceleration was 8.0 g, and the departure angle from the barrier was 7 deg (Table 2).

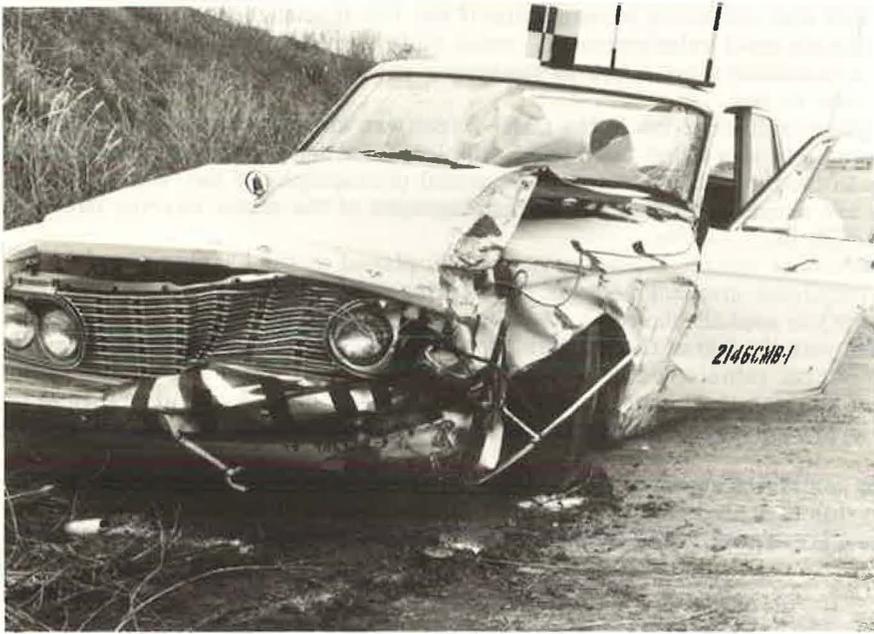
Figure 13. Vehicle damage after CMB-1 test.

The damaged vehicle is shown in Figure 13. As can be seen, the front quarter and wheel were severely damaged, the door on the side of the driver was sprung open, and the windshield was cracked.

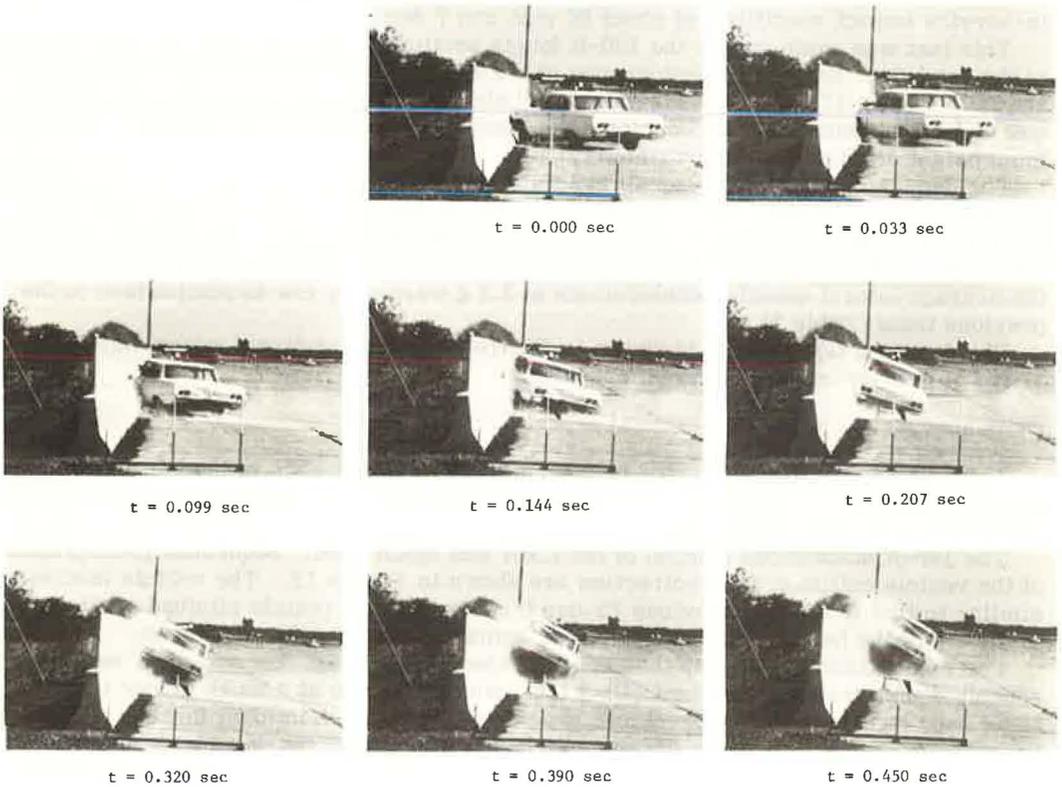
Figure 14. CMB-2 test.

The vehicle-barrier interaction in the CMB-2 test was similar to that of the CMB-1 test. While the vehicle was being redirected, the left front fender was crushed, and the tire rode up to the top of the barrier. Sequential photographs of the vehicle collision and redirection are shown in Figure 14, and photographs of the minor barrier damage are shown in Figure 15.

Linear displacement voltage transducers (LDVT) placed on the barrier showed that the lateral and rotational displacements of the barrier were negligible. The LDVT placed 2 in. above the asphalt showed a maximum displacement of 0.03 in., whereas the LDVT placed near the top of the barrier showed a maximum displacement of 0.09 in.

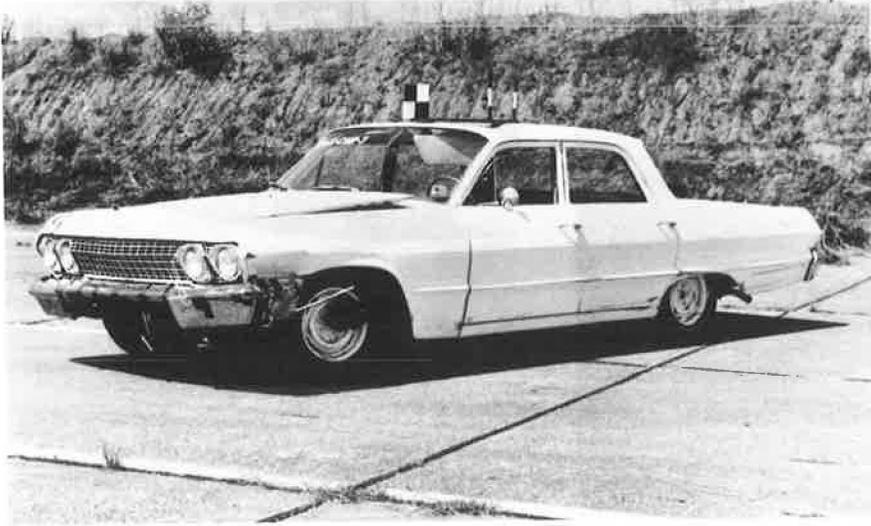
Figure 18. Vehicle damage after CMB-3 test.

The damaged test vehicle is shown in Figure 18. The relatively minor damage consisted of bumper and sheet-metal crushing.

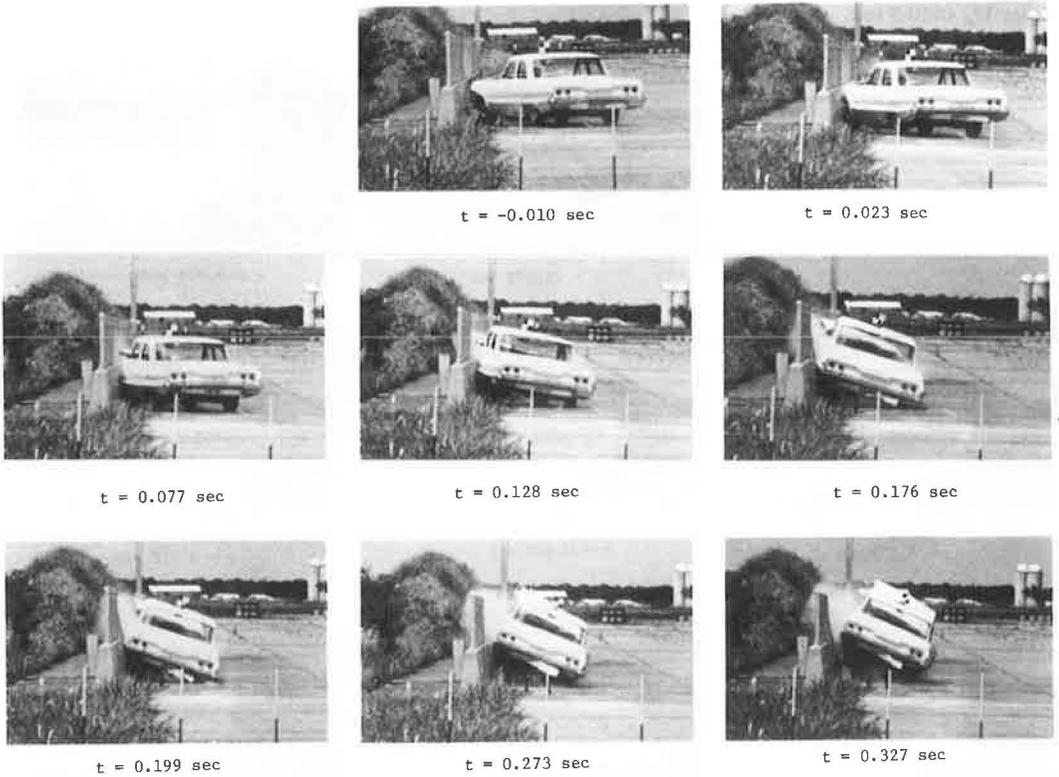
Figure 19. CMB-4 test.

The 150-ft unanchored section of the CMB was again used. Sequential photographs of the vehicle collision and redirection are shown in Figure 19. The vehicle motion was similar to that in the two previous 25-deg tests in that the vehicle climbed all the way to the top of the barrier and caused minor damage to the barrier and fence.

For some unknown reason, the change in the vehicle heading speed of 11 mph was roughly double the speed of the CMB-1 test, which was run at a much larger impact angle and, hence, probably developed greater sheet-metal frictional forces. However, the greater change in heading speed could be the reason for the departure angle of 12 deg being roughly double the departure angles in previous test runs. In any event, it appears

that this larger departure angle would most likely not create any hazardous situation to other nearby vehicles because the drag forces of the damaged front wheel pulled the vehicle back toward the barrier.

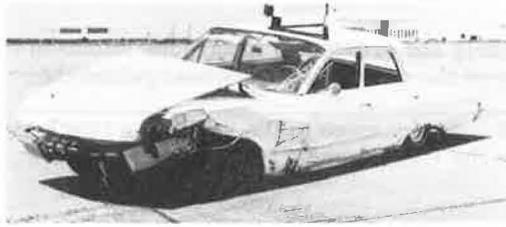
**Figure 20. Vehicle damage after CMB-4 test.**

The damaged vehicle is shown in Figure 20. The damage to the vehicle in this test was slightly less than the damaged vehicles in the CMB-1 and CMB-2 tests that were run at larger impact angles.
