Scaling of Air-Entrained and Non-Air-Entrained Concrete

EDWARD A. ABDUN-NUR, Consulting Engineer, Denver; and
RICHARD C. MIELENZ, Master Builders Division of Martin Marietta Corporation,
Cleveland

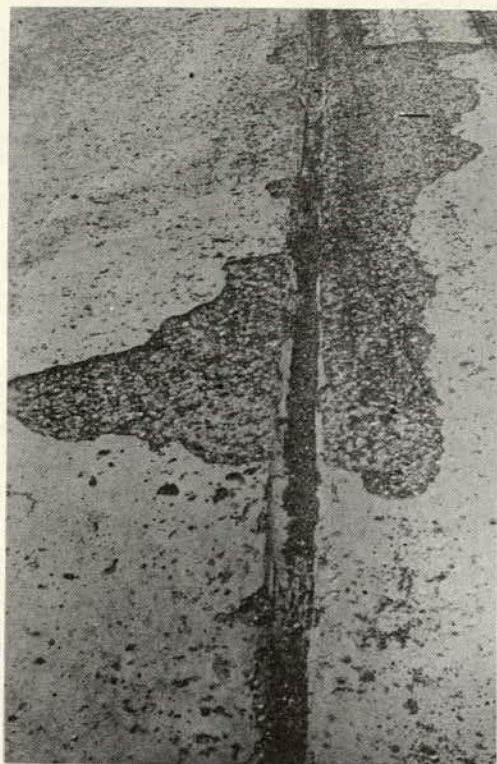
Figure 1. Typical scaling of concrete as it had occurred in areas 92, 93, and 98. Note localized pitting and spalling of the finished surface in advance of general scaling.

Photographs of areas of the pavements at different stages of scaling were taken; Figure 1 shows several stages of deterioration, ranging from severe to lesser stages of symptoms. Four pairs of 4-in. diameter cores were taken at random in various areas. One core of each pair was tested for compressive strength (ASTM Designation C 42); the other was examined by petrographic methods and the air content was determined microscopically. The compressive strengths and visual impressions were as follows:

The four cores extended through the thickness of the pavement. The top of the core from area 80 was partially scaled to a depth of $\frac{1}{16}$ to $\frac{1}{8}$ in., whereas the tops of the cores from areas 92, 93, and 98 were almost completely scaled to a depth of $\frac{1}{8}$ to $\frac{5}{16}$ in. In each instance, active progress of the scaling was indicated by roughly horizontal microfractures through the mortar matrix at depths of $\frac{3}{16}$ to $\frac{3}{8}$ in.

2. Areas 92, 93, and 98 comprised non-air-entrained concrete that was not resistant to freezing and thawing while wet, especially in the presence of de-icing salts. Examination of the local weather records indicates that, although they were not purposefully cured, these pavements could not experience any substantial drying following placing and were well saturated with water at the time of freezing and thawing because of heavy precipitation during the late summer and early fall of 1957. Thus, this concrete of low water-cement ratio was susceptible to rapid disintegration during repeated freezing.

4. The experience illustrates the fact that air-entrainment will not ensure adequate durability of exposed concrete in the absence of good concreting practices. In this instance, the defect leading to failure of concrete in area 80 was the result of inattention to curing and protection of the concrete from early drying prior to development of a sound cement paste matrix of low absorptivity. The defect leading to failure of the pavement surface in the other areas was the absence of a proper entrained air void system in the concrete.
