# Random Cracking of Bridge Decks Caused by Plastic Shrinkage

HOWARD H. NEWLON, JR., Virginia Department of Highways

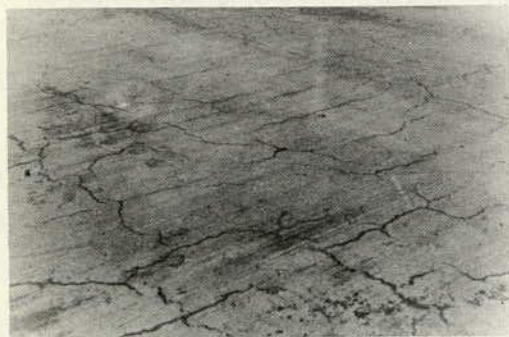
Figure 1. Random cracking in span 4 (surface damp).

Although the cracking was mostly random, in certain areas it appeared to be influenced by the top reinforcing steel. This may be seen in Figure 1. This is also consistent with the view of plastic shrinkage expressed by Blakey (1) that, as evaporation takes place and the surface dries, the resistance to sedimentation is greater over the reinforcement, which then controls the location of the crack that would otherwise form randomly.

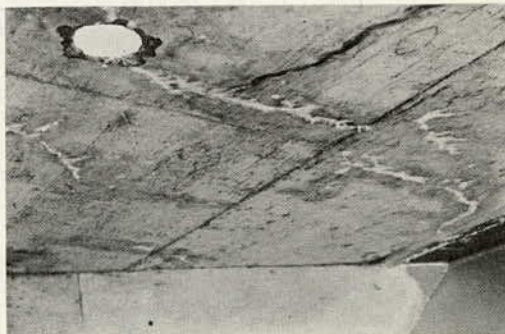
Figure 2. Underside of span 4 showing leaching through cracks and corrosion of longitudinal stringer. Core was removed from hole at upper left.

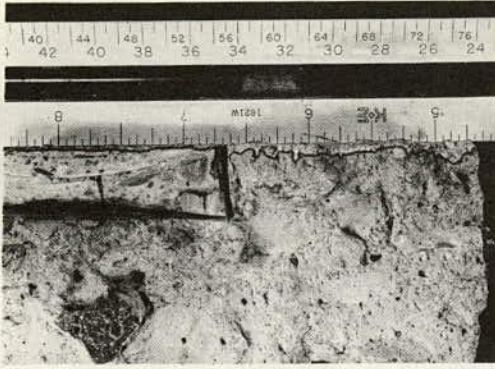
To accomplish this, two 4-in. diameter cores were removed from the cracked area for petrographic examination. Examination of these cores indicated that the cracks traveled around rather than through aggregate particles. Considering this finding and the fact that the strength of the concrete was high based on information from construction records and the petrographic examination, it was possible to conclude that the cracking occurred when the concrete was relatively green and perhaps fresh. This conclusion was supported by an earlier investigation (4) of a similar though less severe occurrence in which it was shown, from a petrographic examination of cores, that the curing compound actually penetrated into the crack as shown in Figure 3, thus proving that formation of the crack preceded or very closely followed the application of curing compound. Results from an earlier, unpublished laboratory study of similar quality concrete suggested that the absence of broken aggregate associated with the crack indicates that the crack occurred during the initial 24 hours.

Figure 3. Top of core removed from a bridge showing random cracking. The right side shows penetration of curing compound into crack to a depth indicated by the dark line. The normal depth of curing compound is indicated on the sawed left section of core.

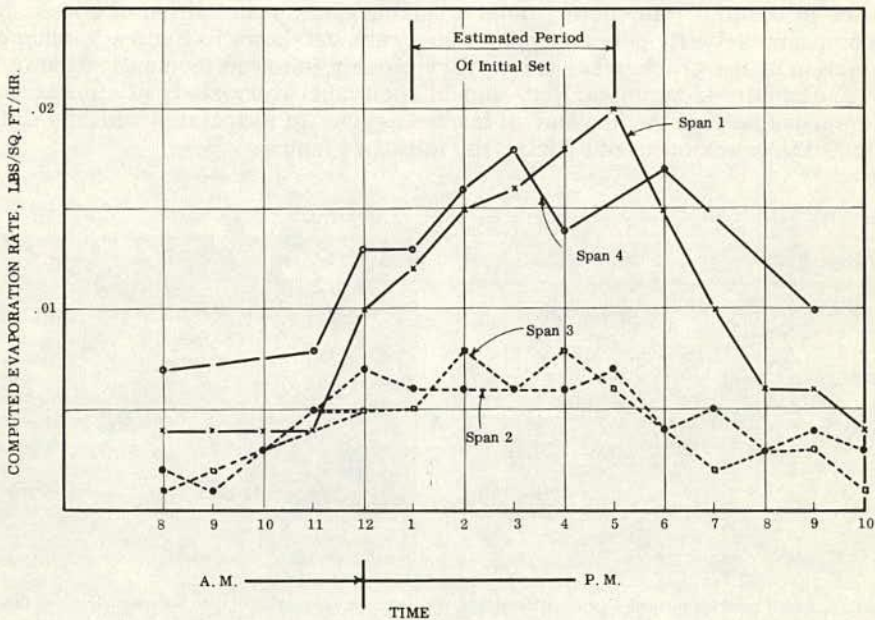
Figure 4. Variation with time of computed evaporation rates for spans 1 and 4 (cracked) and 2 and 3 (uncracked).

It was assumed, on the basis of data from a previous study (2), that the time between placement and setting, during which plastic cracking could occur, was 5 hours. Computed evaporation rates, based on a differential temperature between concrete and air of +10 F, are plotted in Figure 4. The evaporation rates for placement days on which slabs cracked are similar and significantly higher than those for the days on which unaffected slabs resulted. The computed values are above 0.10 lb/sq ft/hr and approach 0.20 lb/sq ft/hr. Guides furnished by the PCA (5) state that there is no way to predict with certainty when plastic shrinkage cracking will occur. When the rate of evaporation is as high as 0.2 to 0.3 lb/sq ft/hr, precautionary measures are almost mandatory. However, if the rate of evaporation exceeds 0.1 lb/sq ft/hr, cracking may occur.
