# Deterioration of Concrete Chimneys

G. M. IDORN and A. G. THOMSEN, Concrete Research Laboratory,  
Karlstrup, Denmark

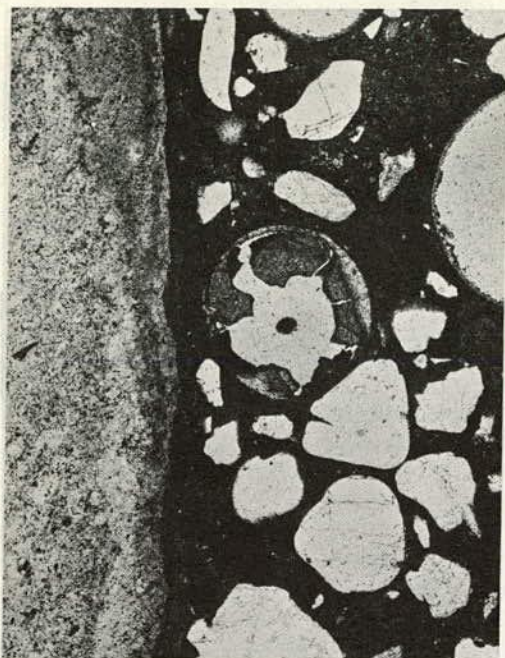
A thin section was prepared from a piece of the deteriorated concrete. From observations of the thin section, it could be concluded that the concrete was strongly carbonated along with secondary precipitations of gypsum in the cement paste. Flint pebbles with distinct symptoms of alkali-aggregate reactions were observed (Fig. 1).

Figure 1. Thin section of concrete from factory chimney near the Mediterranean Sea. Flint pebbles to the right have darkened rim caused by partial solution resulting from alkali-aggregate reaction. Air bubble in center of picture is partly filled by alkali-silica gel, fractured during drying.

It is supposed that a combination of the three factors mentioned previously caused the damage to the chimneys investigated. The presence of gypsum and of reacted flint pebbles in the concrete of the chimney near the Mediterranean indicates that sulfate attack and alkali-aggregate reactions in a combined action have caused a particularly rapid disintegration. The serious damage to the chimney is also caused by a too-thick concrete cover of reinforcement. The ring reinforcement, being too far away from the outer shaft face, has been unable to prevent the cracking of the outer part of the concrete as a result of tensile stress caused by the heating of the interior of the shaft.

The conclusion from the investigations is that concretes used for factory chimneys are exposed to a particularly aggressive milieu. This should be taken into consideration in construction of chimneys and reasonable precautions specified, such as (a) use of sulfate-resistant cement, (b) use of aggregate resistant to alkali-aggregate reactions, (c) possible treatment with epoxy resin, and (d) careful construction.

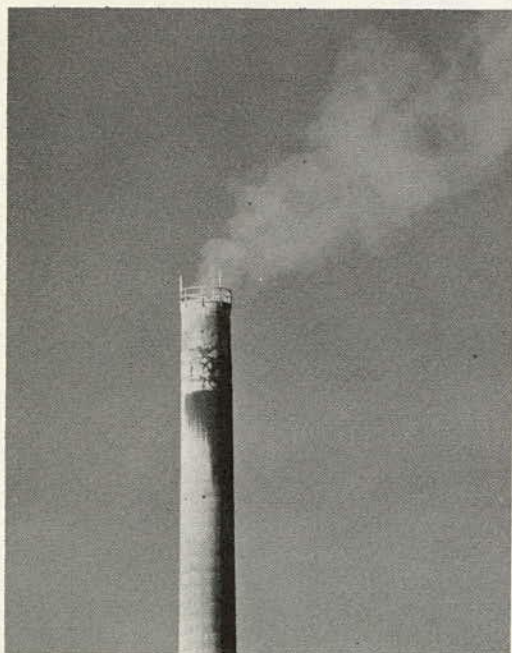
The chimney in Northern Europe was built in 1957 of reinforced concrete. In the autumn of 1965 it was inspected and it was noted that the concrete had scaled off the steel in parts of the upper 60 to 70 cm of the shaft (Fig. 2). The reinforcement was rusting and a 2-mm thick layer of rust could easily be removed. In the construction joint 13 meters from the top, loose flakes of concrete were observed 15 cm above the joint.

Figure 2. Top section of concrete chimney showing disintegration.

The formation of cracks in the Northern European chimney probably resulted from the great and rapid temperature variations at the top of the shaft. But phenomena such as leaching, carbonation, and precipitation of corrosion products all contribute to a reduction of the strength of the concrete and thereby to the risk of crack formation. The coating of syngenite on the outer surface of the chimney probably came from potassium and sulfate from the smoke; the calcium may originate from either the smoke or the concrete. The presence of a hemihydrate instead of gypsum in the coating in the fracture could be explained from the temperature of the chimney.

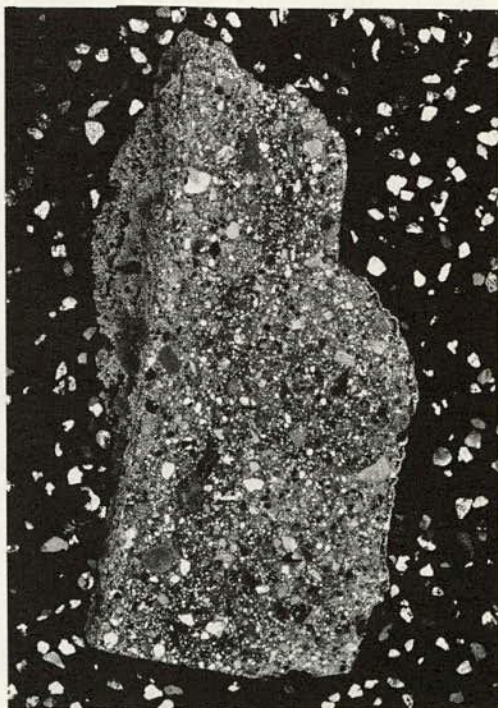
A concrete specimen from the top section was examined by chemical analysis, X-ray diffraction analysis, and a thin-section investigation. The concrete proved to have undergone leaching and carbonation along with the corrosion of the reinforcement. On the outer surface of the specimen, a coating of the mineral syngenite  $[K_2Ca(SO_4) \cdot H_2O]$  was observed (Fig. 3), while a coating consisting of the hemihydrate  $CaSO_4 \cdot \frac{1}{2}H_2O$  was found on the inside of the chimney and situated in a crack in the structure.

Figure 3. Total photo of a thin section prepared from a deteriorated piece of concrete taken from the outside upper part of a chimney (crossed nicols, 1.26x magnification).
