Disintegration of Concrete in Foundation and Anchorage Blocks for an Aerial Mast

G. M. IDORN and P. NEPPER-CHRISTENSEN, Concrete Research Laboratory, Karlstrup, Denmark

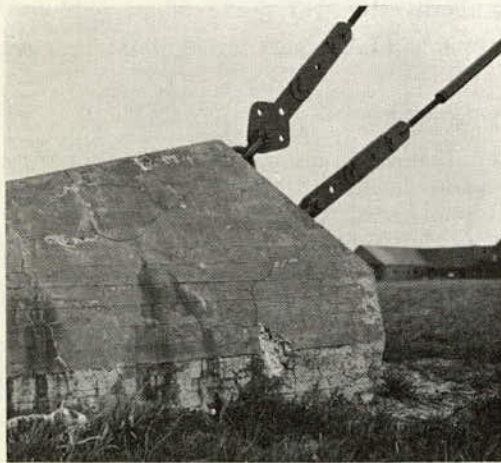
Figure 1. Anchorage block 8 (Fig. 2) with coarse cracks and map-cracking.

foundations. After 5 years of service, the foundations were extensively cracked, with map-cracking, single coarse cracks, and pop-outs (Figs. 1 and 3). Disintegration was most pronounced in foundations 7, 8, and 9 (Fig. 2).

It was concluded that alkali-aggregate reactions had taken part in the disintegration process.

Combined action of alkali-aggregate reactions, freezing and thawing, and dynamic loading were found to be the cause of rather heavy and rapid deterioration of anchorage blocks and foundations for an aerial mast. The initial quality of this concrete was not adequate for the exposure conditions present.

Recommendations for repair constituted (a) removal of all disintegrated concrete to a depth of at least 15 cm from the surface; (b) careful cleaning of the new surface; (c) casting of a covering of high-quality reinforced concrete on top of the old concrete, the high-quality of the concrete being attained by using nonreactive aggregates, a water-cement ratio not higher than 0.55, and a cement content not less than 400 kg/cu m; (d) careful compaction; and (e) wet curing for at least one week after casting.

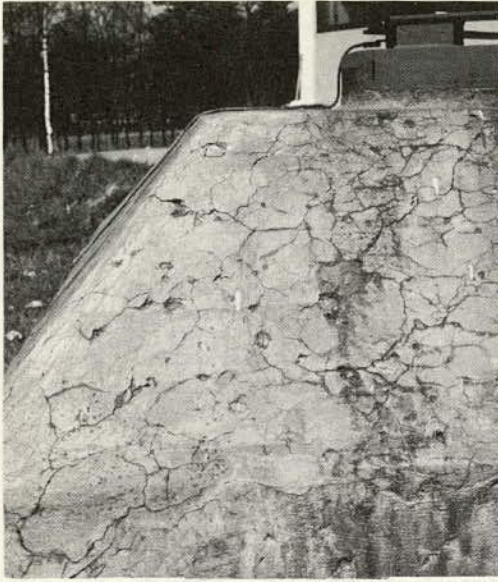
Figure 3. Close-up of mast foundation (10 in Fig. 2) showing extensive map-cracking and pop-outs.
