Dynamic Field Test of Wooden Signposts

FOSTER C. SANKEY, Bureau of Materials, Testing, and Research, Pennsylvania Department of Highways

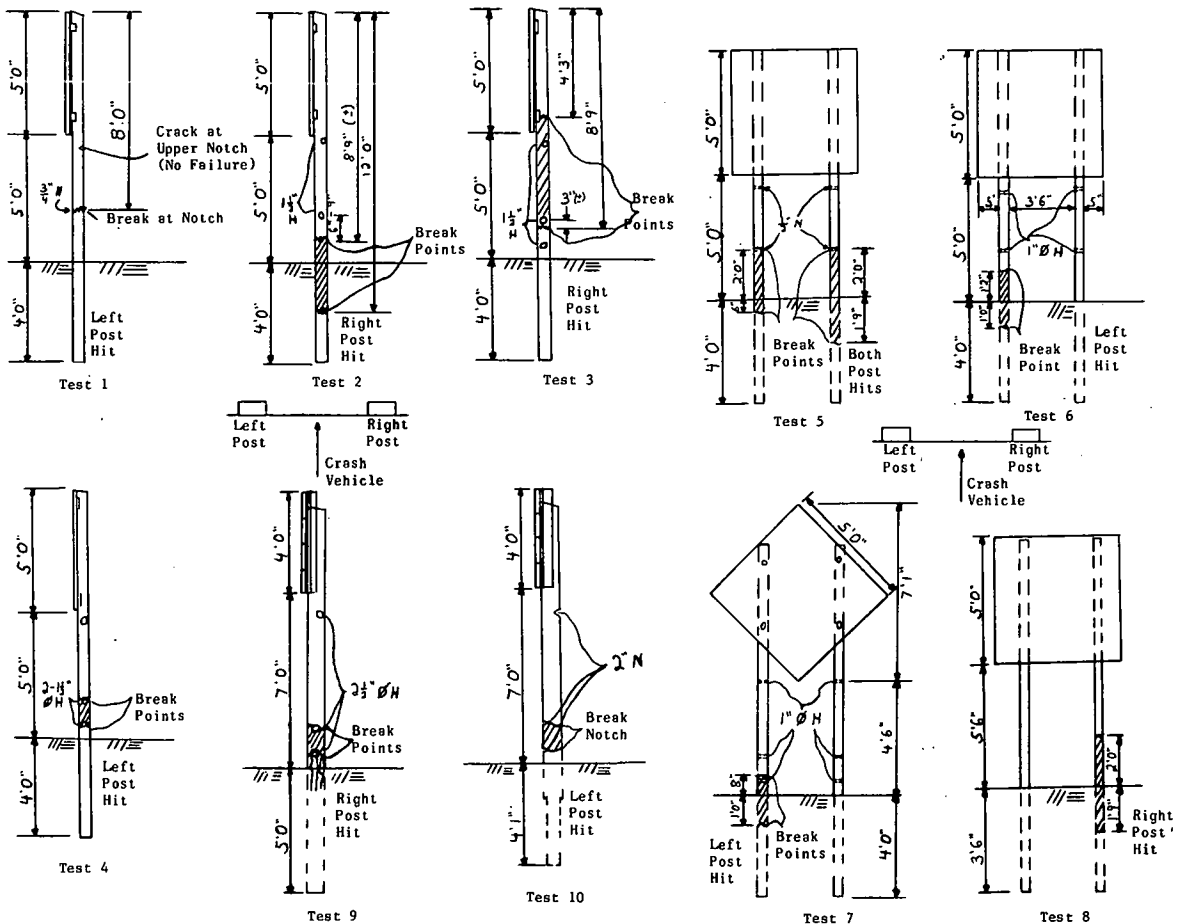
Figure 5. Location of signpost failures.

The results of the 10 tests are given in Table 2 and shown in Figure 5. The tests were run in the order of test 1, 2, 9, 3, 8, 5, 10, 6, 7, and 4.

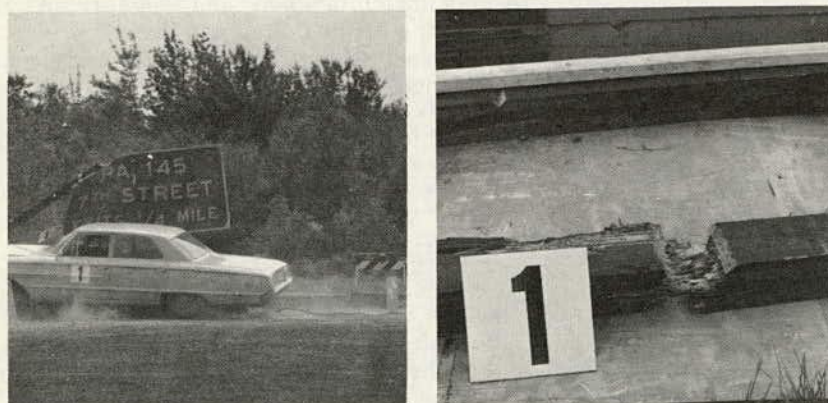
Figure 6. Test 1.

In test 1 (Fig. 6) the sign dropped 2 ft and broke the windshield on the passenger side after the left post was sheared. Thereafter the sign pulled loose from the right

post but stayed attached to the sheared post by the top bolt. A longitudinal crack was observed in the sheared post at the root of the $\frac{3}{4}$ -in. notch, the top plane of weakness.

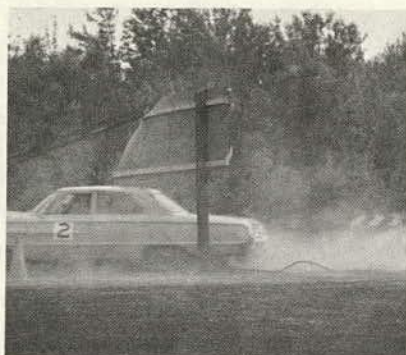
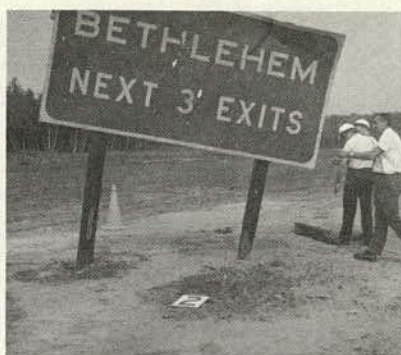
Figure 7. Test 2.

The results from test 2 (Fig. 7) were significant because the left post, the sign, and the upper part of the sheared right post stayed together. The damage to the automobile was caused by the initial impact, and the sign dropped, slightly denting the car roof. If

the sign installation had been mounted with more than 5-ft clearance between the ground line and the bottom of the sign, no further contact with the automobile would have resulted after the initial impact.

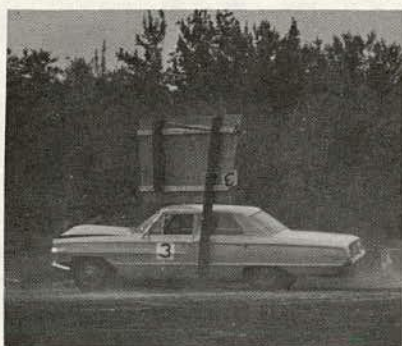
Figure 8. Test 3.

The sign dented the car's roof in test 3 (Fig. 8), and the sheared post also had a failure through the stringer notch above the bottom of the sign. The stringer notch is 2 by 4 in. and is more critical than the top plane failure, which was a $1\frac{1}{2}$ -in. hole. The sign face and right post segment stayed with the left post. A piece of the right post hit the automobile's hood and was carried by it 80 ft from the original sign location.

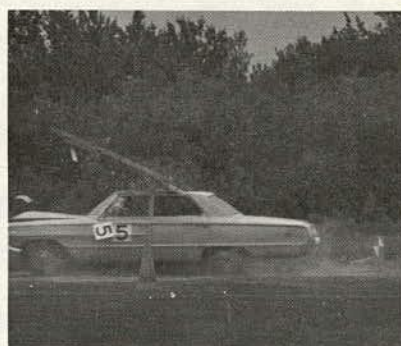
Figure 9. Test 5.

In test 5 (Fig. 9), the most significant of this series of tests, both posts were sheared off at the bottom $1\frac{1}{2}$ -in. notches. The sign dented and tore the roof. The danger of such a collision with a convertible can easily be imagined.

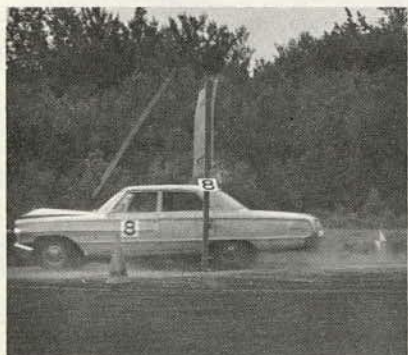
Figure 10. Test 8.

Test 8 (Fig. 10) was supposed to show how a 4- by 4-in. post without any plane of weakness would shear near the ground. Unfortunately, so many knots were prevalent in both posts that it was impossible to exclude them from the bottom of the posts, and the plane of failure was through a knot.

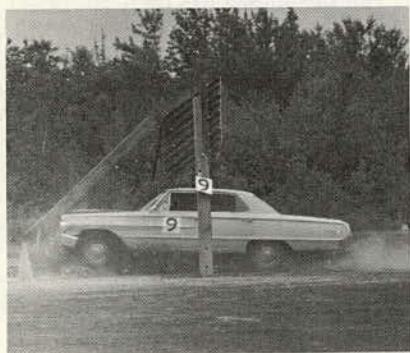
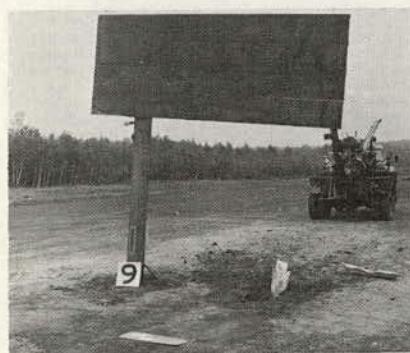
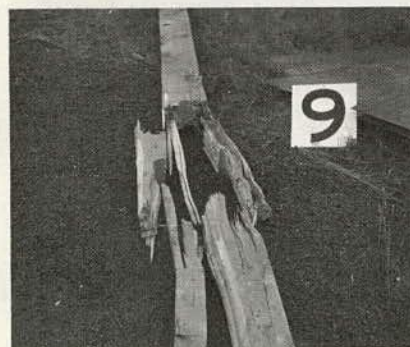
Figure 11. Test 9.

The installation for test 9 (Fig. 11) included a sign mounted with a 7 ft underclearance. The sheared right post pulled loose from the sign; however, the sign stayed attached to the left post. There was secondary contact with the automobile as the sheared post hit the hood and windshield liner, which caused very little damage, and this post segment was carried 120 ft down the runway

by the automobile. The post sheared at the 2 bottom 2 $\frac{1}{2}$ -in. holes, with vertical splitting between the holes.

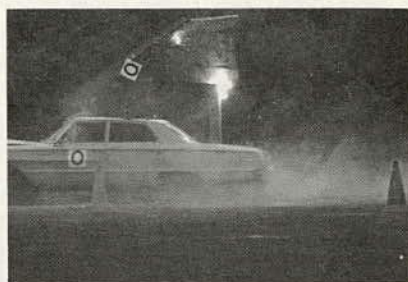
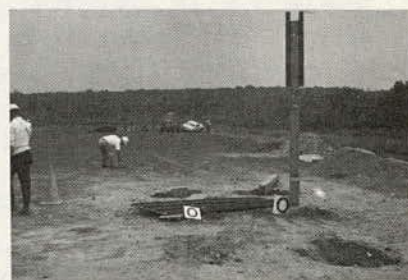
Figure 12. Test 10.

The size of the posts in test 10 (Fig. 12) was the same as those in test 9. The mechanism of failure was through both bottom 2-in. notches initially. After initial contact, the post momentarily stayed with the sign, which did not allow the post to rotate and clear the automobile. A secondary contact with the automobile occurred, and the sheared end of the post smashed the windshield on the driver's side.

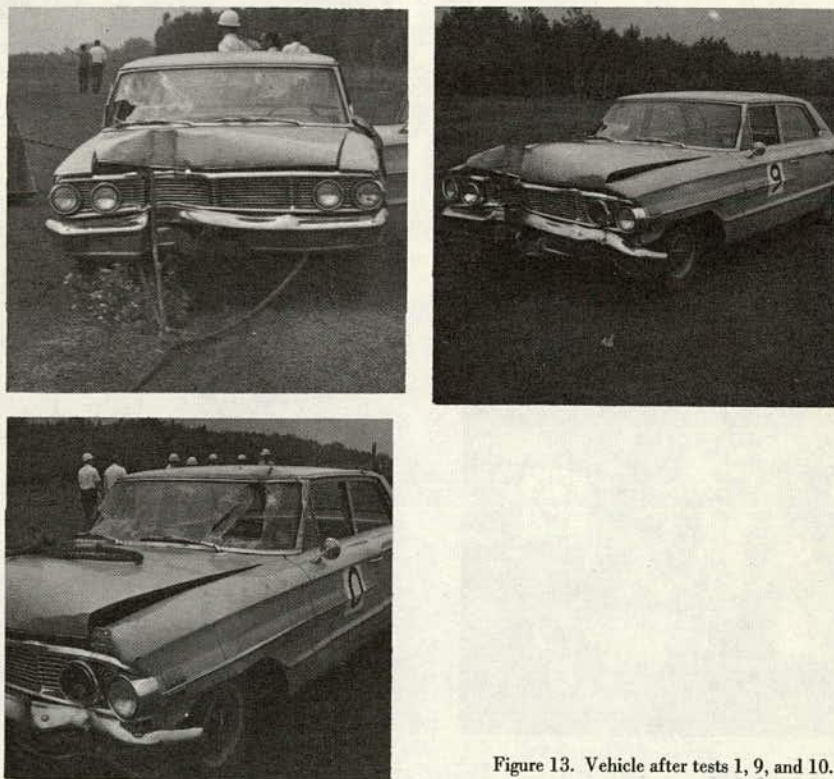
Figure 13. Vehicle after tests 1, 9, and 10.

The automobile was damaged by the sign dropping onto the windshield or roof in all the tests of 6- by 6-in. posts (Fig. 13). The underclearance between the ground and

the bottom of the sign should be increased from 5 ft to 6 or 7 ft. The sign in the tests of the 4- by 4-in. post did not contact the automobile after initial impact, except in test 5 when both posts were sheared. In tests 9 and 10 the 6- by 8-in. post struck the automobile in a secondary contact and in test 10 broke the windshield. This was caused by the more rigid sign-to-post connection.

1. Signs should be mounted so that the minimum clearance from the ground to the bottom of sign is 6 ft and preferably 7 ft.
2. The only plane of weakness should be $2\frac{1}{2}$ -in. diameter holes in 6- by 8-in. posts and $1\frac{1}{2}$ -in. diameter holes in 6- by 6-in. posts spaced at $\frac{1}{2}$ and $1\frac{1}{2}$ ft from the ground line.
3. Posts with 4- by 4-in. cross sections should not be so altered.
4. Strong bolts should be used to make the sign-to-post connection for 6- by 6-in. posts.
